GOLDEN SCOPE INSPECTIONS, LLC

GS TN FINAL

9627 Starry Eyes Lane
Richmond, TX 77407

PROPERTY INSPECTION REPORT FORM

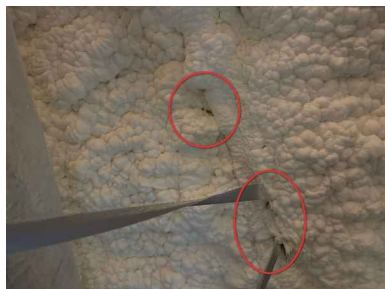
Living Room

1: Foam Defect(s)

The foam insulation in the attic may not have been installed according to the manufacturer's instructions. The foam may lack the proper thickness, and some rafters are not fully covered. These conditions can lead to thermal bridging, which may cause moisture from condensation. This moisture can lead to various issues, such as mold, mildew, or rot. The builder should be consulted regarding this condition.

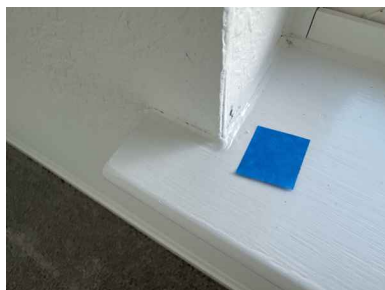
Bedroom Front

New construction tapes

Since this is a newly constructed home, the color tape was used to mark spots and issues that need a touch-up, repair, and or mechanical adjustment throughout the home. These are cosmetic issues. Issues such as these are outside the scope of this report. It is recommended that the buyer note all areas of concern and bring them to the attention of the builder items in the following photos. It is recommended that the buyer still walks through the home, pointing out any areas that inspector may have missed as cosmetic issues can sometimes be subjective.

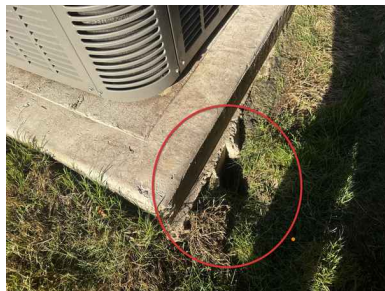
1: Ext. pad(s) erosion

Condensing unit(s) pad(s) show signs of soil erosion. Improvement is recommended.

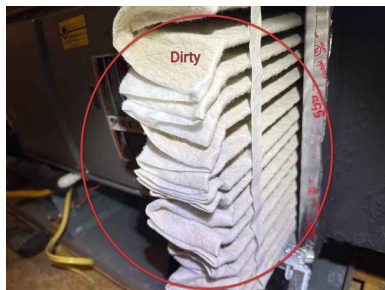
1: Filter dirty

The filter(s) was/were observed to be dirty and should be replaced. Inspector recommends replacing filters according to the manufacturers instructions, typically once monthly for disposable filters and every 6 months for media filter, to ensure the health of the HVAC system. Manufacturer instructions on the unit and filter should be followed.

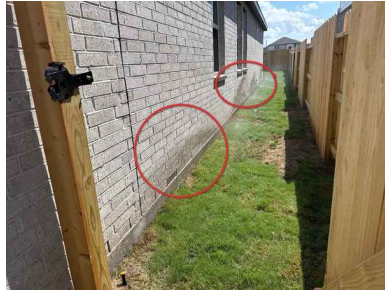
Station 4

1: Sprinkler sprays on home

The sprinkler heads spray excessively onto the home at various zones. Long term, water damage can occur to the home. Recommend evaluation and improvement by a qualified landscape irrigation system contractor.

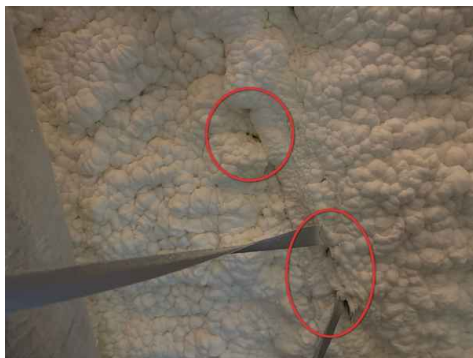
Living Room

FOAM DEFECT(S)

The foam insulation in the attic may not have been installed according to the manufacturer's instructions. The foam may lack the proper thickness, and some rafters are not fully covered. These conditions can lead to thermal bridging, which may cause moisture from condensation. This moisture can lead to various issues, such as mold, mildew, or rot. The builder should be consulted regarding this condition.
