Saji Home 'Spections LLC

4307 Blossom Valley Ln, Richmond, TX 77469
Inspection prepared for: Jonathan Prudencio
Date of Inspection: 4/21/2024 Time: 1000
Age of Home: 2023 Size: 1800 Sq Ft
Weather: Clear & Warm

PROPERTY INSPECTION REPORT

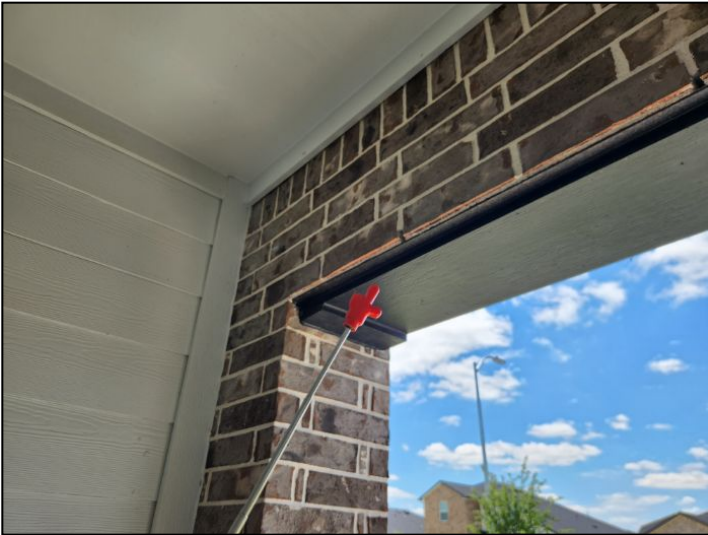
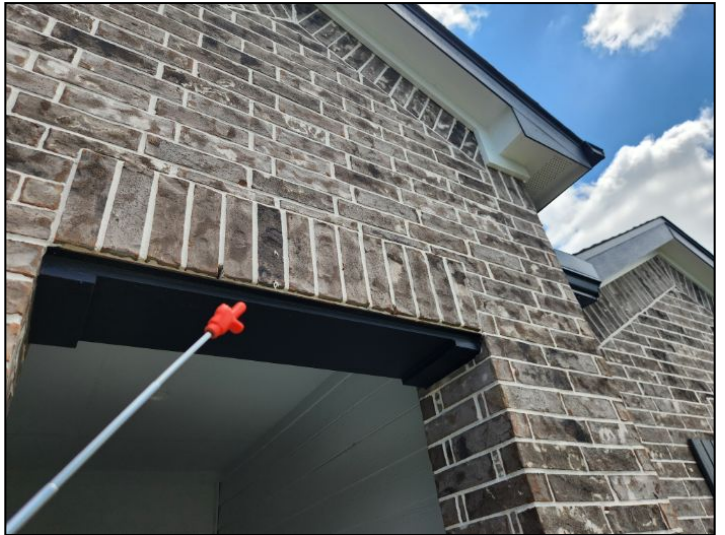
RUST / DETERIORATION AT METAL LINTEL

- Maintain all exterior finishes, caulking, and other sealants at any dissimilar material abutments and all penetrations to the walls and roof. This inexpensive task aids in the prevention of moisture intrusion and saves on costly repairs.
- All pipes, cables, and vent lines should be properly sealed, where they penetrate the exterior siding throughout the home.
- All deficiencies noted in red OR captioned in the pictures should be further evaluated by a qualified professional.
- Seal deterioration / Unsealed areas were noted at one or more exterior siding intersections. Ensure all areas are properly sealed to help prevent issues and water intrusion.
- Rust / Deterioration noted at the metal support lintels. Ensure painting all areas as needed to prevent issues.

| STRUCTURAL SYSTEMS | | |
|---|---|--|
| Page 9 Item: E | Walls (Interior and Exterior) | <ul style="list-style-type: none"> • Seal deterioration / Unsealed areas were noted at one or more exterior siding intersections. Ensure all areas are properly sealed to help prevent issues and water intrusion. • Rust / Deterioration noted at the metal support lintels. Ensure painting all areas as needed to prevent issues. |

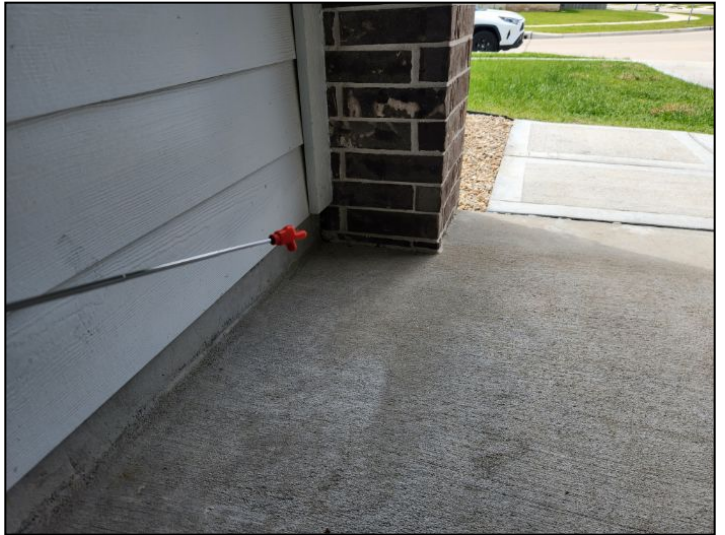
UNSEALED AREAS

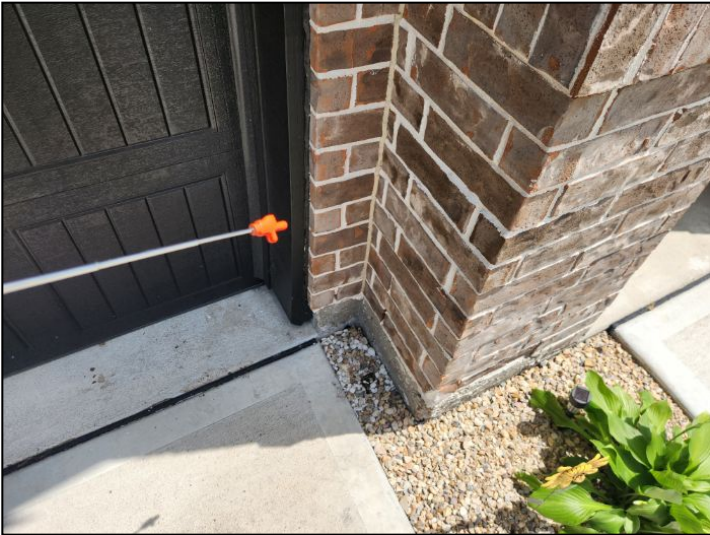
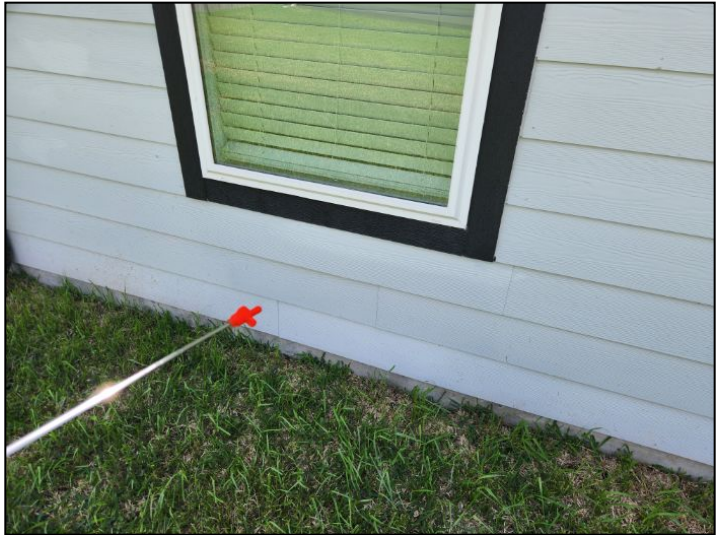
SEAL DETERIORATION

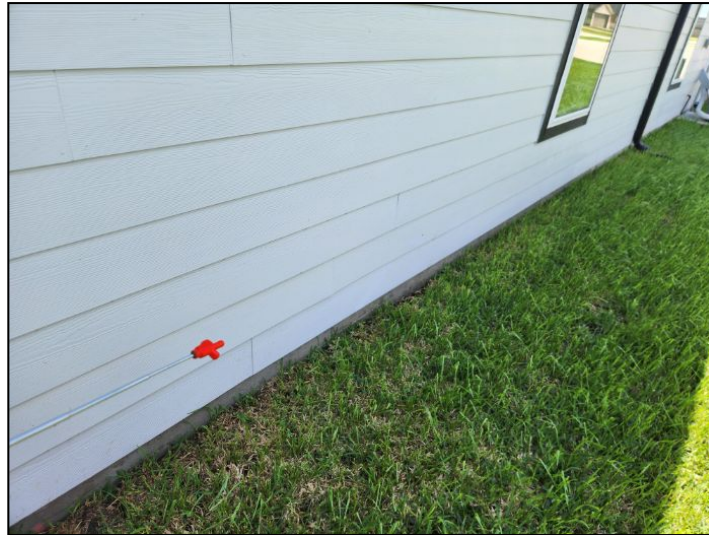
UNSEALED AREA

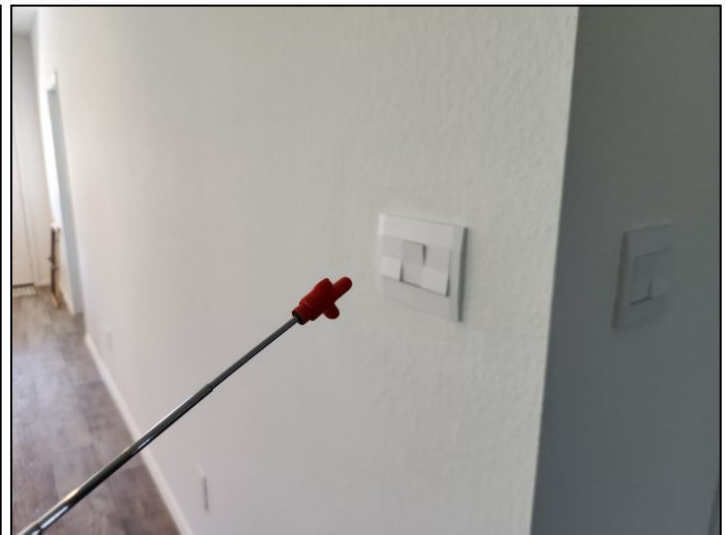
- Limitation: Outlets that are not accessible due to furniture and personal items were not tested at the time of the inspection.
- MAINTENANCE: Periodic testing and changing batteries yearly to ensure proper Smoke Alarm operation is required.
- All deficiencies noted in red OR captioned in the pictures should be further evaluated by a qualified professional.
- **One or more 3 way circuits were noted inoperable. Ensure proper repairs as needed.**

DAMAGED / INOPERABLE 3 WAY SWITCH

| STRUCTURAL SYSTEMS | | |
|---|---|--|
| Page 17 Item: B | Branch Circuits, Connected Devices, and Fixtures | <ul style="list-style-type: none"> • One or more 3 way circuits were noted inoperable. Ensure proper repairs as needed. |

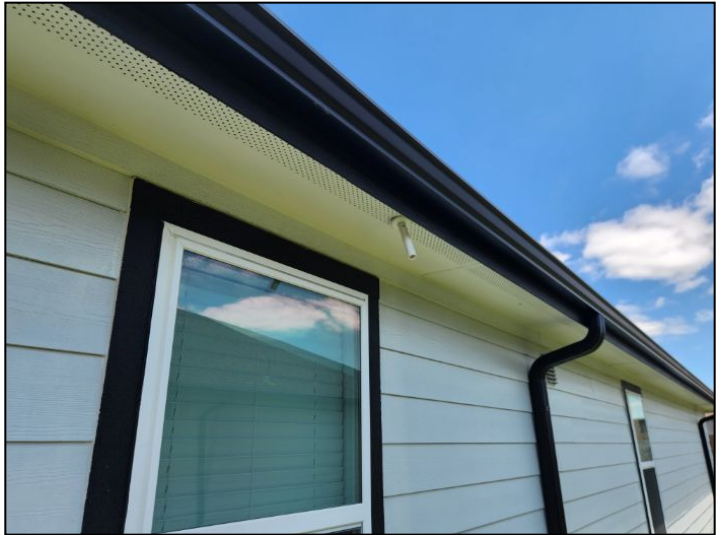
EVAPORATOR SECONDARY DRAIN PIPE
ROUTED HERE

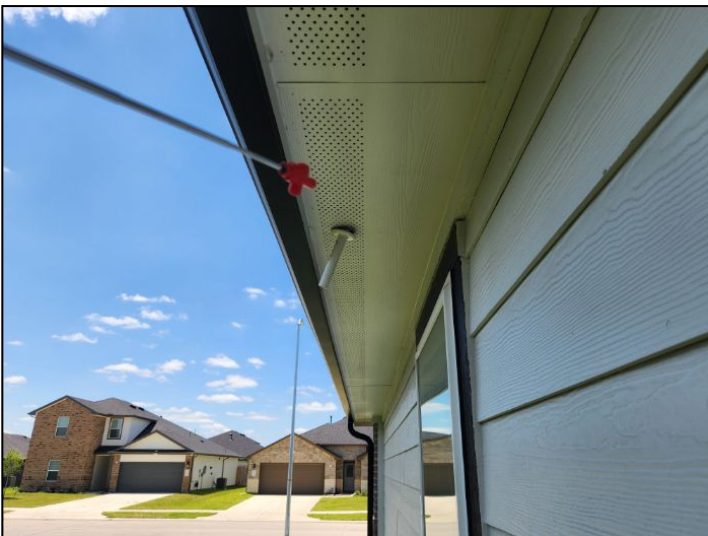
- MAINTENANCE: Remember to properly clean the primary drain line from the evaporator. It is recommended to clean this line with bleach every other month or as needed to prevent clogging / water damage.
- Air differential tested: Register =52 Return = 72 DELTA = 20 degrees (Standard range is 14 - 22 degrees for the cooling equipment.) YOU CAN ALWAYS VERIFY THIS INFORMATION WITH THE PROVIDED PICTURE OF THE ACTUAL MEASUREMENT
- The secondary drain line for the evaporator was noted exiting at the RIGHT of the home. (If this pipe ever drips then the primary line is clogged and needs cleaning)
- Unsealed areas noted at the secondary drain termination and eave area. Ensure properly sealing all areas as needed.

UNSEALED AREA

| STRUCTURAL SYSTEMS | | |
|---|---|--|
| Page 19 Item: B | Cooling Equipment | <ul style="list-style-type: none"> • Unsealed areas noted at the secondary drain termination and eave area. Ensure properly sealing all areas as needed. |

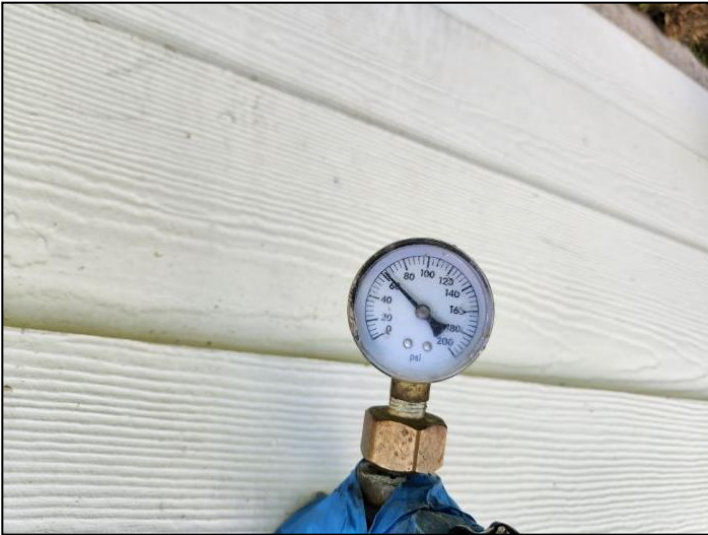
WATER PRESSURE OK; 60 PSI

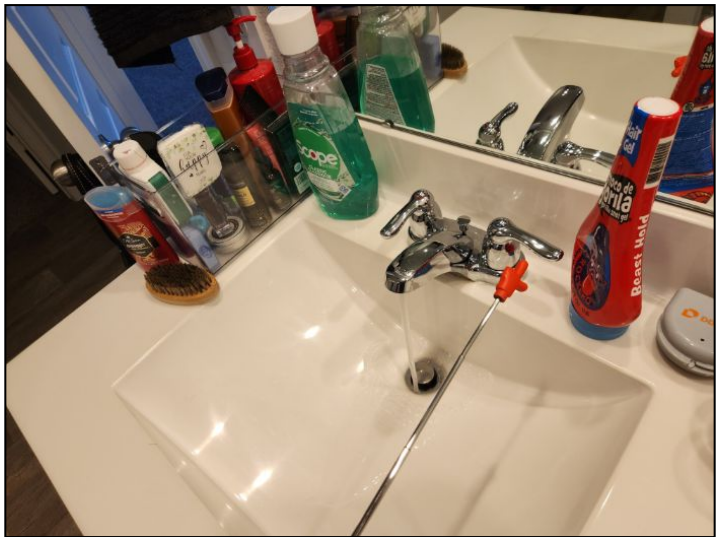
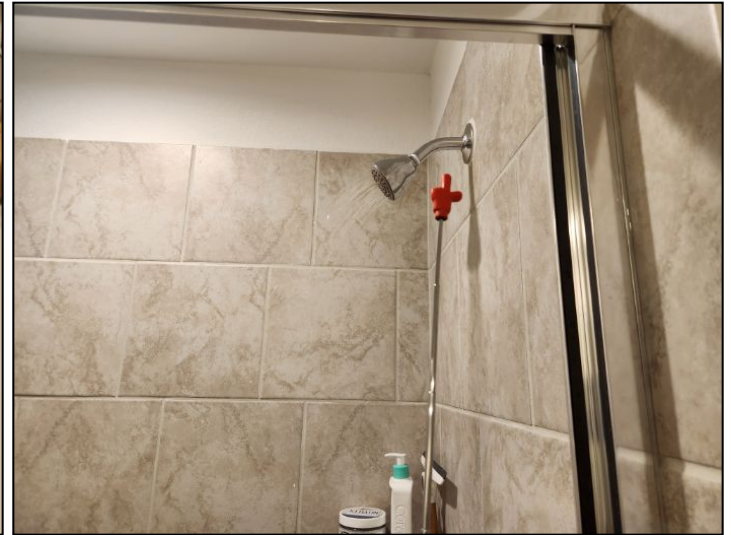
- Suggest all tile edges and tub/shower walls be caulked and sealed to prevent moisture penetration. All missing/damaged grouting should be replaced. Failure to keep walls sealed can cause deterioration and extensive moisture damage to the interior walls and surrounding sub-flooring. This damage is not always visible or accessible to the inspector at the time of inspection.
- Plumbing Supply Material(s): PEX
- Static Water Pressure Reading:60 PSI
- All deficiencies noted in red OR captioned in the pictures should be further evaluated by a qualified professional.
- One or more plumbing fixtures found with poor water flow / pressure. The overall pressure to the home is within range suggesting local fixtures are clogged with debris. Ensure proper repairs as needed.

LOW PRESSURE / POOR WATER FLOW

| STRUCTURAL SYSTEMS | | |
|---|---|--|
| Page 23 Item: A | Plumbing Supply, Distribution System and Fixtures | <ul style="list-style-type: none"> • One or more plumbing fixtures found with poor water flow / pressure. The overall pressure to the home is within range suggesting local fixtures are clogged with debris. Ensure proper repairs as needed. |

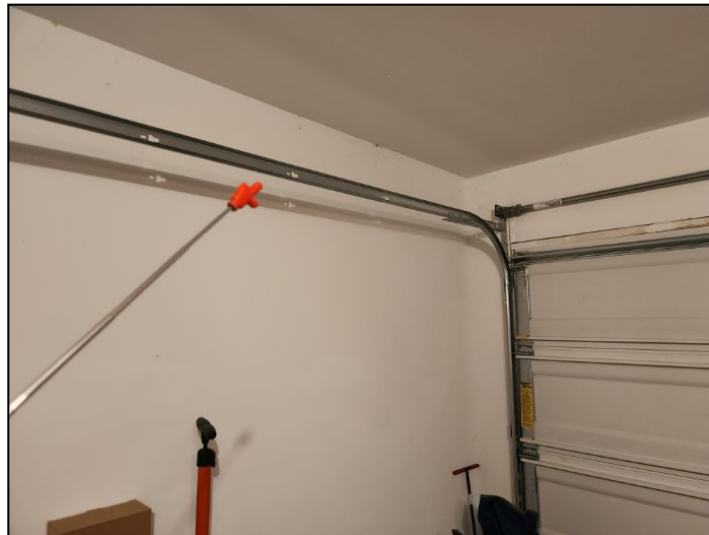
- All deficiencies noted should be evaluated and repaired by an garage door installation professional.
- The overhead garage door(s) operated normally when tested. No deficiencies were observed regarding operation.
- Excessive friction and noise were noted at the railing and garage doors when operated. Recommend proper lubrication all areas of the railing and garage door rollers.

LUBRICATION NEEDED AT RAILING

| STRUCTURAL SYSTEMS | | |
|---|---|--|
| Page 28 Item: G | Garage Door Operators | <ul style="list-style-type: none"> • Excessive friction and noise were noted at the railing and garage doors when operated. Recommend properly lubrication all areas of the railing and garage door rollers. |

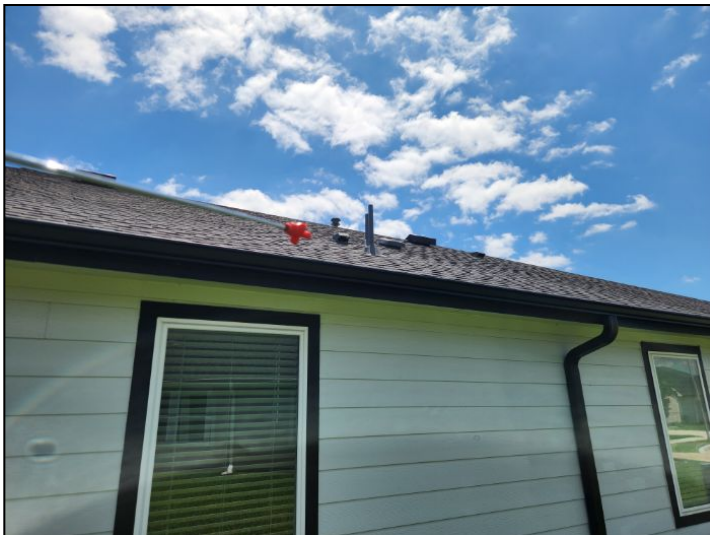
- The washer / dryer or appliances were noted present and connected thus the connections and drain line could not be fully verified.
- Excessive lint build-up at the exterior vent cover. Recommend cleaning the dryer vent duct line.

LINT BUILDUP AT DRYER VENT

| STRUCTURAL SYSTEMS | | |
|---|---|--|
| Page 30 Item: H | Dryer Exhaust Systems | <ul style="list-style-type: none"> • Excessive lint build-up at the exterior vent cover. Recommend cleaning the dryer vent duct line. |

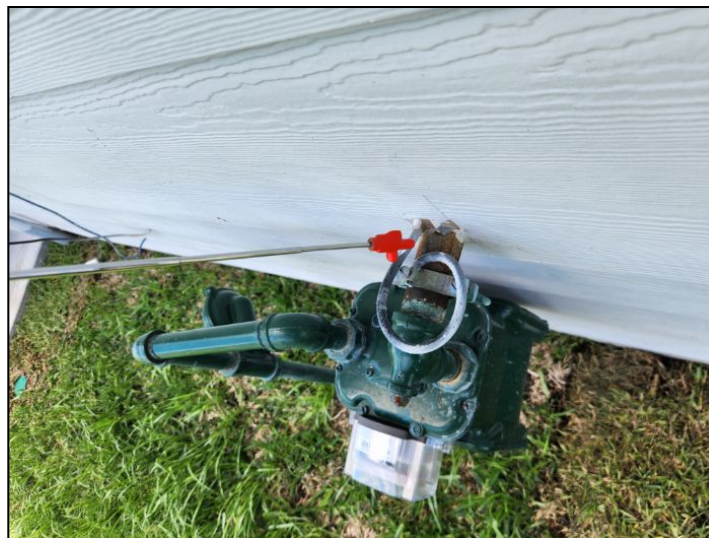
- Minor / Minimal signs of rust and deterioration were noted present at the main connections and pipes. Recommend properly painting all areas as needed to prevent issues or further deterioration.

RUST / DETERIORATION AT GAS MAIN

| STRUCTURAL SYSTEMS | | |
|---|---|--|
| Page 31 Item: I | Other | <ul style="list-style-type: none"> • Minor / Minimal signs of rust and deterioration were noted present at the main connections and pipes. Recommend properly painting all areas as needed to prevent issues or further deterioration. |
