JMark Inspections, Inc.

1067 Lakemont Bend Lane Magnolia TX 77362

PROPERTY INSPECTION REPORT FORM

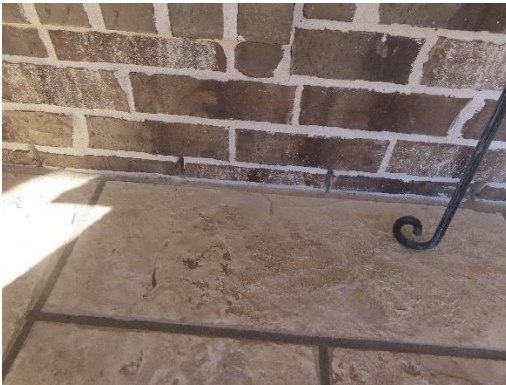
Comments: Grading & Drainage is written as deficient due to;

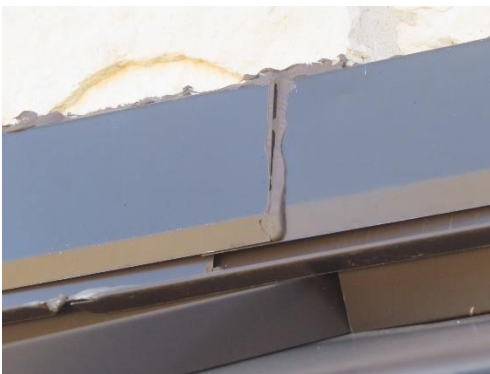
Item#1

1. The void at the flashing joint above the garage door opening needs to be sealed to prevent possible water penetration.

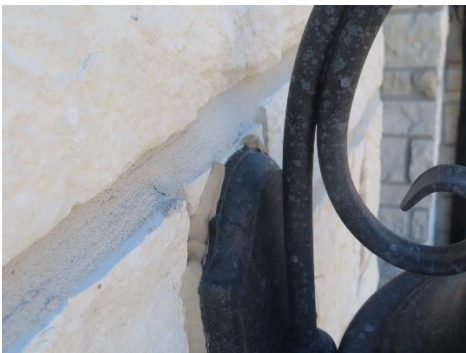
Item#1

1. There is a void in the caulk around the exterior coach light at the north side of the front door entrance. This is an area of possible water penetration.
2. The HVAC shutoffs on the north exterior wall need to be fully sealed on the tops and sides to prevent possible water penetration.
3. The generator box on the north exterior wall needs to be sealed on the top and sides to prevent possible water penetration.
4. There is a void in the mortar on the south exterior wall, just above the breakfast room windows. Should seal void to prevent possible water penetration and/or pest intrusion.

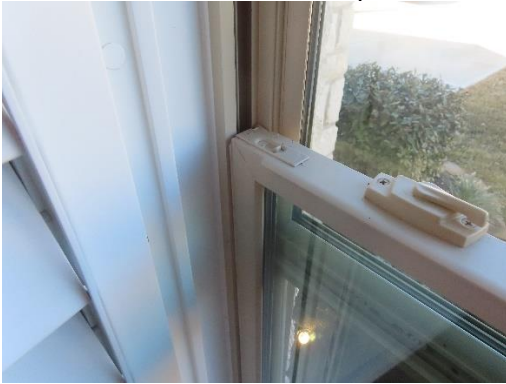
Item#1

1. The southeast garage window's left latch does not engage as intended.
2. The windows with the wood shutters installed, will not allow the "fold in" option, due to the trim blocking. The "fold in" option allow for cleaning glass from the interior of the home.

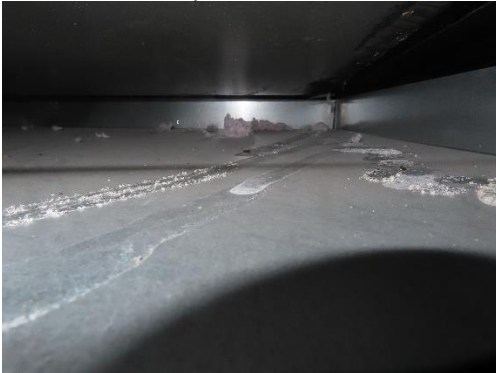
Item#1(unit accessed by attic stairs)

1. There is insulation in the safety pans of the both units in the attic areas. The insulation should be removed to prevent the drain line from being clogged, if water were to be introduced.

Due to defects observed, recommend service by qualified H.V.A.C Service Company
 Note: RECOMMEND MAINTENANCE AND SERVICE PRIOR TO USE.

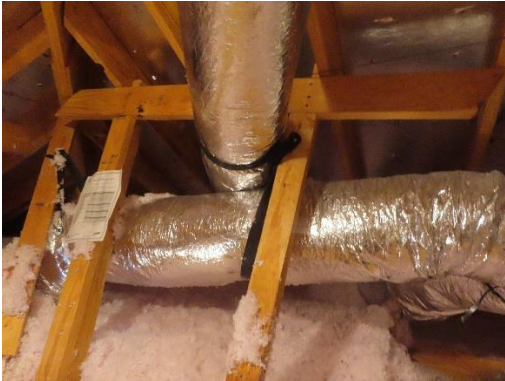
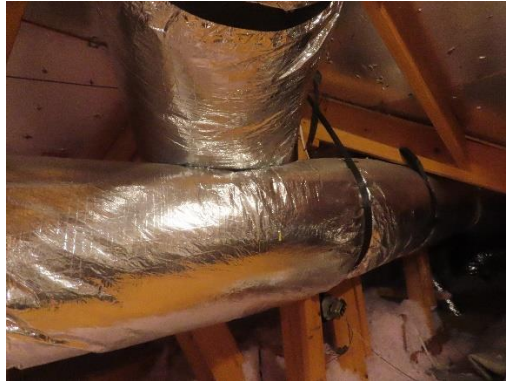
Item#1(sample area)

1. There are a couple of ducts touching in the attic area accessed by the attic stairs. The ducts should be separated...ie..batt insulation. The separation will help prevent possible moisture build up on the touching ducts.

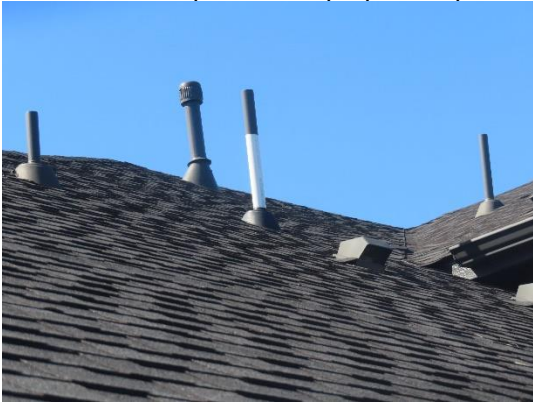
Item#1

- 1. There is a plumbing vent stack at the roof covering that is not fully painted. The stacks should be fully painted for proper UV protection.

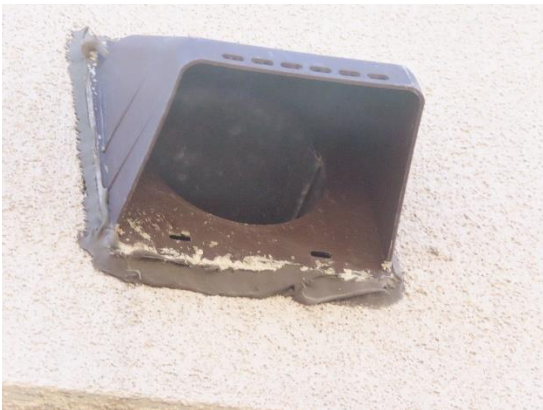
Item#1

1. The exhaust vent of the north exterior wall is missing its flapper cover. The flapper helps with pest intrusion.

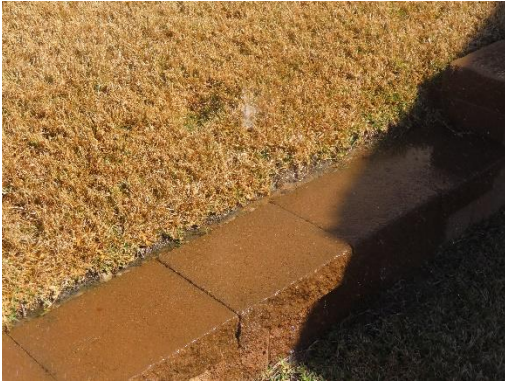
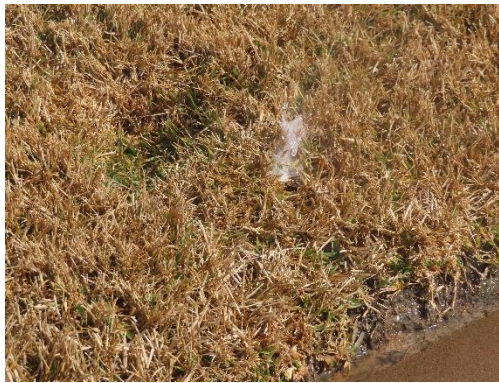
Item#1

- 1. Zone 3 – Head near the south retaining wall, in the front yard, does not come up high enough in the grass. This does not all for proper coverage as intended.
