TREC REI 7-6 HOME INSPECTION (MEER INSPECTIONS)

10515 Logger Pines Trail  
Houston, TX 77088

# PROPERTY INSPECTION REPORT FORM

03/13/2024 1:00 pm

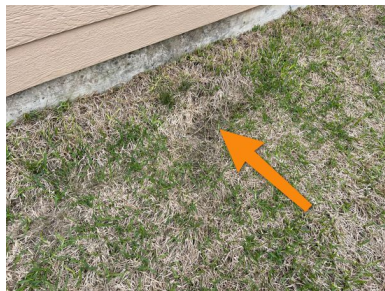
Right side of home

**1: Grading - Soil erosion under valley**

Soil erosion observed. Address as needed.

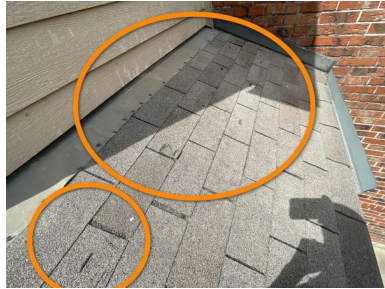
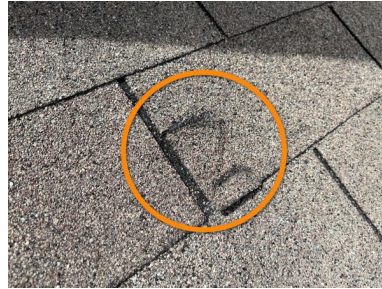
Ladder damage front porch

**1: Shingles - Damaged**

Damaged shingles may allow moisture intrusion. Recommend a qualified roofer to evaluate and address as needed.

Close up ladder damage front porch

Recommendation: Contact a qualified roofing professional.

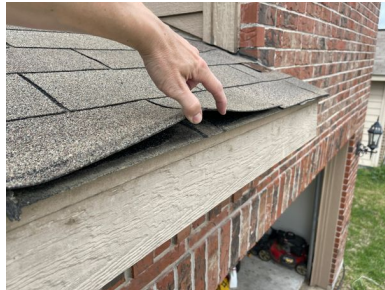
Bottom row around home

**2: Shingles - Loose shingles**

Shingles are not properly secured down, which may result in wind uplift or damage to shingles in windy conditions. Recommend qualified roofing contractor to evaluate and address as needed.

Recommendation: Contact a qualified roofing professional.

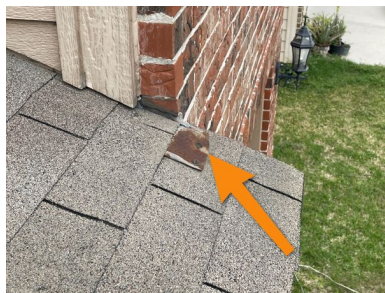
Above garage

**3: Flashing - Rusted**

Rusted flashing may allow moisture intrusion. Evaluate and address as needed.

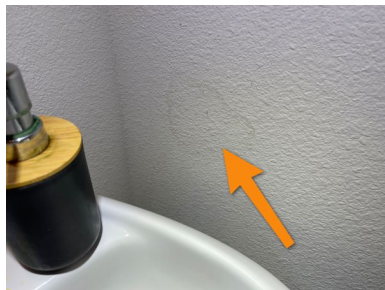
Half Bathroom right of sink

**1: Interior - Water stain on wall**

Water stain on wall indicates moisture intrusion. The area tested dry with a surface moisture meter. The cause was not determined. Evaluate and address as needed.

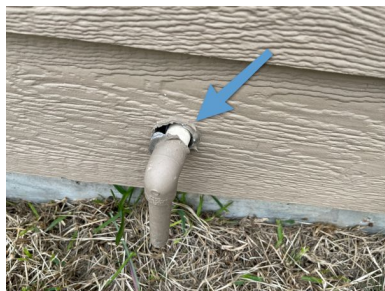
Right wall

**2: Exterior - Missing/cracked caulk**

Missing or cracked caulk at openings in the wall and items mounted to or pass through the wall. It is recommended that any penetrations through exterior walls should be sealed (caulked) to prevent moisture intrusion. Address as needed.

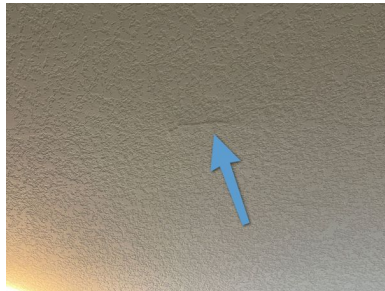
Left rear bedroom

**1: Ceiling - Typical flaws / Imperfections**

This is considered cosmetic. Address as needed.

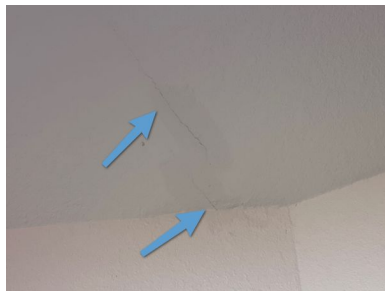
Master Bedroom

**2: Ceiling - Tape joint cracks**

Hairline texture cracks along ceiling drywall tape joints are normally associated with normal settlement and are considered cosmetic. Address as needed

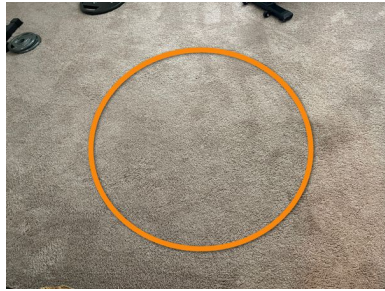
Random Areas

**3: Floors - Squeaky subfloor**

Squeaky sub flooring when walked on. Evaluate and address as needed.

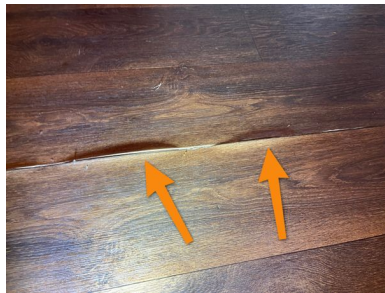
Half Bathroom at seam

**4: Flooring - Lifted flooring**

The flooring is slightly lifting or loose. This may indicate prior moisture contact. Evaluate and address as needed.

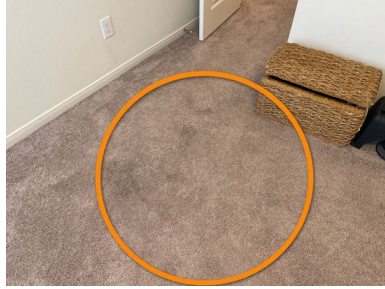
Rear left bedroom

**5: Flooring - Slight unevenness**

The flooring is just slightly uneven. This does not appear to be causing any structural side effects.

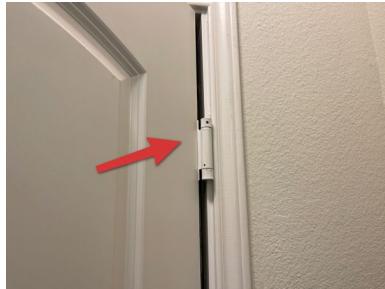
Door to garage

**1: Missing or ineffective self closer**

The self closing door hinge is missing or ineffective between the home and the attached garage. Current building standards recommend a self closer in this location to ensure the door stays closed to prevent hazardous combustion products from entering home.

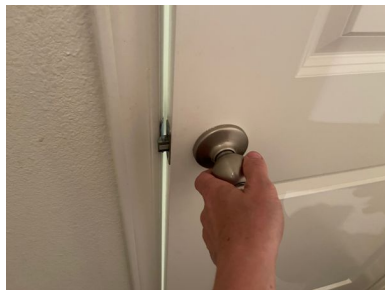
2nd Floor Hall Bathroom

**2: Door not latching**

The door can be pulled open without turning the knob. Address/Adjust as needed.

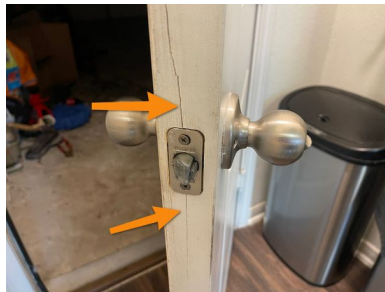
Door to garage

**4: Damaged door**

Address as needed.

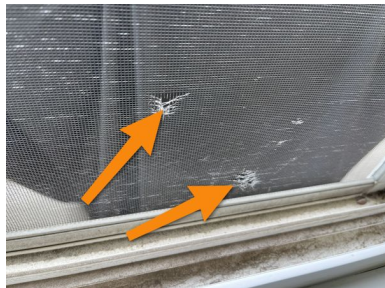
Random Windows

**1: Missing and/or damaged screens**

This may allow pests to enter home. Address as needed.

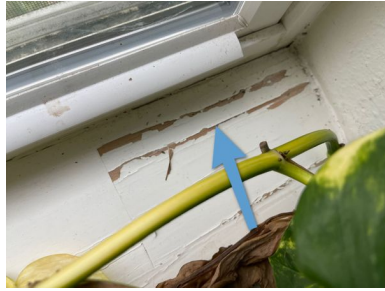
Random Windows

**2: Water stain/water damage near window**

Water stains or water damage on the window sill or drywall at windows may be from windows condensating. Address as needed.

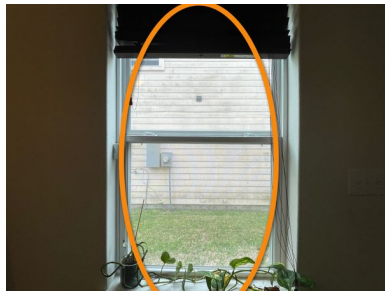
Foyer

### 3: Failed thermal seal

Window appears hazy or has condensation between the window panes, which indicates a failed seal. Once the thermal seal has failed the window is no longer as energy efficient as it was. Over time the window may become less transparent.

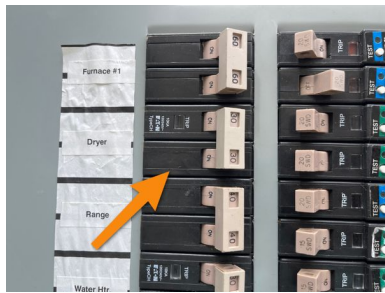
Breaker Panel

**1: Dryer GFCI not present**

Current building standards call for the dryer outlet to be GFCI (Ground Fault Circuit Interrupter) protected. Address as needed.

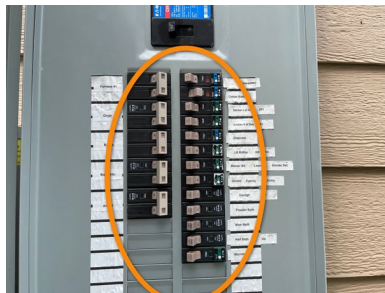
Breaker Panel

**2: Surge protection not present**

Current building standards call for surge protection for the electrical system. Address as needed.

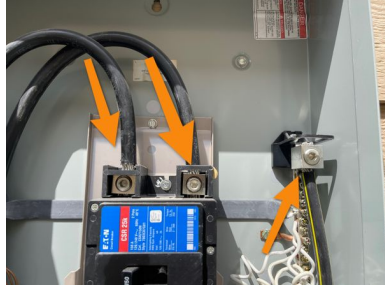
Breaker Panel

**3: Anti-oxidant missing on aluminum wires**

Missing anti-oxidant paste on aluminum service wires. This is a current building standard.

Recommendation: Contact a qualified electrical contractor.

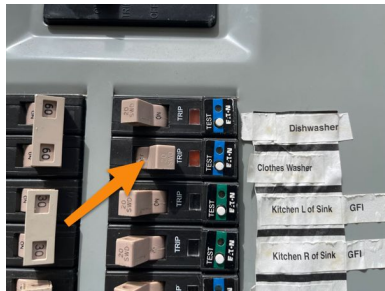
Washing machine breaker

**4: Breaker tripped**

The breaker is tripped off. If reset, it trips off again. This indicates an issue either with the breaker or wiring or outlet. Recommend further evaluation by an electrician.

Recommendation: Contact a qualified electrical contractor.

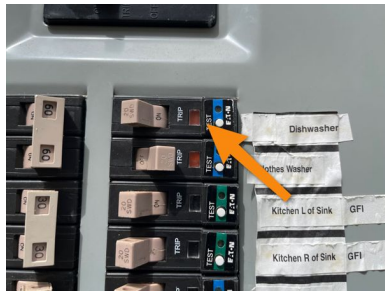
**5: Dishwasher breaker shows to be tripped**

The dishwasher breaker shows to be tripped off but the dishwasher worked. So the breaker may not be functioning correctly. Recommend further evaluation by an electrician.

Recommendation: Contact a qualified electrical contractor.

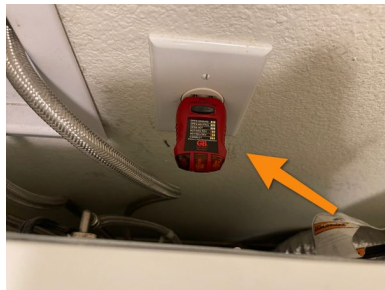
Washing machine outlet

**1: Outlets - No power**

No power at receptacle. Recommend evaluation by electrician to determine the best method of remedy.

Recommendation: Contact a qualified electrical contractor.

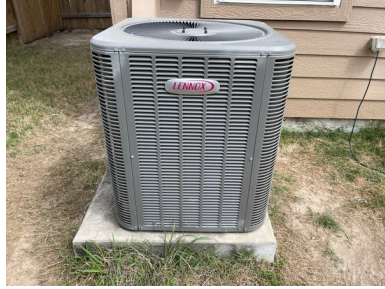
6 years old

**1: Service due to age and limitations of inspection**

At the time of inspection HVAC system was performing as intended, although due to age of the air conditioner and the limitations of this inspection it is recommended to have a general annual service and cleaning performed on the air conditioner by an HVAC technician.

Recommendation: Contact a qualified HVAC professional.

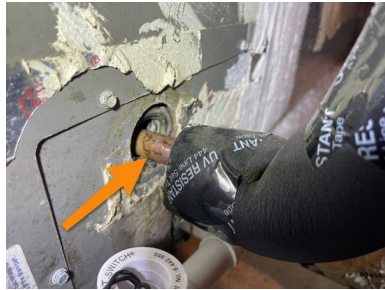
Evaporator housing

## 2: Damaged/missing insulation on refrigerant line

Missing or damaged insulation on the refrigerant line can cause energy loss and condensation that may drip and cause water damage if in the attic. Address as needed.

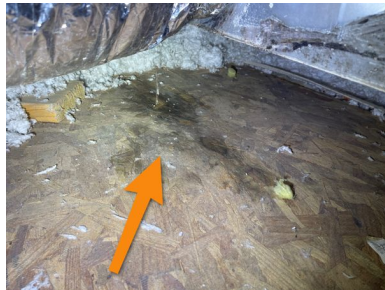
Left of furnace

## 3: Water stain at HVAC equipment

Water stain indicates evidence of condensation dripping onto the attic floor. Recommend further evaluation by an HVAC technician.

Recommendation: Contact a qualified HVAC professional.

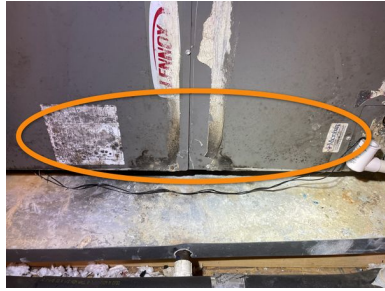
## 4: Microbial growth on HVAC system

Microbial growth was observed on the HVAC system. This indicates condensation build up on the exterior of the unit and will not impact air quality passing through the system. Recommend evaluation by a qualified HVAC company.

Recommendation: Contact a qualified HVAC professional.

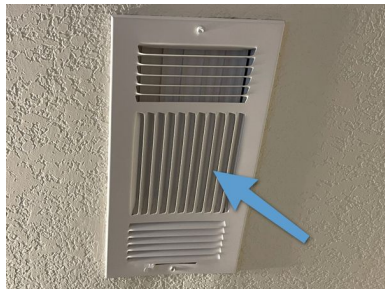
Right rear bedroom

**1: Vents - Closed air register**

Closed air register observed. Recommend opening all closed registers for best air circulation.

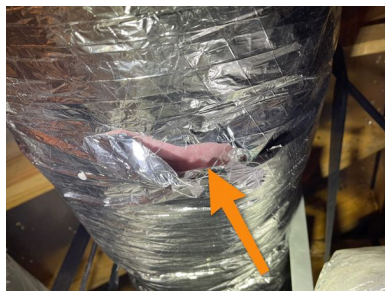
Left of furnace

**2: Ducts - Outer layer of duct is torn**

Address as needed.

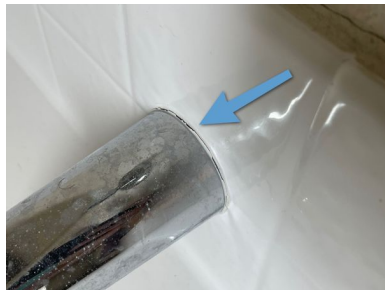
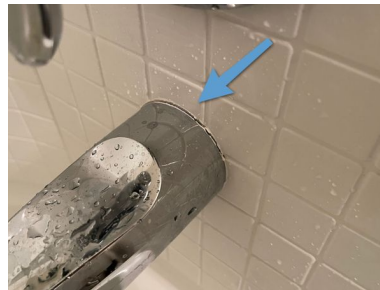
Master Bathroom tub

**1: Faucet - Missing/deteriorated caulk**

Missing or deteriorated caulk may allow moisture intrusion into the wall. Recommend caulking to prevent moisture intrusion. Evaluate and address as needed.

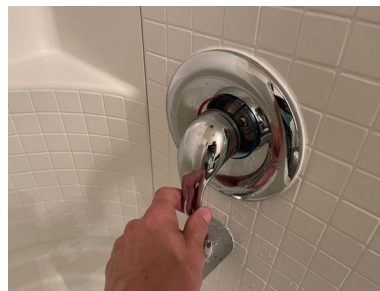
2nd Floor Hall Bathroom tub

**2: Faucet - Loose**

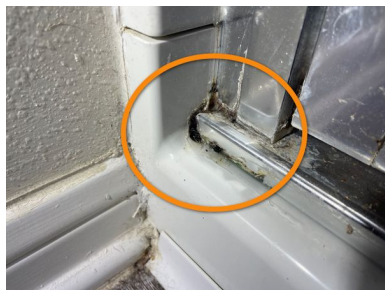
Master Bathroom

**3: Shower - Water leaking out of shower**

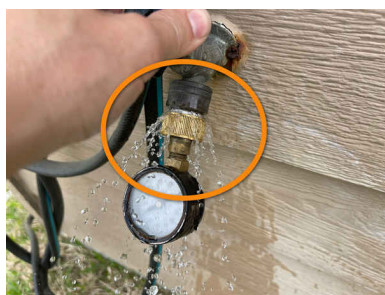
Both hose bibbs

**4: Hose bibb - Backflow prevention is leaking**

The backflow prevention device leaks when the water is turned on. Address as needed.

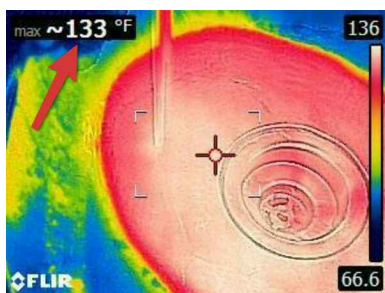
Water Temp

**▲ Safety Hazard**

The water heater is adjusted above the recommended temperature of 120 degrees. Scalding hazard. The temperature can be adjusted at the water heater. There is a round dial that can be turned to the desired temperature. Adjust temperature as needed.

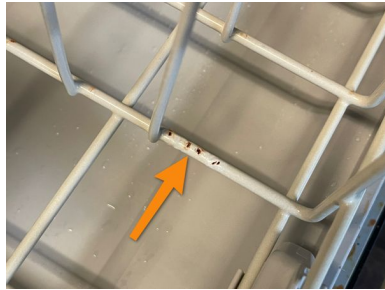
Dishwasher

**1: Rust/missing tines on dish rack**

Rust and/or missing tines were observed on the dish racks. Address as needed.

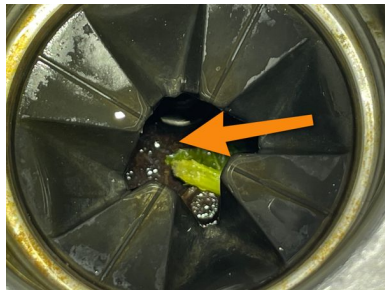
Waste disposal

**1: Rust inside waste disposal**

Evaluate and address as needed.

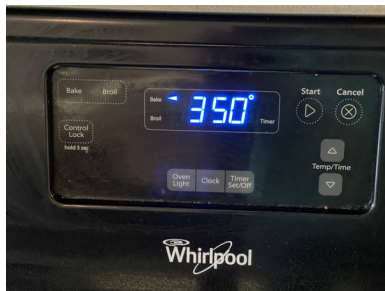
Oven

The oven was not within 25 degrees of 350, which is the tested temperature. Adjust as needed.
