DANE INSPECTION SERVICES

INTERNACHI RESIDENTIAL

8510 Robindell Dr
Houston, TX 77074

04/15/2026

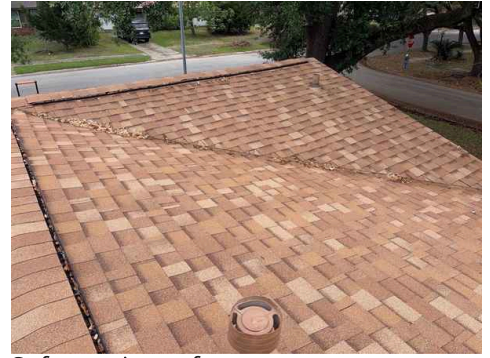
ROOF DEFLECTION/SOFT SPOT

Deflection or soft spots were observed in the roof covering during inspection. This indicates the roof deck may be weakened, potentially from water damage, rot, or structural issues beneath the surface. A roofing professional should evaluate the affected area to determine the cause and recommend appropriate repairs to prevent further deterioration and potential water intrusion.

Soft spot in roof

Contact a qualified professional.

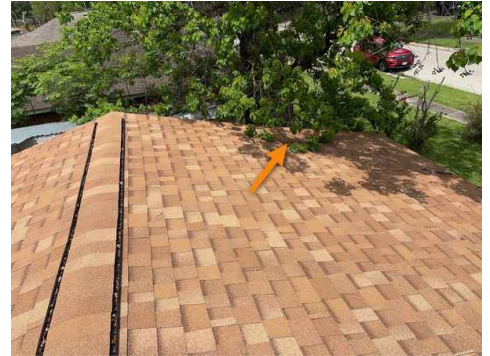
TREES TOUCHING ROOF

Trees were noted to be touching the roof and the time of inspection. We recommend having all tree limbs trimmed back to prevent premature wear and damage to the shingles.

Trees touching roof

Contact a qualified professional.

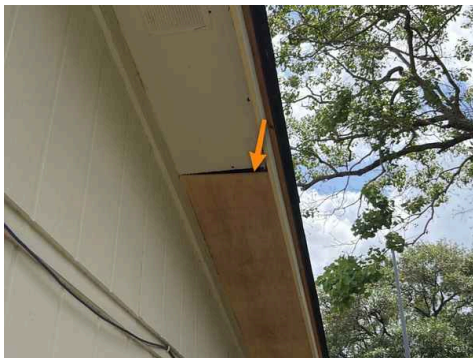
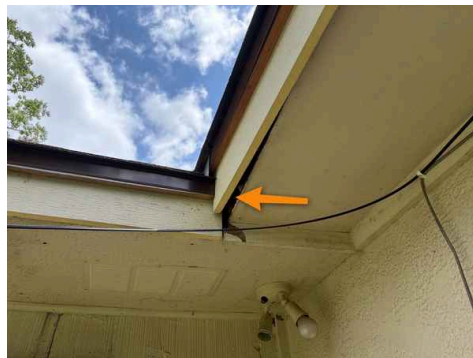
DAMAGED SOFFIT

Soffit damage was observed during the roof covering inspection. Damaged soffit can allow water infiltration, pest entry, and may indicate underlying ventilation or structural issues. A roofing professional should evaluate the extent of damage and recommend appropriate repairs or replacement.

Contact a qualified professional.

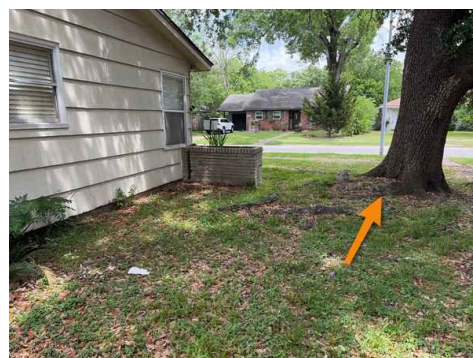
Left

TREE ROOTS NEAR FOUNDATION

Tree roots were observed in close proximity to the foundation during inspection. Root systems can potentially infiltrate foundation cracks, exert pressure on foundation walls, or damage underground utilities and drainage systems. A tree service professional should evaluate the specific trees involved and recommend appropriate measures such as root barriers, tree removal, or monitoring to prevent future foundation damage.

Contact a qualified professional.

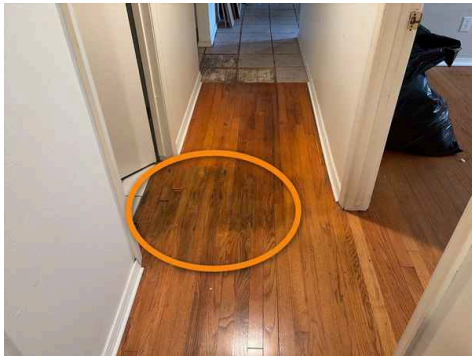
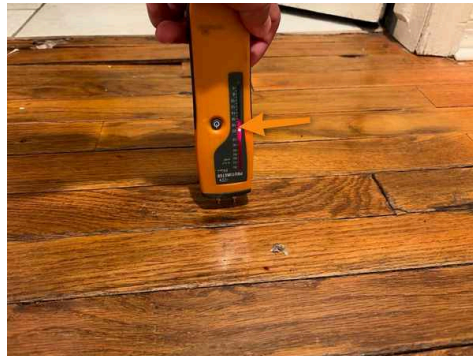
SOFT/ROTTED FLOORS WITH MOISTURE

Soft or rotted flooring was confirmed to be wet during inspection. This indicates active moisture damage and wood deterioration, which compromises structural integrity and creates potential safety hazards. A foundation or structural contractor should evaluate the extent of damage, identify the moisture source, and recommend necessary repairs or replacement.

Hall confirmed wet

Contact a qualified professional.

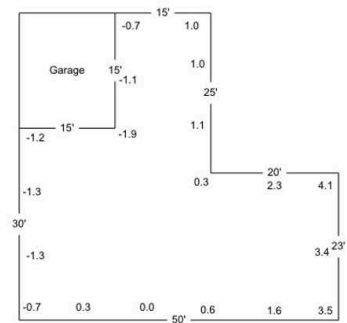
FOUNDATION MEASUREMENTS OUT OF TOLERANCE

Foundation measurements were found to be outside acceptable tolerances during inspection. This indicates potential structural settlement, shifting, or construction irregularities that warrant professional evaluation. A structural engineer/foundation specialist should assess the extent of deviation and determine whether repairs or monitoring is necessary.

Contact a qualified professional.

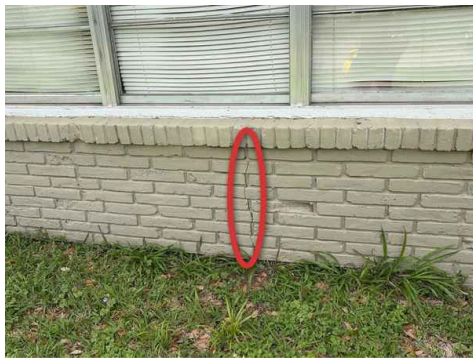
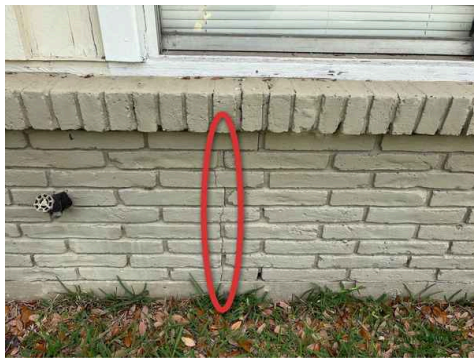
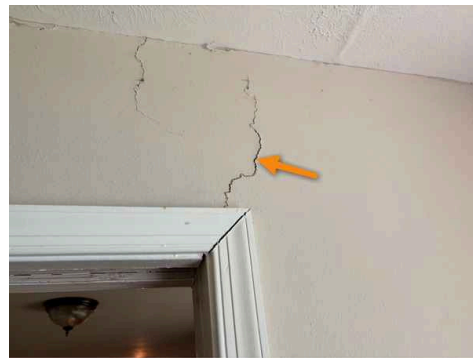
CRACKS - MAJOR

Step cracking observed in wall structure. This could be from moisture intrusion at the structure and/or soil movement. Recommend a qualified structural engineer evaluate and advise on course of action.

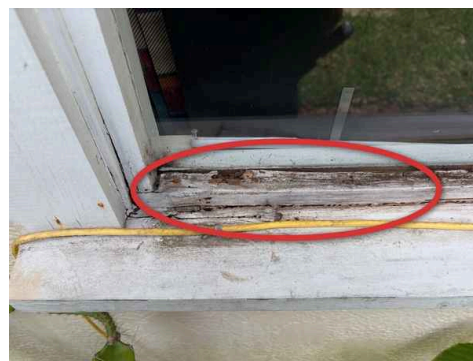
TERMITE DAMAGE

Termite damage was observed in the wall structure during inspection. Termites feed on wood, creating galleries and weakening structural integrity. This can compromise the stability of walls and support systems. A pest control professional should evaluate the extent of damage and recommend treatment options.

Contact a qualified professional.

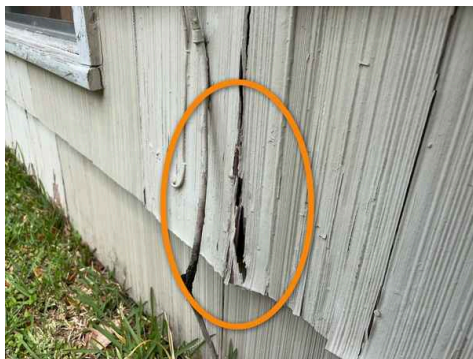
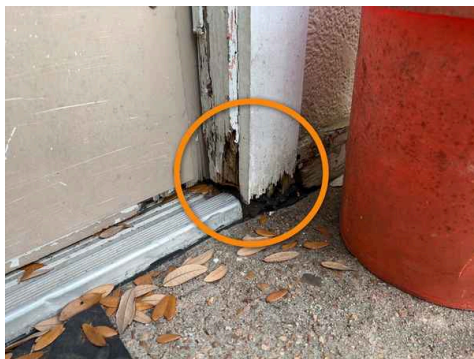
WOOD ROT

Wood rot was observed throughout the property during inspection. This decay compromises the structural integrity of affected wood components and can spread to additional areas if moisture conditions persist. A qualified professional should evaluate the extent of the rot, identify moisture sources, and recommend appropriate repair or replacement of damaged wood members.

Contact a qualified professional.

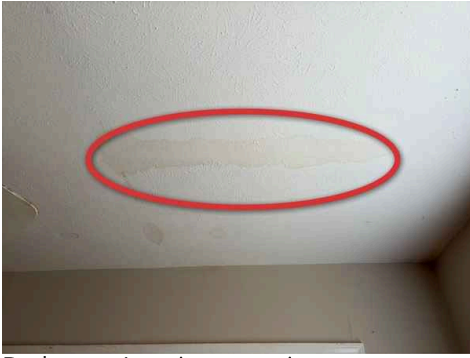
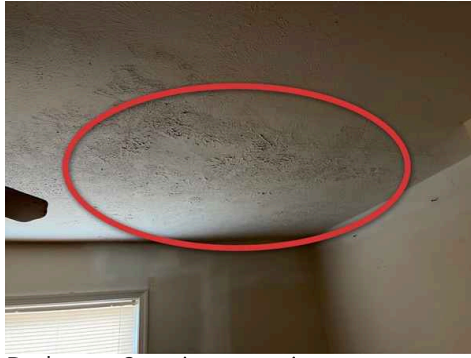
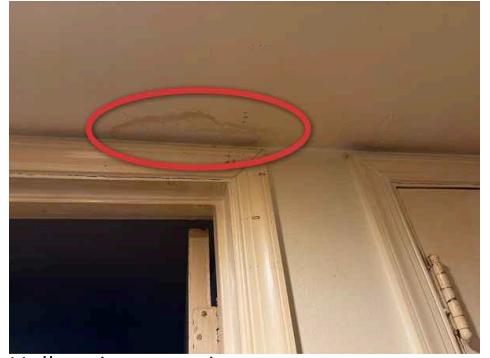
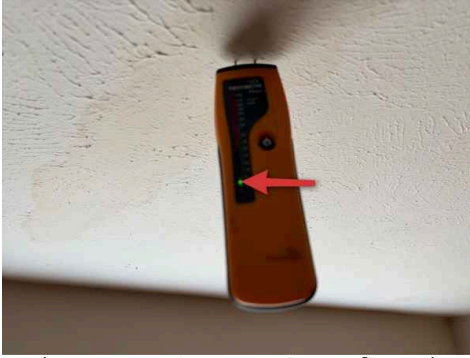
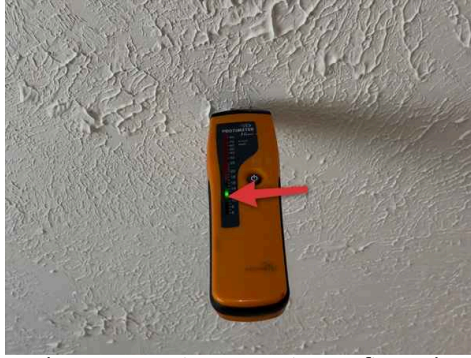
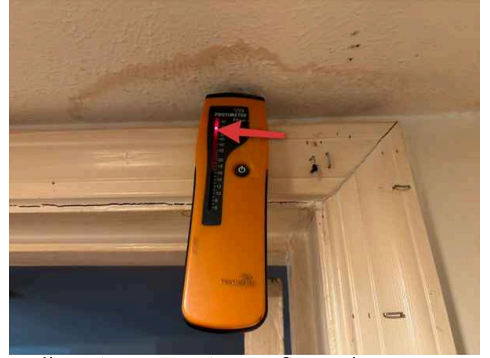
EVIDENCE OF WATER INTRUSION

Ceiling structure showed signs of water intrusion, which could lead to more serious structural damage. Recommend a qualified contractor identify source or moisture and remedy.

Bedroom 1 moisture stain

Bedroom 2 moisture stain

Hall moisture stain

Bedroom 1 moisture stain confirmed dry

Bedroom 2 moisture stain confirmed dry

Hall moisture stain confirmed wet

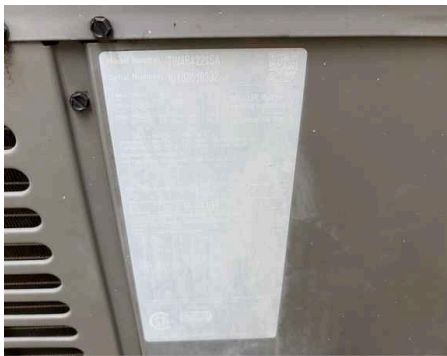
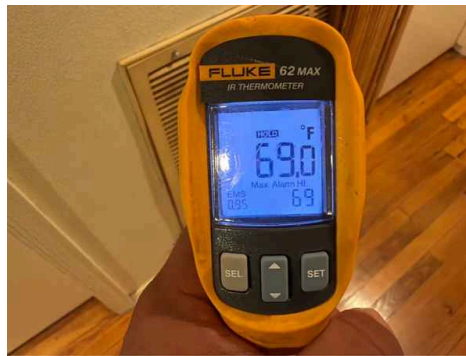
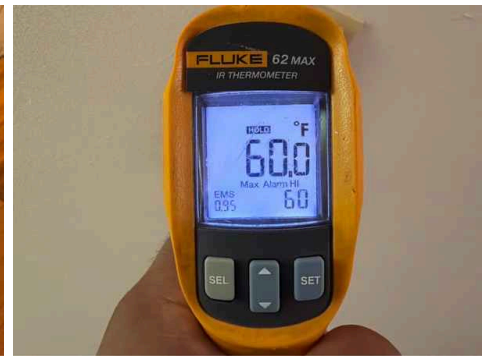
9° temperature differential

Data plate

Return temperature

Vent temperature

TEMPERATURE DIFFERENTIAL 9°

The ac temperature differentials were not within normal ranges. Recommend having the cooling system further evaluated by qualified HVAC specialist.

Contact a qualified professional.

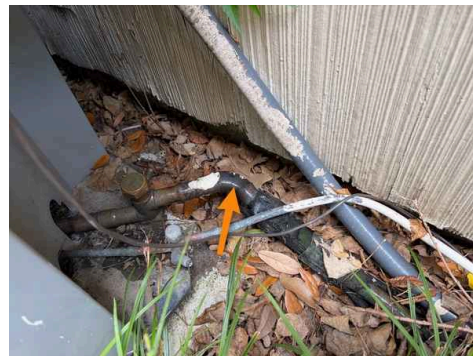
INSULATION MISSING OR DAMAGED

Missing or damaged insulation on refrigerant line can cause energy loss and condensation.

Damage refrigerant line insulation

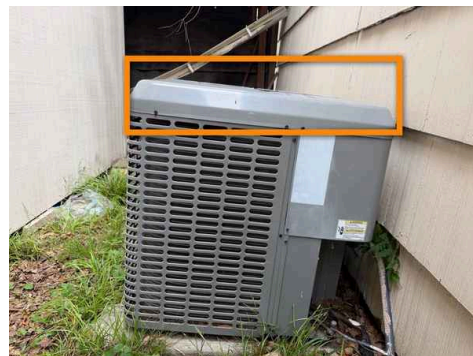
UNIT NOT LEVEL

Concrete pad supporting the outdoor condensing unit is not level. This can cause accelerated deterioration of components. Recommend licensed HVAC contractor level the unit.

Not level

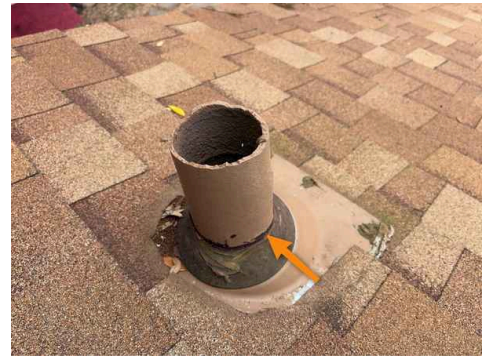
PRESENCE OF CAST-IRON DRAINS

The presence of cast-iron drain was noted in the home at the time of inspection. Cast iron is an older drain material used in the 70s. Which typically occurs from the inside out, causing draining issues. We recommend the drain system be further evaluated by a qualified plumbing contractor.

Cast iron drain present

Contact a qualified professional.

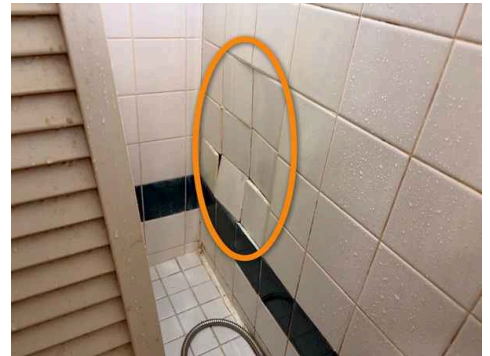
BATHROOM 1

DAMAGED SHOWER TILES

Cracked or broken tiles were observed in the shower enclosure during inspection. Damaged tiles can allow water to penetrate behind the tile surface, potentially leading to mold growth, wood rot, and structural damage over time. The affected tiles should be replaced by a qualified tile contractor to restore the shower's water-resistant integrity.

Damaged tiles

Contact a qualified professional.

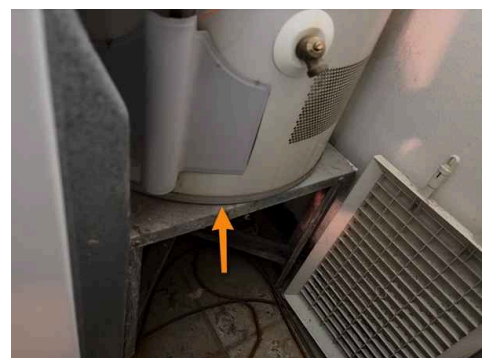
NO DRIP PAN

No drip pan was present. Recommend installation by a qualified plumber.

No pan

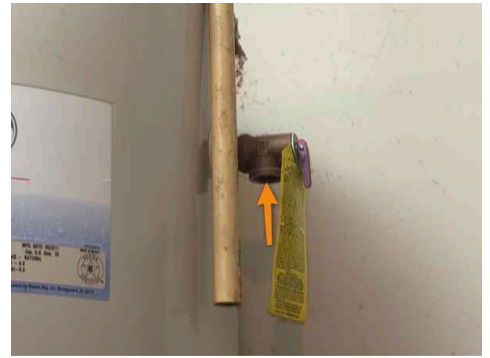
MISSING TEMPERATURE AND PRESSURE RELIEF DISCHARGE PIPE

The water heater lacks a discharge pipe connected to the temperature and pressure relief (TPR) valve. This valve is a critical safety component designed to release excess pressure or temperature buildup. Without a proper discharge pipe, pressure relief water could spray onto occupants or surrounding materials, creating a scalding hazard and potential property damage. A qualified plumber should install an appropriate discharge pipe that directs water safely to a floor drain or exterior location.

Missing discharge pipe

Contact a qualified professional.

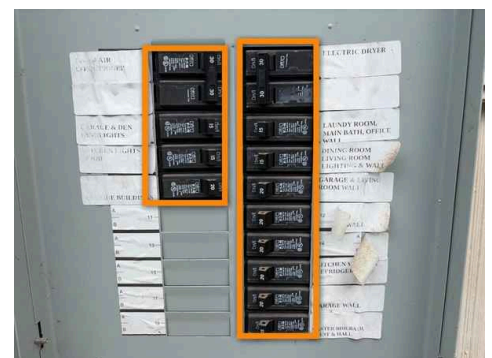
MISSING AFCI BREAKERS

Arc Fault Circuit Interrupter (AFCI) breakers provide enhanced protection against electrical fires caused by arcing faults in circuits. The electrical panel lacks AFCI breakers in locations where they are typically recommended for safety, such as bedroom circuits and other areas prone to arc faults. An electrical contractor should evaluate the panel and install appropriate AFCI protection to enhance fire safety.

No afci breakers

Contact a qualified professional.

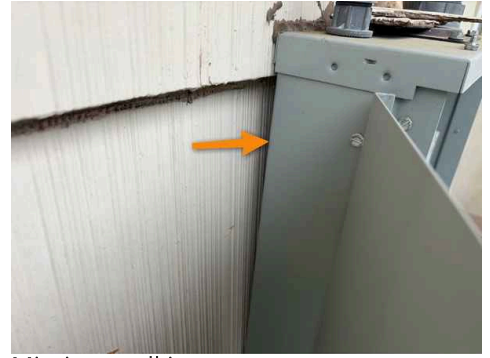
MISSING CAULKING

The tops and size of the electrical panel were missing sealant. We recommend having this added to prevent moisture intrusion into the adjacent wall.

Missing caulking

Contact a qualified professional.
