FULL INSPECTION REPORT

146 Sugar Pine Ct
Montgomery, TX 77316

PROPERTY INSPECTION REPORT FORM

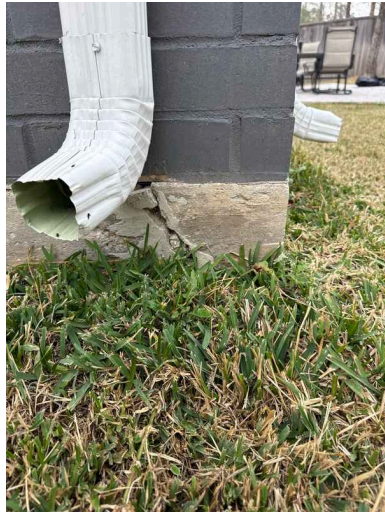
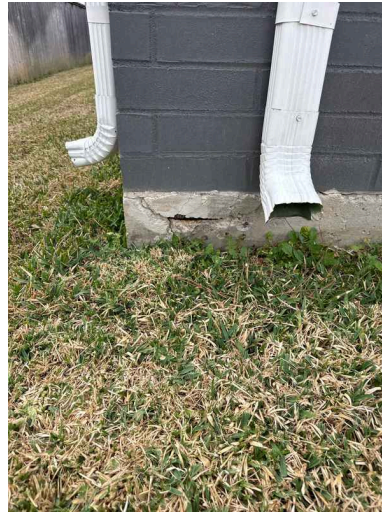
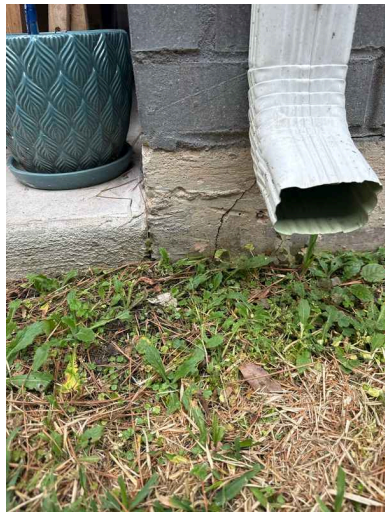
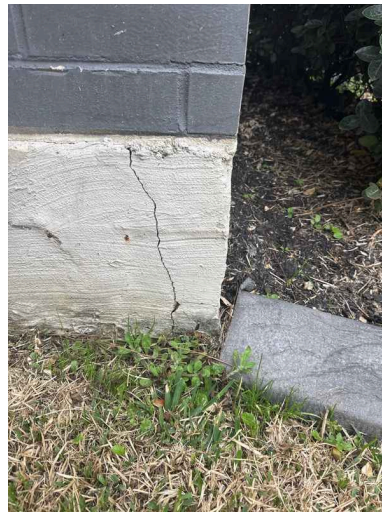
1: Slab: Corner Crack/Pop

One or more of the foundation perimeter beam corners were observed to be either cracked, or sheared off (corner pop). This is a common condition in slab on grade foundations. This condition does not adversely affect the performance of the foundation. However, in some cases, some cosmetic improvements may be necessary

Back Right

Back Left

Front Left

Recommendation: Contact a qualified professional.

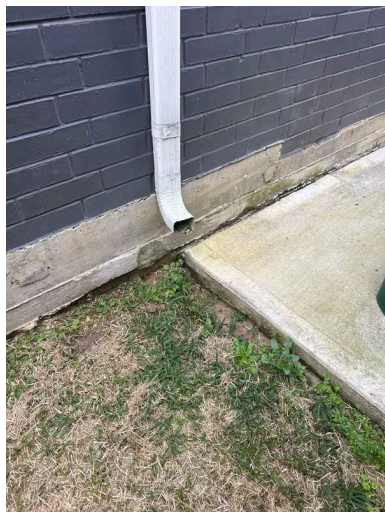
1: Gutter(s): Splash Blocks Missing

Observed missing splash blocks. Recommend installing splash blocks to help divert water away from the foundation to prevent erosion.

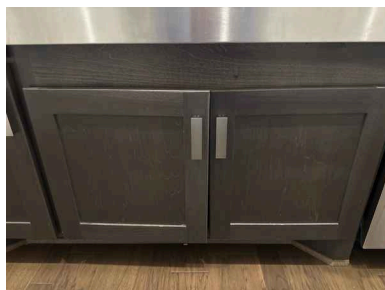
Several cabinet doors were observed to be misaligned at the time of inspection. This condition can prevent proper closing, cause uneven gaps, and lead to premature wear on hinges and hardware. Misalignment is commonly due to loose or improperly adjusted hinges.

Adjust and secure the cabinet hinges to properly align the doors and ensure smooth operation. If this is a newly constructed home, recommend the builder perform the necessary adjustments and repairs.

Recommendation: Contact a qualified professional.

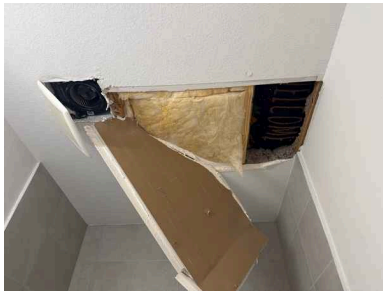
1: Drywall: Damage

The ceiling in the referenced area had damage present. The damage appears to be from mechanical damage due to a persons foot stepping on the drywall from the attic structure above.

Repairs to the damage as needed is recommended by a qualified contractor.

Recommendation: Contact a qualified professional.

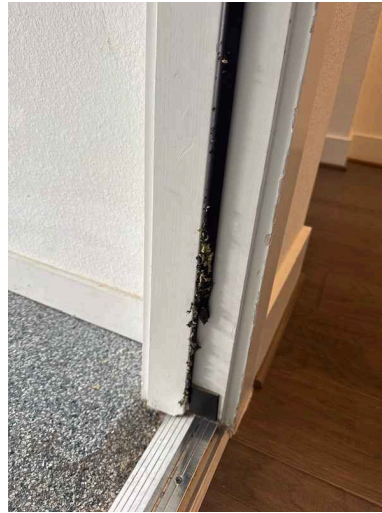
1: Weatherstripping: Damaged

The door had damaged weatherstripping. Replacing affected portions is recommended to be performed by a qualified person.

Back Door

Garage

Recommendation: Contact a qualified professional.

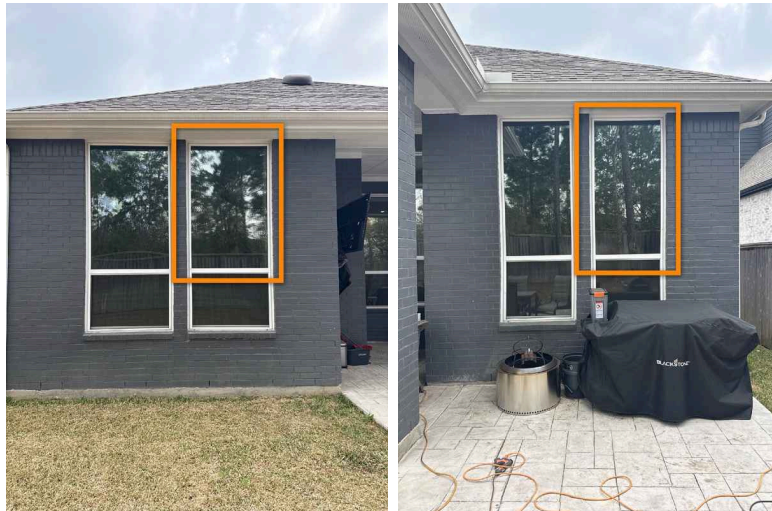
1: Glass: Double Pane Seal Failure

There were windows present that showed potential indications of seal failure. Discerning between dirty windows and seal failure can be difficult when the seal failure is not visually obvious. Changes in conditions such as high humidity and temperature extremes can allow the glass to show signs of failure that were not visible at the time of inspection. If seal failure is a concern, I recommend having a glazing contractor to evaluate all the windows in the home.

Recommendation: Contact a qualified window repair/installation contractor.

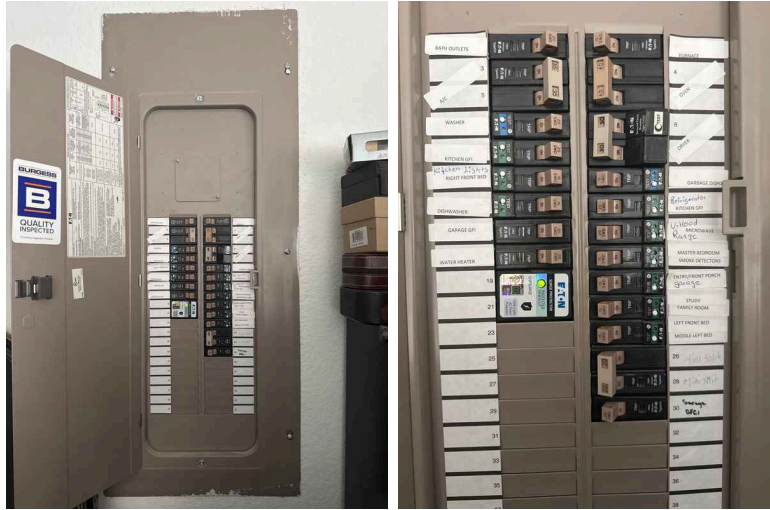
Main Service Panel: Information:

The main electrical panel was inspected for any wiring deficiencies, rust, proper labeling and physical damage. The dead front cover was removed where accessible and all circuits were inspected for proper sizing to match the amperage breaker its connected too. Breakers that are 240V were inspected for proper trip ties were designated. Branch circuit breakers were inspected for any visible signs of damage due to arcing, heat, etc. Corresponding conductors were inspected for double lugging, sizing, damage, etc. Corrosion of wire terminals or water intrusion was inspected and noted.

Service Entrance Conductors Type: Aluminum
Service Entrance Type: Underground Service Lateral -

Main Service Panel Manufacturer: Eaton
Main Service Panel Location: Garage
A/C Breaker Size: 35 amp
Main Breaker Size: 200 amp

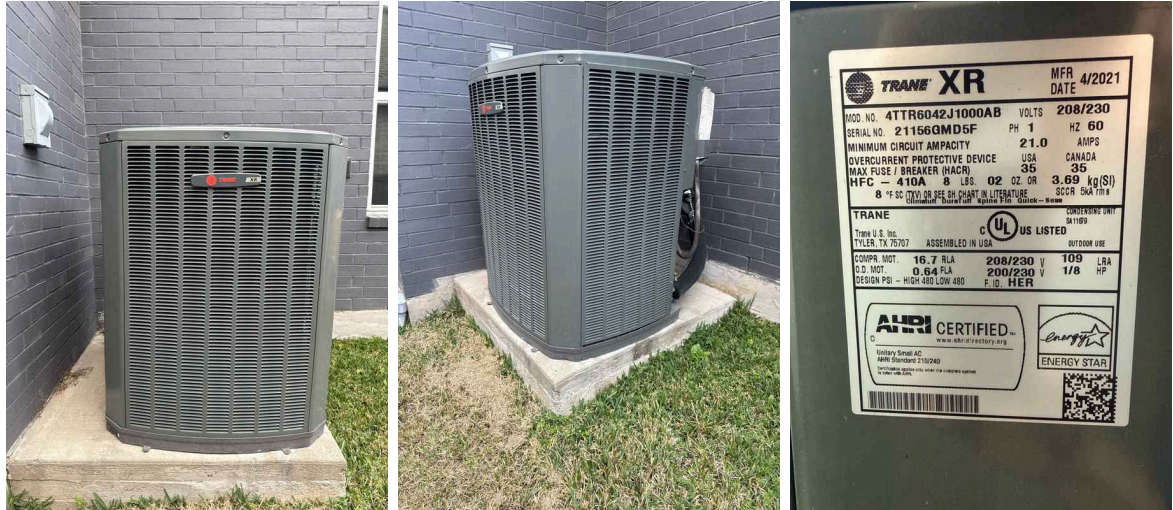
HVAC: Information:

The exterior and interior unit(s) were inspected visually and tested by ensuring they respond to normal operating controls (at the thermostat), and that heat and conditioned air was produced (weather permitting). The inspection of the system is limited to the response of the system at normal operating controls (the thermostat) in cooling and heating modes. If a more thorough inspection is desired, an HVAC contractor should be consulted.

Type of System(s): Central Air Conditioner

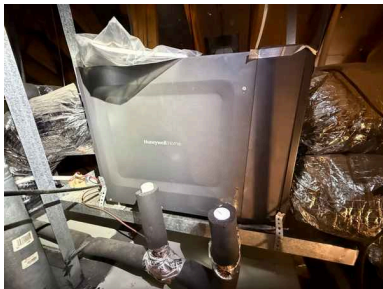
1: Fresh Air Filter Dirty

⚠️ Minor

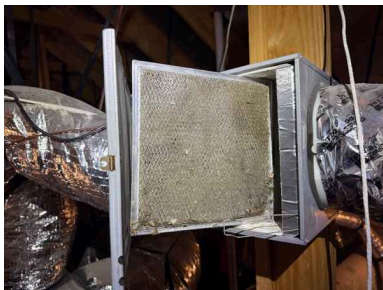
The fresh air filter was inspected and showed to be dirty. Recommend cleaning. Fresh air filters should be cleaned or replaced every 30 to 60 days.

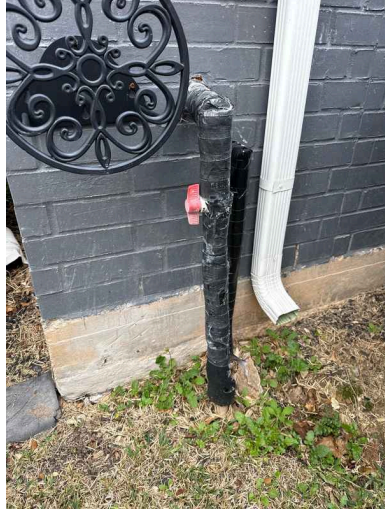
Location of Water Meter: Front

Main Shut Off Valve Location: Exterior Wall

Type of Supply Piping Material: PEX

Static Water Pressure: 55 PSI

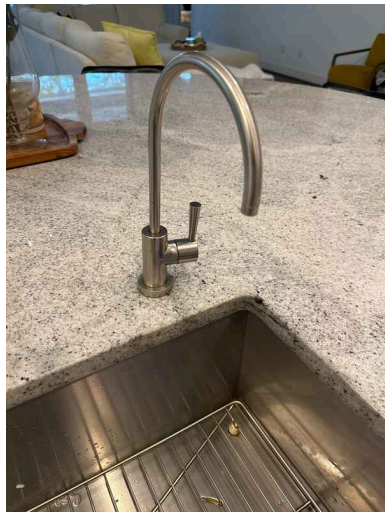
2: Loose Faucet

The faucet listed in this section was loose.

Recommendation: Contact a qualified plumbing contractor.

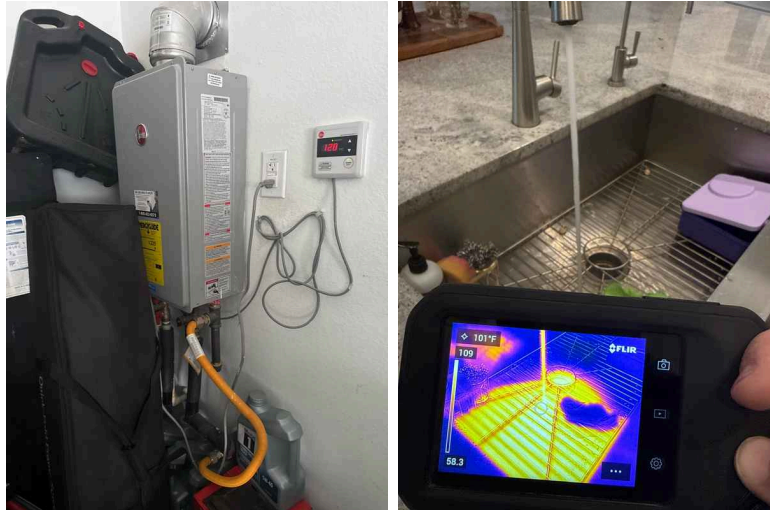
Water Heater: Information:

The water heater was inspected by looking at the overall condition of the unit, its power source, the water pipes, etc., and that it produced heated water at the time of inspection.

Energy Sources: Gas

Capacity: Tankless Unit

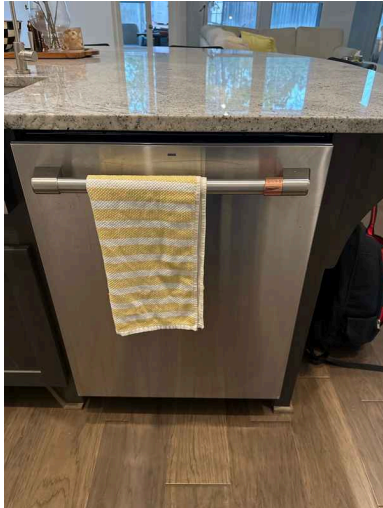
Dishwasher: Information:

The dishwasher was operated by running a wash cycle and was functional at the time of inspection. No leaks or water was present at the base of the unit at the completion of the cycle. The unit's efficiency of cleaning dishes is not tested.

Manufacturer: Cafe

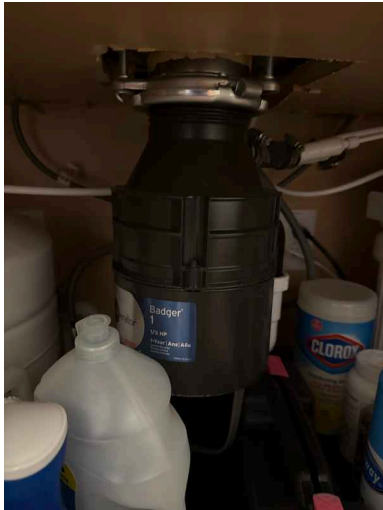
Disposal: Information:

The garbage disposal was inspected by activating it at normal controls and ensuring the motor ran, while also looking for leaks from the unit, an exposed power cord, heavy rust, or other deficiencies. The unit is not tested to determine if it can effectively "grind" food waste.

Manufacturer: Badger

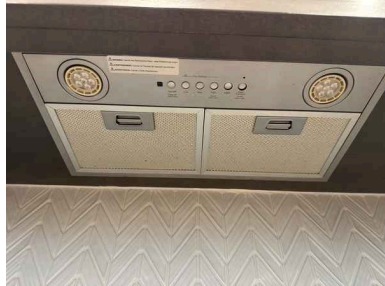
Range Hood and Exhaust Systems: Information:

The kitchen exhaust fan was inspected by operating normal controls and checking for proper operation. The type, condition and termination point of the vent pipe was also inspected.

Fan Type and Termination Point: Exterior Vented

Manufacturer: Unknown
