PROPERTY INSPECTION REPORT FORM

Ray Williams <i>Name of Client</i>	12/16/2022 <i>Date of Inspection</i>
17627 Cook Forest Dr , Humble, TX 77346 <i>Address of Inspected Property</i>	
Dale Hall <i>Name of Inspector</i>	TX #21144 <i>TREC License #</i>
<i>Name of Sponsor (if applicable)</i>	<i>TREC License #</i>

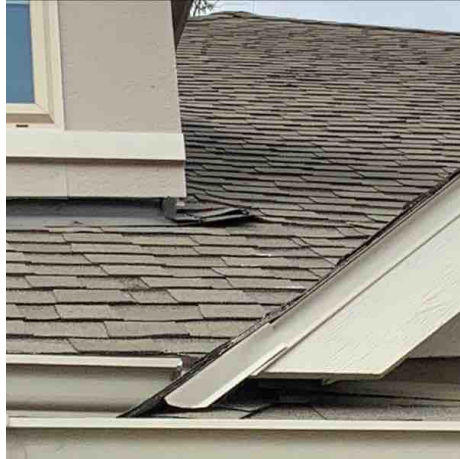
- There are some raised shingles or flashing, some times called nail pops or a lack of adhesion. These all should be sealed down to help prevent wind/ water damage. Minor repairs to the roofing are recommended, examine and seal roof as required.

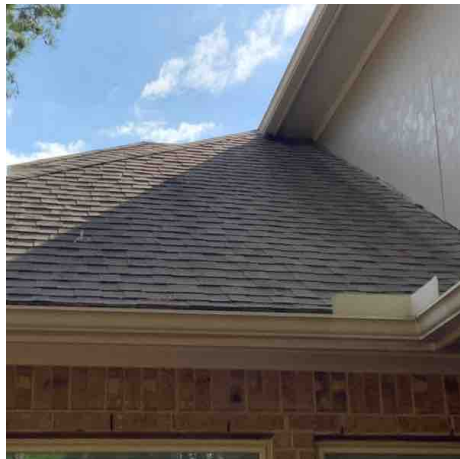
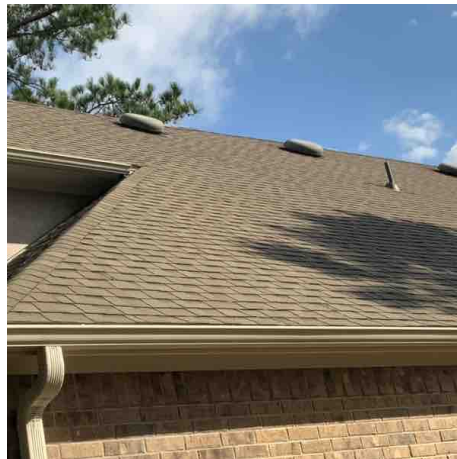
The roof covering appears to be in good condition at the time of the inspection.

Roof should be kept clean and free of debris, Trees should be trimmed away. This will extend its service life.

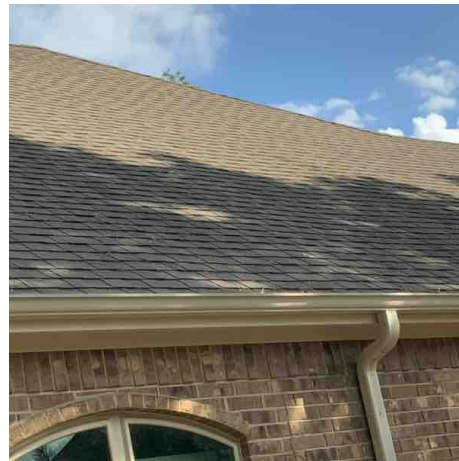
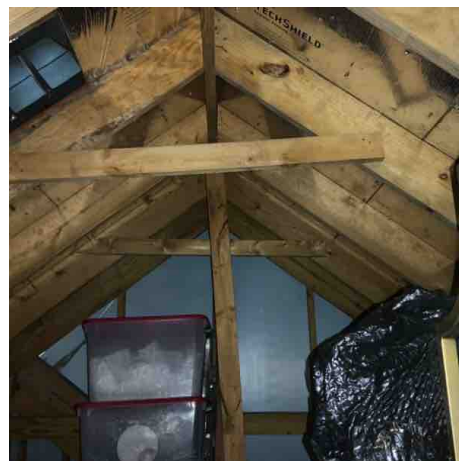
- Roof structure is conventional wood framed, supported by the interior and exterior walls. It appears stable and to be performing as intended at this time. This is a standard method of construction. (Exceptions will be noted)

Ventilation: Roof and soffit vents appears to be of the time period. There is no evidence of excessive moisture in the attic. Insulation in attic appears to be adequate. (exceptions will be noted)

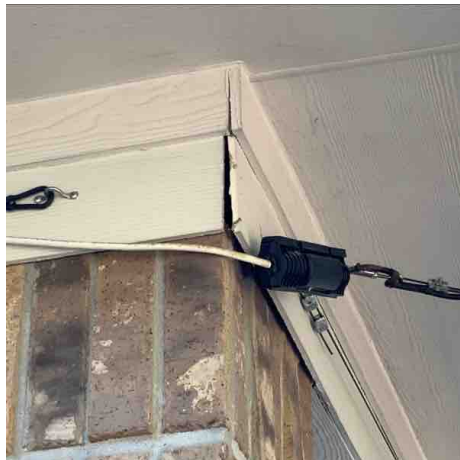
- Secure or seal gap as needed. **(Exterior Back)**

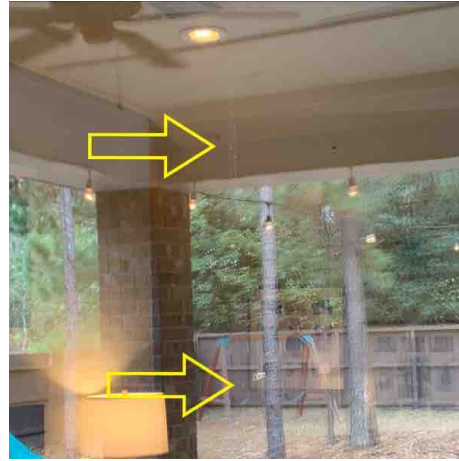
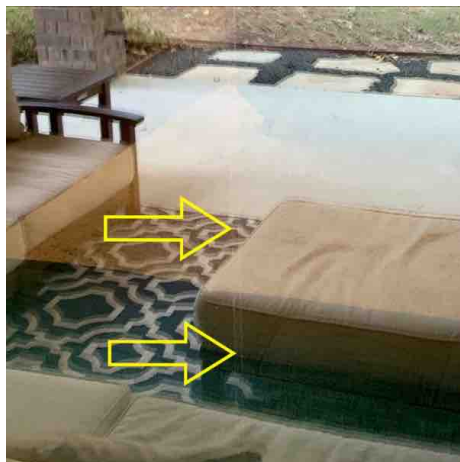
- There is a streak or run between panes of glass. This appears to be a manufacturing defect. Contact a window manufacturer for cost or repairs (Exterior Back)

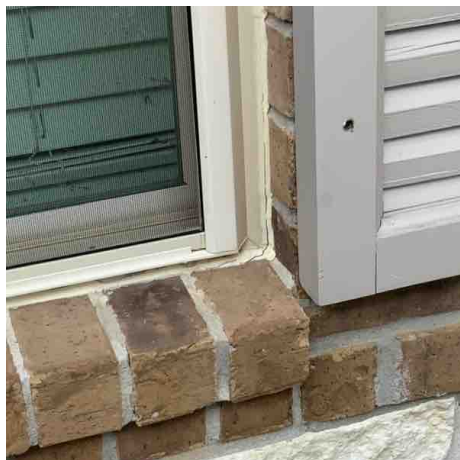
- Recommend sealant in any cracks and gaps around outside window frames and / or inside sills to reduce possibility of leaking water or air. All windows should be evaluated and sealed as needed.

- Throughout
- Various

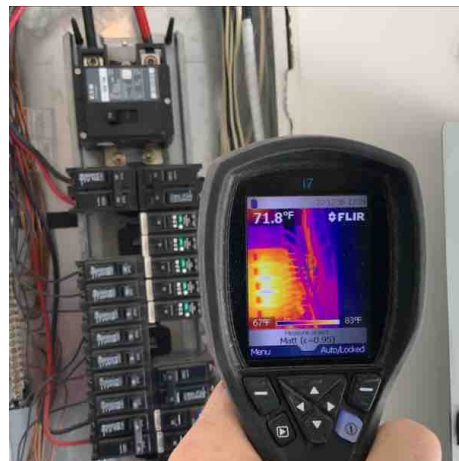
• Eaton brand, sub panel. Subpanel appears to be properly installed. And in good condition.

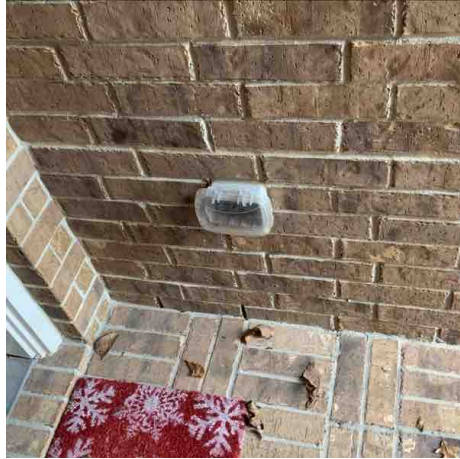
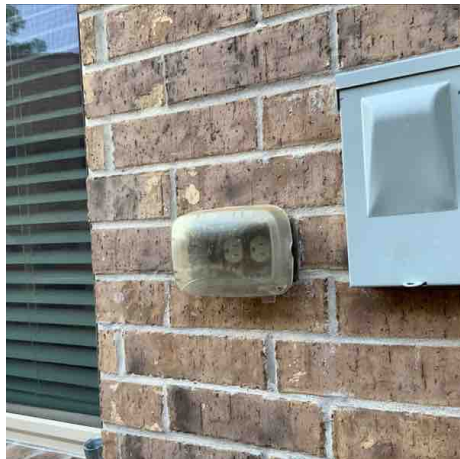
• At the time of the inspection, one receptacle in front porch, one at the AC disconnect and two on the back patio are not functioning. I was not able to locate a GFCI's that protects these receptacles. Contact sellers for information on the location of the GFCI, or electrician for an evaluation and repairs.

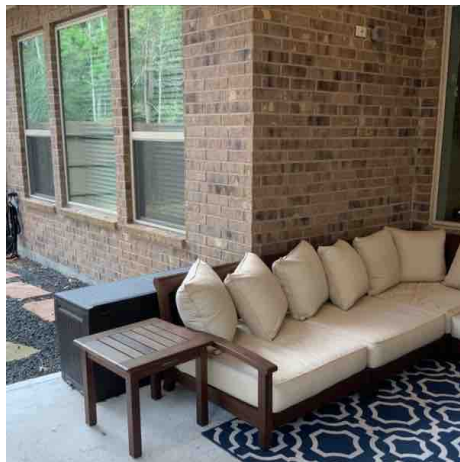
- There is a working GFCI noted on the ceiling on the back patio. No testing was done it is inaccessible at this time.

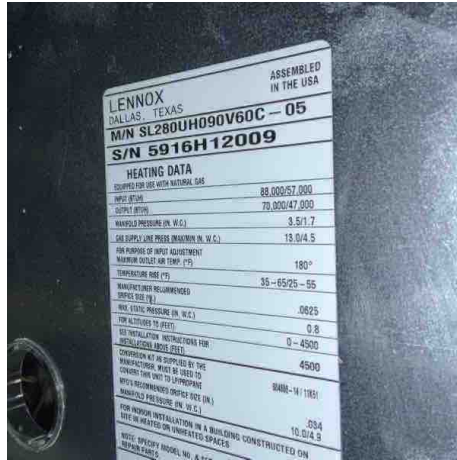
- Please be aware that the heat exchanger (which is the central and most critical part of a hot air furnace) could only be viewed to a limited extent. Those areas that were visible appeared to be serviceable. You should understand that this is a very limited examination and not a conclusive evaluation of the heat exchanger. A conclusive evaluation can only be done either visually by at least a partial dismantling of the furnace or by a smoke test or other tests that would identify combustion products in the heated air.

- The system(s) operated and appears to be delivering heat. Consider adding a home warranty to the home purchase.

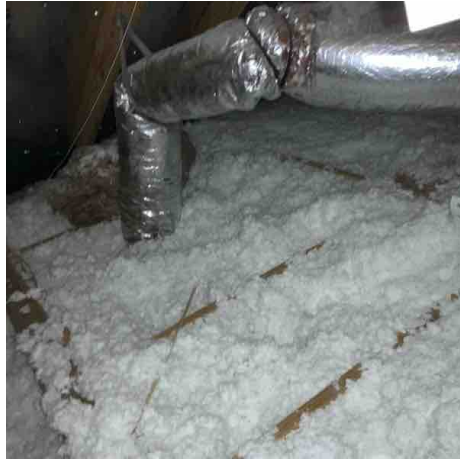
- Ductwork should have smooth curves, not hard turns or squeezed with the hanging straps. Improve duct runs, as needed for better air flow. Improve duck work as needed.

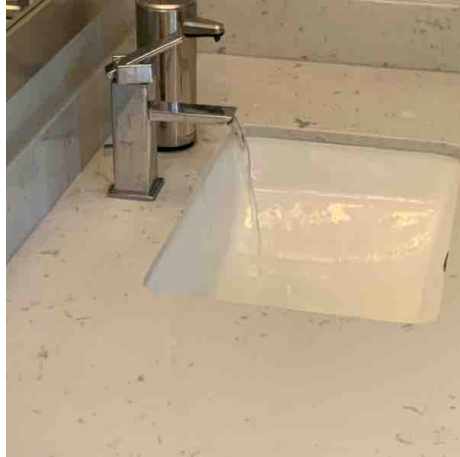
- Slightly less than the average water flow at one faucet in the primary. This is common with singles handled fixtures, the control cartridge gets turned slightly and it just doesn't line up properly properly contact a plumber for an evaluation and possible adjustment.

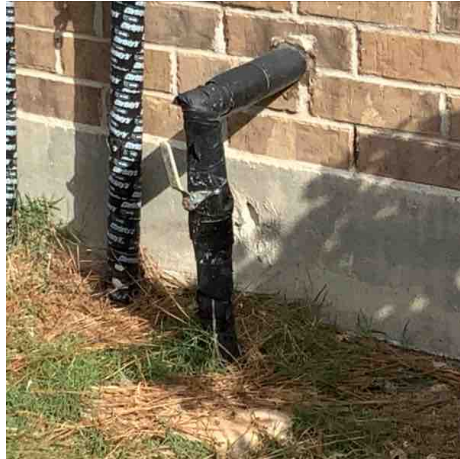
- Water pressure in the home was good. (exceptions noted) Water lines located in the attic or outdoors that may be prone to freezing - insulation is recommended. **(Exterior Left)**

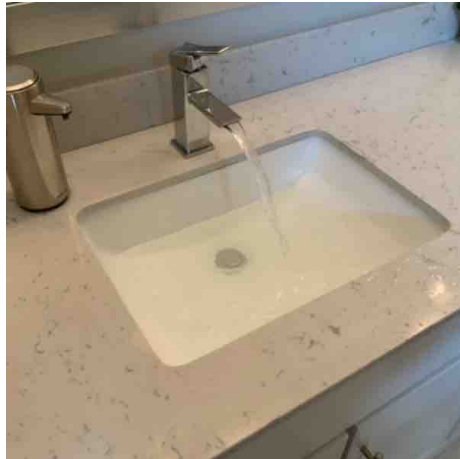
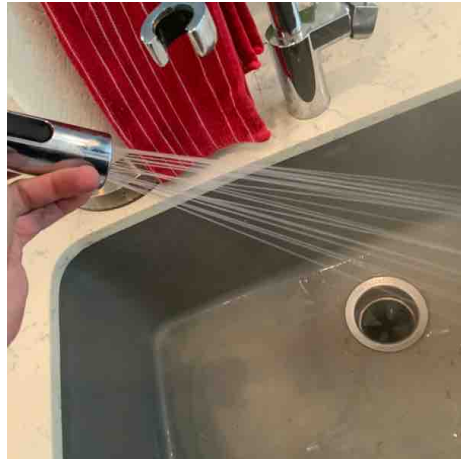
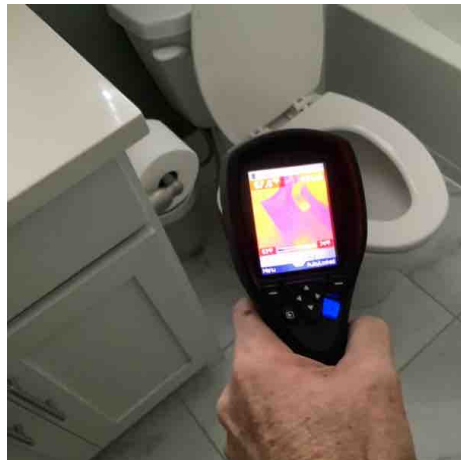
• At the time of the inspection there was no indication of moisture from the supply system.

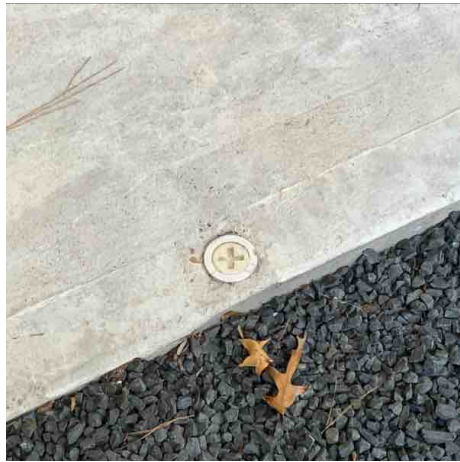
- Drain system connection for an outdoor kitchen

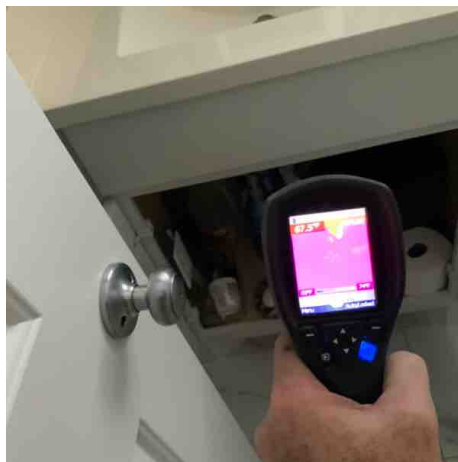
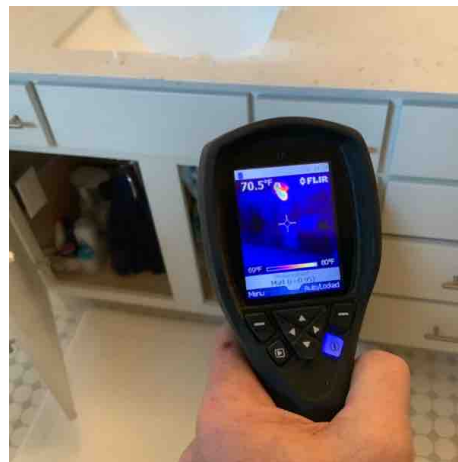
At the time of the inspection there was no indication of moisture under drains

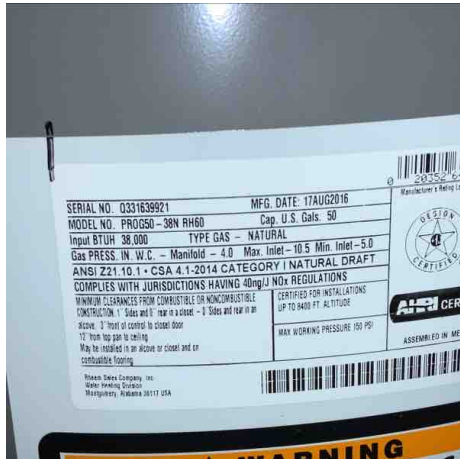
A water Shut Off is located on the cold water in supply line next to the heater.

Relief valve(s) are installed. This is a safety device that is required. Relief valve was NOT tested, testing can lead to leaks with the rubber seals when not tested regularly. If the valve is over two years old, consider replacing.

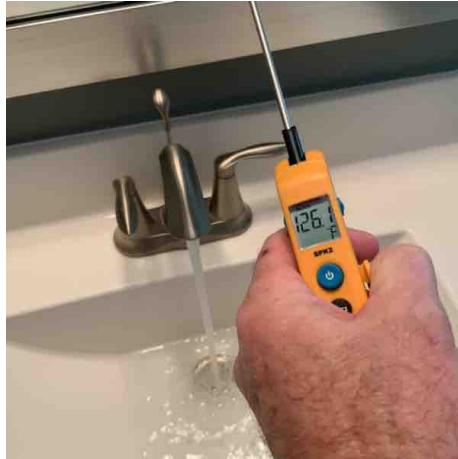
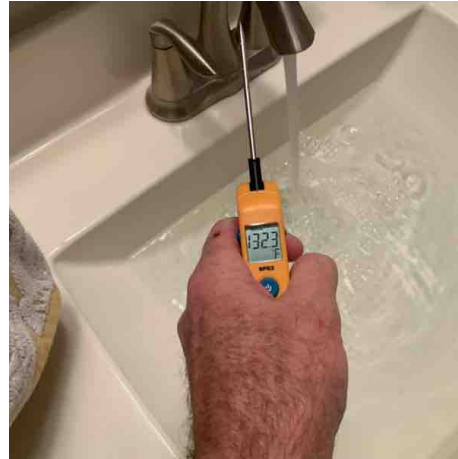
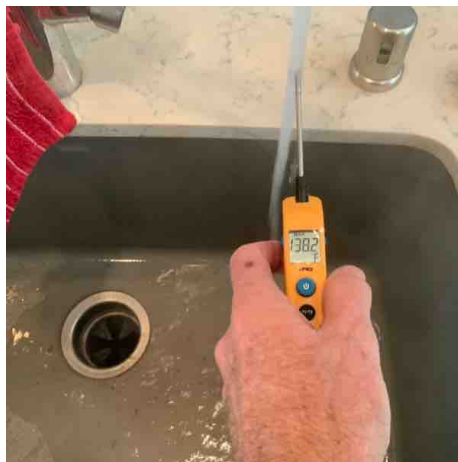
- Water Heater(s) provides hot water and in operation at the time of the inspection. Temp setting over 125 deg, can be a safety issue, adjust as needed.

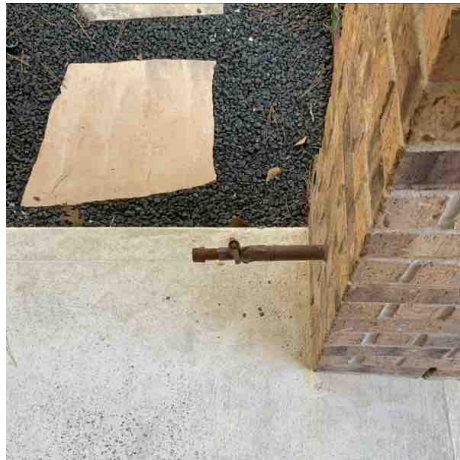
- Gas grill connection for an outdoor grill **(Exterior Back)**

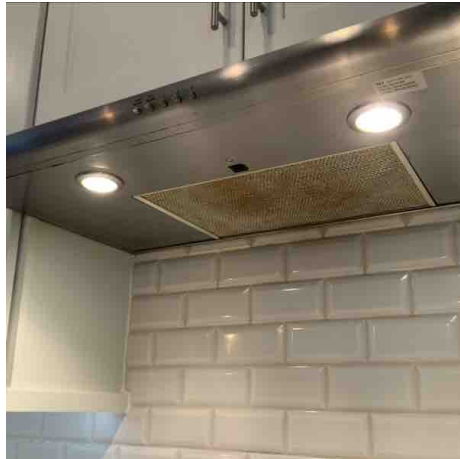
- Kitchen range exhaust and light are in good condition and operate satisfactorily. Keep Charcoal and Grease filters clean.

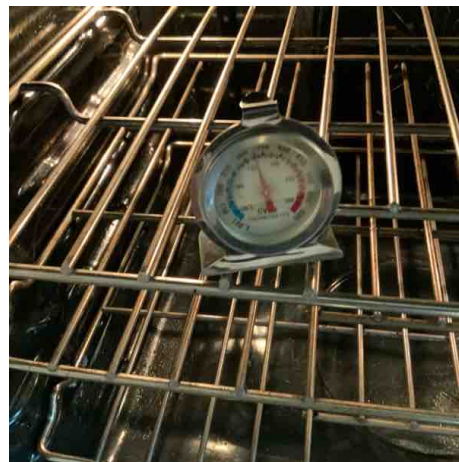
- Cook top and oven are in good condition. All burners on cook top were checked and oven set at 350, actual temperature was 325, The temperature is allowed under my standards. However some sort of calibration or adjustments to the thermostats may be needed.

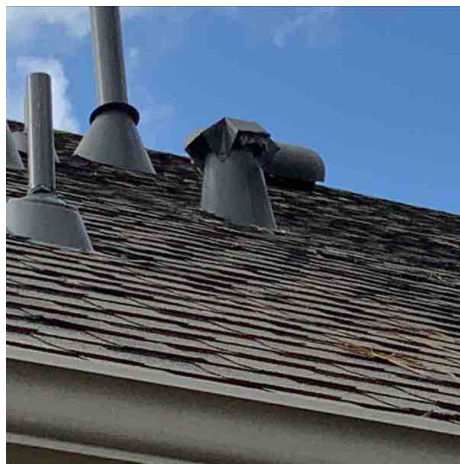
- Dryer vent appears to be installed to vent outside as required. All dryer vents should be kept clear and clean. Lint build-up can be a fire hazard. Inside the vent pipe was not inspected. This is very important if its a vertical vent.
- **This vent pipe needs cleaned, Lint build-up can be a fire hazard.**
- Dryer vent is using an old style vent at the roof top. Consider upgrading to an approved roof level dryer vent or go to the soffit, new vent covers have back flow damper. At least keep it sealed at the roof line to not allow lint into the attic. Lint build-up in the pipe and attic can become a fire hazard.

- This vent pipe needs cleaned, Lint build-up can be a fire hazard.

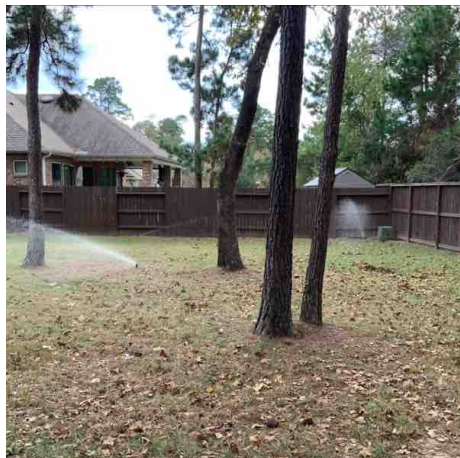
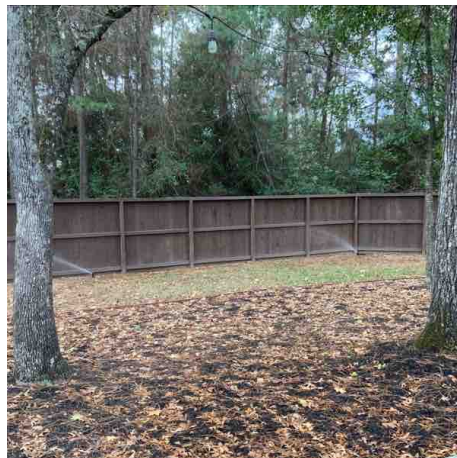
At the time of the inspection there are no visible issues, identifying underground leaks is outside of the scope of this inspection. The effectiveness of each zone should be adjusted as needed. Maintain the system as needed. Exceptions in zone seven noted.

Spray heads should be kept adjusted as to not hit the house and on to the lawn as much as possible.

The effectiveness of the zone heads distribution is not evaluated in this report, adjust as needed.

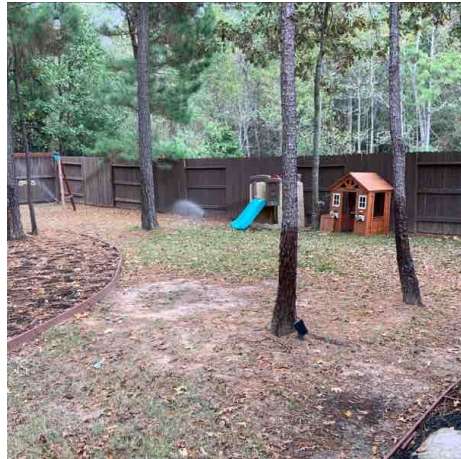
• One head in zone seven is not rotating. Repair as needed.
