PROPERTY INSPECTION REPORT

Concerning: 626 Longview Drive Sugar Land, TX 77478 FICS file # 3062943

By: Art Byrd 1171

04/20/2026

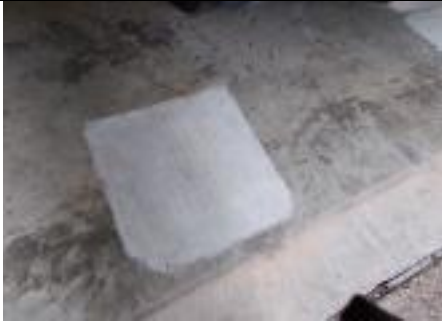
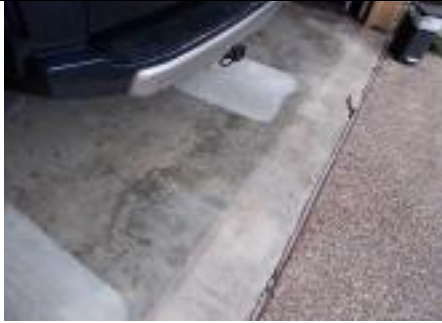
Previous Repairs to Foundation

I. STRUCTURAL SYSTEMS
(I) A. Foundations: Please Note: Previous repairs were observed at the foundation/slab. Recommend obtaining all relevant documentation regarding previous structural repairs.

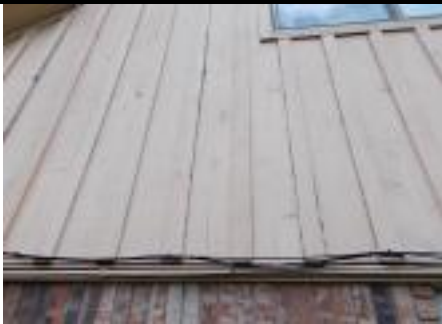
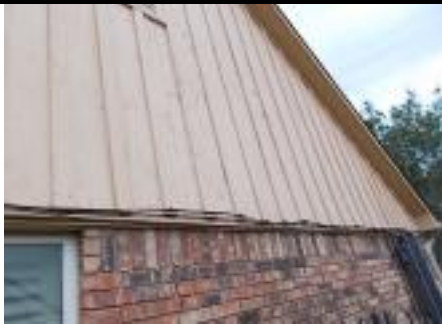
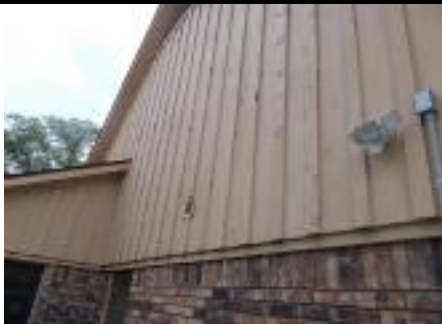
Comments: The wood siding is cracked at the left and right elevation walls.		
	Exterior Cladding Type: Brick, Wood Siding		
	Note: <i>Stucco/stone type is based on generalist knowledge only. Technical determination by a specialist is recommended.</i>		
	Visible signs of cracks or settlement? No		
	Visible evidence of water / moisture penetration? Yes Moisture and/or damage has been observed in the following visually observable areas of the home: moisture damage was observed on the right side family room wall paneling.		
	Visible evidence of mold / fungus at interior walls? No		
	Fire separation breached between house & attached garage? No

Cracked Wood Siding

(I) E. Walls (Interior and Exterior): The wood siding is cracked at the left and right elevation walls.

Recommendations: Contractor to replace the cracked wood siding at the left and right elevation walls.

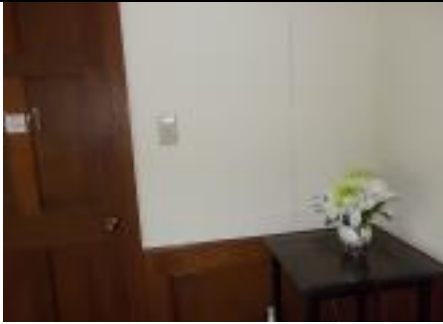
Moisture Damage to Wall Paneling

(I) E. Walls (Interior and Exterior): Moisture and/or damage has been observed in the following visually observable areas of the home: moisture damage was observed on the right side family room wall paneling.

Recommendations: Elimination/correction of the source of moisture is required. Repair/replacement of any associated damage is also necessary, if present. All work should be performed by a qualified contractor.

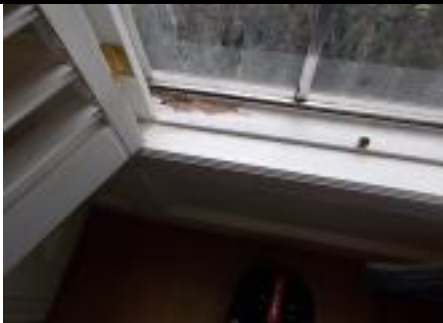
<input type="checkbox"/>	<input type="checkbox"/>	<input type="checkbox"/>	<input checked="" type="checkbox"/>	H. Windows
				Comments: The right front bedroom window sill is damaged.
				Any visible failed thermal pane windows? No

Damaged Window Sill

(I) H. Windows: The right front bedroom window sill is damaged.

Recommendations: Contractor to replace the damaged window sill.

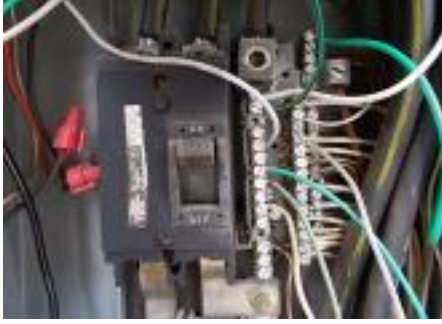
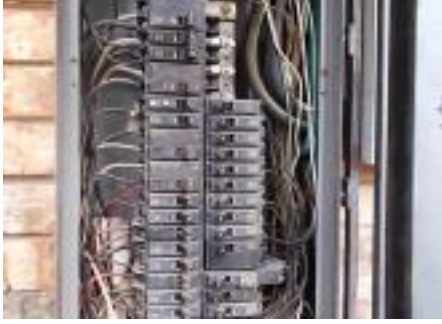
<input type="checkbox"/>	<input type="checkbox"/>	<input type="checkbox"/>	<input checked="" type="checkbox"/>	A. Service Entrance and Panels
				Comments: The main electric panel is a Federal Pacific brand electric panel.
				Amps: 200 Volts: 120/240 Type of Panels: Breakers
				Number of Electrical Panels: 1 Locations of Panels: Left Exterior Wall
				Is the electrical service adequate to meet the needs of the dwelling? Yes

Federal Pacific Electric Panel	Federal Pacific Electric Panel

(II) A. Service Entrance and Panels: The main electric panel is a Federal Pacific brand electric panel.

Recommendations: Licensed electrician to replace the Federal Pacific panel and any necessary components.

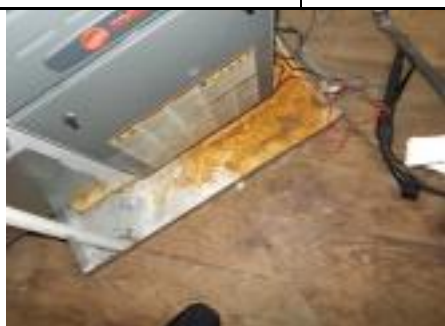
<input type="checkbox"/>	<input type="checkbox"/>	<input type="checkbox"/>	<input checked="" type="checkbox"/>	B. Cooling Equipment
				Comments: The air handler condensate pan is rusted.
				Type of Systems: (see A/C type below)
				A/C Type #1: Central Air Approx Age: 8 yrs. Design Life: 15 yrs. Energy Source(s): Electric
				A/C Type #2: Central Air Approx Age: 9 yrs. Design Life: 15 yrs. Energy Source(s): Electric
				The ambient temperature did not allow for safe testing of the air conditioning system (less than 60 degrees). No
				Supply Air Temp #1 (degrees): 48 Return Air Temp #1 (degrees): 67
				Supply Air Temp #2 (degrees): 50 Return Air Temp #2 (degrees): 68
				Are temperature differentials within normal range of 15-20 degrees? Yes

Rust in Condensate Pan

(III) B. Cooling Equipment: The air handler condensate pan is rusted.

Recommendations: Cooling contractor to repair the source of the rust and to eliminate the rust from the air handler condensate pan.

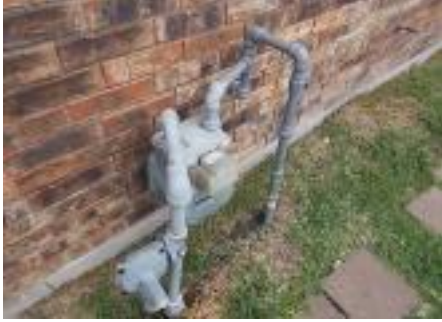
<input type="checkbox"/>	<input type="checkbox"/>	<input type="checkbox"/>	<input checked="" type="checkbox"/>	E. Gas Distribution Systems and Gas Appliances
				Comments: The gas system is not bonded.
				Location of Gas Meter: Right Wall
				Type of Gas Distribution Piping Material: Black Steel

<p>Gas Meter Not Bonded</p>		
---	--	--

(IV) E. Gas Distribution Systems and Gas Appliances: The gas system is not bonded.

Recommendations: Licensed electrician to bond the gas system.

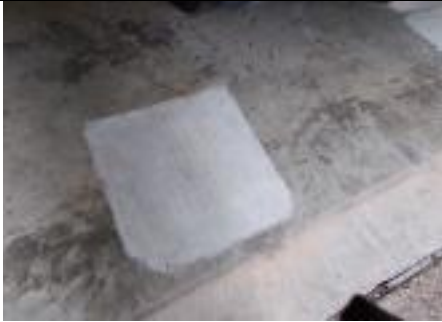
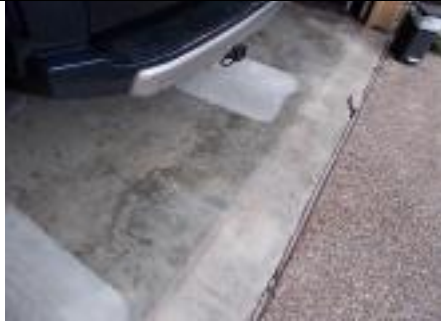
Previous Repairs to Foundation

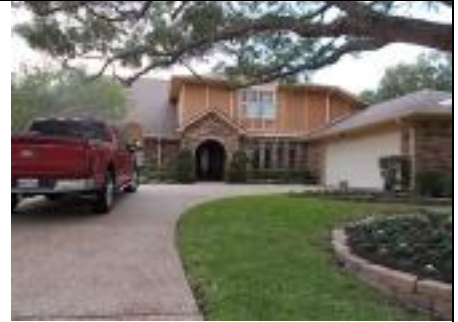
Front Elevation

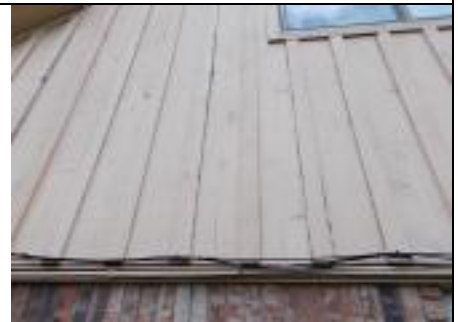
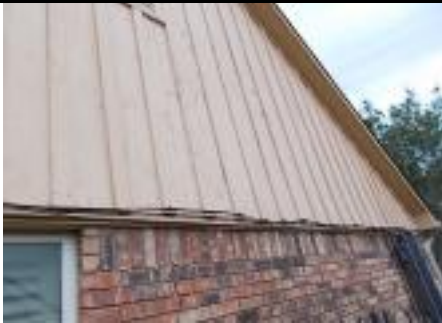
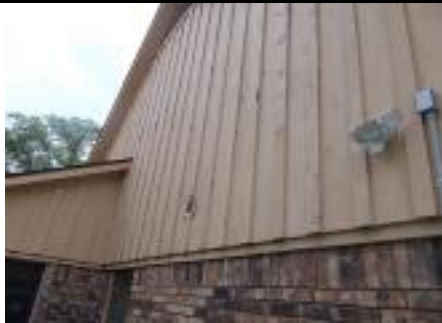
Cracked Wood Siding

Cracked Wood Siding	Cracked Wood Siding	Moisture Damage to Wall Paneling

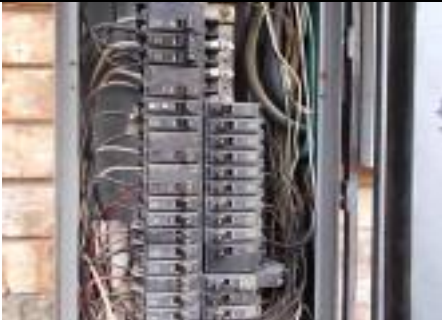
Federal Pacific Electric Panel	Federal Pacific Electric Panel	Electric Panel

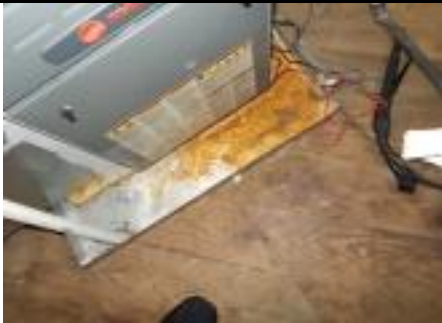
<p>Rust in Condensate Pan</p>	<p>A/C Equipment</p>	<p>A/C Equipment</p>

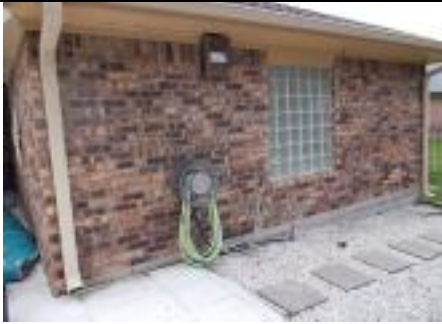
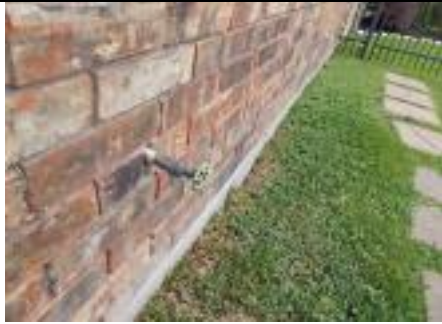
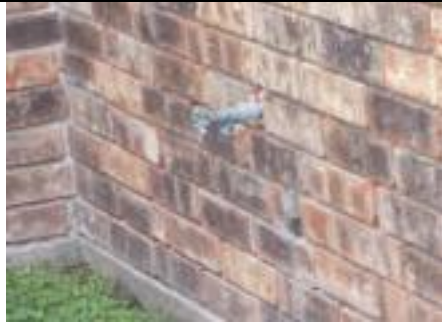
(IV) A. Plumbing Supply, Distribution Systems, and Fixtures: The exterior faucets are missing back flow prevention devices.

<p>Exterior Faucets Missing Backflow Prevention</p>	<p>Exterior Faucets Missing Backflow Prevention</p>	<p>Exterior Faucets Missing Backflow Prevention</p>

Recommendations: Plumber to install back flow prevention devices for the exterior faucets.
