Allpoints Home Inspections LLC

PROPERTY INSPECTION REPORT FORM

Date of Inspection: 2023-09-16

Address of Inspected Property: 6511 Canyon Mist Ln Dickinson , Texas 77539

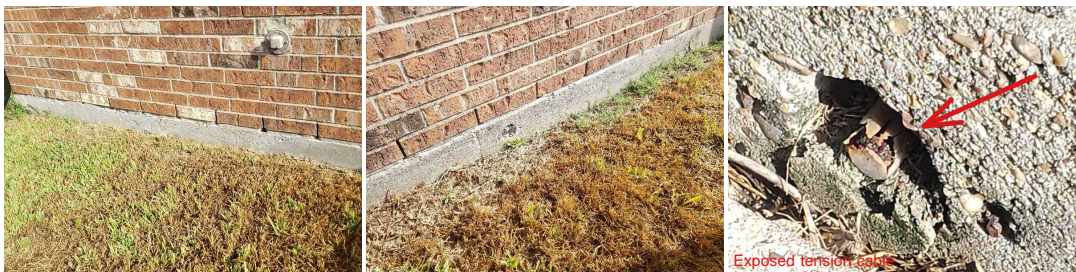
☒☐☐☒ A. Foundations

Exposed tension cables observed, right side

Recommend have deficient areas corrected

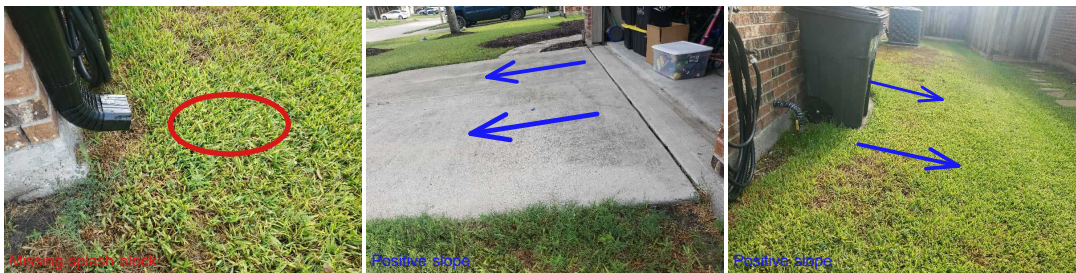
☒☐☐☒ B. Grading and Drainage

Missing splash blocks, several downspouts

Recommend have deficient areas corrected

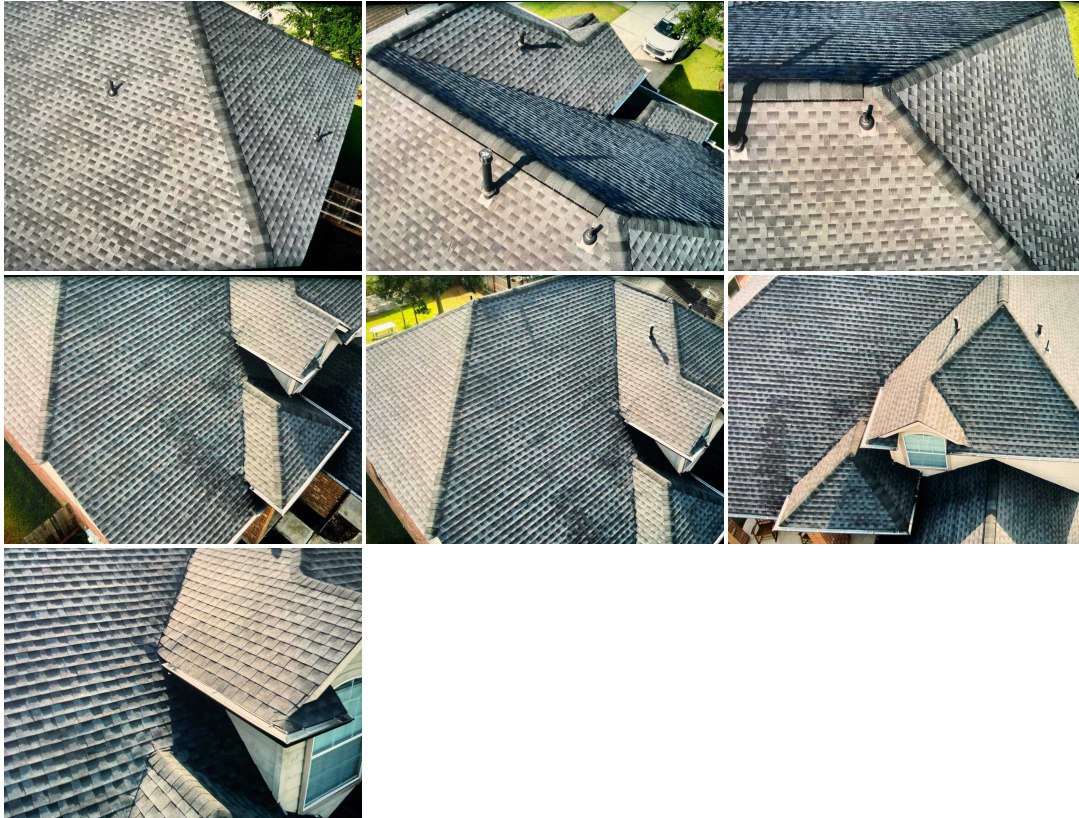
C. Roof Covering Materials

Comments: Asphalt shingle Limited access and visibility to all areas of the roof.

The roof covering was evaluated and appeared to be installed properly

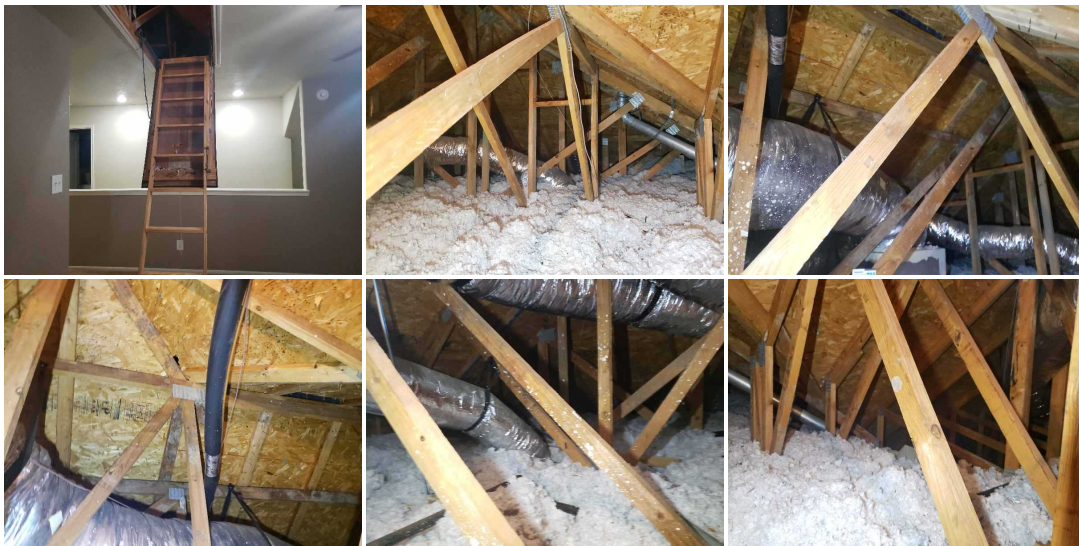
D. Roof Structures and Attics

Comments: 2x4 Truss Limited access and visibility to all areas of the attic. Limited flooring

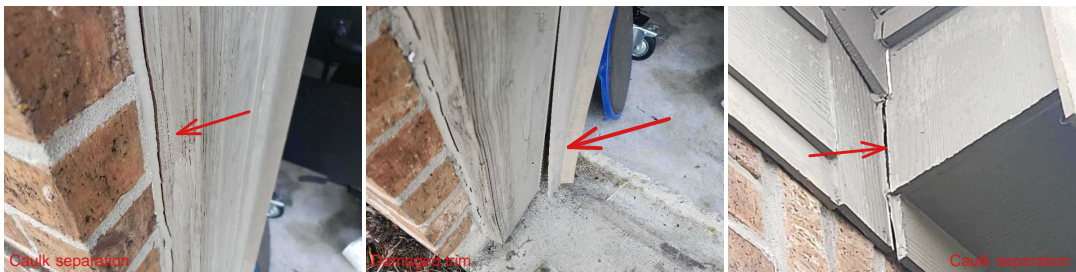
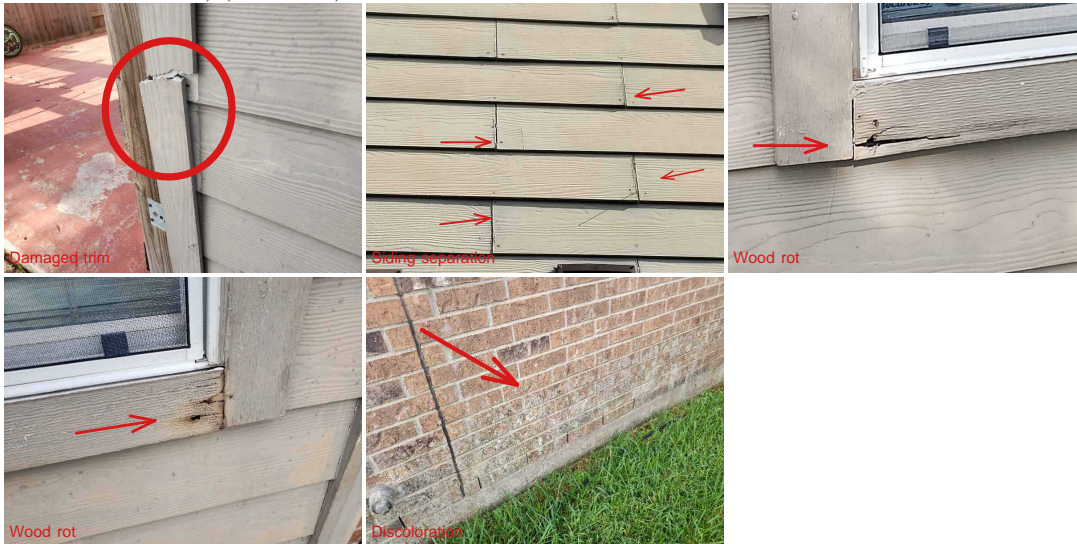
E. Walls (Interior and Exterior)

Separations - Exterior siding and trim, front side, right side

Damaged exterior siding/ trim, front side, back side

Rot - Exterior siding and trim, back side

Discoloration observed on exterior wall, left side

Recommend have deficient areas corrected

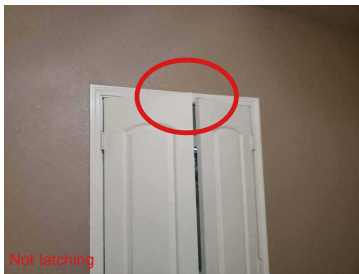
☒☐☐☒ G. Doors (Interior and Exterior)

Comments: Wood with glass, Door not Latching, main bathroom, several closets

Recommend have deficient areas corrected

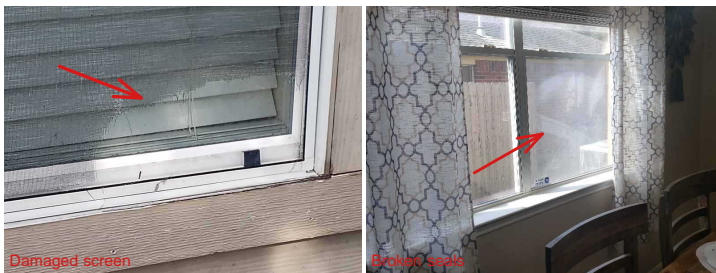
☒☐☐☒ H. Windows

Comments: Vinyl double hung, Missing/damaged window screens observed, several areas

Broken window seals, fog observed between the glass, dining

Recommend have deficient areas evaluated and corrected by a qualified professional

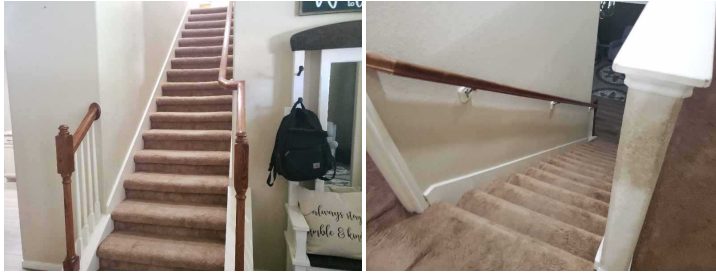
I. Stairways (Interior and Exterior)

Comments: Wood stairs with wood handrails

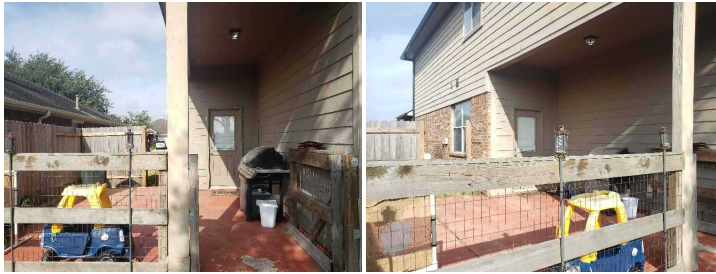
K. Porches, Balconies, Decks, and Carports

Comments: Poured Slab, Covered patio

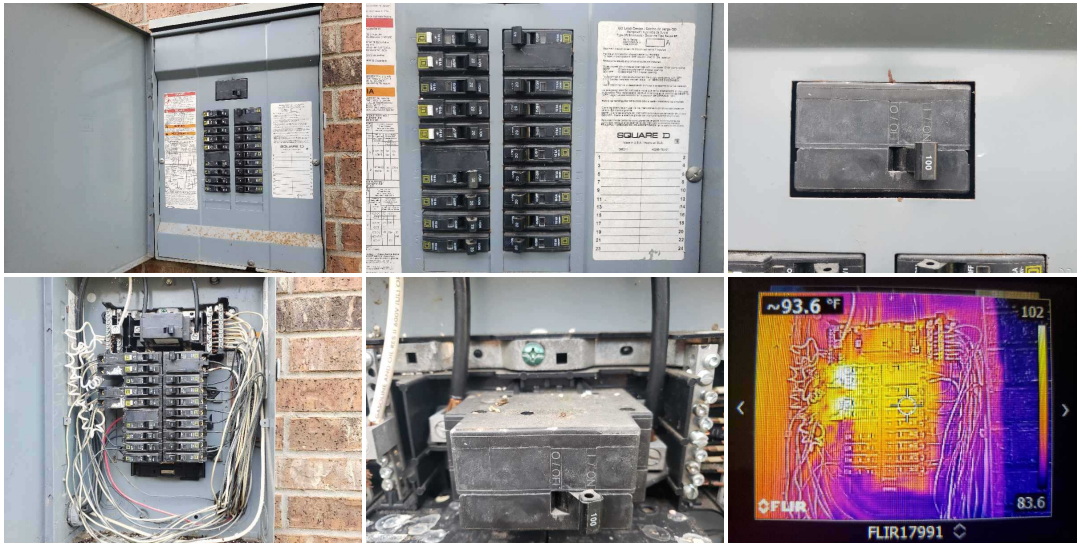
A. Service Entrance and Panels

Comments: Square D, Underground service, 100 amp, Copper service entry, Not Labeled , Breaker panels are not clearly labeled

Recommend have deficient area corrected

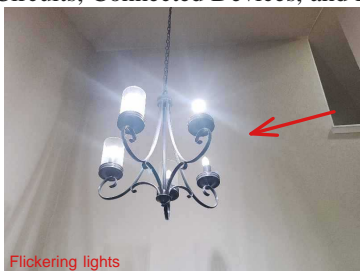
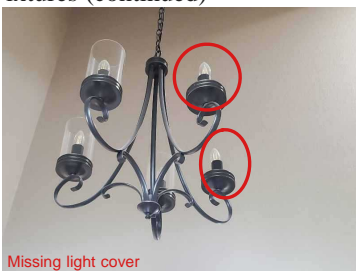
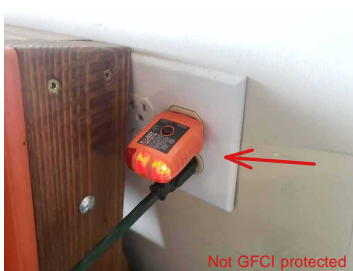
B. Branch Circuits, Connected Devices, and Fixtures (continued)

Type of Wiring: Copper, Romex
Comments: Copper Flickering lights observed, front entry way

Missing light covers, front entry way

No GFCI's in TREC Required areas, garage

Evaluation by a licensed electrician is recommended

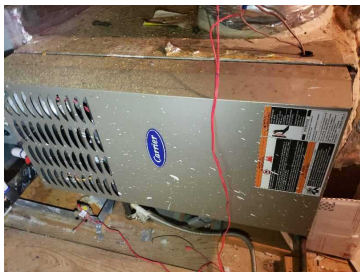
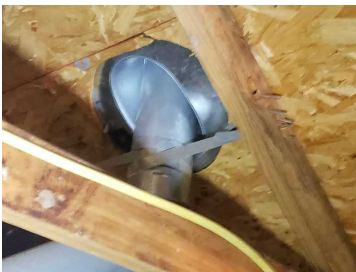
A. Heating Equipment

Comments: Carrier, 2008 Due to age of unit it is recommended to have systems serviced by a professional technician

The heating system did not respond to testing at this time

Recommend have unit evaluated by a qualified Technician

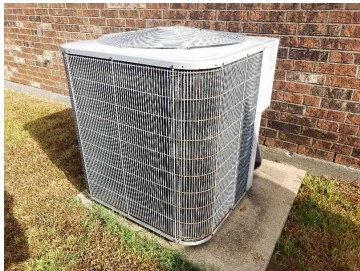
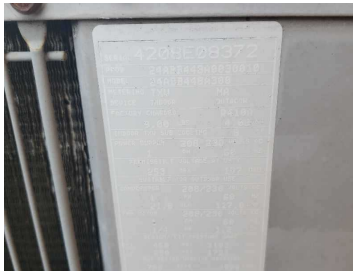
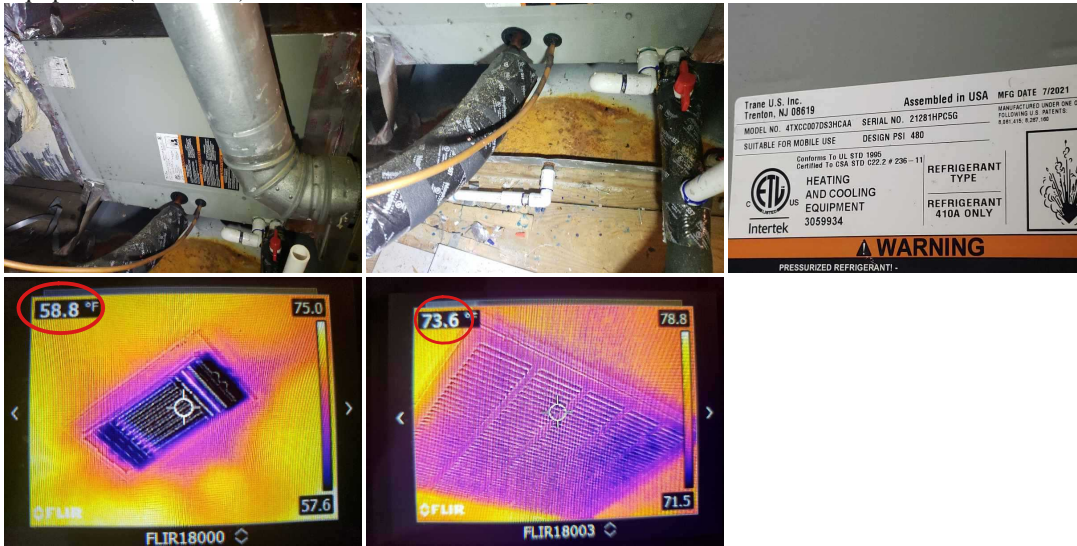
B. Cooling Equipment

Comments: Carrier, 2008, 4 ton, 40 amp; evaporator Trane, 2021 Due to age of unit it is recommended to have systems serviced by a professional technician

The cooling system was tested and functioned properly at this time

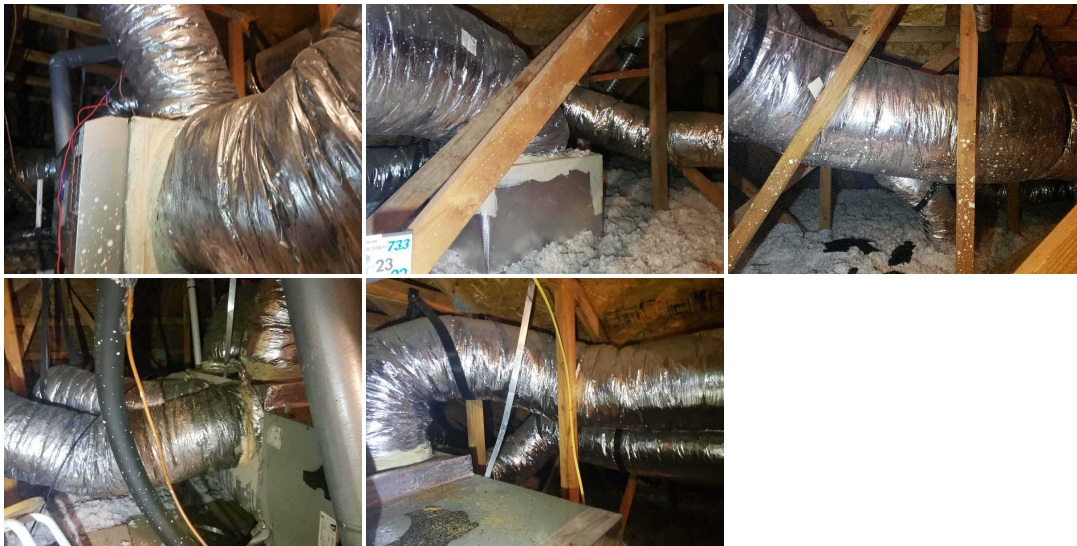
C. Duct Systems, Chases, and Vents

Comments: Insulated flex, Limited access and visibility to all areas of the ducts, due to confined area with limited attic flooring

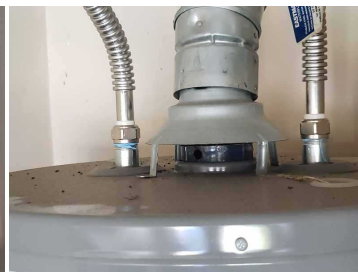
Capacity: 50 gallon

Comments: Rheem, 2021

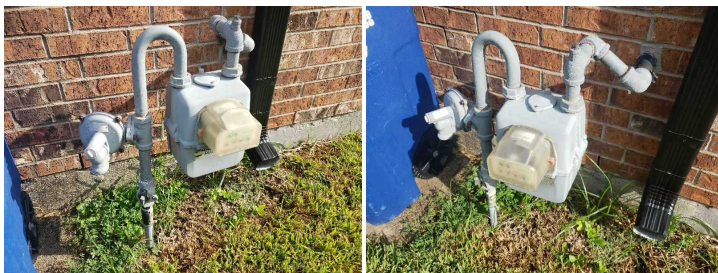
E. Gas Distribution Systems and Gas Appliances

Location of gas meter: Exterior surface mount at side of home
 Type of gas distribution piping material: Black iron
 Comments: Black Iron

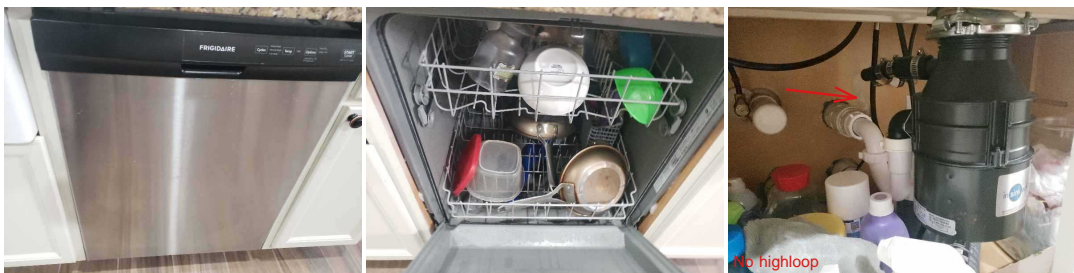
A. Dishwashers

No highloop installed on the dishwasher drain line, this can lead to water leaks
Recommend have deficient area corrected

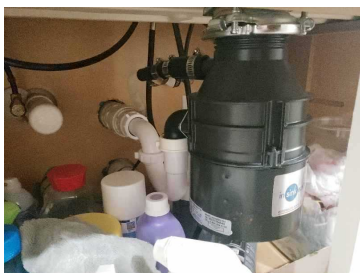
B. Food Waste Disposers

Comments: In-Sinkerator, Unit operating properly

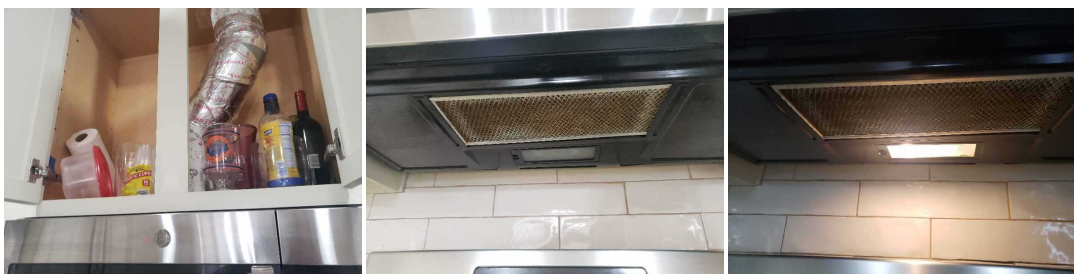
C. Range Hood and Exhaust Systems

Comments: General Electric, Vent hood was tested and functioned properly at this time

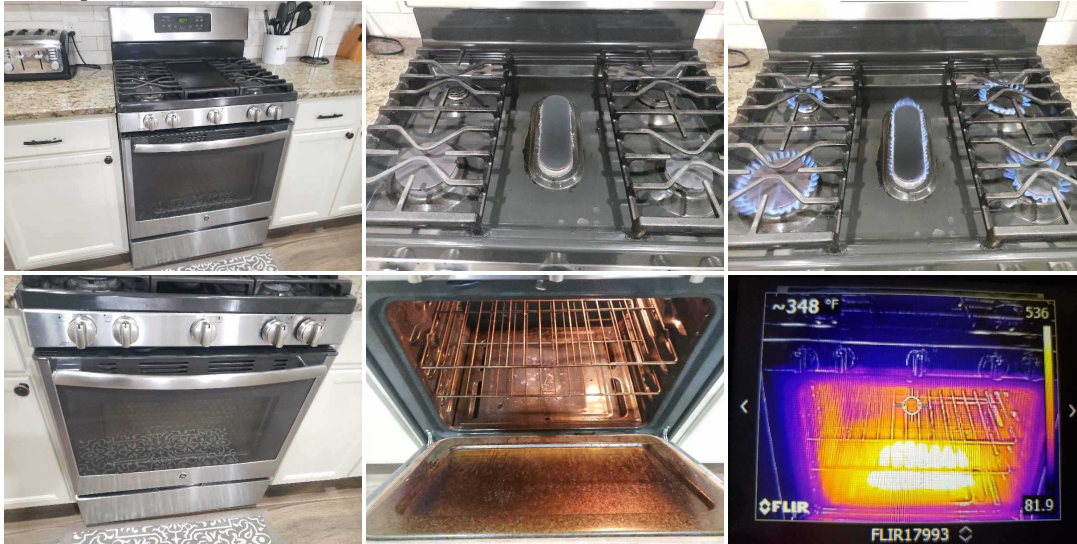
D. Ranges, Cooktops, and Ovens (continued)

Comments: General Electric, Both units were tested and functioned properly at this time

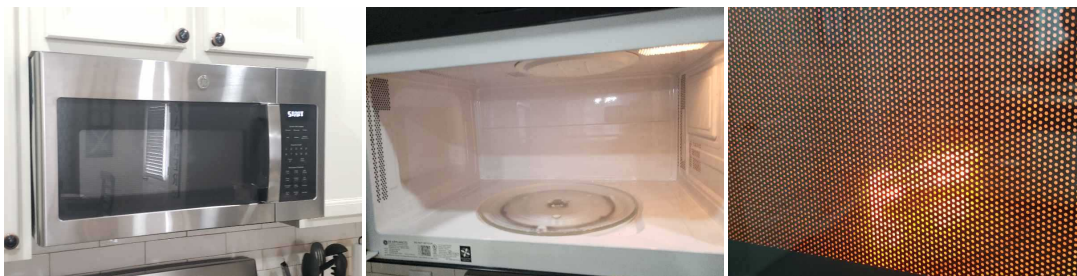
E. Microwave Ovens

Comments: General Electric, Microwave oven was tested and functioned properly at this time

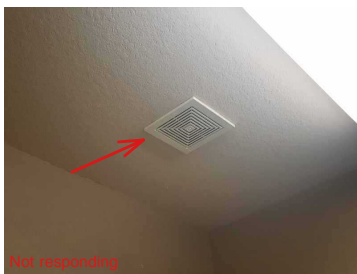
F. Mechanical Exhaust Vents and Bathroom Heaters

Vent fan not responding when tested, laundry room

Recommend have deficient area corrected by a qualified Technician

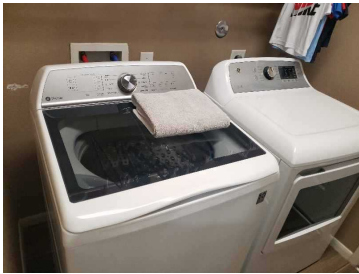
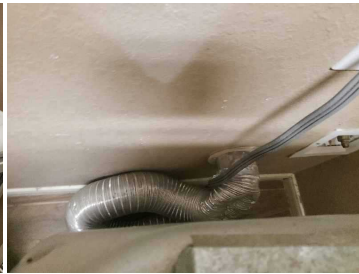
H. Dryer Exhaust Systems

Comments: Metal flex, Limited access and visibility to all areas of the dryer vent

Exhausting to the exterior

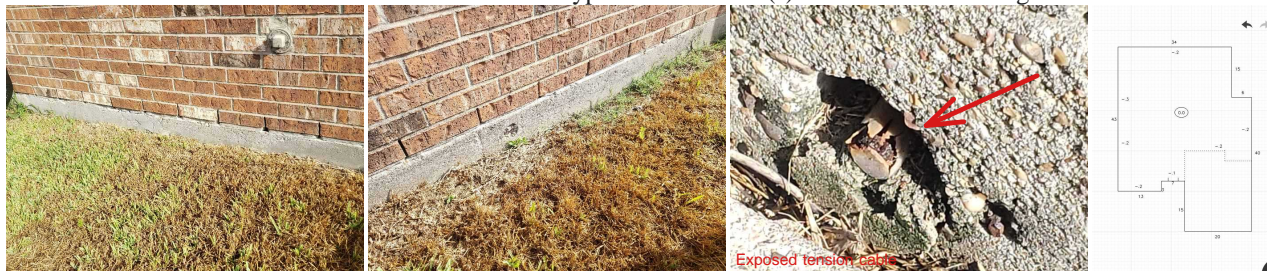
Exposed tension cables observed, right side

Recommend have deficient areas corrected

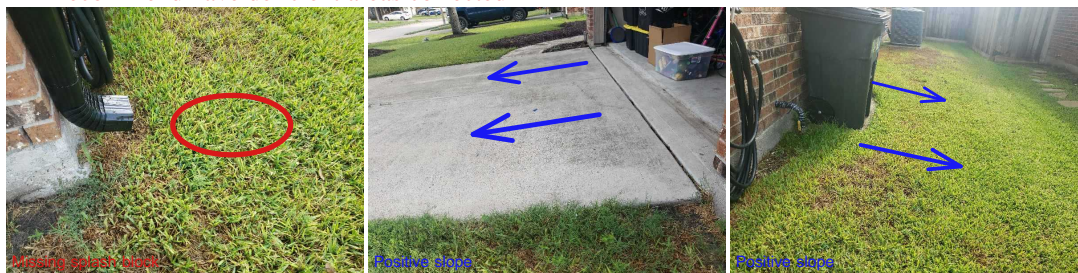
Missing splash blocks, several downspouts

Recommend have deficient areas corrected

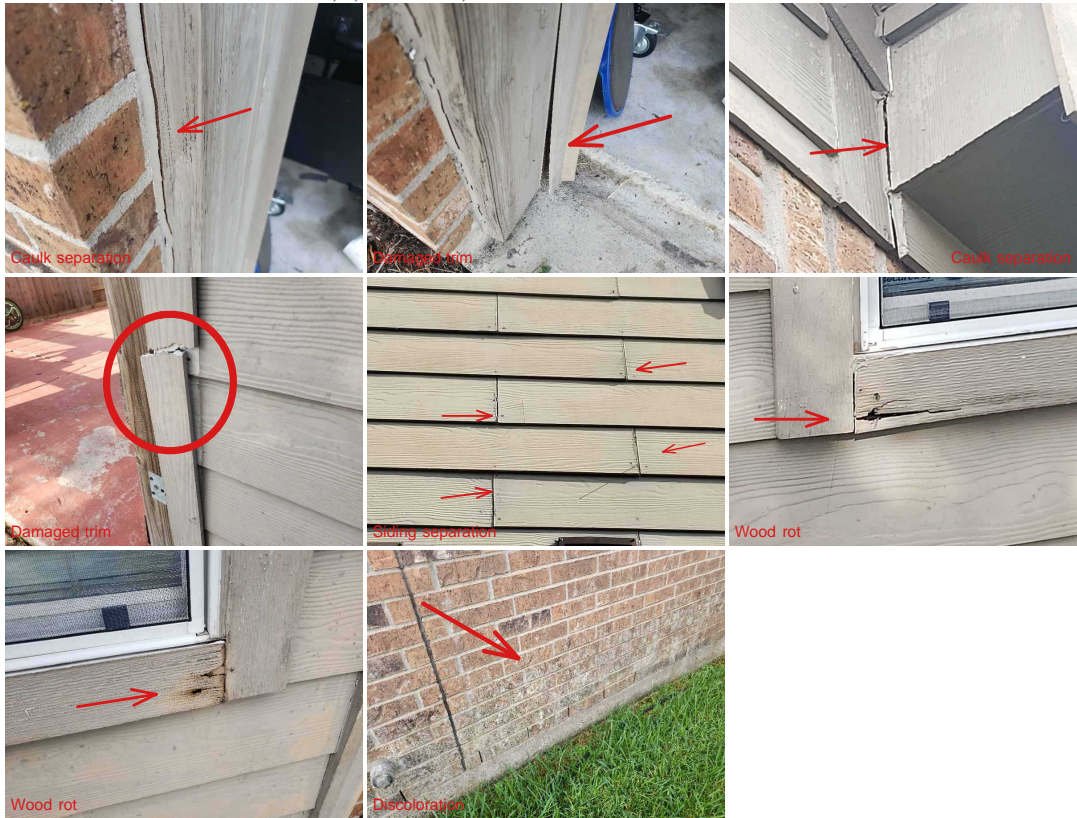
E. Walls (Interior and Exterior) (continued)

Separations - Exterior siding and trim, front side, right side

Damaged exterior siding/ trim, front side, back side

Rot - Exterior siding and trim, back side

Discoloration observed on exterior wall, left side

Recommend have deficient areas corrected

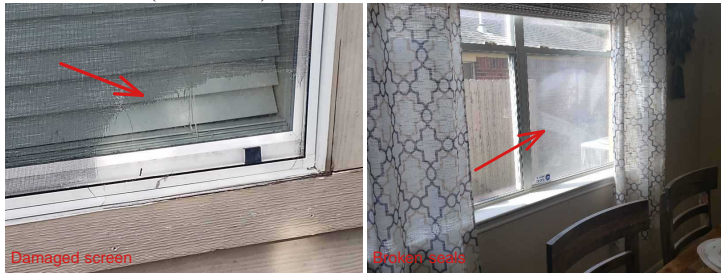
H. Windows (continued)

Broken window seals, fog observed between the glass, dining

Recommend have deficient areas evaluated and corrected by a qualified professional

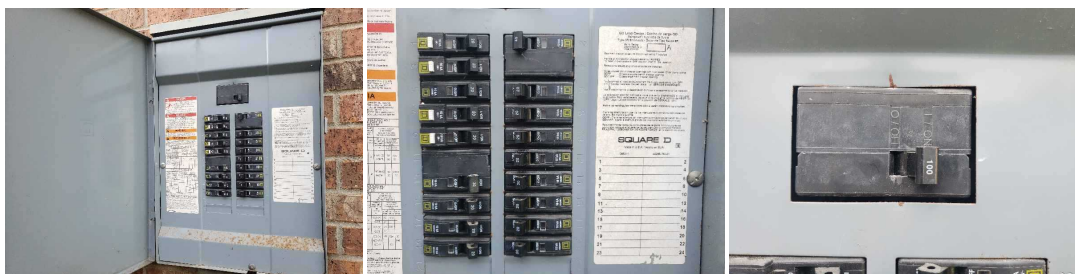
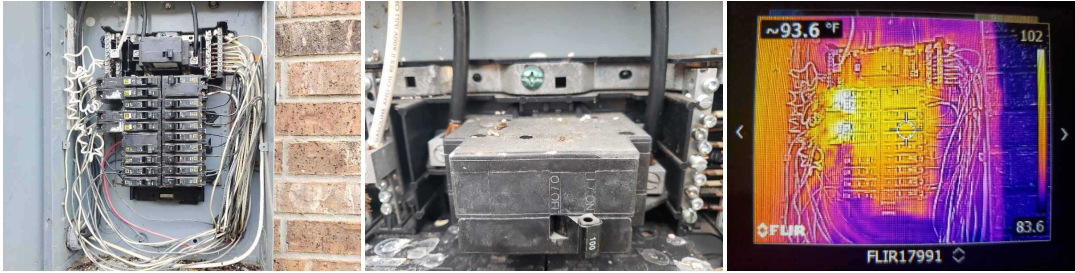
A. Service Entrance and Panels Square D, Underground service, 100 amp, Copper service entry, Not Labeled , Breaker panels are not clearly labeled

Recommend have deficient area corrected

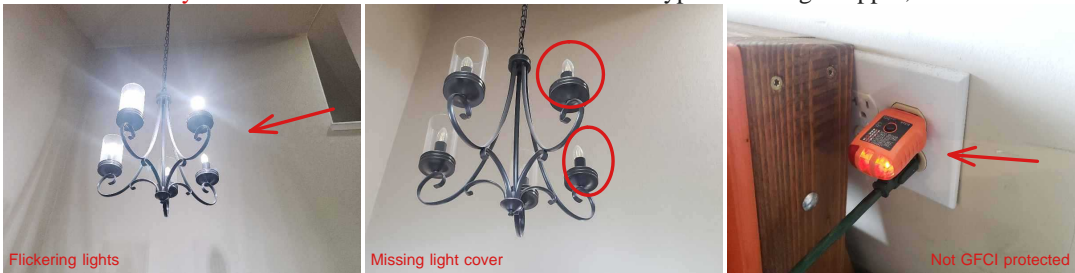
B. Branch Circuits, Connected Devices, and Fixtures Copper, Flickering lights observed, front entry way

Missing light covers, front entry way

No GFCI's in TREC Required areas, garage

Evaluation by a licensed electrician is recommended Type of Wiring: Copper, Romex

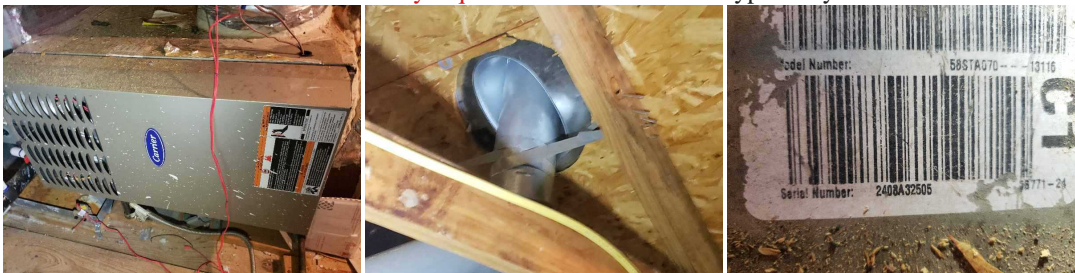
The heating system did not respond to testing at this time

Recommend have unit evaluated by a qualified Technician Type of System: Forced air Energy Source: Natural gas

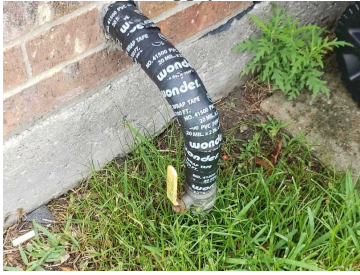
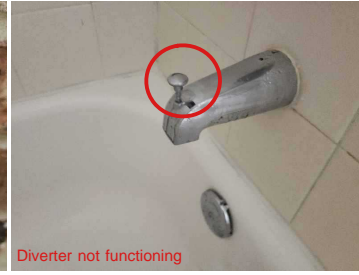
A. Plumbing Supply, Distribution Systems and Fixtures (continued)

A. Plumbing Supply, Distribution Systems and Fixtures PVC, Shower diverter not functioning, shower stays on, 2nd floor bathroom

Recommend have deficient area corrected Location of water meter: Curb side Location of main water supply valve: Side of house Static water pressure reading: 70 psi Type of supply piping material: PVC

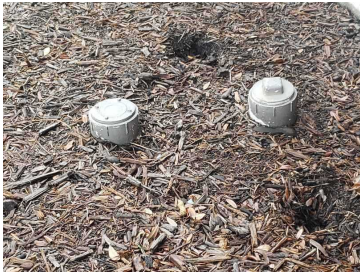
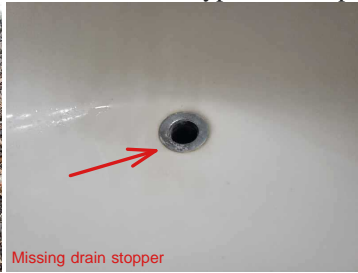
Missing drain stopper, main bathroom sink

Recommend have deficient areas corrected Type of drain piping material: PVC

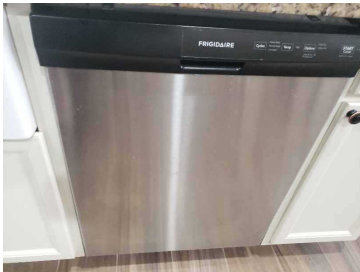
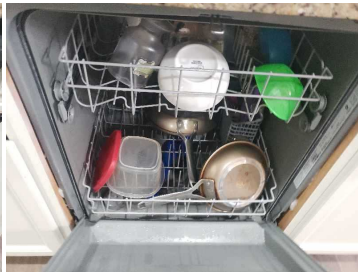
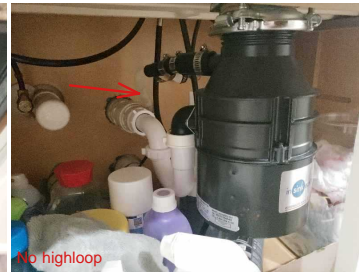
No highloop installed on the dishwasher drain line, this can lead to water leaks

Recommend have deficient area corrected

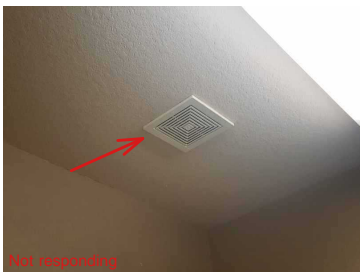
Vent fan not responding when tested, laundry room

Recommend have deficient area corrected by a qualified Technician
