KMB Home Inspection

Home Inspection

PROPERTY ADDRESS: 610 Private Road 5130, Woodville, Texas 75979
House | 2095 sqft | Built in 2020 | 6 Bedrooms | 3.5 Bathrooms

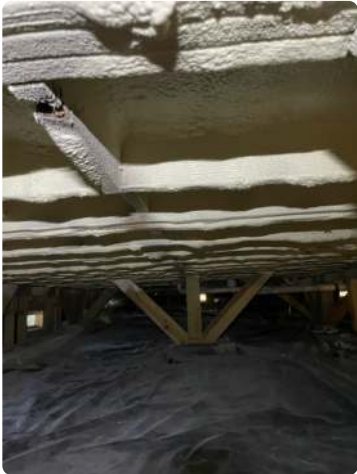
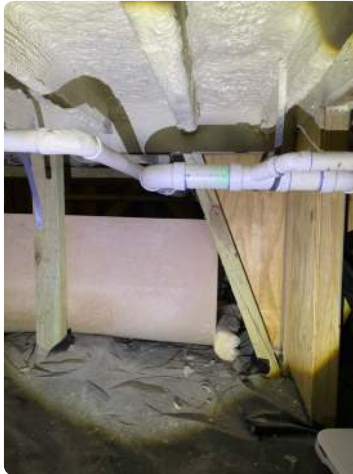
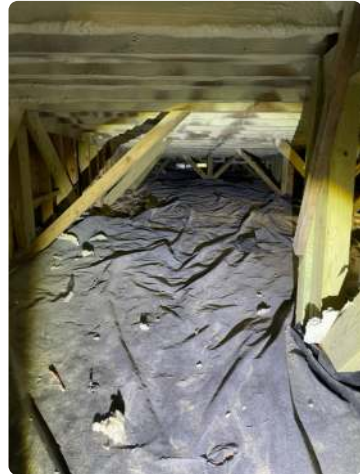
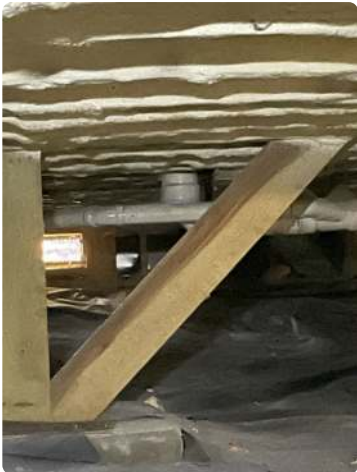
A. Foundations

Type of Foundation(s): Pier-and-Beam

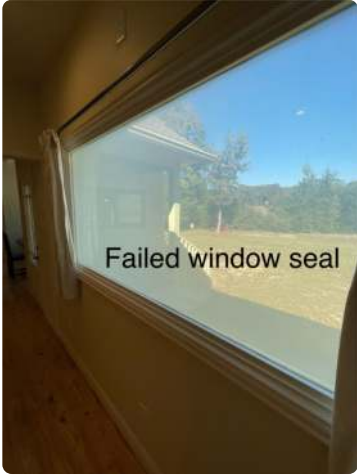
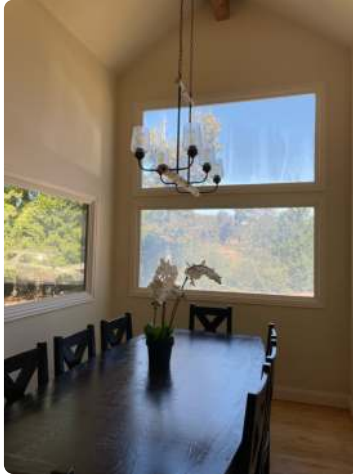
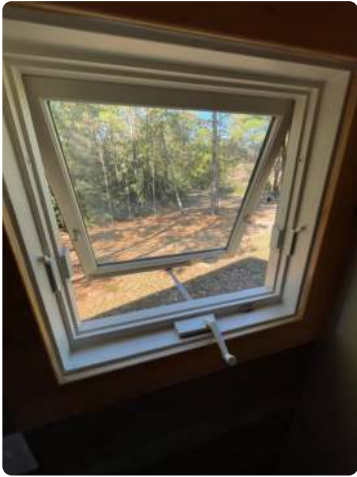
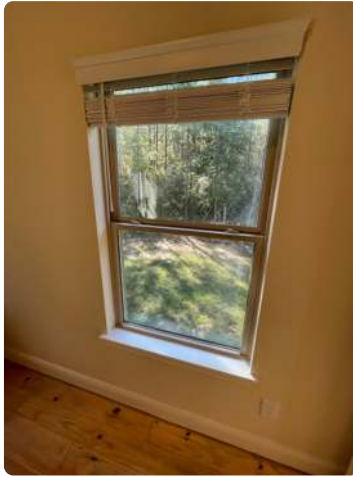
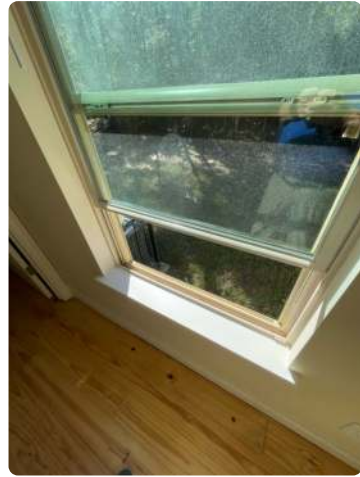
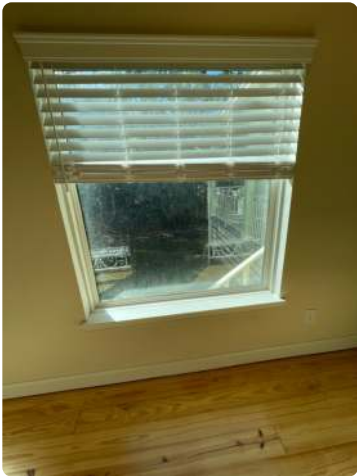
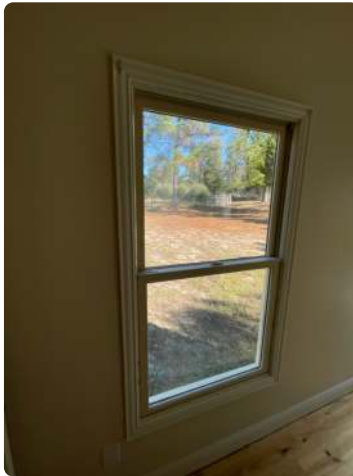
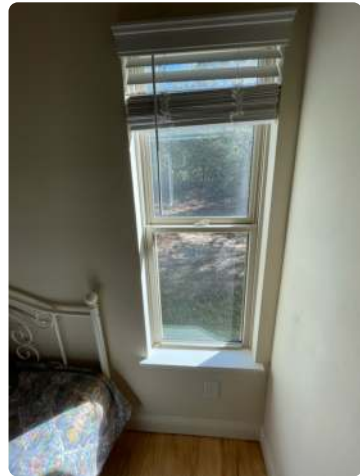
Numerous windows showed signs of failed seals. Failed seals will cause the window to become cloudy and can eventually lead to moisture intrusion, loss in efficiency, and/or possible mildew or mold growth over time.

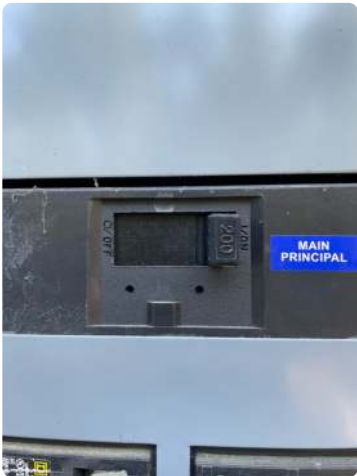
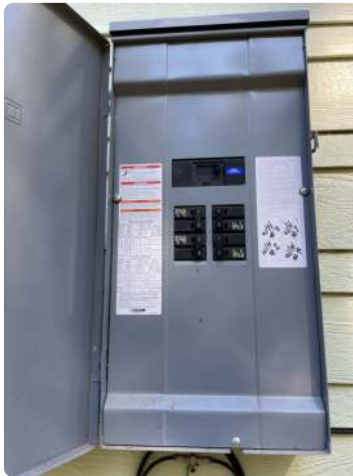
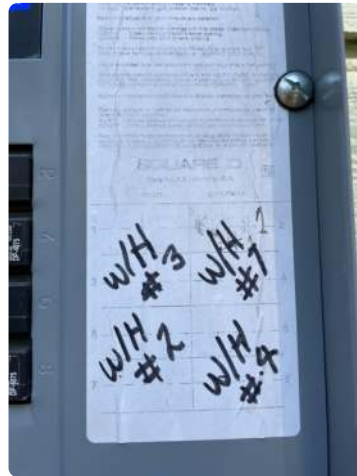
There is 200 Amp service to the home The main disconnect breaker is a 200 amp breaker and is on the back of the home. The 4 additional breakers are connected to circuits breakers in the attic left of attic entrance. Clarify with the homeowner what the circuits may power.

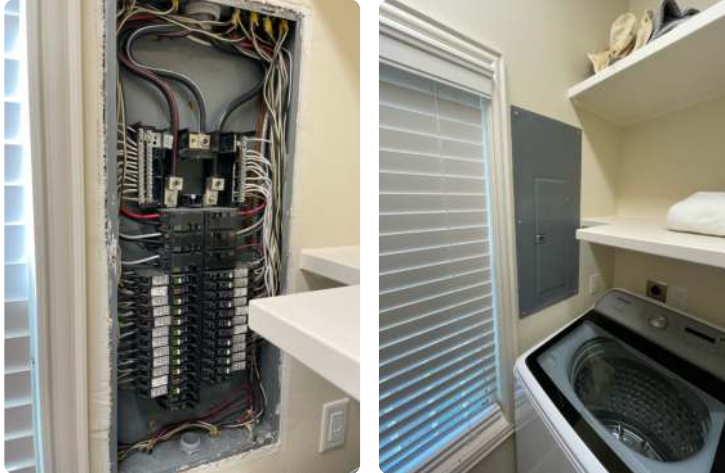
The subpanel is without required working clearance. The subpanel is obstructed and does not meet the minimum 36-inch deep by 30-inch wide by 6.5-foot high working space required by the NEC and OSHA. This condition is a safety hazard and must be corrected by removing obstructions to provide a clear path for safe access. It is blocked

by the washer/dryer and a shelf.

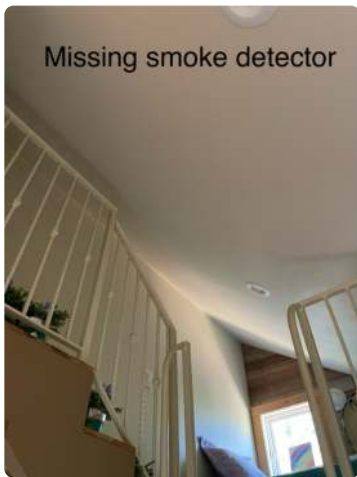
Although the outer rooms have smoke alarms, I would recommend the room with the 2nd story sleeping loft smoke alarm be installed on the upper portion of the ceiling. Therefore in the event of fire or smoke, the person in the loft would not be inundated by smoke without an alarm sounding.

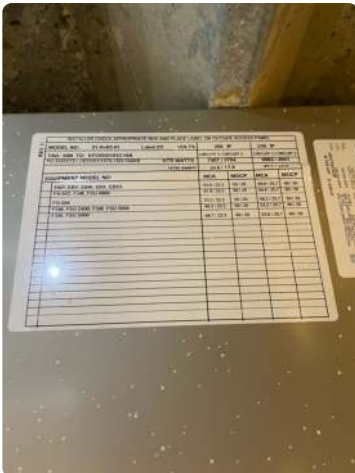
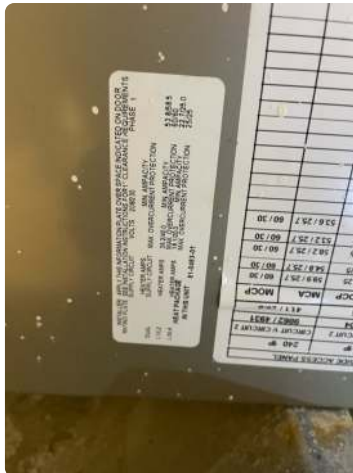
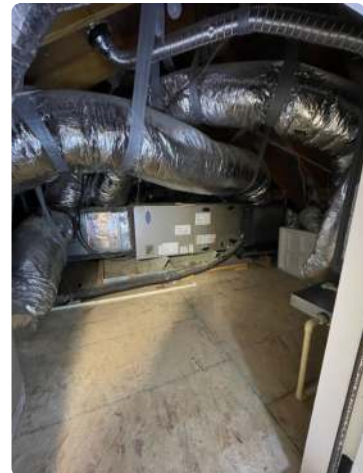
The heater when tested showed a 19 degree differential between return and supply registers. This is within the acceptable 15-22 degree range for operation.

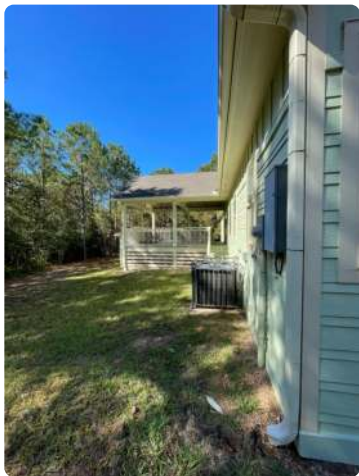
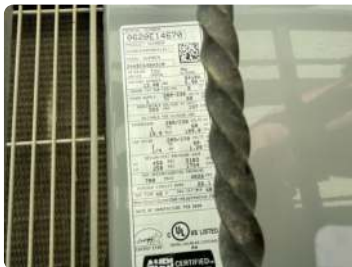
Although the unit was visually inspected the unit was not tested for operation. The ambient temperature outside was 56 degrees, below the safe operation temp of 60 degrees. Testing the cooling functions of the unit in temperature below 60 degrees could potentially damage the unit.

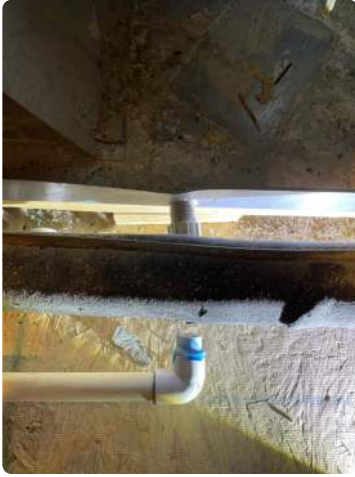
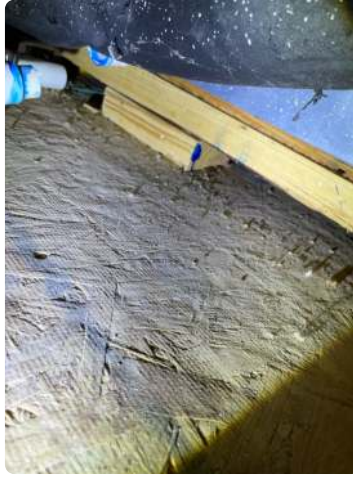
The drain piping on the secondary drain pan in the attic has come loose. This could potentially drain the water, in the event of a main line clog, into the ceiling below the drain pan.

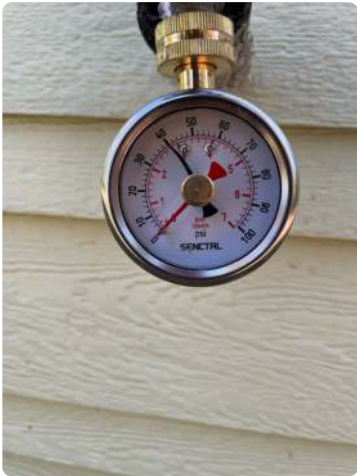
The static water pressure measured 41 p.s.i.. Acceptable measurements are between 40-80 p.s.i..
