Home Inspections

Inspection Report

1915 Kolfahl St A
Houston TX 77023

PROPERTY INSPECTION REPORT FORM

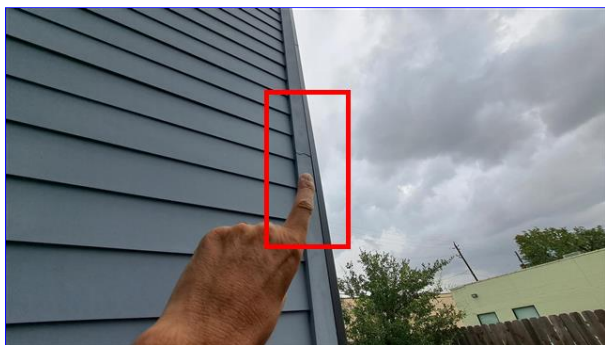
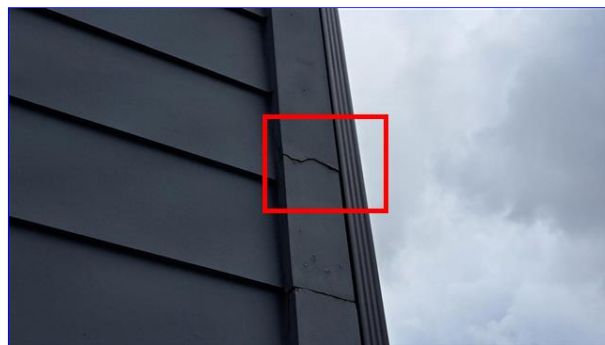
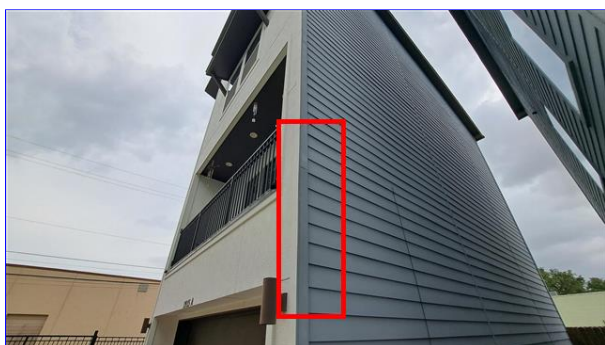
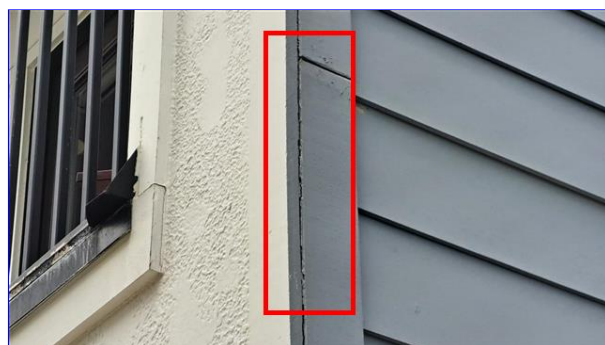
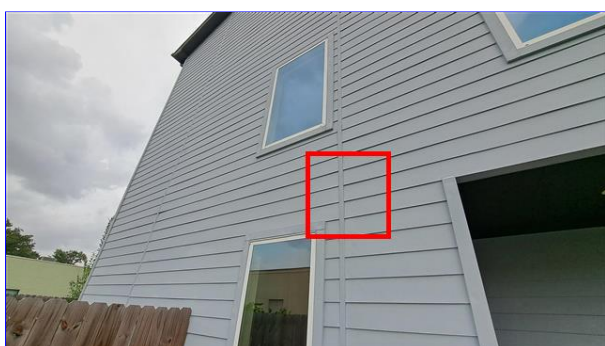
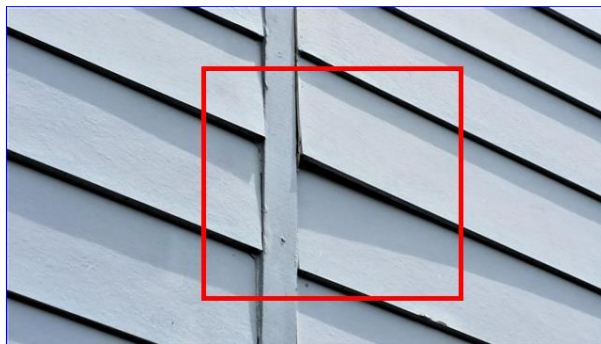
T11 (1) Openings and/or Gaps were noted at one or more locations around the exterior of the structure.

A leak in any one of these areas could cause concealed structural damage that would not be obvious in a visual inspection. We were not able to determine whether there was any hidden latent damage caused by this condition.

Recommend a qualified person or licensed contractor closing in and/or sealing/caulking any openings/gaps as required to avoid water and insect penetration into the structure.

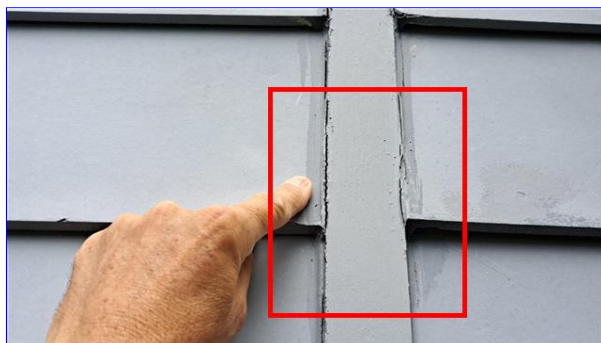
(2) **FYI: Suspected prior repairs were noted on the exterior siding in various locations.**

Various siding panels and trim are a different color. Repairs appear to be satisfactory at this time, however client is recommended to monitor over time for any change.

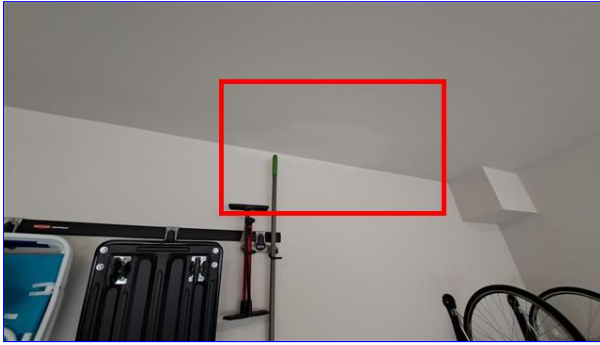
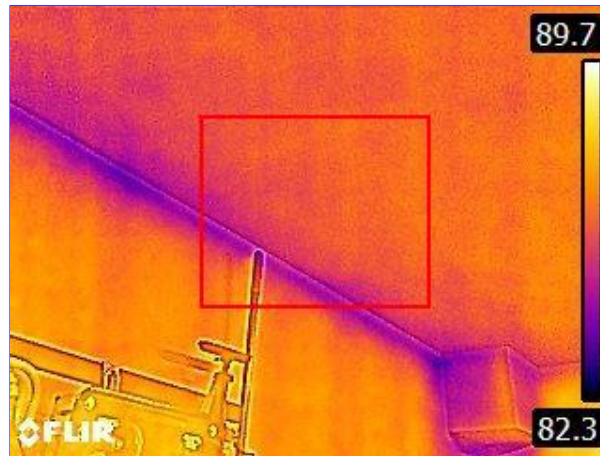
- (1) The Ceilings and Floors appear to be in satisfactory condition at the time of the inspection.
- (2) **FYI:** Prior patching was noted on the garage ceiling. This area was tested with a thermal imaging camera and was found to be dry at this time.

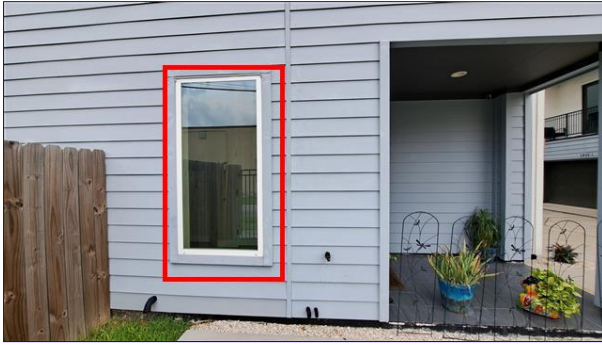
-Left Side of Home-

TI One or more thermal pane windows with suspected broken seals were noted around the home at the time of the inspection.

This condition allows condensation/moisture inside between the panes of glass. This causes fogging to take place, which will eventually cause staining to the point of zero visibility. The thermal pane windows no longer function as designed when they loose their seals and gas. Recommend a window company further evaluate all windows and repair or replace as needed.

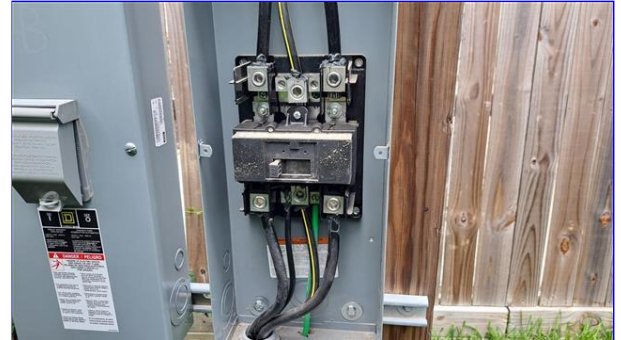
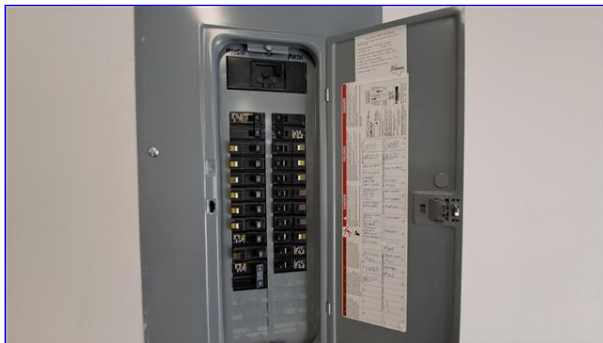
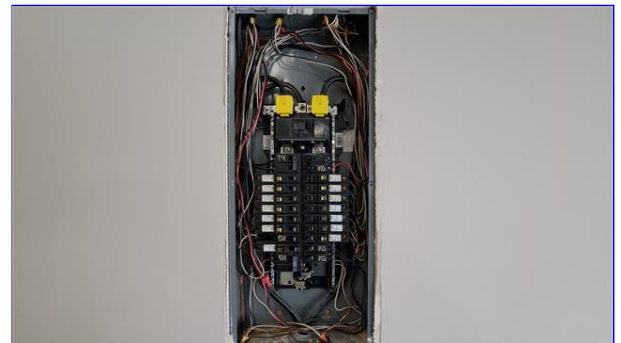
The Service Entrance and Panel (sub panel) appear to be operational and in satisfactory condition at time of the inspection.

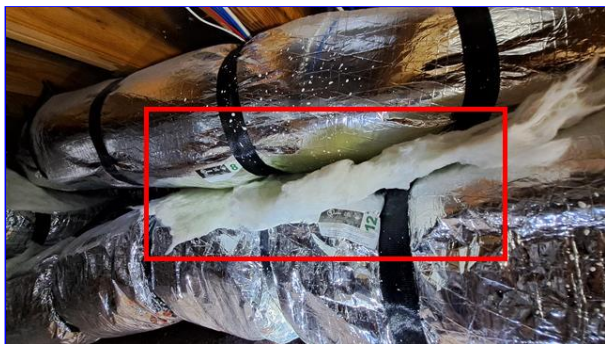
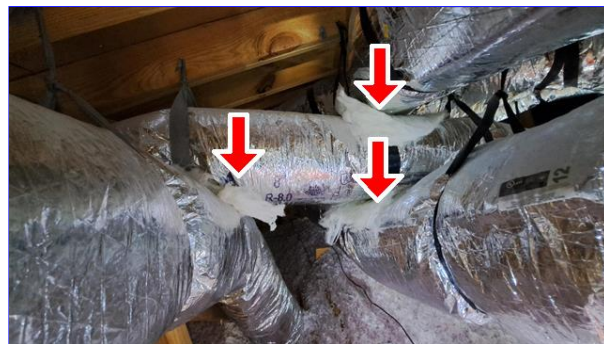
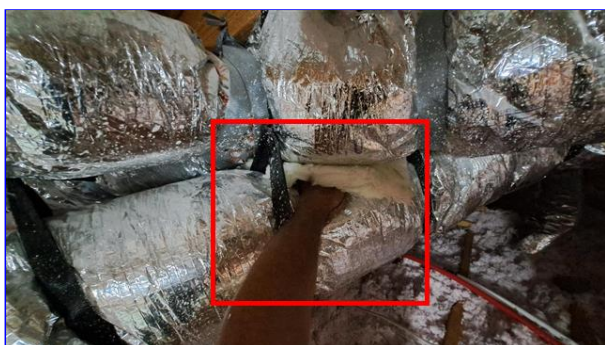
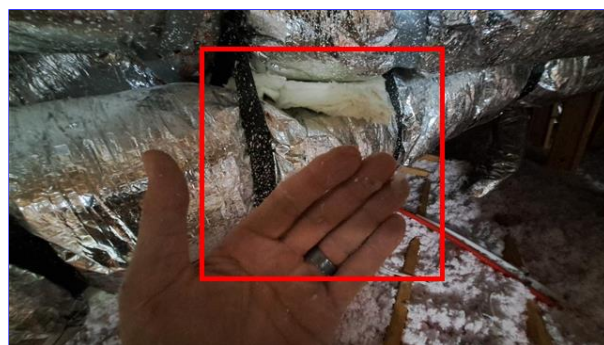
TIP (2) Dirty filters are recommended to be replaced to improve the efficiency of the AC system and the quality of the air you breath.

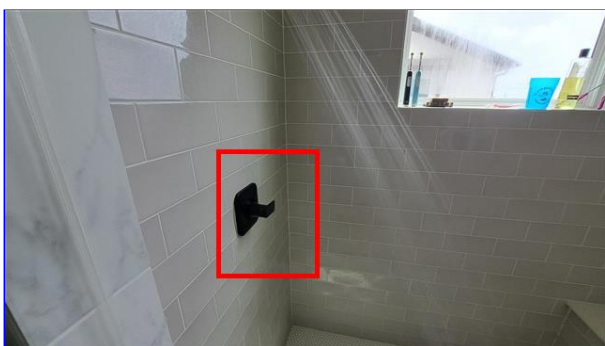
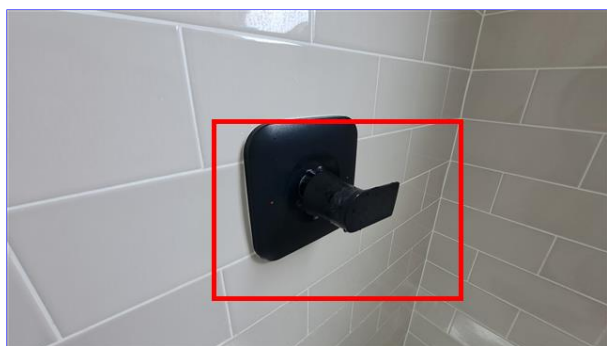
-Primary Bathroom-

T11 (3) The hot and cold water supply at the Primary Bathroom shower mixing valve is reversed and recommended to be corrected as needed.

The hot water should come from the far left side and cold water from the far right side of the fixture as indicated on the backing plate with red and blue markings/or H and C. Recommend a qualified person make repairs as required.

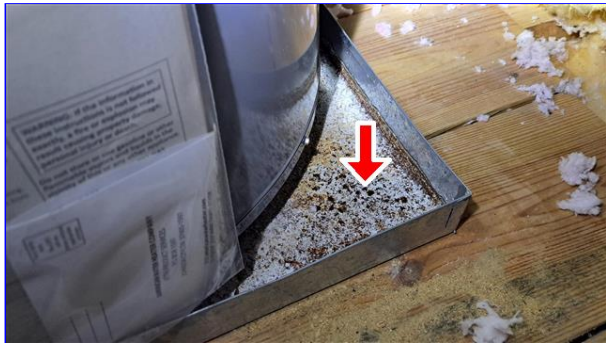
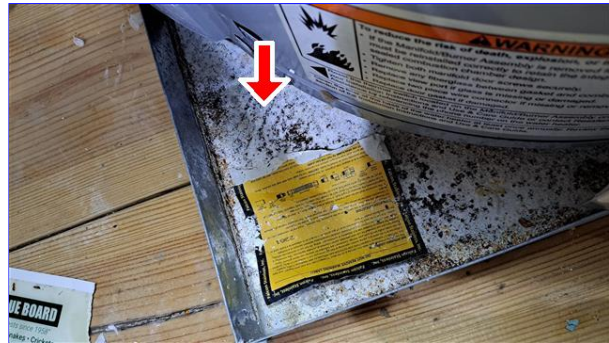
T12 (2) *FYI:* **Rust and/or Water stains were noted in the safety pan under the water heating unit(s).** This would suggest a plumbing leak at one point of time. The pan was found to be dry at the time of the inspection, but I recommend monitoring periodically to ensure a leak does not return.

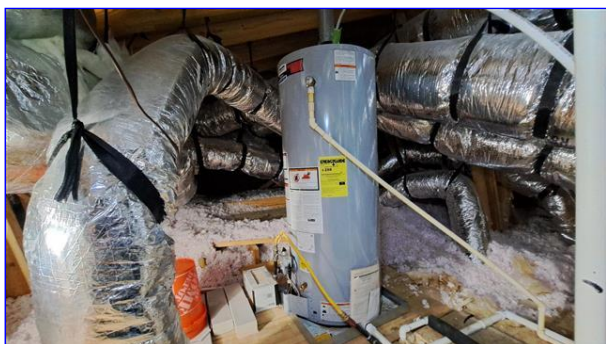
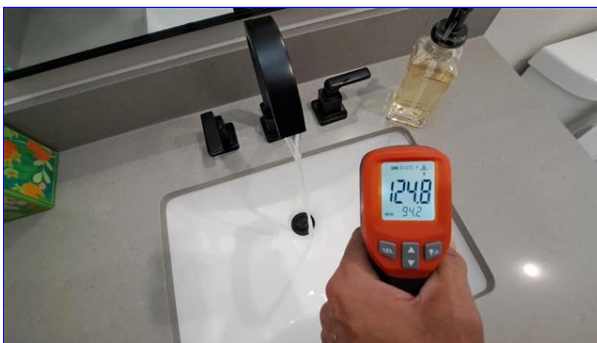
(3) **FYI: Photos of water heating unit(s) for your information.**
