# ***GILRODS HOME Inspections***

## **Property Inspection Report**

7111 Timber Post Ln, Humble , TX 77346  
Inspection prepared for: Sibel Reed  
Real Estate Agent: Lakendra Gaffney -

Date of Inspection: 6/1/2026 Time: 8:00  
Age of Home: 2004 Size: 2882 sqft  
Weather: 91 degrees

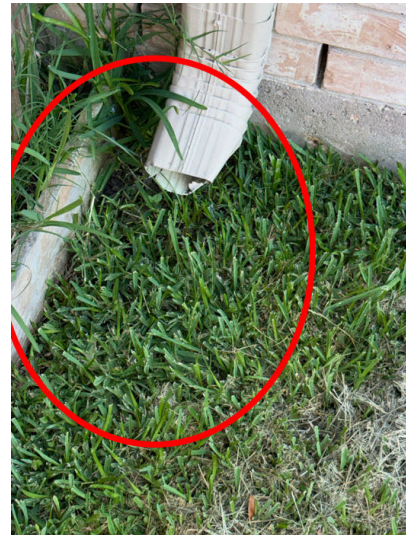
Proper drainage is critical to prevent inconsistent moisture content in the soil. In expansive soil conditions, it is key to maintain moisture consistency in the soil surrounding the foundation. If one area of the foundation receives too much moisture, the soil swells and may cause an upheaval in that area of the slab, placing stress on the foundation. If one area is allowed to dry out or lose moisture, the soil will contract from the foundation also causing stress on the foundation. Stress on the foundation can result in the appearance of cracks in walls and ceilings, sticking windows and doors and sloping floors. If neglected, further serious problems can occur such as damaged underground plumbing and even foundation failure. Therefore, it is recommended to maintain a consistent moisture content and proper drainage to reduce foundation movement in areas of expansive soils.

The downspouts need splash-blocks at the exterior areas.

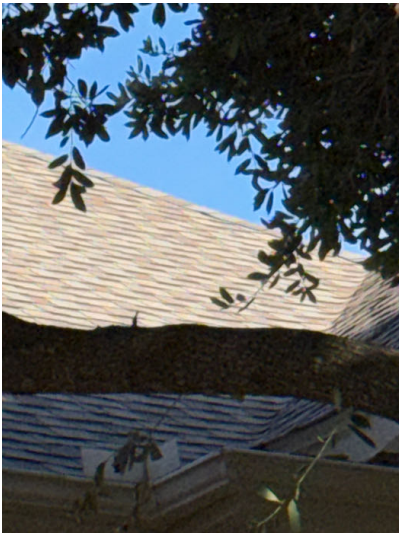
Noted overall roofing materials appear to be performing as expected and show normal wear and tear. The asphalt shingle roof exhibited moderate delamination across certain portions of the roof. Recommend obtaining certificate of feasibility of insurance coverage.

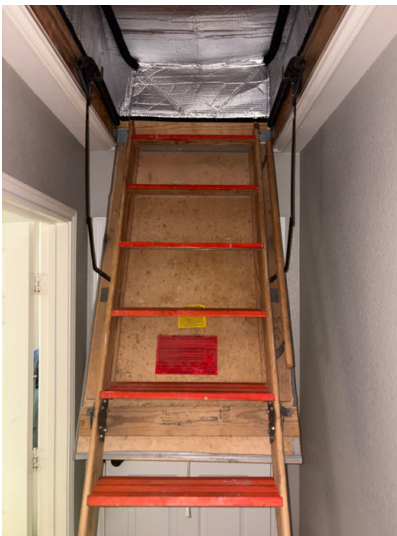
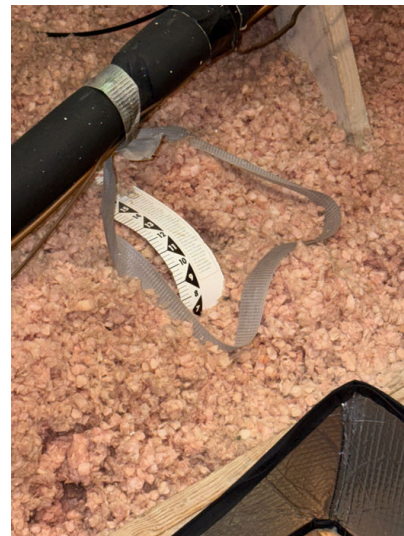
About [ 75%] of the attic and attic floor was visible and/or accessible due to normal attic conditions (framing, duct work, insulation, storage, inaccessible areas, etc.). There is the possibility that defects or other problems are present but not visible due to conditions. Note that attic insulation is never moved or otherwise disturbed, so anything under the insulation was not inspected or otherwise examined. Condition of attic and interior ceilings and walls seemed to indicate that there were no major defects relating to the attic or roof at the time of the inspection. Recommend further investigation and or installation of access attic stairs at opposite end of attic area.

Noted overall roof structure appears to be performing as expected and show normal wear and tear.

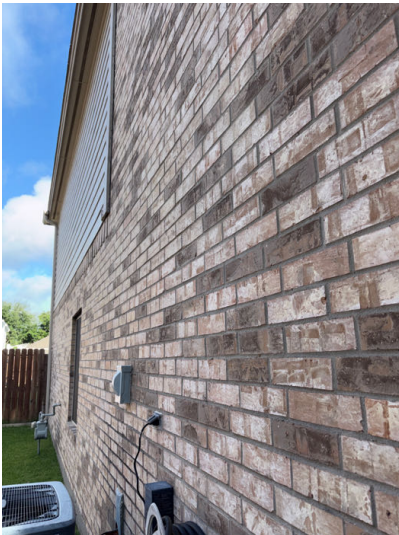
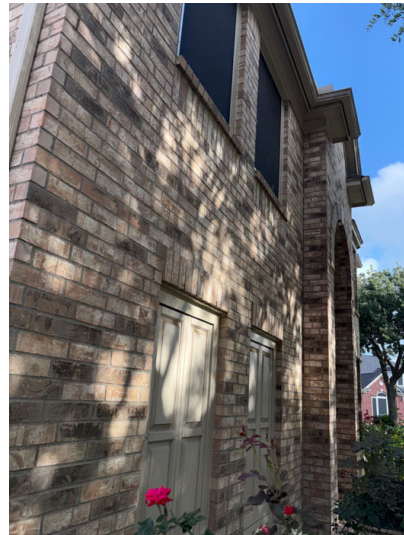
Maintain all exterior finishes, caulking, and other sealants at any dissimilar material abutments and all penetrations to the walls and roof. This inexpensive task aids in the prevention of moisture and (pest intrusion) and saves on costly repairs. Recommend repair by qualified person.

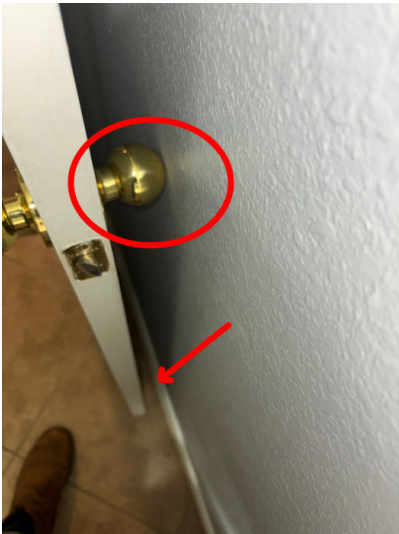
*Missing door stops were observed in several areas, corrections are recommended to prevent damage to wall surfaces.*

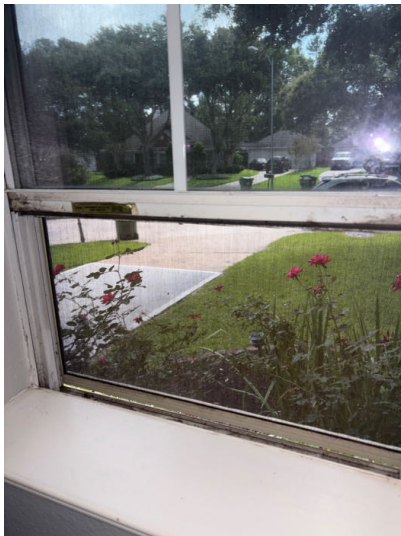
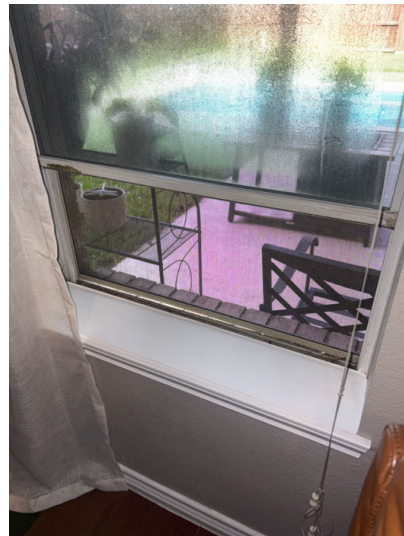
Broken sash wire/cord observed at upstairs bedroom window. This is a "Safety Concern". Sash wire/cord holds window in open position. Suggest repairs/replacement as needed to ensure safety.()

Cracked and/or broken glass was observed. Recommend repair/replace as necessary(Master Bedroom)

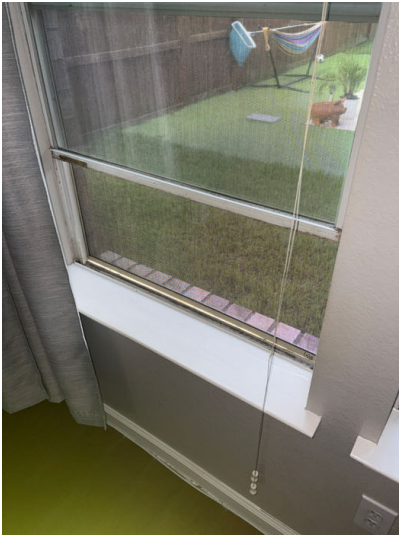
*Cracked and/or broken glass was observed. Recommend repair/replace as necessary(Master Bedroom)*

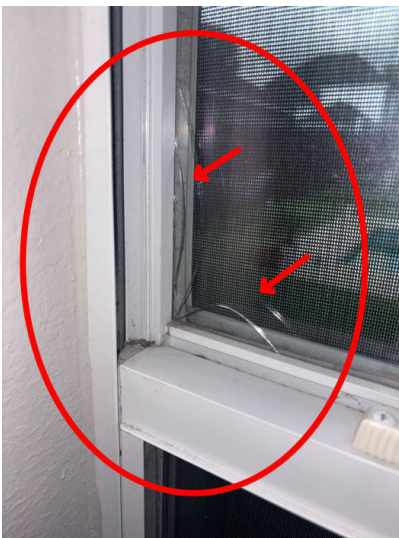
*Broken sash wire/cord observed at upstairs bedroom window. This is a "Safety Concern". Sash wire/cord holds window in open position. Suggest repairs/replacement as needed to ensure safety.()*

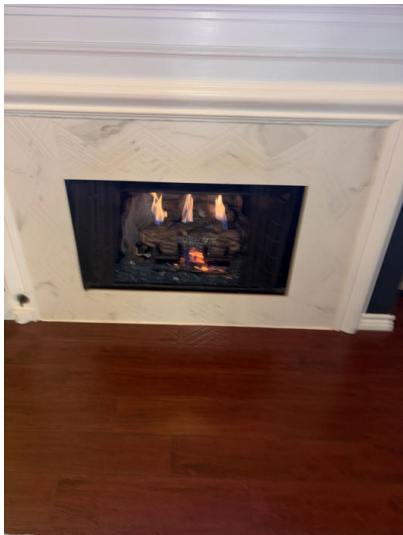
Artificial gas logs were present within the firebox and the damper is required to be permanently blocked in the open position so as to prohibit any accidental spillage of carbon monoxide into the living space.

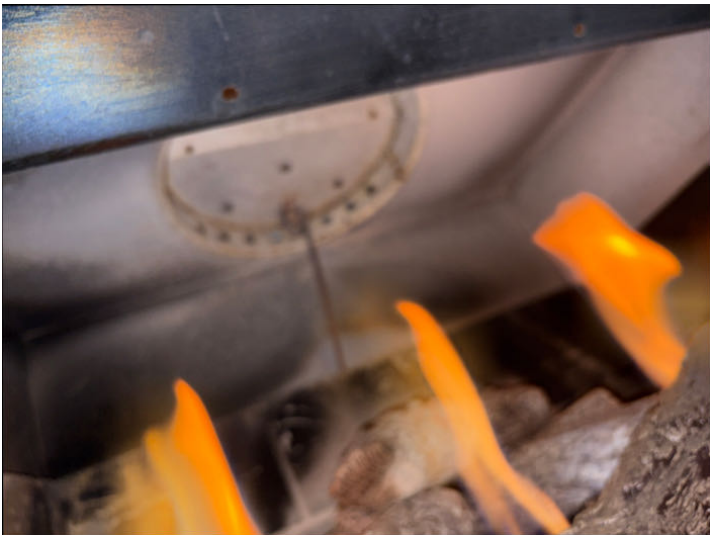
Artificial gas logs were present within the firebox and the damper is required to be permanently blocked in the open position so as to prohibit any accidental spillage of carbon monoxide into the living space.

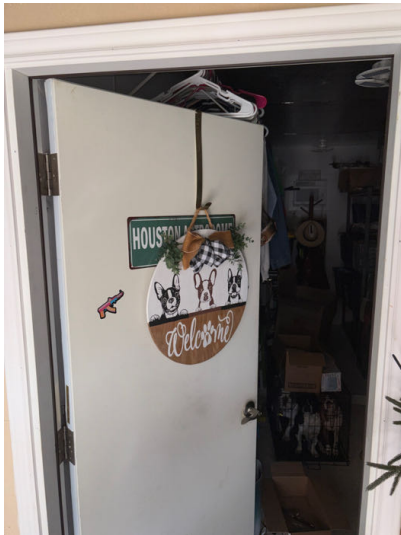
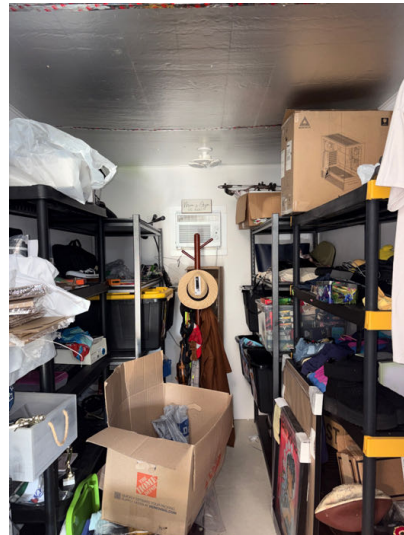
*An addition to the property appears to have been made at. This inspection does not review permits or determine if they exist. That determination should be made by client through the local building officials or with sellers prior to closing to ensure all additions were built with permits.*

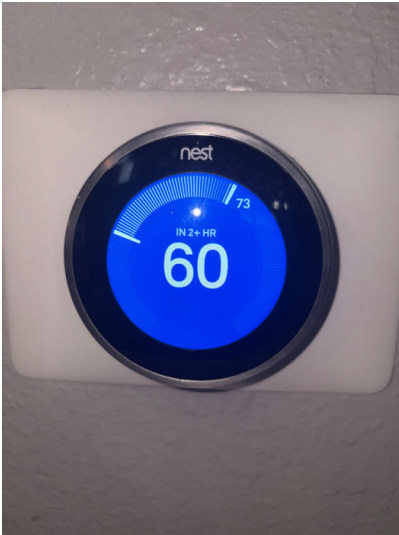
*NTS: Supply temperature typically +/- {55} degrees. Return air should be between {14 - 22} degrees greater. This unit appears to be functioning as intended at the time of inspection and consistent with accepted industry standards.*

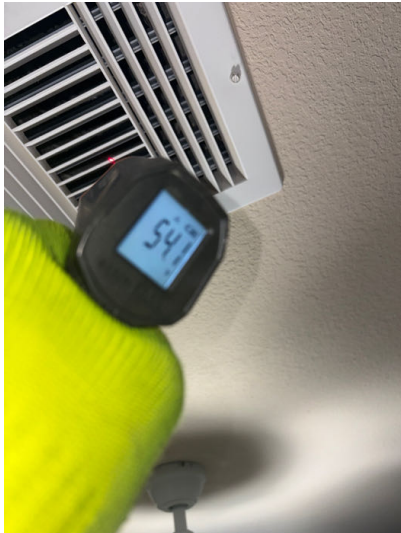
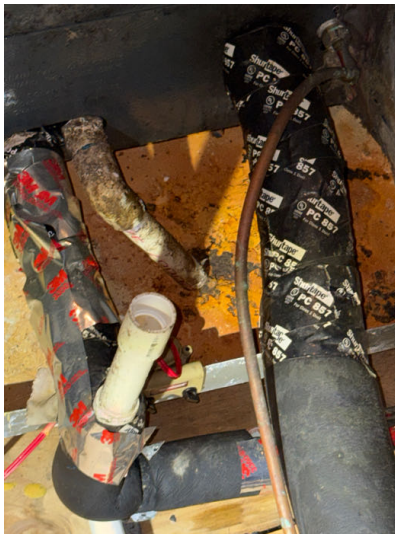
The condensate pan was observed to be holding heavy rust residue. Recommend have a clean check service and further investigation by a licensed HVAC contractor to evaluate the system.

| Page 27 Item: B | Cooling Equipment | The condensate pan was observed to be holding heavy rust residue. Recommend have a clean check service and further investigation by a licensed HVAC contractor to evaluate the system. |

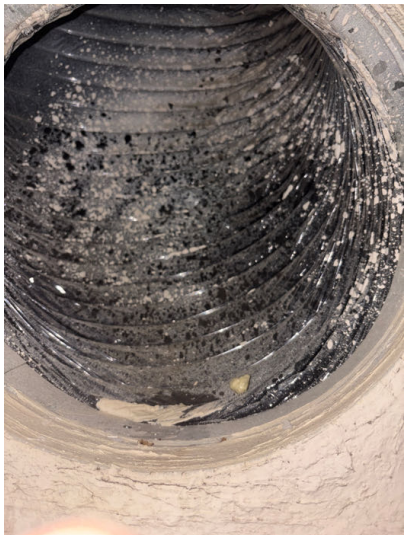
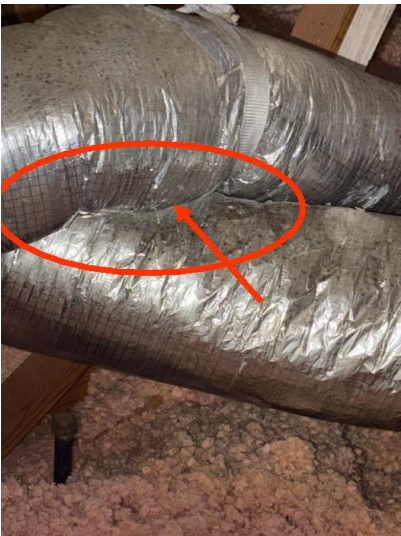
*The plenum duct should not have any contact with other ducts or any attic insulation. I recommend further inspection and proper installation by licensed HVAC contractor.*

The plenum duct should not have any contact with other ducts or any attic insulation. I recommend further inspection and proper installation by licensed HVAC contractor.

| Page 29 Item: C | Duct Systems, Chases, and Vents | The plenum duct needs support straps on some and should be raised at least 6 inches and not have contact with any attic insulation. Recommend further inspection and proper installation by licensed HVAC contractor.<br><br>The plenum duct should not have any contact with other ducts or any attic insulation. I recommend further inspection and proper installation by licensed HVAC contractor. |

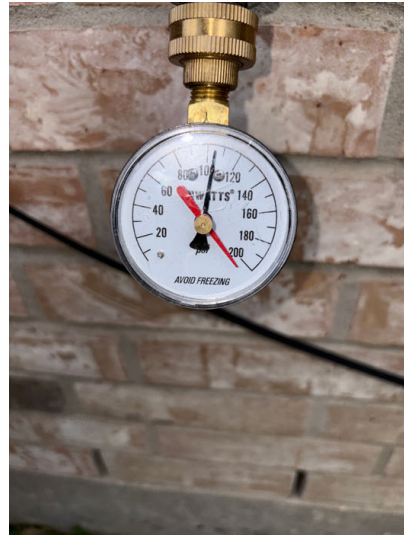
*Meter Location*

*WATER PRESSURE Static Water Pressure Reading: (80+psi)  
water pressure: (Rule of Thumb: Consider 45 or 50 psi on the low  
side, 60 good, above 80 is too much) if pressure drops below 40 psi  
we recommend plumber to evaluate all areas.*

WATER PRESSURE Static Water Pressure Reading: (80+psi) water pressure:(Rule of Thumb: Consider 45 or 50 psi on the low side, 60 good, above 80 is too much) if pressure drops below 40 psi we recommend plumber to evaluate all areas.

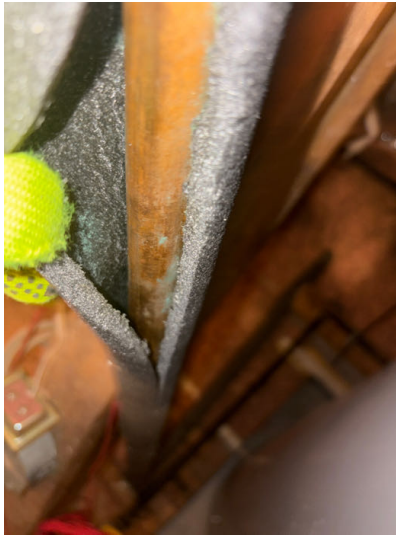
*Type of Supply Piping Material: COPPER*

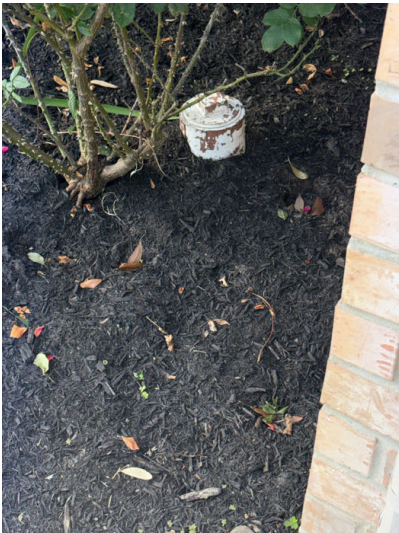
*The exterior main cleanout was located at the front of the structure. Recommend Home Sewer Scope Inspection. "A sewer scope is a video inspection of the lateral sewer line leading from the house at/near the foundation and connecting to the city or HOA tap or septic tank. ... Sewer-scoping the line can reveal blockages, damage to the pipe system, and other problems, which are vital for homeowners and home buyers to be aware of"*

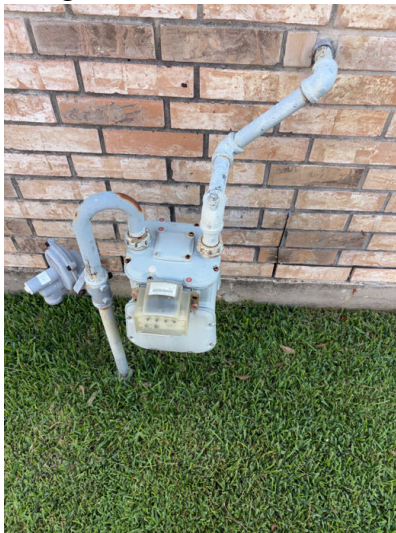
*Limitations: Only readily accessible and visible connections at the point of use are inspected. Contact your gas company or other specialized gas professional for a more exhaustive check of the gas line connections inside walls and at other inaccessible areas.*
