Pool Inspection Report

14014 Hampton Cove Drive, Houston, TX 77077

Date of Inspection: 4/30/2026 Time: 8:30 AM

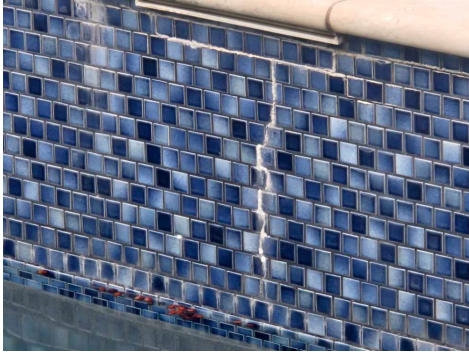
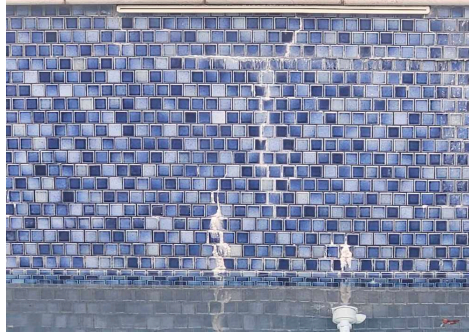
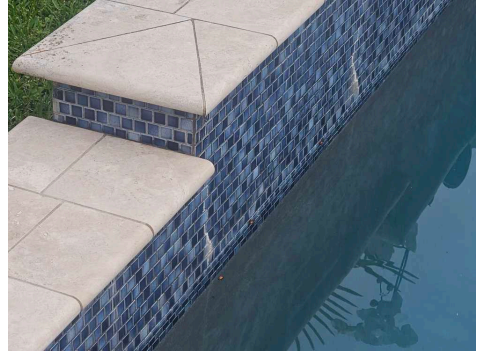
Some calcium buildup observed spa & pool walls.

Calcium buildup observed on the tiles.

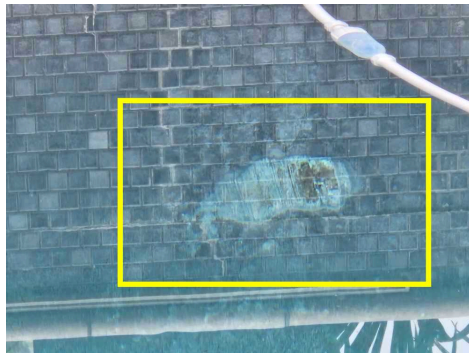
Damaged tiles.

Loose, damaged and/or missing tiles should be repaired or replaced immediately to prevent further damage to pool & spa tiles.

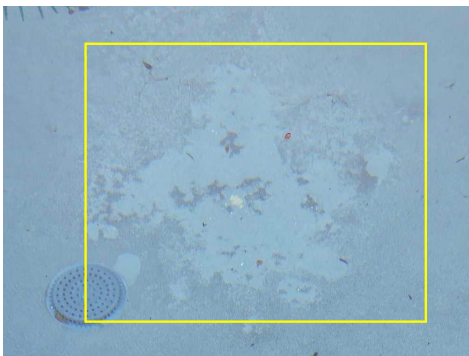
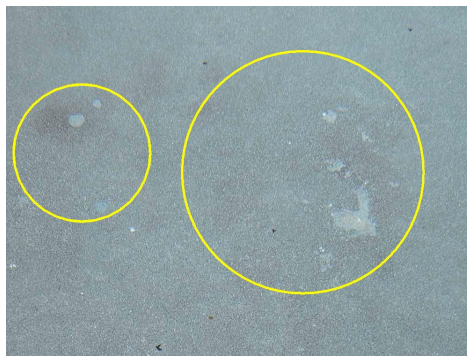
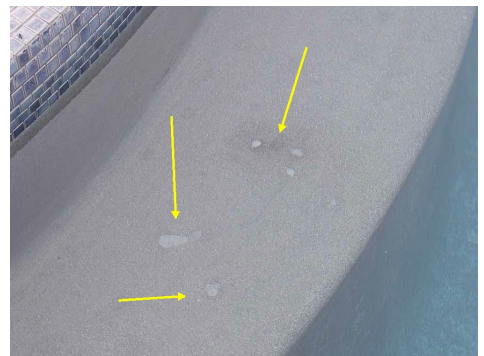
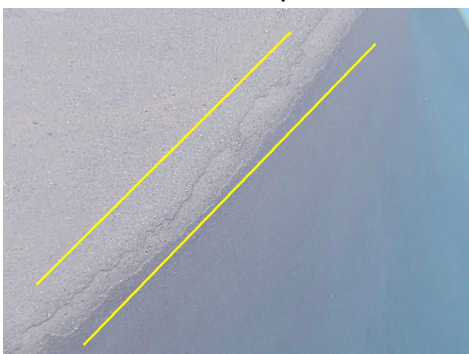
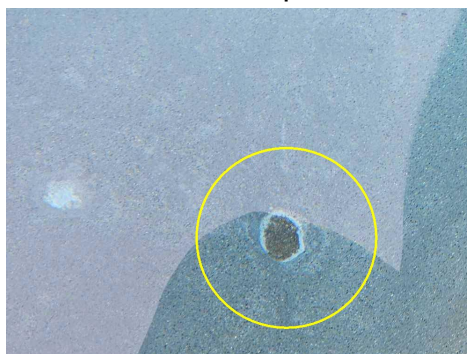
There are some visible deficiencies observed in the pool finished surface at this time. Some resurfacing may be necessary. This condition should be further evaluated by a qualified pool service.

Some discoloration of the pool surface was observed at the time of this inspection. A qualified technician should investigate the cause and remedy of this condition.

Pool plaster showing signs of major wear, plaster worn to point that gunite shell of pool is showing through.

Excessive wear and tear observed on the pool finish.

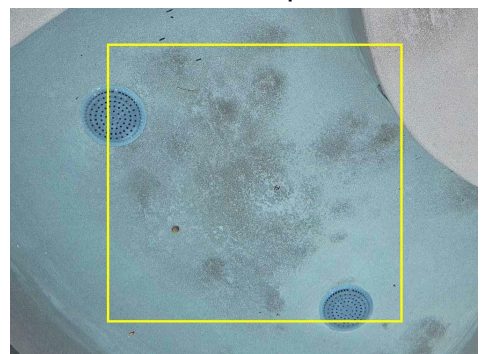
There are some visible deficiencies observed in the spa finished surface at this time. Some resurfacing may be necessary. This condition should be further evaluated by a qualified pool service.

Some discoloration of the spa surface was observed at the time of this inspection. A qualified technician should investigate the cause and remedy of this condition.

Excessive wear and tear observed on the spa finish.

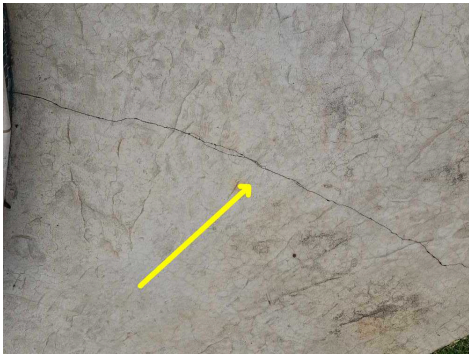
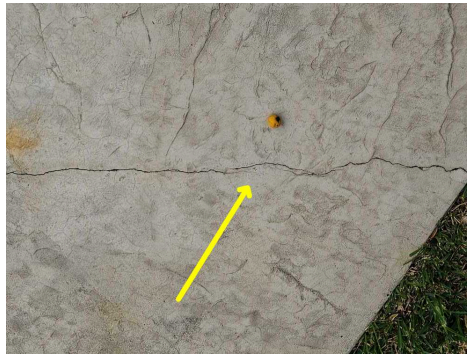
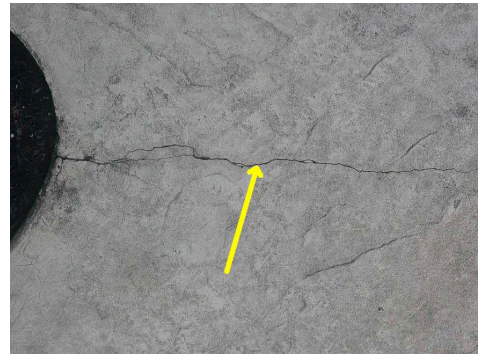
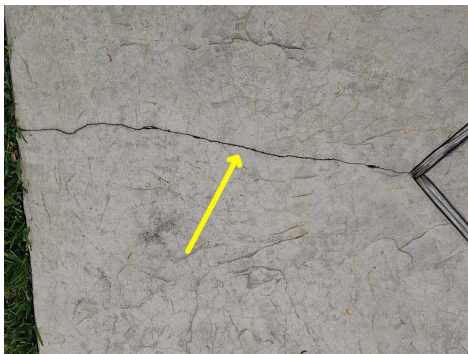
Some damage, cracking, and/or deficiencies to the decking were observed.

Cracks for observed in the pool deck.

Cracks were observed in the pool deck.

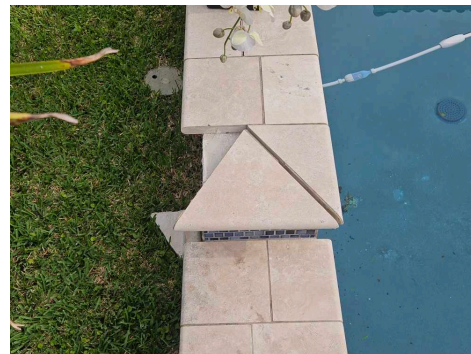
Loose flagstone/coping observed; water wall.

Loose tile was observed on the water wall.

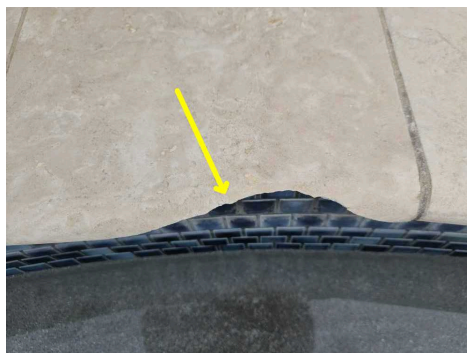
Some damage to the coping was observed.

The coping was damaged near the stairs.

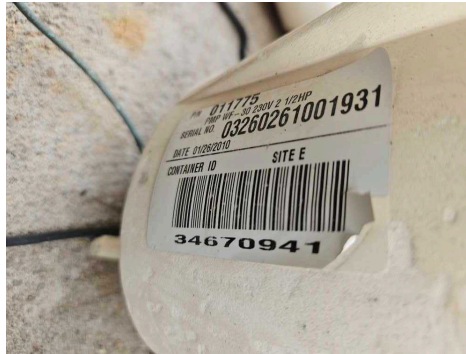
The filter pump appears to be operating as intended.

The filter pump data plate. 16 years old

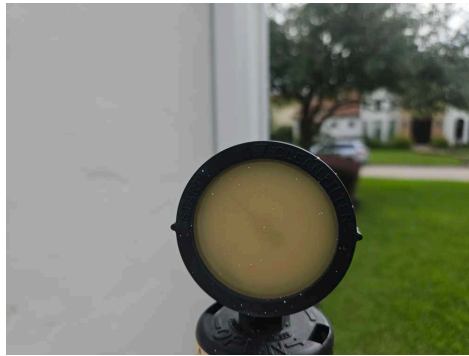
The filter gauge is damaged.

Filter gauge cloudy / damaged

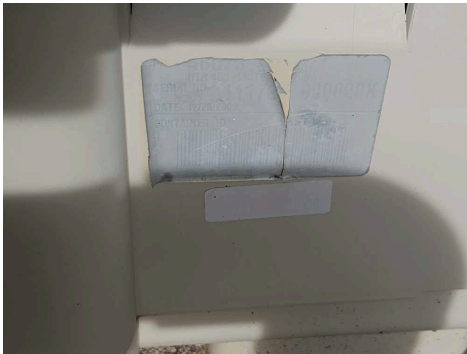
The heater data plate was not legible at the time of the inspection.

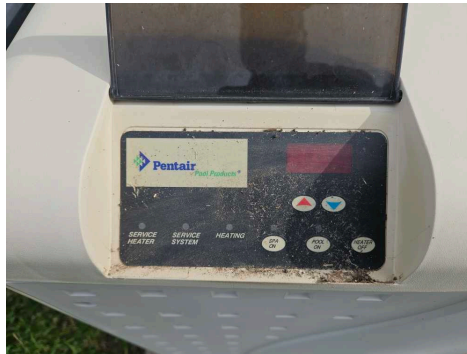
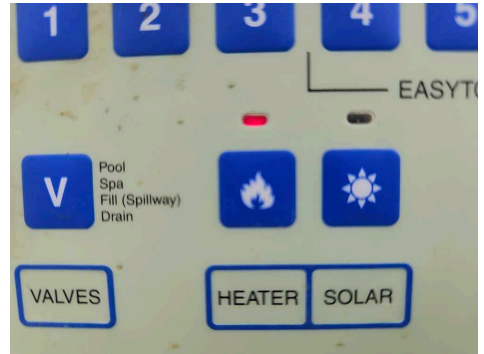
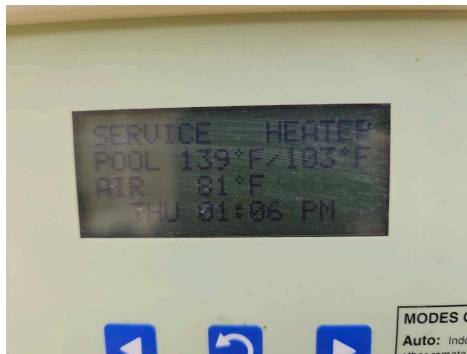
The pool heater did not respond to controls when tested in the manual / service settings. The cause and remedy should be further elevated.

The pool heater is not responding to any of the control panel commands.

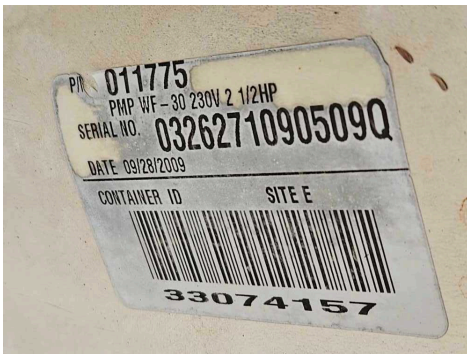
Pump bearing noise observed coming from Water feature pump which generally indicates imminent failure in the not-too-distant future.

The water feature pump data plate. 17 years old

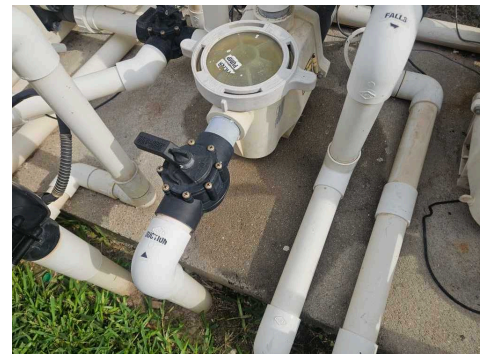
A leak was observed on the water feature pump. Further evaluation as to the cause and remedy is recommended.

The pool equipment pad was wet underneath the water feature pump at the time of the inspection.

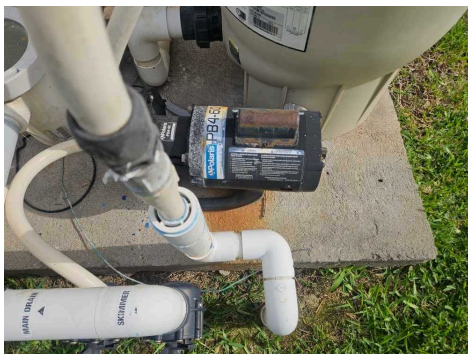
Pump bearing noise observed coming from Pool / Cleaner pump which generally indicates imminent failure in the not-too-distant future.

The pool cleaner booster pump was noisy at the time of the inspection.

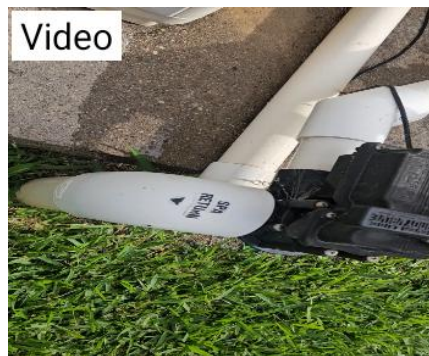
Leak observed at spa control valve.

The spa valve was leaking at the time of the inspection.

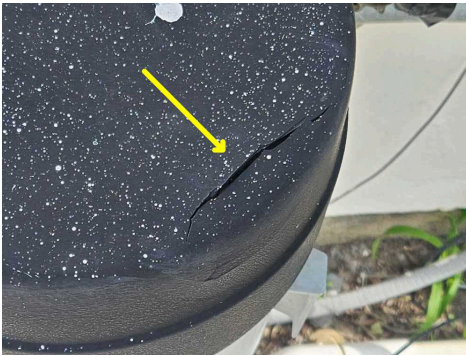
The spa housing was cracked at the time of the inspection.

The air blower housing is damaged. Recommend repair.

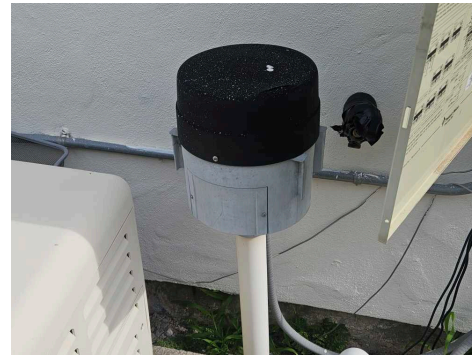
The spa blower did not respond to commands from the control panel.

Not operational, repair/replace as needed.

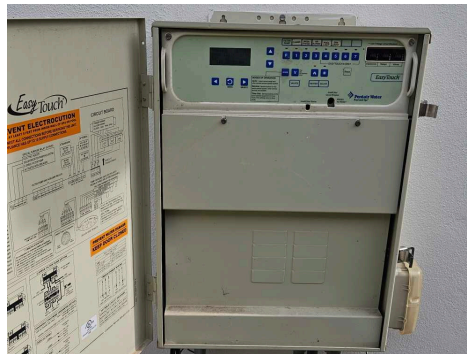
Not all pool equipment/ features are responsive from the panel when put in "Service Mode". Recommend qualified pool technician repair as necessary.

The pool equipment control panel.

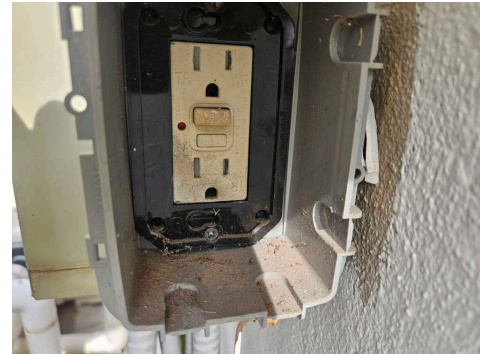
The pool equipment GFCI panel was damaged at the time of the inspection.

GFCI not operational, recommend replacement.

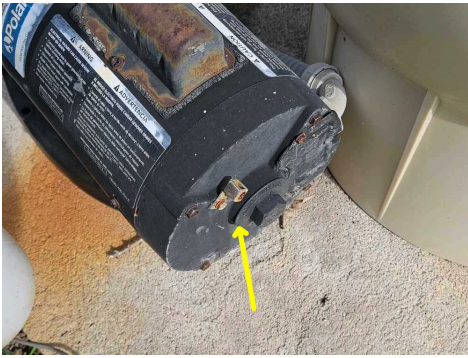
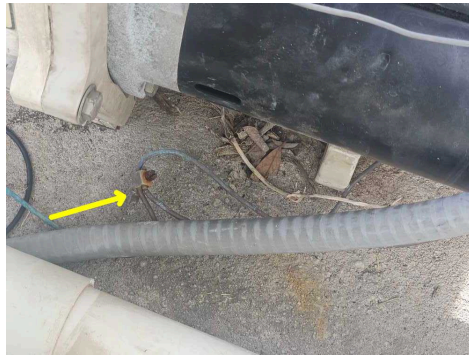
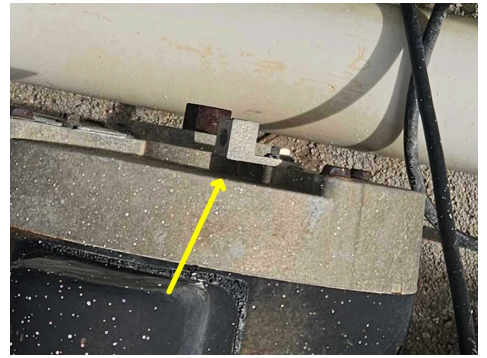
The motor(s) are not electrically bonded back to the rest of the associated components.

Did not observe proper electrical bonding wire attachment to all pool mechanical equipment. This is required for safety from potential shock hazard.

The booster pump motor was not bonded at the time of the inspection period

The pool filter motor was not bonded at the time of the inspection period

The water feature motor was not bonded at the time of the inspection.
