PROPERTY INSPECTION REPORT FORM

Kirk Mosher <i>Name of Client</i>	11/03/2023 <i>Date of Inspection</i>
7916 Santa Catalina , San Antonio, TX 78250 <i>Address of Inspected Property</i>	
Mike Mullins <i>Name of Inspector</i>	21584 <i>TREC License #</i>
<i>Name of Sponsor (if applicable)</i>	<i>TREC License #</i>

Home Inspection Report

Inspection No. 521159-2630

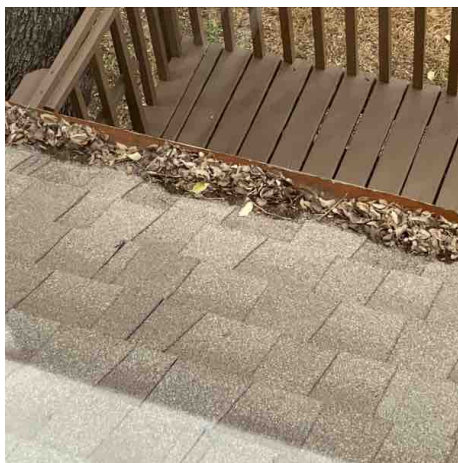
- **Gutters was filled with debris. Recommend clearing gutters for efficient dispersion of runoff water. (Exterior Back)**

<i>Comments:</i>
 • Gutters was filled with debris. Recommend clearing gutters for efficient dispersion of runoff water. (Exterior Back)</p> |

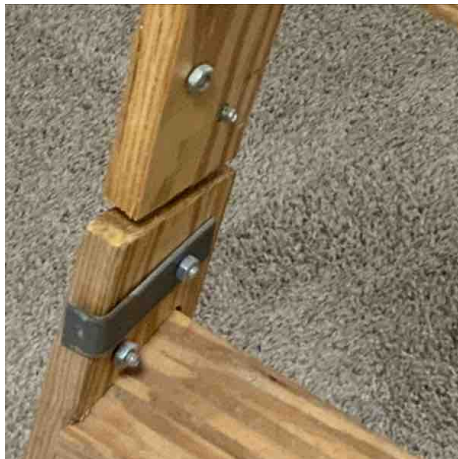
- **Attic ladder hardware was loose and missing.**

<i>Comments:</i>
 • Attic ladder hardware was loose and missing.

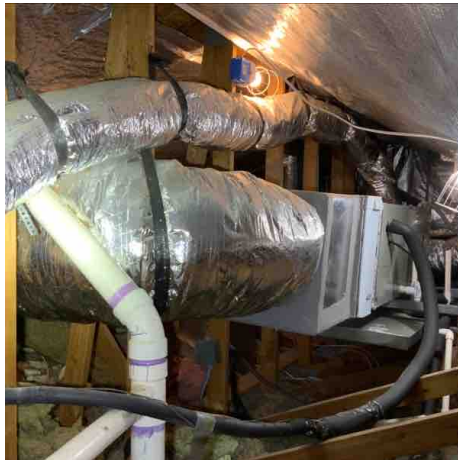
- View of attic space.

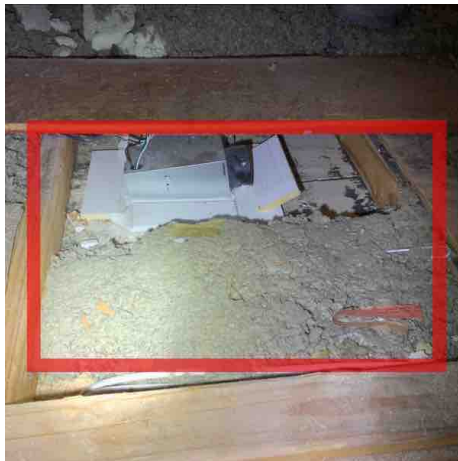
- Areas of the attic walkway were missing which may pose a safety hazard. This walkway is required to service the air handlers and water heaters..

• Areas of the attic walkway were missing which may pose a safety hazard. This walkway is required to service the air handlers and water heaters..</p> |

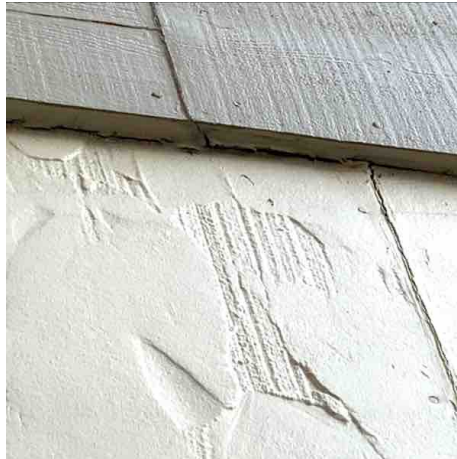
- **Gaps were observed at some exterior wall penetrations. Recommend sealing gaps to prevent water intrusion.**

<i>Comments:</i>
 • Gaps were observed at some exterior wall penetrations. Recommend sealing gaps to prevent water intrusion.</p> |

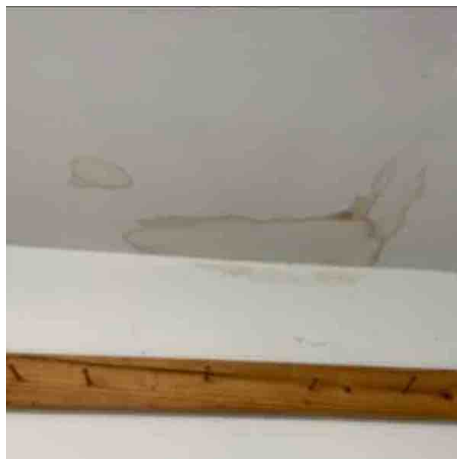
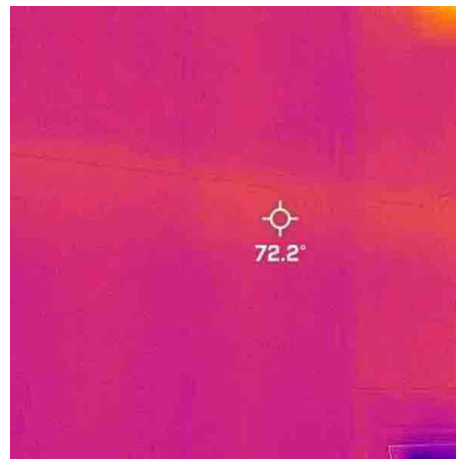
- **Signs of previous moisture was identified at garage ceiling area. The inspection couldn't determine the cause or condition of underlying materials. (Garage)**

<i>Comments:</i>
 • Signs of previous moisture was identified at garage ceiling area. The inspection couldn't determine the cause or condition of underlying materials. (Garage)</p> |

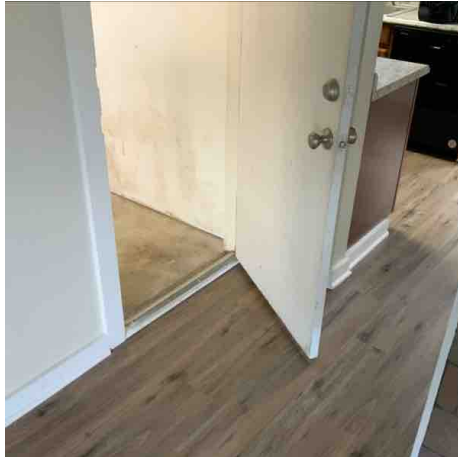
• **Garage entrance door wasn't self closing. This is a potential fire safety issue. Additionally, it could allow carbon monoxide or toxic fumes from chemicals stored in the garage into the house. (Garage)**

<i>Comments:</i>
 • Garage entrance door wasn't self closing. This is a potential fire safety issue. Additionally, it could allow carbon monoxide or toxic fumes from chemicals stored in the garage into the house. (Garage)</p> |

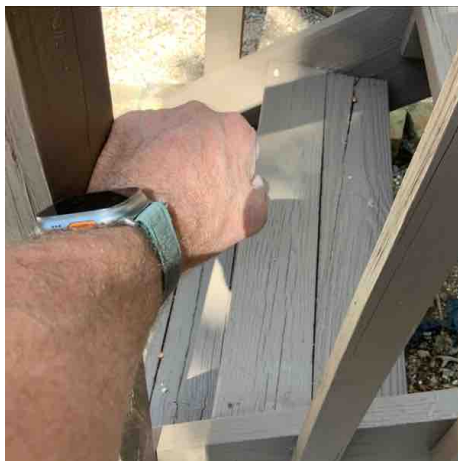
• **Stair or railing baluster spacing is greater than 4" apart. This does not meet today's standard and may pose a safety hazard, especially for small children.**

<i>Comments:</i>
 • Stair or railing baluster spacing is greater than 4" apart. This does not meet today's standard and may pose a safety hazard, especially for small children.

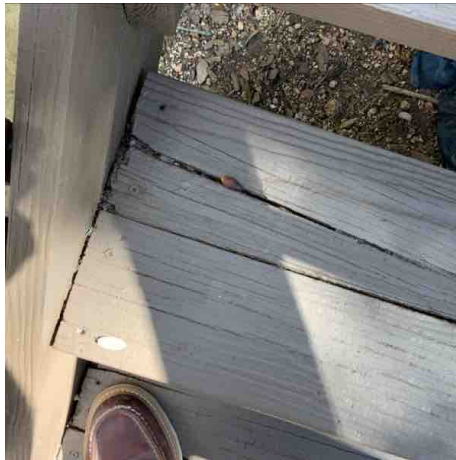
• Damaged steps were observed.

• Damaged steps were observed.

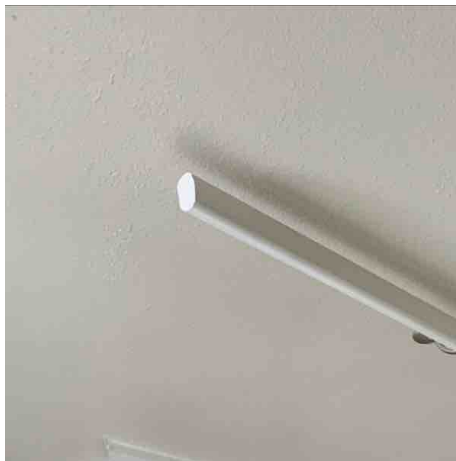
• Today's standard requires a stair handrail to return (terminate) into the wall. This installed stair handrail does not. (Stairs)

• Today's standard requires a stair handrail to return (terminate) into the wall. This installed stair handrail does not. (Stairs)</p> |

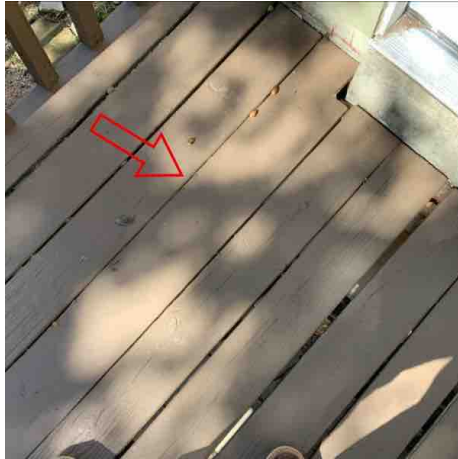
- **Board deflection was observed. (Exterior Back)**

<i>Comments:</i>
 • Board deflection was observed. (Exterior Back)

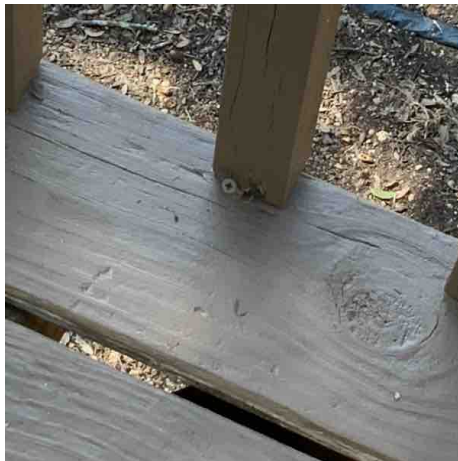
- **Loose balusters were observed.**

• Loose balusters were observed.

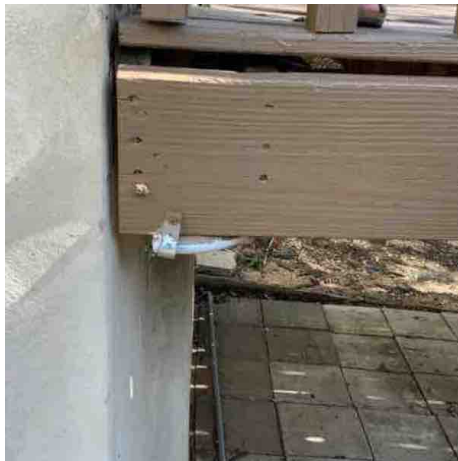
- **Deck wasn't level.**

• Deck wasn't level.</p> |

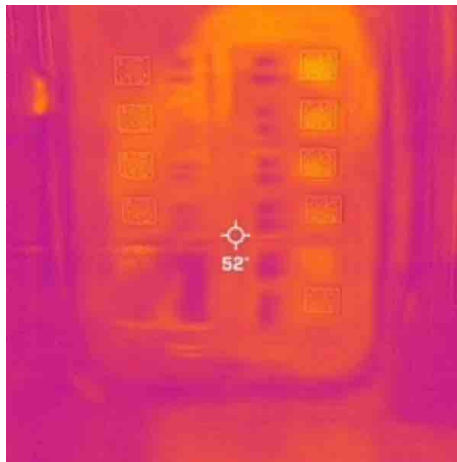
- This system was performing as intended.
- View of interior electrical panel infrared scan with normal operating temperatures

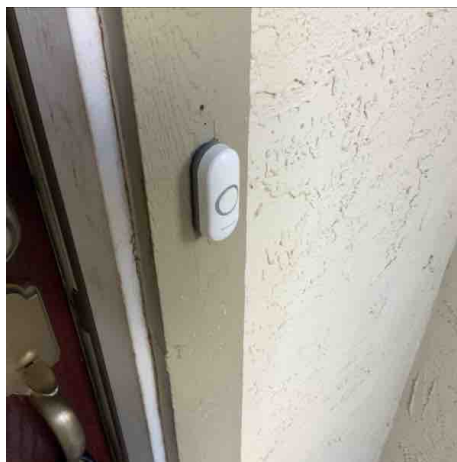
• **Doorbell didn't work. (Exterior Front)**

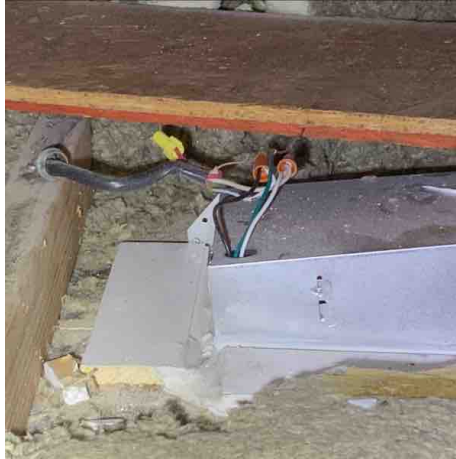
- **Open electrical splices were observed in the attic. All electrical splices are required to be in an approved, accessible, electrical junction boxes with covers. Recommend installing junction boxes to prevent potential fire safety issues.**

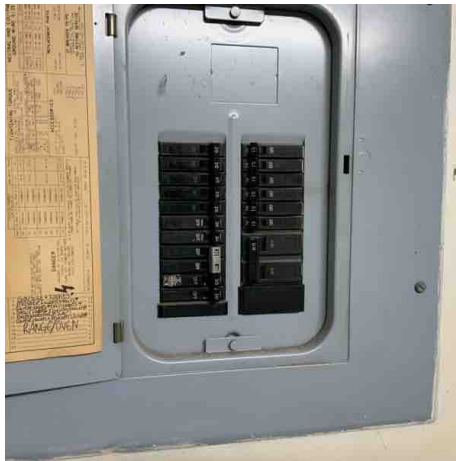
- **Arc Fault Circuit Interrupt (AFCI) protection was missing in required locations, which may pose a safety hazard. AFCI protection is required in the following locations: kitchens, family rooms, dining rooms, living rooms, parlors, libraries, dens, bedrooms, sunrooms, recreation rooms, closets, hallways, laundry area.**

- Arc Fault Circuit Interrupt (AFCI) protection was missing in required locations, which may pose a safety hazard. AFCI protection is required in the following locations: kitchens, family rooms, dining rooms, living rooms, parlors, libraries, dens, bedrooms, sunrooms, recreation rooms, closets, hallways, laundry area.

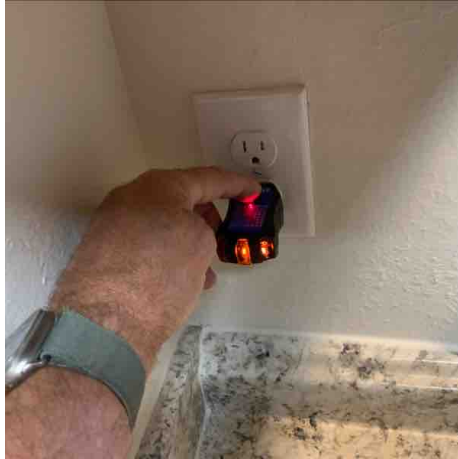
- **Outlets in the following locations were not GFCI (Ground Fault Interrupt) protected: kitchen. GFCI protection is required at the kitchen counter tops, bathrooms, exterior, garage & within 6' of a sink. Recommend installing GFCIs to prevent potential shock.**

- Outlets in the following locations were not GFCI (Ground Fault Interrupt) protected: kitchen. GFCI protection is required at the kitchen counter tops, bathrooms, exterior, garage & within 6' of a sink. Recommend installing GFCIs to prevent potential shock.

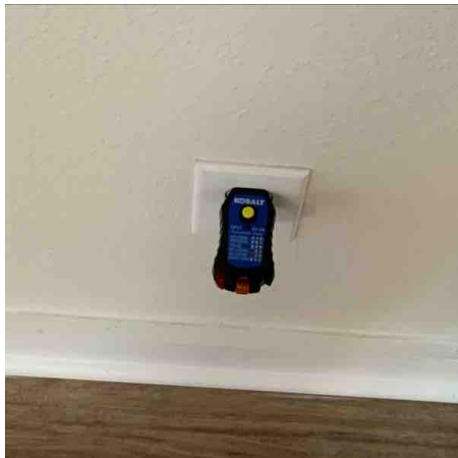
- **Receptacle didn't have power. (Kitchen)**

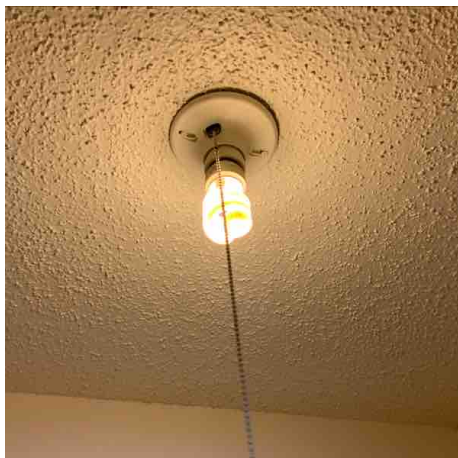
- **Closet lights were missing covers which may pose a safety hazard.**

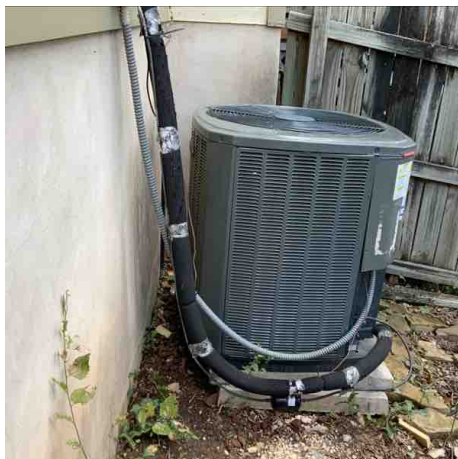
- **Exterior air conditioner wasn't level, which may cause damage to the system. Recommend leveling the unit to prevent damage. (Exterior Back)**

- Exterior air conditioner wasn't level, which may cause damage to the system. Recommend leveling the unit to prevent damage. **(Exterior Back)**

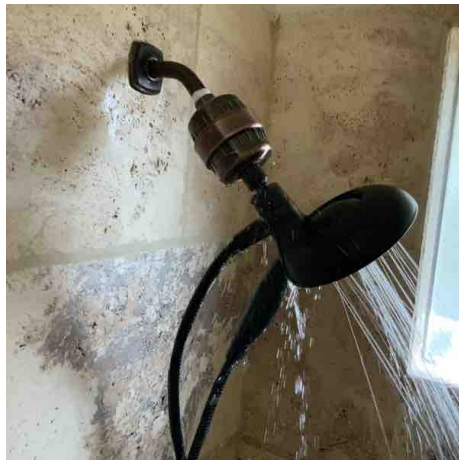
- **A water leak was observed at the shower head. (Hallway Bathroom)**

- A water leak was observed at the shower head. **(Hallway Bathroom)**

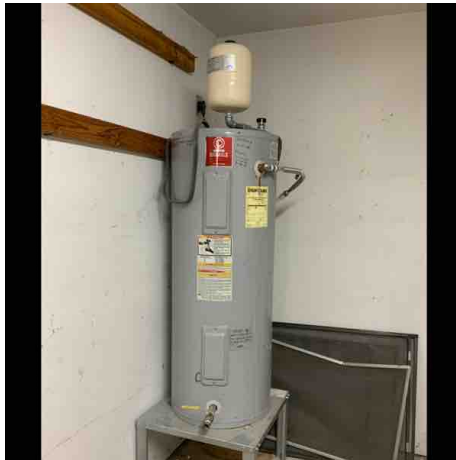
- View of water heater.

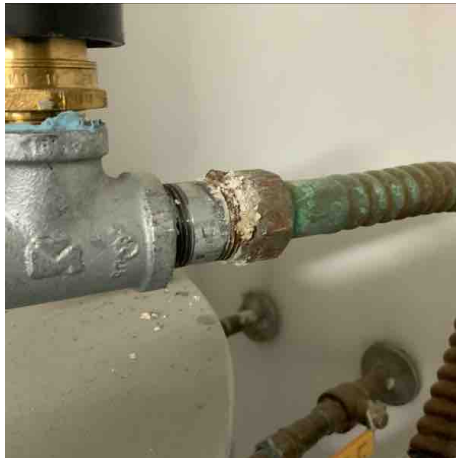
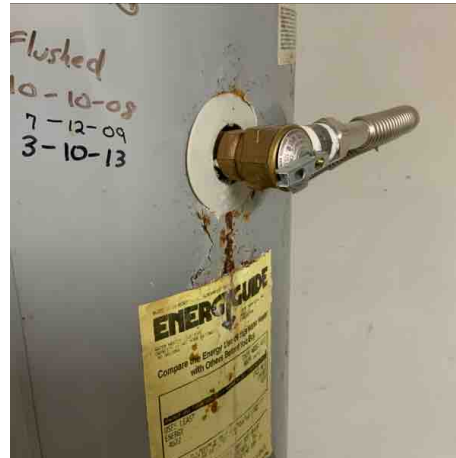
- Rust/corrosion was observed at the cold water inlet and side of the water heater.

- Rust/corrosion was observed at the cold water inlet and side of the water heater.

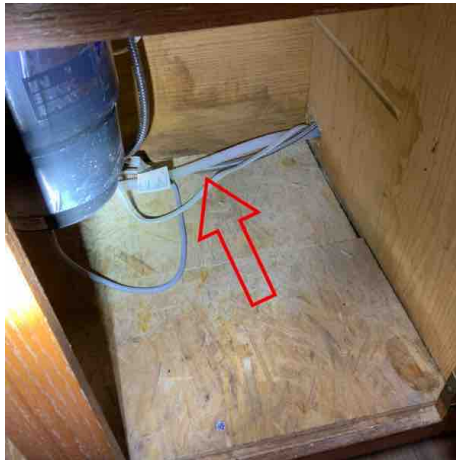
- The dishwasher drain hose appeared to be improperly installed to prevent back flow or anti-siphoning (missing high-loop). It is recommended that an air gap device or high loop be installed in the drain line to prevent contamination of water supply. (Kitchen)

- The dishwasher drain hose appeared to be improperly installed to prevent back flow or anti-siphoning (missing high-loop). It is recommended that an air gap device or high loop be installed in the drain line to prevent contamination of water supply. **(Kitchen)**

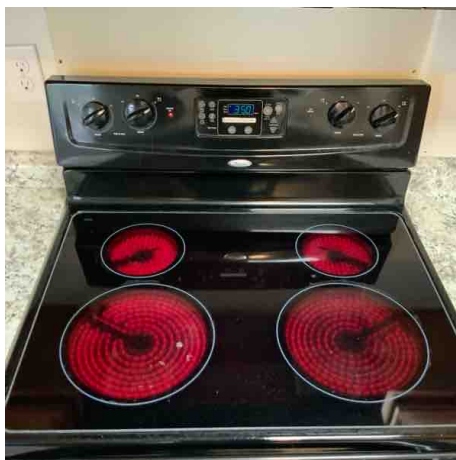
- Stove was missing an anti-tip device, which may pose a safety hazard. Recommend installation of an anti-tip device to prevent injury. (Kitchen)

- Stove was missing an anti-tip device, which may pose a safety hazard. Recommend installation of an anti-tip device to prevent injury. **(Kitchen)**
