REDFISH INSPECTIONS HOUSTON

2300 Halls Creek Ct
Friendswood, TX 77546

PROPERTY INSPECTION REPORT FORM

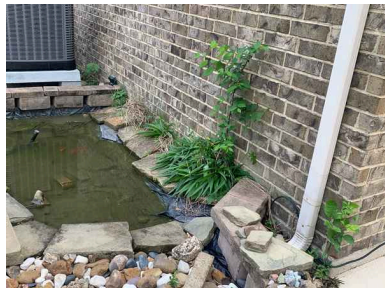
2: Grading Too Low / Improvement Needed

Foliage was noted close to the structure. We recommend trimming all bushes and tree limbs at least 1 foot away from buildings. Bushes and trees too close to the structure can prevent the walls from drying properly, their roots can affect the foundation, and their branches can damage the roof.

Recommendation: Contact a handyman or DIY project

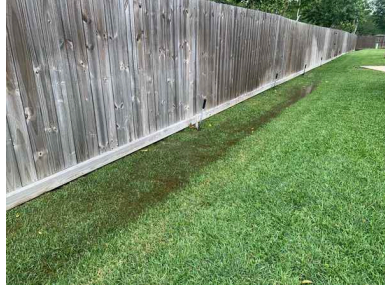
Example Rear Exterior

Low elevation of grading noted. The grading should be improved to promote the flow of storm water away from the house. This can usually be accomplished by the addition of top soil. The ground should slope away from the house at a rate of one inch per foot for at least the first ten feet. Ideally, at least eight (8) inches of clearance should be maintained between soil level and the top of the foundation walls.

Recommendation: Contact a qualified landscaping contractor

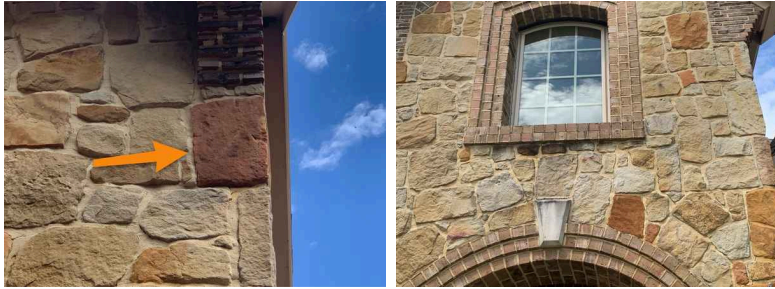
Example Front Exterior

The mortar at the exterior brick/stone veneer was cracked and/or deteriorated. We recommend having these areas repointed to prevent excess moisture intrusion.

Recommendation: Contact a qualified masonry professional.

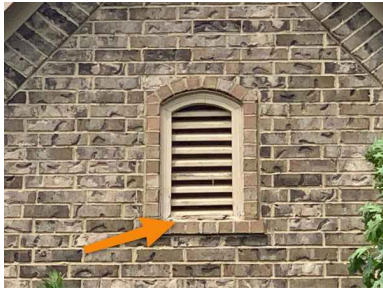
Example Front Exterior

Wood decay was observed on the exterior siding. We recommend repairs/replacement to all decayed wood to prevent further deterioration and creating conducive conditions for wood destroying insect activity.

Recommendation: Contact a qualified professional.

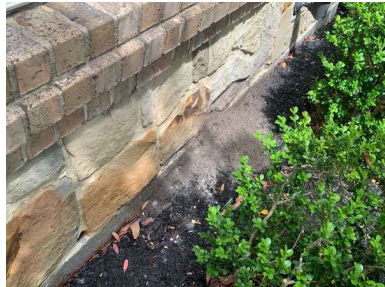
Example Front Exterior

Ant nests were observed. We recommend treatment against any type of pest insect, especially when close to structure.

Recommendation: Contact a qualified professional.

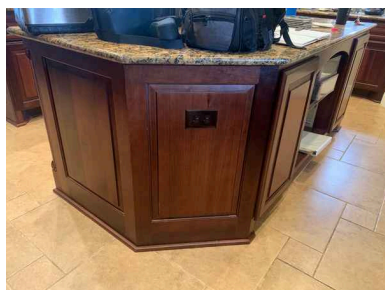
Outlet receptacles were present on the side of the kitchen island/peninsula. While installation of receptacles in these locations is not prohibited, since 2023, it has come to be considered a potential safety hazard by many experts as the cord for common cooking appliances could be pulled or snagged resulting in impact or burn injuries. Safer receptacle designs capable of being installed on the top surface are available by various manufacturers. Extra care should be taken when using these receptacles to prevent hazards, particularly if/when children are present.

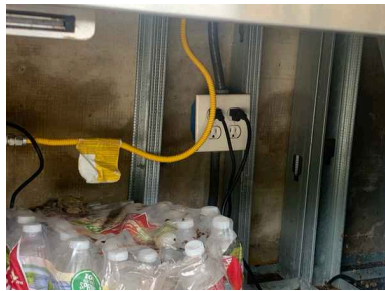
Example Outdoor Kitchen

One or more outlets lacked proper Ground Fault Circuit Interrupter (GFCI) protection. Today's standards require GFCI protection be installed at all 120 and 240 volt circuits in the kitchen, laundry rooms, basements, crawl spaces, garages, exterior outlets, as well as any interior receptacles located within 6 feet of a plumbing fixture as measured by flexible cord, in order to avoid potential electric shock or electrocution hazards. It is also a best practice for floor outlets to be GFCI protected. We recommend having proper GFCI protection installed per today's standards.

Recommendation: Contact a qualified electrical contractor.

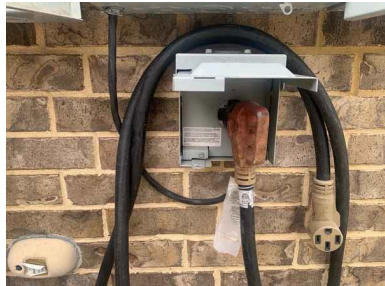
Specialty equipment and/or wiring was present that appeared to be intended for vehicle charging. This type of equipment is beyond the scope and qualification of a typical home inspection. We recommend further evaluation and repair as needed by a licensed electrician.

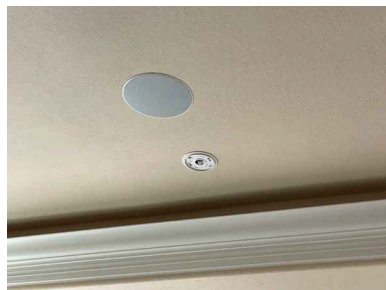
Example Primary Bedroom

Smoke/Carbon monoxide detector is not present at time of inspection. Recommend installation before closing.

Recommendation: Contact a qualified professional.

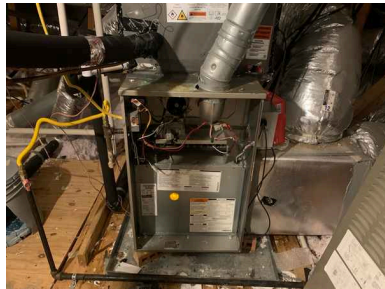
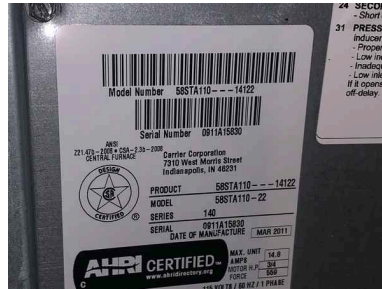
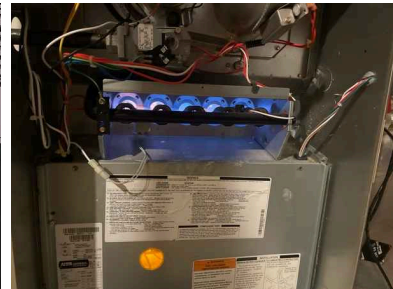
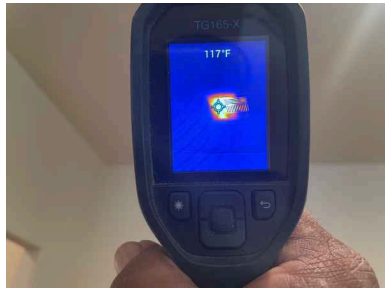
Unit 2: Photo Manufactures Label, Photo of flames, Photo of hot air temperature

Given the age of the furnaces, replacement should be anticipated in the near future.

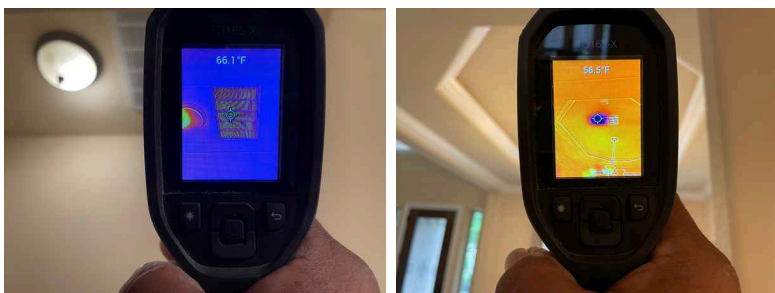
Example 1st Floor

The difference in air temperature at the supply register and the return air should be 15 to 22 degrees F according to the Texas Real Estate Commission. A difference that is too high or too low indicates a possible problem with the cooling system and should be evaluated further by a HVAC technician and repaired as needed.

Recommendation: Contact a qualified HVAC professional.

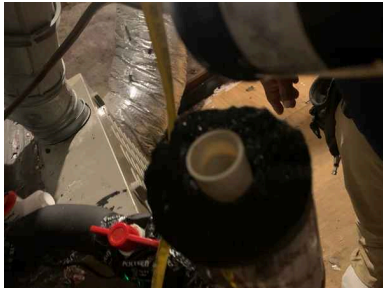
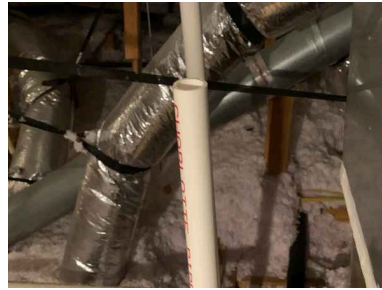
3: Drain Pan Has Water

The auxiliary drain pan installed below the of the air conditioning system contains water and debris. Most likely a clogged drain. This should be emptied and cleaned.

Recommendation: Contact a qualified HVAC professional.

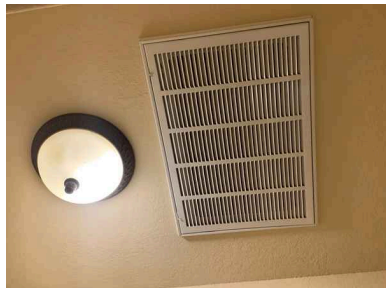
Example 1st Floor

2: Temperature Variance in Living Space

One or more area of the home felt significantly warmer or cooler than other areas. This could be the result of multiple conditions or deficiencies in the HVAC system, duct work, insulation or design of the structure and may vary throughout the year depending on the climate. We were unable to determine the cause. Should this affect your comfort level, we recommend consulting with a licensed, qualified HVAC technician. Further investigation from other contractors may be required.

Recommendation: Contact a qualified professional.

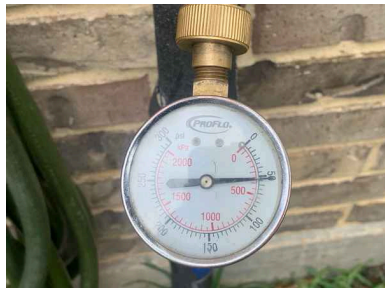
Photo of Type of Supply Piping Material: PEX

Photo of Static Water Pressure Reading: 50 PSI

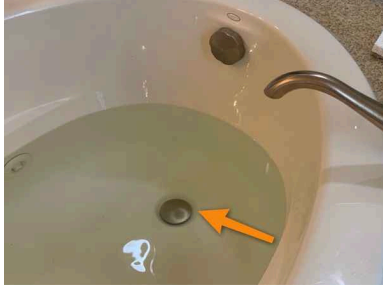
Example Primary Bathroom

4: Faulty Diverter

The bathroom shower diverter did not fully divert the water from the spout to the shower head or visa versa. We recommend having this repaired/adjusted to operate as intended.

Recommendation: Contact a qualified professional.

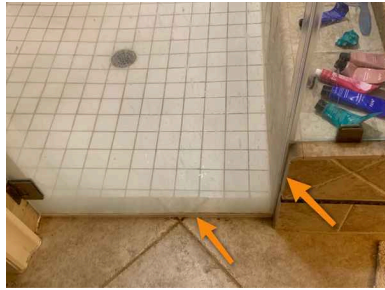
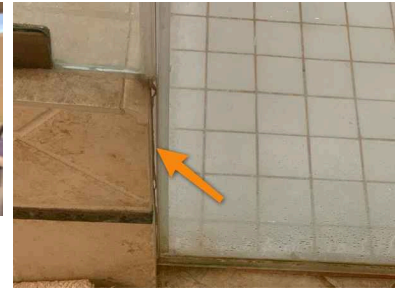
Example Primary Bathroom

5: Shower door sweeps missing / damaged

The shower door sweeps are missing/damaged. The sweeps help prevent water from exiting the enclosure when operating the shower. Recommend to install door sweeps.

Recommendation: Contact a handyman or DIY project

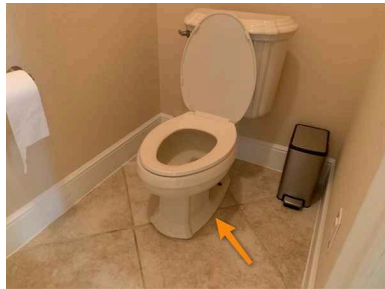
Example Primary Bathroom

Loose toilet. Recommend to properly secure to flange

Recommendation: Contact a qualified plumbing contractor.

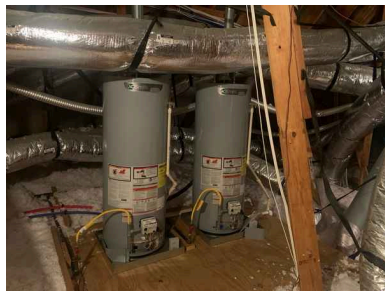
Photos Unit 1: Manufacture Label, Burner Flame, Top of Unit
Capacity 50gal - 2022

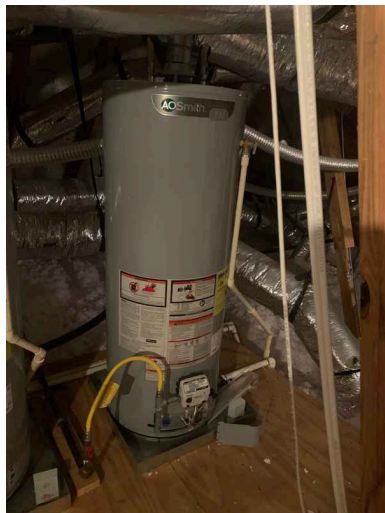
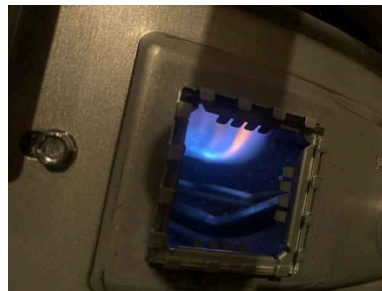
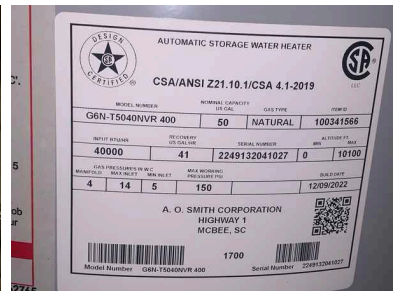
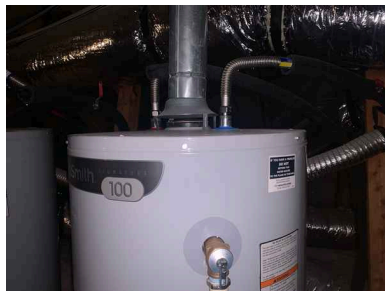
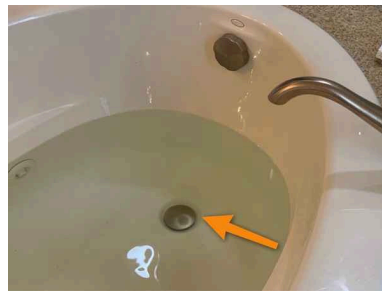
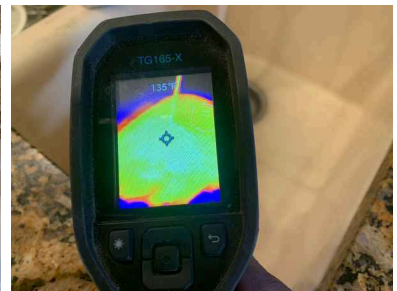
Photos Unit 2: Hot water temperature, Manufacture Label, Top of Unit, Burner Flame
Capacity 50gal- 2022

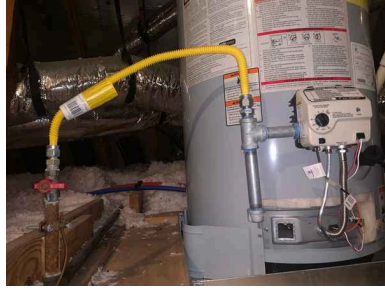
Example Unit 1

1: Scalding Water

Scalding water temperature was measured. We recommended adjusting the water heater thermostat so as not to exceed 120 degrees Fahrenheit. 134 degrees was observed.

Recommendation: Contact a qualified professional.

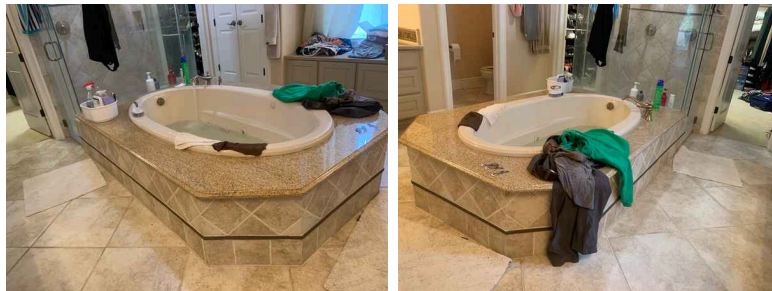
No Access Hatch: There was no hatch provided for access to the pump for the whirlpool tub. A hatch should be provided to allow for inspection, service and repair of tub, pump and electrical equipment.

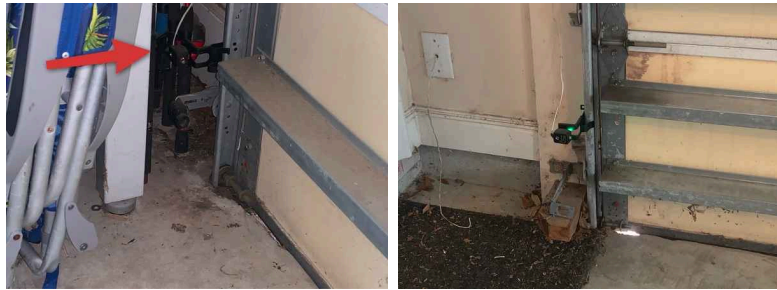
Example

The photo sensor was installed at a height greater than 6 inches. Safety standards designed to protect small children limit the maximum mounting height for garage door photo sensors at 6 inches. We recommend correction by a qualified contractor.

Recommendation: Contact a qualified professional.

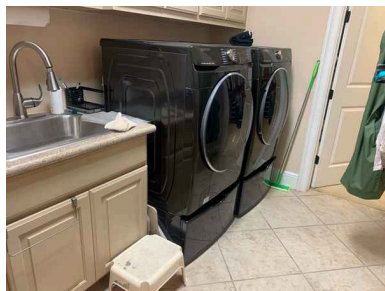
Dryer Connected : A dryer was connected to its exhaust vent. We were unable to view the condition of the duct interior. We recommend having the dryer exhaust vent cleaned on a yearly basis to prevent lint buildup.

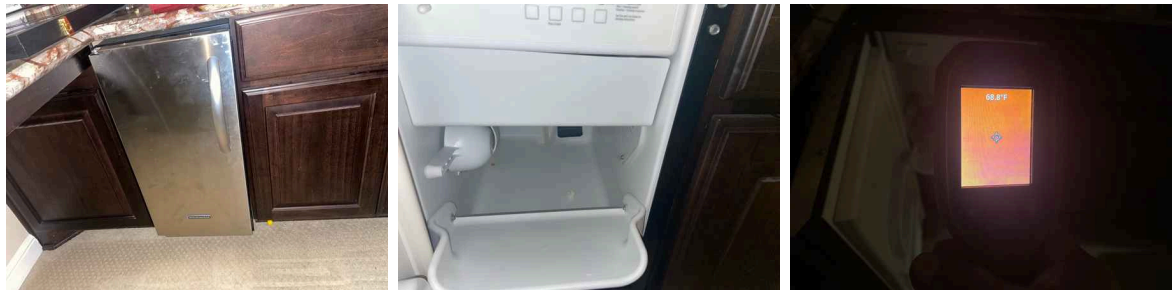
1: Ice Maker/Water Dispenser Inoperative

Ice maker/water dispenser appears to be inoperative. Recommend further evaluation/repair by appliance repair technician.

Recommendation: Contact a qualified professional.

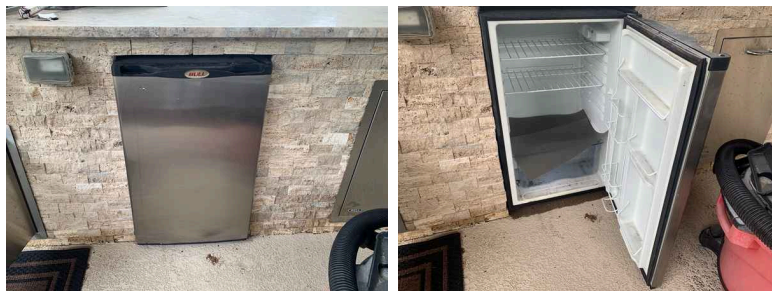
The refrigerator was inoperable at the time of the inspection recommend evaluation and repair as needed

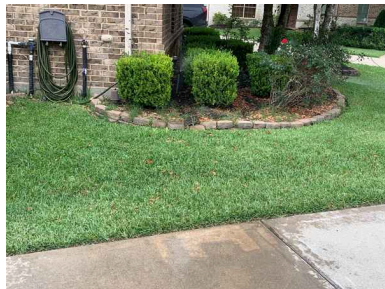
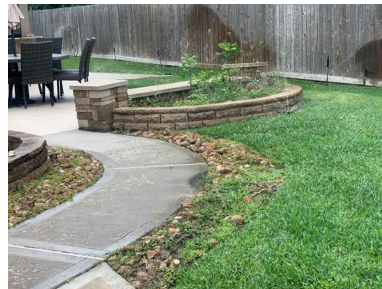
Example zone 1

8: Damaged Head

One or more sprinkler heads were damaged and/or did not operate as intended. We recommend repair.

Recommendation: Contact a qualified professional.

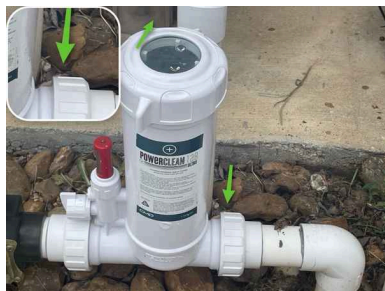
Photo of the Chlorinator: In-Line Chlorinator -
ADDITIONAL INFORMATION

In-line pool chlorinators are pool sanitization systems that are installed in your pool’s plumbing system. This type of pool chlorinator system is more common in in-ground pools and is a bit more difficult to install. These pool chlorination systems have a feeder line that provides chlorine to the pool through a feeder line that reaches into the pool water. In-line pool chlorinators are designed based on the size of the pool and water capacity.
