REPAIR REQUEST LIST

2300 Halls Creek Ct
05/18/2026 4:58 pm

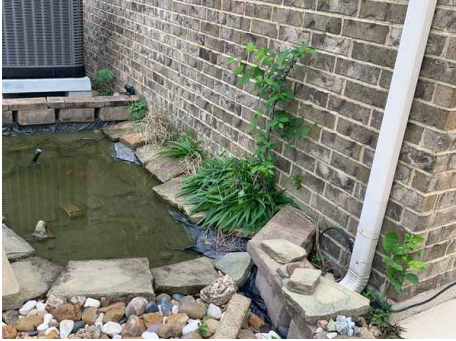
2.2.1 - I. Structural Systems: B. Grading and Drainage FOLIAGE / VEGETATION NEAR STRUCTURE

Foliage was noted close to the structure. We recommend trimming all bushes and tree limbs at least 1 foot away from buildings. Bushes and trees too close to the structure can prevent the walls from drying properly, their roots can affect the foundation, and their branches can damage the roof.

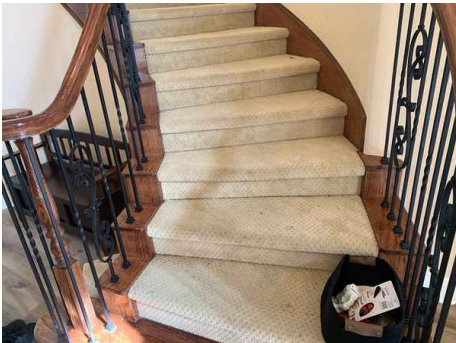
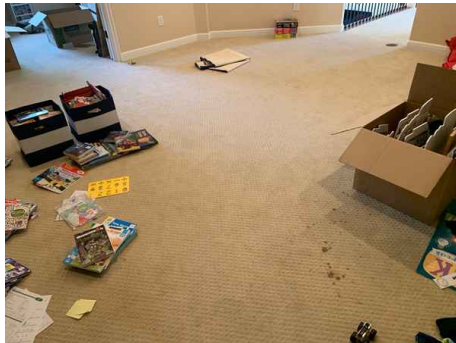
2.6.1 - I. Structural Systems: F. Ceilings and Floors STAINED CARPET

Carpet is stained in multiple areas are recommended to evaluation and

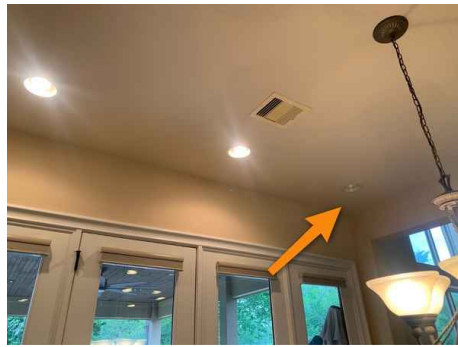
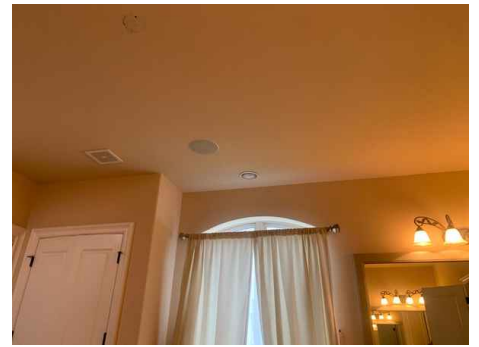
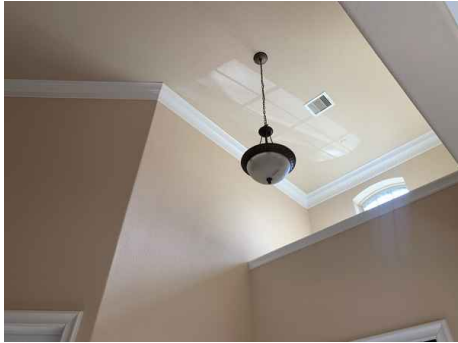
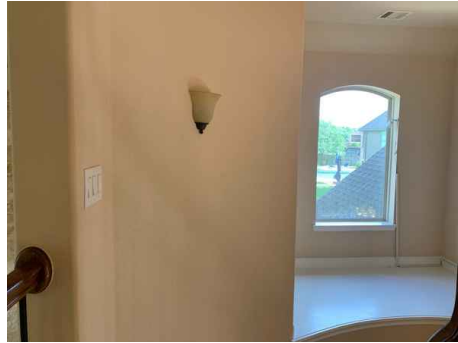
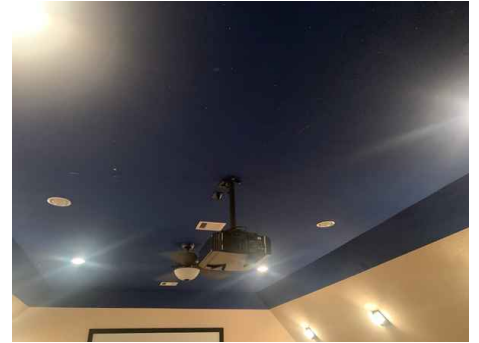
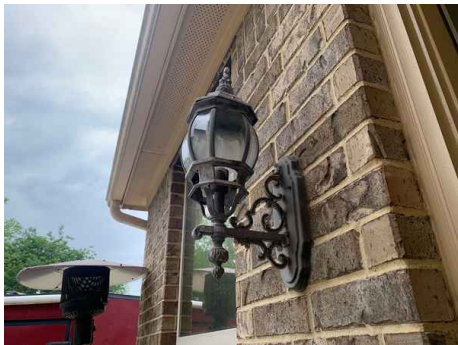
INOPERATIVE LIGHT FIXTURE(S)

One or more inoperative light fixtures were noted. We recommend replacing the bulb. Should this not resolve the issue, we recommend having the fixture repaired/replaced.

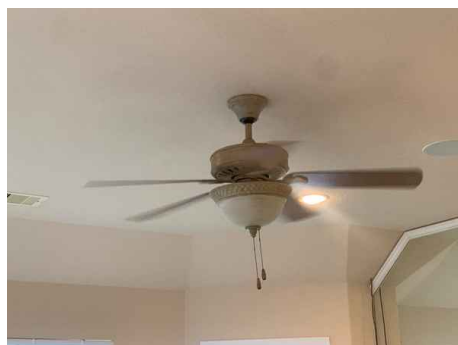
Example Guest Bedroom

3.2.2 - II. Electrical Systems: B. Branch Circuits, Connected Devices, and Fixtures CEILING FAN OUT OF BALANCE

A ceiling fan was out of balance. We recommend to balance the fan for proper function.

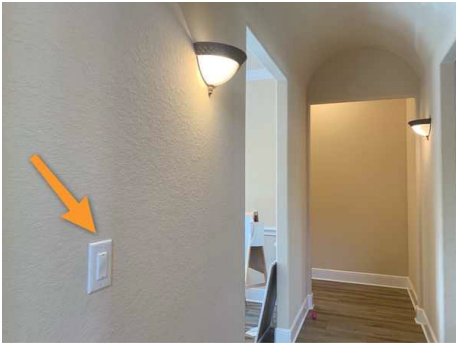
Example Hall

3.2.3 - II. Electrical Systems: B. Branch Circuits, Connected Devices, and Fixtures LIGHT SWITCH DAMAGED

Damaged light switches should be repaired or replaced.

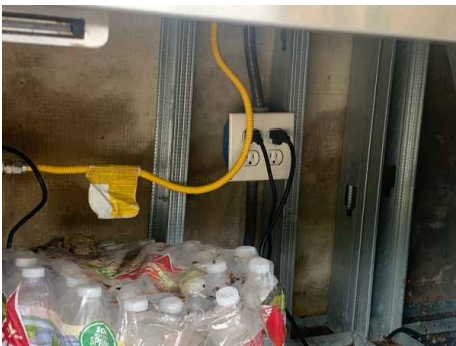
Example Outdoor Kitchen

3.2.4 - II. Electrical Systems: B. Branch Circuits, Connected Devices, and Fixtures OUTLET NOT GFCI PROTECTED

One or more outlets lacked proper Ground Fault Circuit Interrupter (GFCI) protection. Today's standards require GFCI protection be installed at all 120 and 240 volt circuits in the kitchen, laundry rooms, basements, crawl spaces, garages, exterior outlets, as well as any interior receptacles located within 6 feet of a plumbing fixture as measured by flexible cord, in order to avoid potential electric shock or electrocution hazards. It is also a best practice for floor outlets to be GFCI protected. We recommend having proper GFCI protection installed per today's standards.

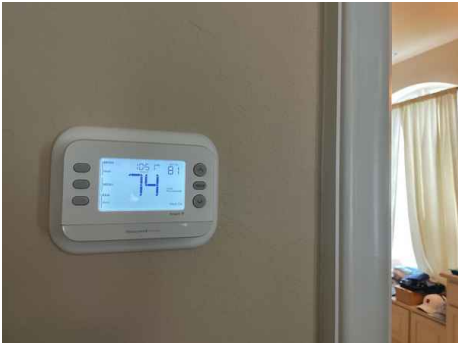
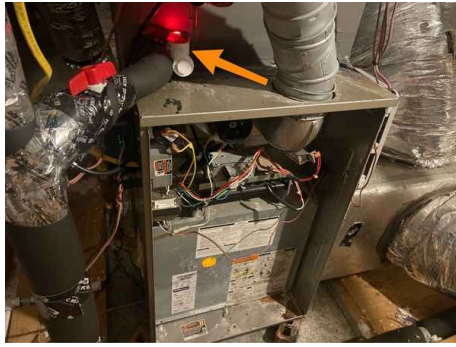
4.1.1 - III. Heating, Ventilation and Air Conditioning Systems: A. Heating Equipment DID NOT RESPOND

The furnace did not respond to the thermostat and should be examined by a licensed, professional, competent and qualified HVAC technician.

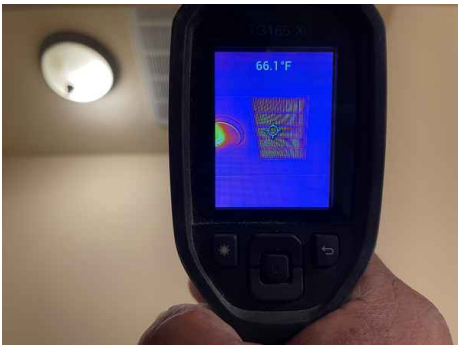
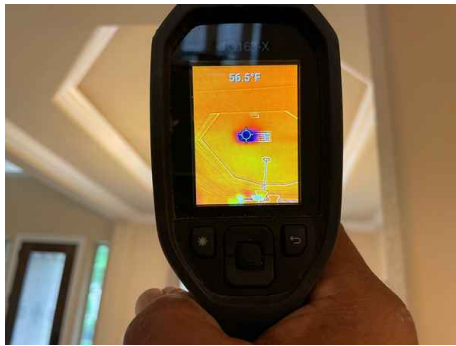
4.2.1 - III. Heating, Ventilation and Air Conditioning Systems: B. Cooling Equipment
DID NOT PASS DIFFERENTIAL TEST

The difference in air temperature at the supply register and the return air should be 15 to 22 degrees F according to the Texas Real Estate Commission. A difference that is too high or too low indicates a possible problem with the cooling system and should be evaluated further by a HVAC technician and repaired as needed.

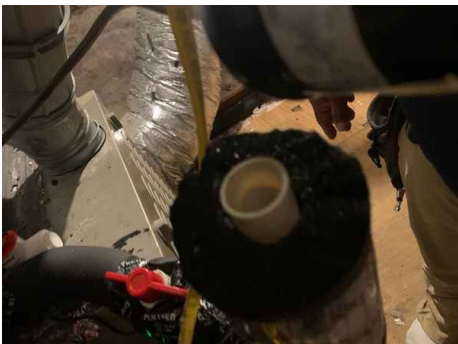
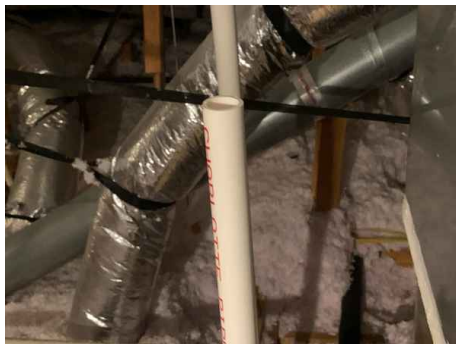
4.2.2 - III. Heating, Ventilation and Air Conditioning Systems: B. Cooling Equipment
CAP MISSING

The primary condensate drain line cleanout did not have cap. We recommend adding one to prevent debris from clogging the line.

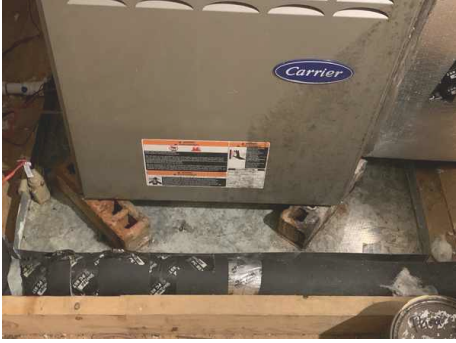
DRAIN PAN HAS WATER

The auxiliary drain pan installed below the of the air conditioning system contains water and debris. Most likely a clogged drain. This should be emptied and cleaned.

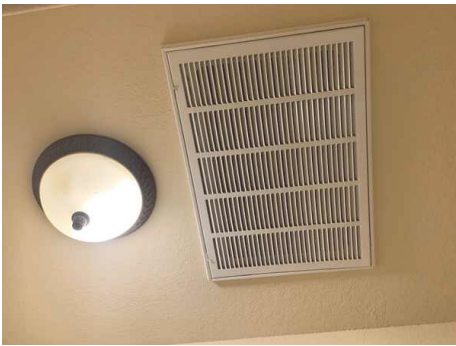
Example 1st Floor

DIRTY FILTER(S)

One or more air filters were dirty and should be changed. Conventional filters should be checked every month and replaced as necessary. Homes in areas with high indoor levels of airborne pollen or dust may need to have air filters checked and changed more frequently. Failure to change the filter when needed may result in the following problems: - Reduced blower life due to dirt build-up on vanes, which increasing operating costs. - Reduced indoor air quality. - Increased resistance resulting in the filter being sucked into the blower. This condition can be a potential fire hazard. - Frost build-up on air-conditioner evaporator coils, resulting in reduced cooling efficiency and possible damage. - Reduced air flow through the home.

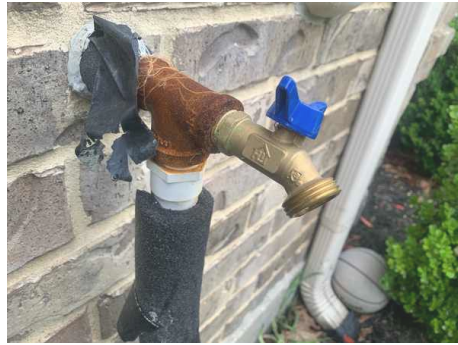
ANTI-SIPHON / BACKFLOW PREVENTION DEVICE MISSING

One or more exterior hose bibs did not have a back flow preventer. Anti-siphon devices keep contaminated water from entering the potable water of the house plumbing. These devices are typically affordable and can be found in most home improvement stores. We recommend having these added.

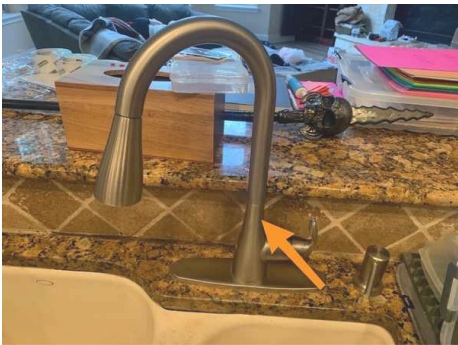
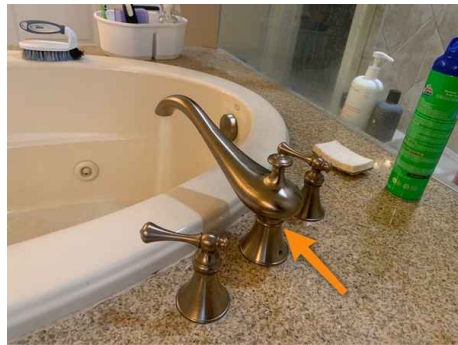
5.1.2 - IV. Plumbing Systems: A. Plumbing Supply, Distribution Systems, and Fixtures LOOSE FAUCET

A loose faucet was noted. We recommend having this properly secured.

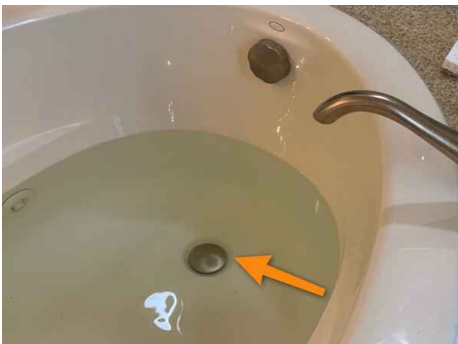
Example Primary Bathroom

5.1.3 - IV. Plumbing Systems: A. Plumbing Supply, Distribution Systems, and Fixtures INOPERABLE TUB STOPPER(S)

One or more bathtub stopper(s) was not functional at a bathroom. We recommend having stoppers adjusted or repaired to retain water as designed.

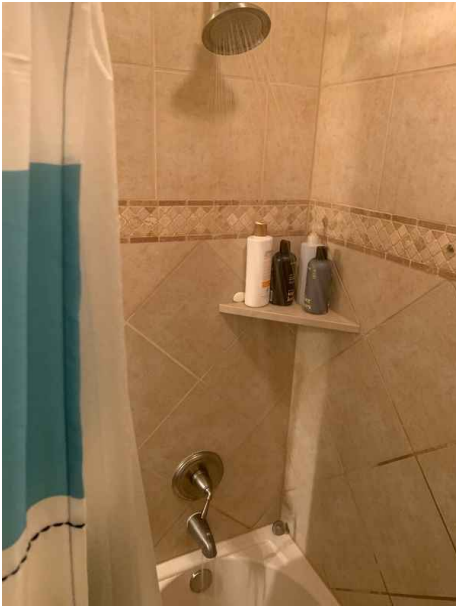
Example 2nd Floor Hall Guest Bathroom

5.1.4 - IV. Plumbing Systems: A. Plumbing Supply, Distribution Systems, and Fixtures FAULTY DIVERTER

The bathroom shower diverter did not fully divert the water from the spout to the shower head or visa versa. We recommend having this repaired/adjusted to operate as intended.

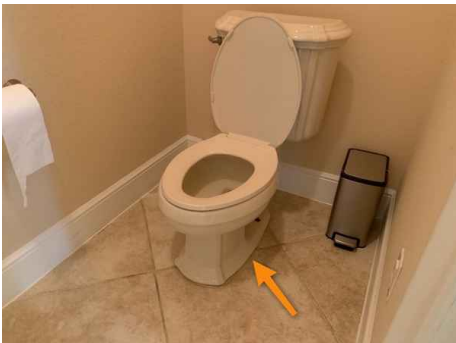
Example Primary Bathroom

TOILET LOOSE

Loose toilet. Recommend to properly secure to flange

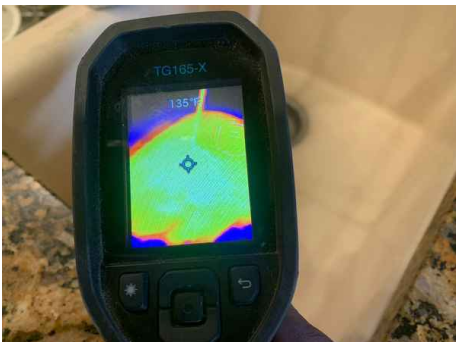
SCALDING WATER

Scalding water temperature was measured. We recommended adjusting the water heater thermostat so as not to exceed 120 degrees Fahrenheit. 134 degrees was observed.

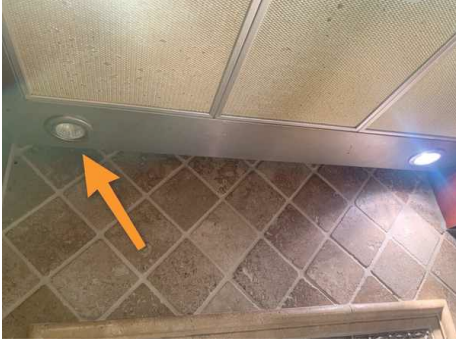
Example

6.3.1 - V. Appliances: C. Range Hood and Exhaust Systems
INOPERABLE HOOD LIGHTS

One or more range hood lights were inoperable at the time of the inspection. The bulb may be burned out, or there may be a problem with the switch, wiring or light fixture. If, after replacing the bulb, the light fixture still does not respond, we recommend correction by a qualified contractor.

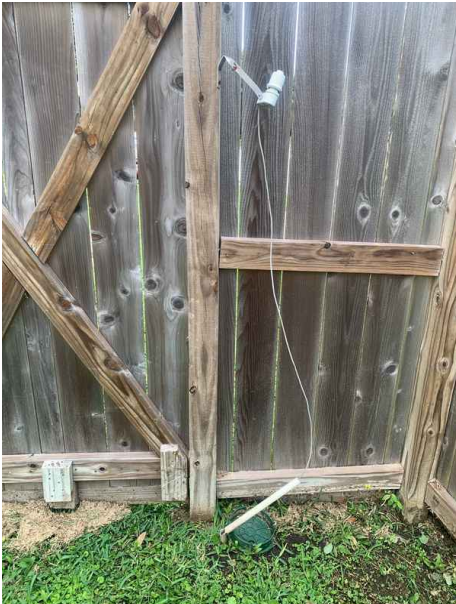
7.1.1 - VI. Optional Systems: A. Landscape Irrigation (Sprinkler) Systems
DAMAGED CONDUIT

The conduit is damaged. Recommend to repair.

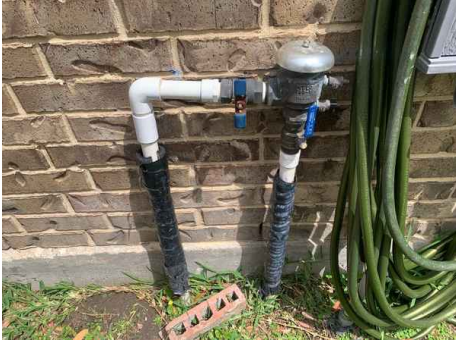
7.1.4 - VI. Optional Systems: A. Landscape Irrigation (Sprinkler) Systems
PIPE INSULATION MISSING / INSUFFICIENT

Missing, damaged, deteriorated or insufficient was noted. Pipe insulation improvement recommended.

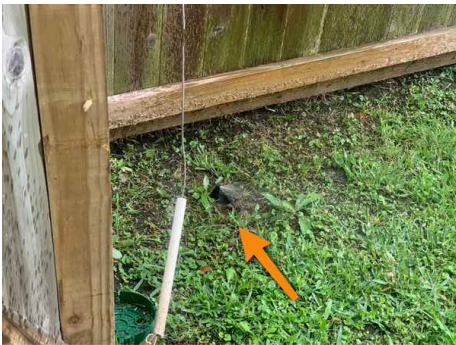
Example zone 3

7.1.5 - VI. Optional Systems: A. Landscape Irrigation (Sprinkler) Systems
SPRINKLER NOT SPRAYING AS INTENDED

One or more sprinkler heads was not spraying as intended. We recommend having this repaired as needed.

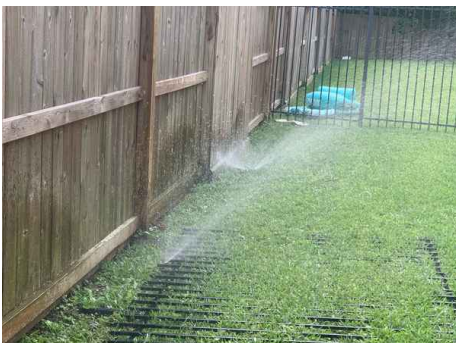
Example zone 3

7.1.6 - VI. Optional Systems: A. Landscape Irrigation (Sprinkler) Systems
SPRINKLERS SPRAYING AGAINST HOUSE / FENCE

One or more sprinkler heads are spraying against either the house or the fence. Adjust spray pattern accordingly

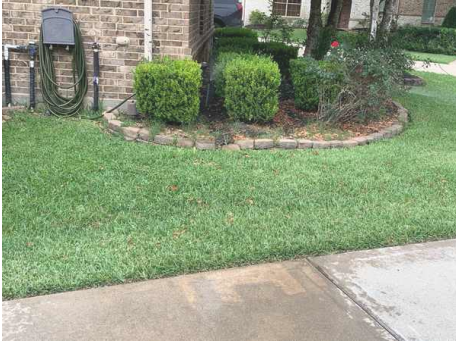
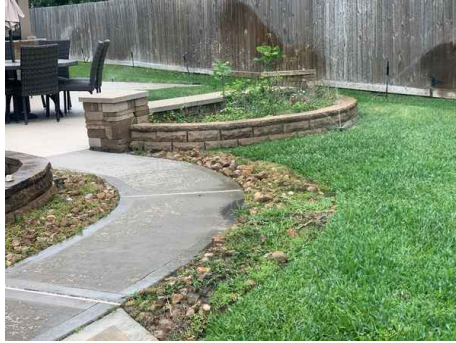
7.1.7 - VI. Optional Systems: A. Landscape Irrigation (Sprinkler) Systems
SPRAYING OVER CONCRETE

The sprinklers are currently spraying over concrete. This practice has been outlawed in Texas as part of the water conservation act.

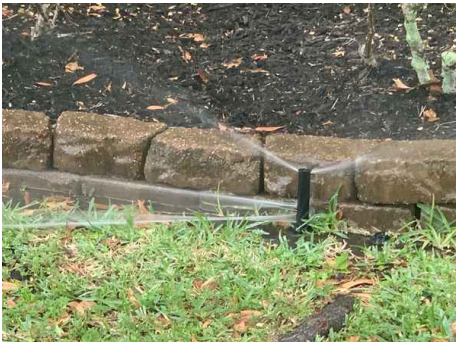
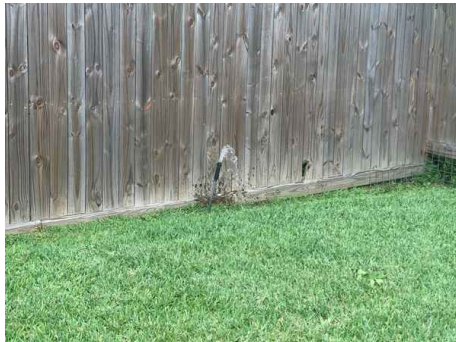
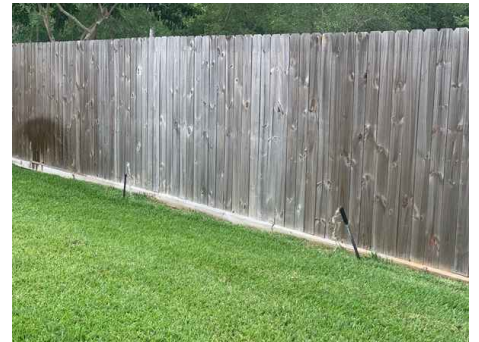
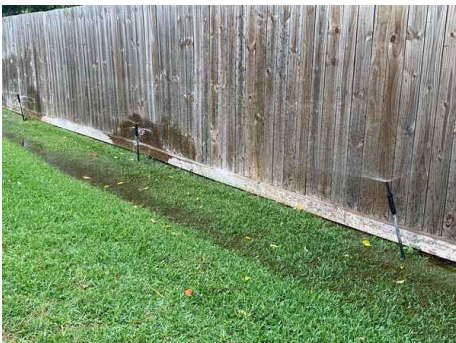
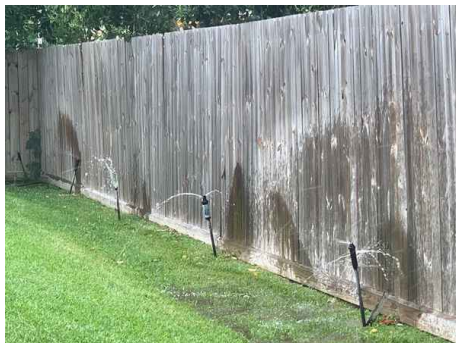
7.1.8 - VI. Optional Systems: A. Landscape Irrigation (Sprinkler) Systems
DAMAGED HEAD

One or more sprinkler heads were damaged and/or did not operate as intended. We recommend repair.
