314 Roofing Solutions

Apr 28, 2025 | 13 Photos

2506 Seedling St

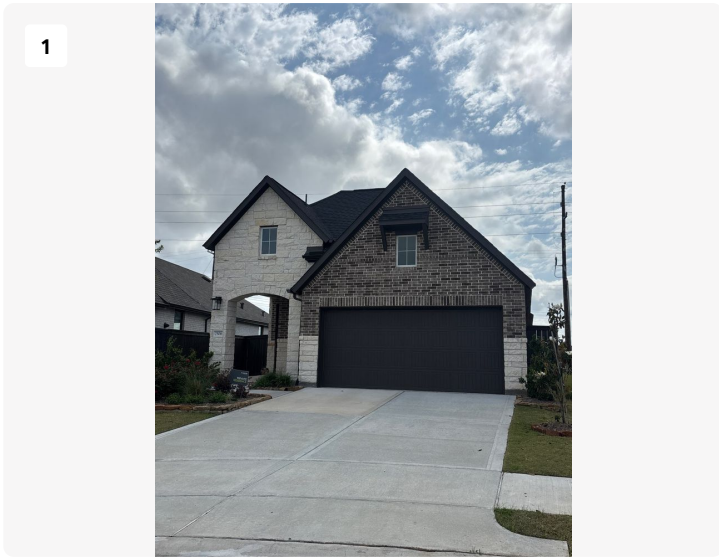
Project: 2506 Seedling St
 Date: Apr 22, 2025, 10:32 AM
 Creator: Angel Gomez

2 Roof Covering Materials

SHINGLES: LIFTED/CUPPED
RIGHT
 Observed buckled/lifted shingles on the roof covering. This condition is where the shingles are lifted or are not laying flat due to wrinkling of the underlayment or a shingle issue. High humidity and moisture issues at decking can also contribute to this condition. Recommend further evaluation by a roofing contractor to determine the extent of necessary repair.

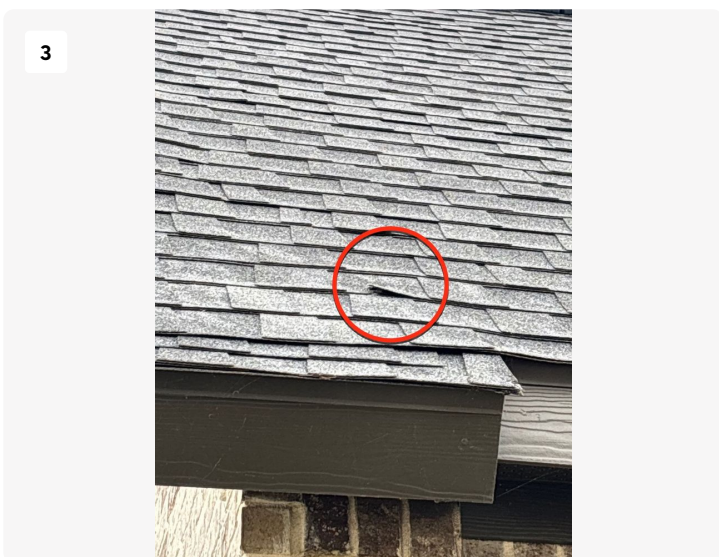
Project: 2506 Seedling St
 Date: Apr 28, 2025, 12:01 PM
 Creator: Javier Perez

2.3.2 - C. Roof Covering Materials

FLASHING: LOOSE/RAISED FLASHING
RIGHT, LEFT
 Raised or loose flashing areas were observed around the roof covering. This condition leaves the covering exposed to potential moisture or pest intrusion. Recommend all areas be evaluated and secured/sealed as needed.
