Mechanical Serviceability Inspection

4301 Willowick Drive Bryan, TX, 77802

Scheduled February 27, 2025 8:34 PM

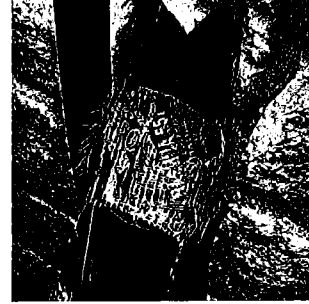
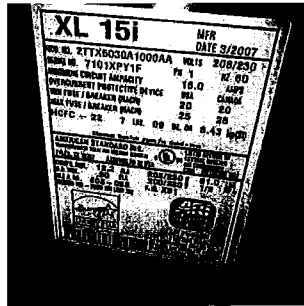
Items	Good	Fair	Clean	Dirty	Damaged	Notes
Condenser		✓		✓		2007 Trane 2.5ton R22 Clean condenser coils and electrical section, secure low voltage and install locking valve caps. Seal wall penetration. System is beyond serviceable life, recommend replacement.  <b>**Average Appliance Life Expectancy**:</b> <a href="https://www.nachi.org/life-expectancy.htm">https://www.nachi.org/life-expectancy.htm</a>
Furnace		✓		✓		2007 Trane Furnace in operational condition, need to clean blower wheel and install CO detector.  <b>**Average Appliance Life Expectancy**:</b> <a href="https://www.nachi.org/life-expectancy.htm">https://www.nachi.org/life-expectancy.htm</a>
Evaporator Coil		✓		✓		2006 Trane Evaporator Coil is rusted, but has no detectable leaks, need to have coil cleaned, drain cleaned, and insulated. Install safety switches and replace supply plenum. System is beyond serviceable life, recommend replacement.  <b>**Average Appliance Life Expectancy**:</b> <a href="https://www.nachi.org/life-expectancy.htm">https://www.nachi.org/life-expectancy.htm</a>
