KELLY INSPECTION SERVICES

PROPERTY INSPECTION REPORT FORM

Kelsey Stewart <i>Name of Client</i>	04/07/2023 2:00 pm <i>Date of Inspection</i>
611 Walnut Branch Dr, Mont Belvieu, TX 77523 <i>Address of Inspected Property</i>	
Andy Marcinkowska <i>Name of Inspector</i>	TREC #25412 <i>TREC License #</i>
<i>Name of Sponsor (if applicable)</i>	<i>TREC License #</i>

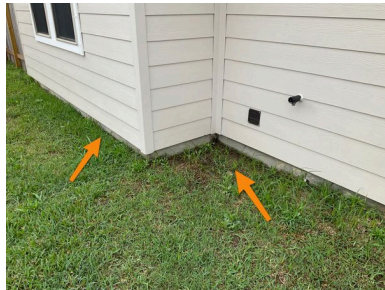
East

1: Negative Grading

Grading is sloping towards the home in some areas. This could lead to water intrusion and foundation issues. Recommend qualified landscaper or foundation contractor regrade so water flows away from home.

Recommendation: Contact a qualified landscaping contractor

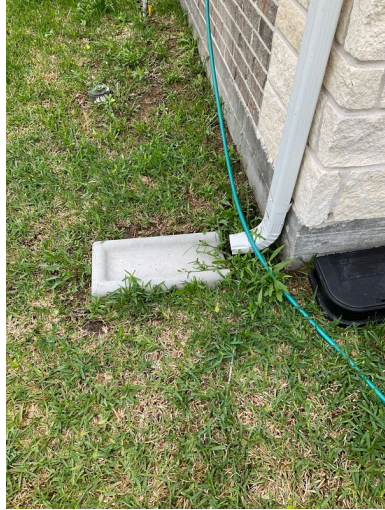
2: Drainage block improperly placed

The concrete drainage block below the outlet of the gutter spout is incorrectly placed. This is preventing water from draining as intended, as well as creating an environment conducive to pest.

Recommendation: Contact a qualified professional.

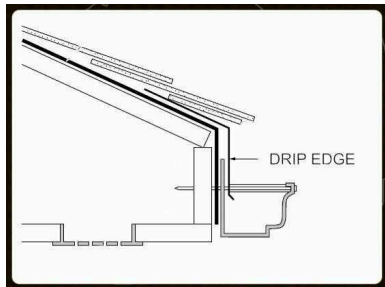
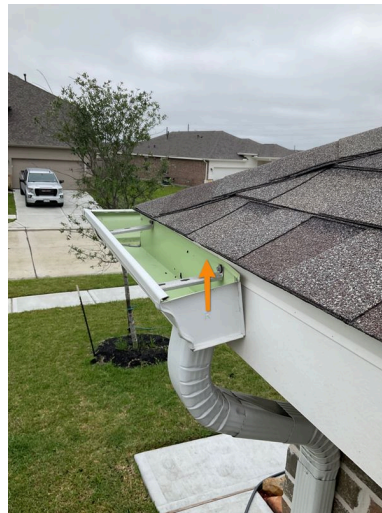
3: Gutter improperly installed

The gutters are presently installed over the drip edge and potentially voids any warranty. The current configuration can allow water behind the gutter along the fascia. Installation as per manufacturer's instruction and best practices will have the drip edge installed over the gutter as shown in the diagram.

Recommendation: Contact a qualified professional.

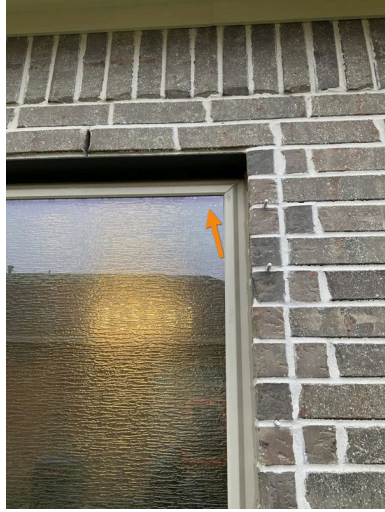
South

1: Failed Seal

Observed condensation between the window panes, which indicates a failed seal. Recommend qualified window contractor evaluate & replace.

Recommendation: Contact a qualified window repair/installation contractor.

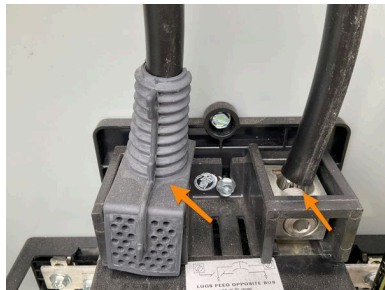
1: Antioxidant paste missing

Aluminum service wires should have antioxidant paste at the terminal connections in panel.

Recommendation: Contact a qualified professional.

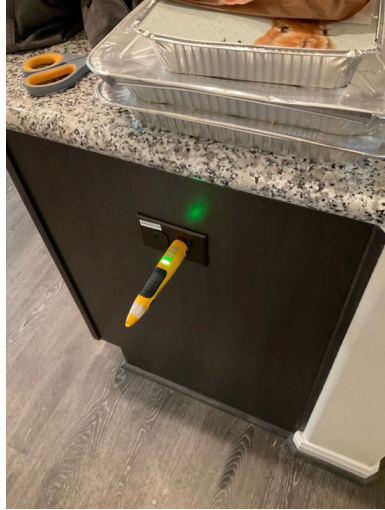
Kitchen

1: No GFCI Protection

No GFCI protection present in a location. Recommend licensed electrician upgrade by installing ground fault receptacles in all locations.

Recommendation: Contact a qualified electrical contractor.

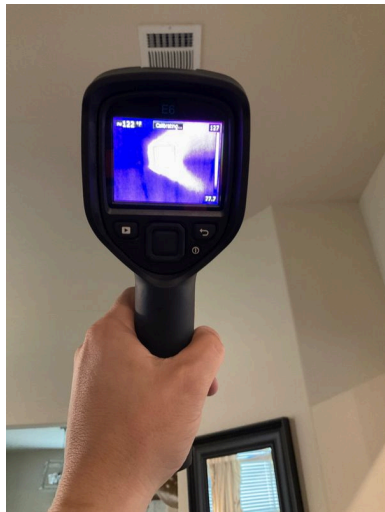
Living Room

1: Uneven distribution of conditioned air

One or more HVAC registers had a varying temperature of 10 or more degrees from the majority of the other registers. Have a HVAC technician check to ensure the system is properly balanced.

Recommendation: Contact a qualified professional.

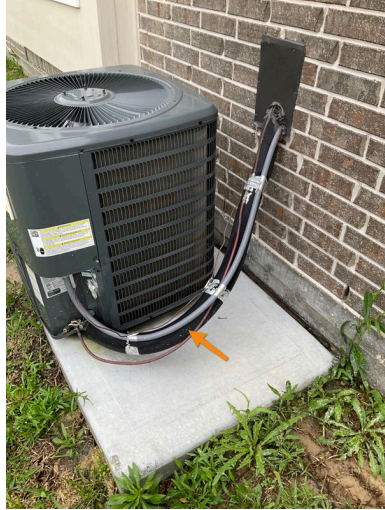
1: Solar cover for insulation missing

IECC-2018 C403.11.3.1 Protection of piping insulation (Mandatory)

“Piping insulation exposed to the weather shall be protected from damage, including that caused by sunlight, moisture, equipment maintenance, and wind, and shall provide shielding from solar radiation that can cause degradation of the material. Adhesive tape shall not be permitted.”

Recommendation: Contact a qualified professional.

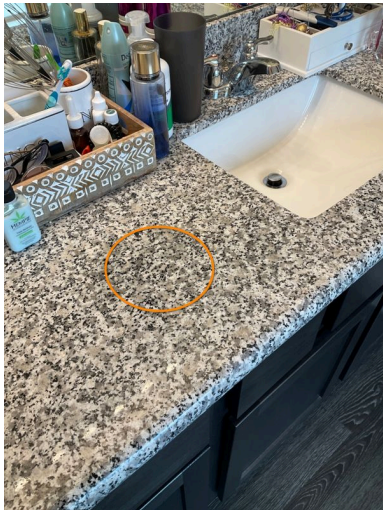
Master Bathroom

1: Granite countertops not sealed

Granite countertops need to be sealed to prevent liquids from staining.

Recommendation: Contact a qualified countertop contractor.

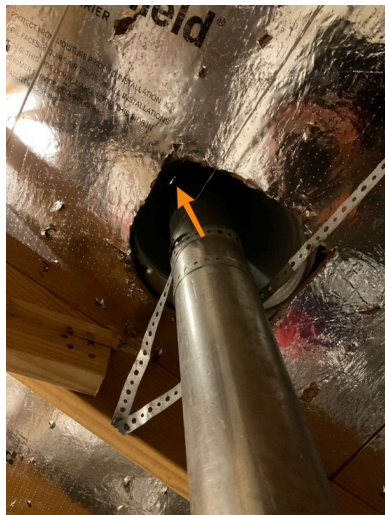
1: Daylight observed at roof penetration of vent

Roof penetrations need flashings and to be sealed.

Recommendation: Contact a qualified roofing professional.

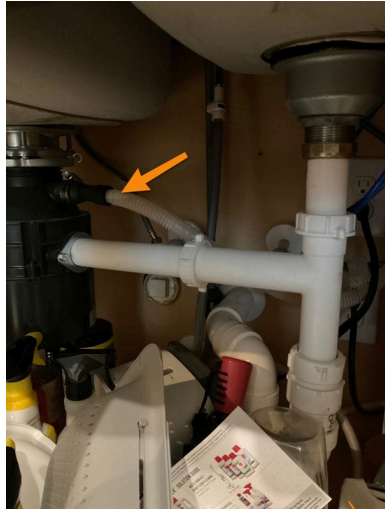
1: Dishwasher drain line improperly installed

It is recommended that the drain line for the dishwasher be installed with a loop near the top of the counter. This is to prevent unnecessary back flow of waste water from the sink into the dishwasher. I recommend having a qualified professional evaluate this and repair properly.

Recommendation: Contact a qualified professional.
