PROPERTY INSPECTION REPORT FORM

<i>Name of Client</i>	06/07/2026 1:00 pm
201 Bailey Brook Ln, Dickinson, TX 77539	<i>Date of Inspection</i>
<i>Address of Inspected Property</i>	
John Setticas	TREC # 23459
<i>Name of Inspector</i>	<i>TREC License #</i>
	I'm
<i>Name of Sponsor (if applicable)</i>	<i>TREC License #</i>

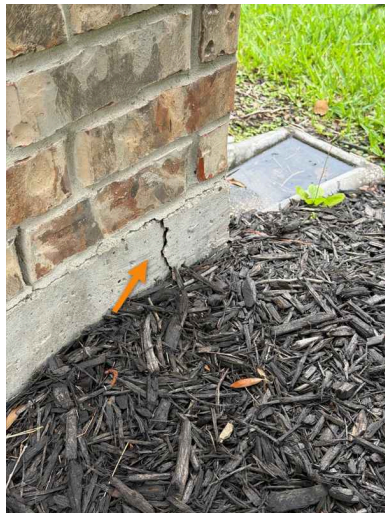
Front right corner

Corner pops or Corner wedge cracks are not structural concerns and are not stress related. It occurs due to the expansion and contraction of concrete and brick at different rates.

Recommendation: Contact a qualified professional.

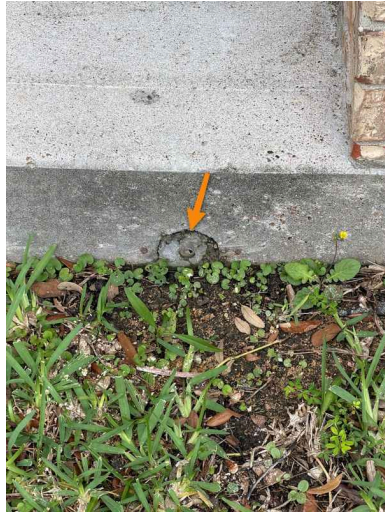
Left Side

One or more post tension cable ends are exposed and will rust in time.

Recommendation: Contact a qualified professional.

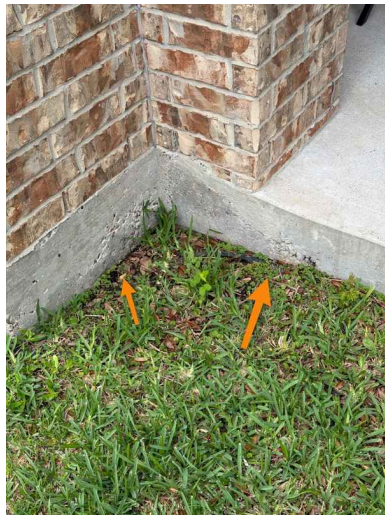
Left Side

Honeycombs are hollow spaces and cavities left in concrete mass on surface or inside the concrete mass where concrete could not reach due to improper vibration during concrete pour.

Recommendation: Contact a qualified professional.

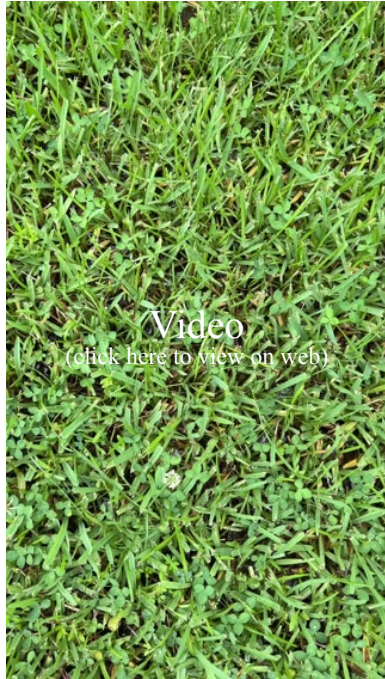
Standing water observed, which could indicate poor drainage and/or grading. It is recommended to be evaluated and repaired by a qualified professional.

Recommendation: Contact a qualified professional.

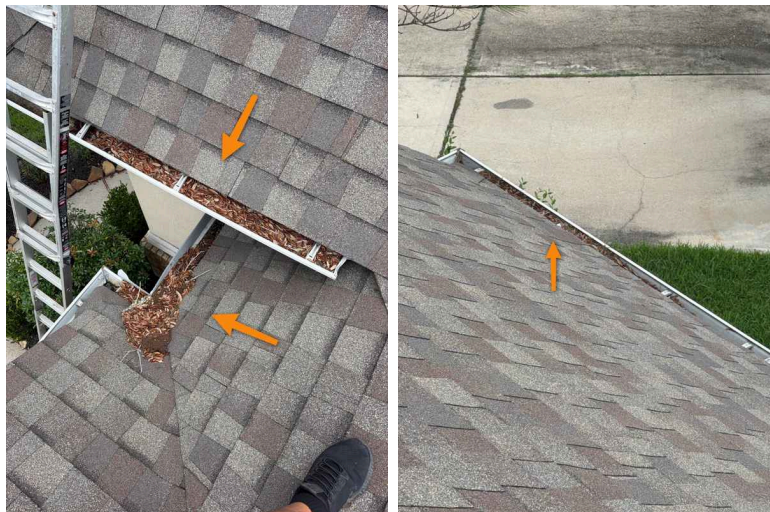
Gutters are partially restricted with debris which could allow runoff to back up into structure. It is recommended to periodically clean gutters to prevent restrictions.

Recommendation: Contact a qualified professional.

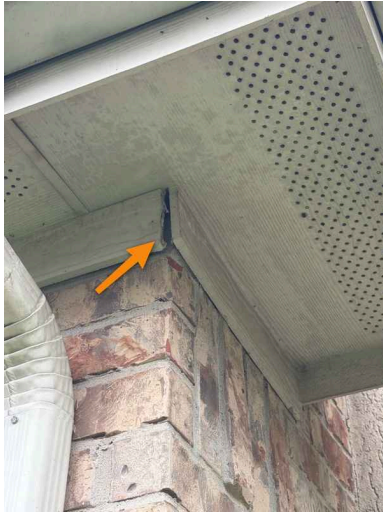
Left Side

2: TREE LIMBS

Tree limbs/vegetation are near or have come into contact with the roofing material, fascia, soffits, and exterior walls. These will need to be maintained to prevent further damage.

Recommendation: Contact a qualified professional.

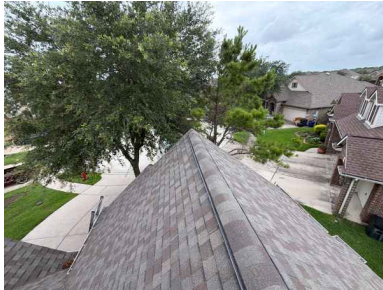
3: FLASHING PULLING UP

Flashing where roof intersects wall, in valley or around vents are pulling up. It is recommended to be evaluated and repaired by a qualified professional.

Recommendation: Contact a qualified roofing professional.

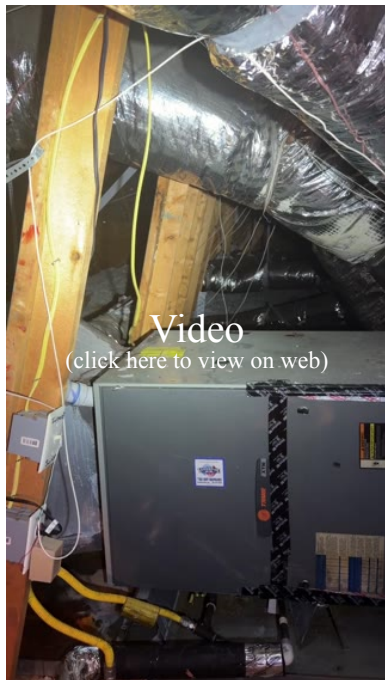
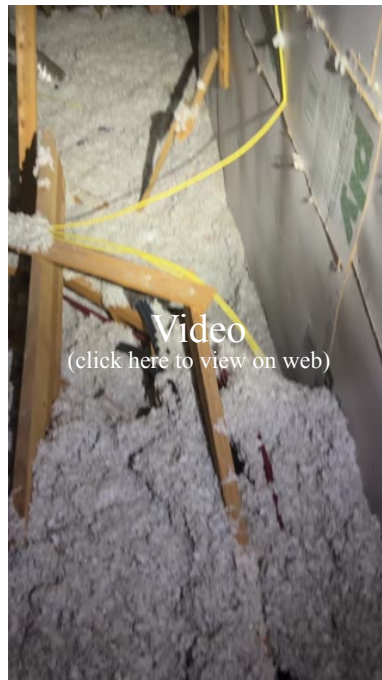
Split/damaged structural member at one or more locations in attic. It is recommended to be evaluated and repaired by a qualified professional.

Recommendation: Contact a qualified professional.

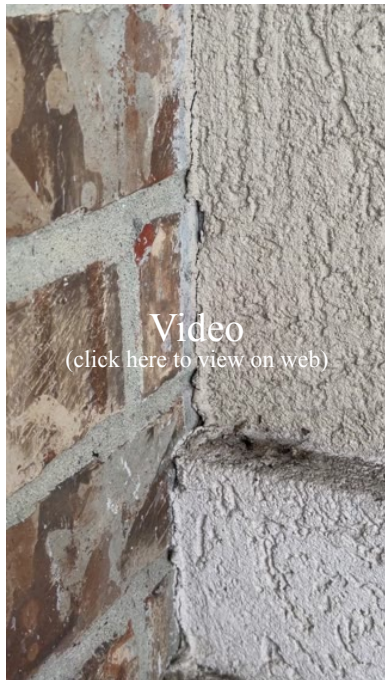
Front Porch

Cracks, damage and/or deterioration to the walls was visible in one or more locations.

Recommendation: Contact a qualified professional.

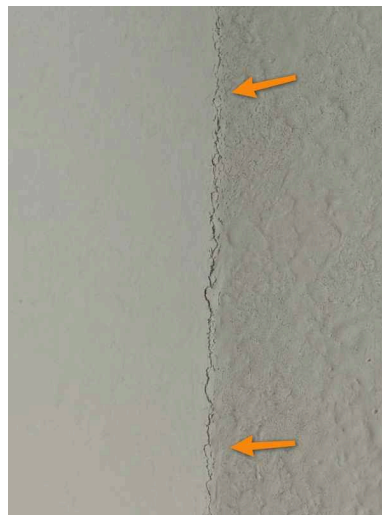
2: Baseboards

Separation/damage to baseboards at one or more locations.

Recommendation: Contact a qualified professional.

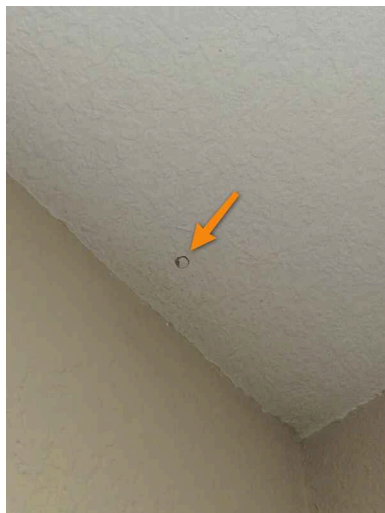
Bathroom #1

Cracks, nail pops and/or damage to the ceiling was visible at one or more locations.

Recommendation: Contact a qualified professional.

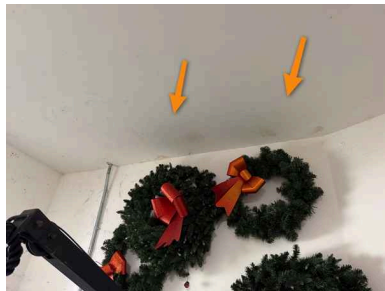
Garage

Ceiling showed signs of water intrusion, dry at time of inspection. Recommend a qualified professional identify source of moisture and properly repair.

Recommendation: Contact a qualified professional.

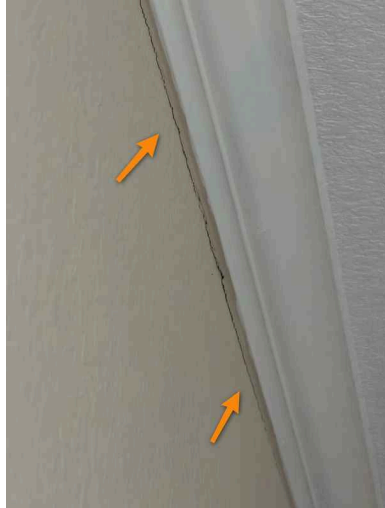
Bedroom #3

Separation/damage at crown molding at one or more locations.

Recommendation: Contact a qualified professional.

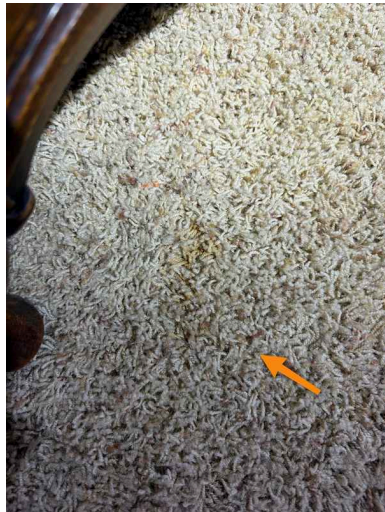
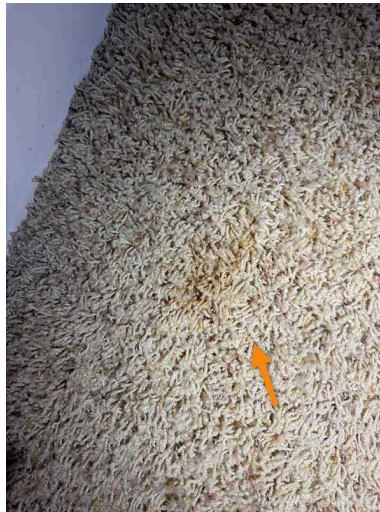
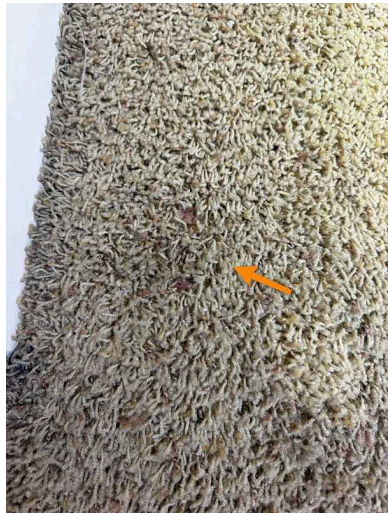
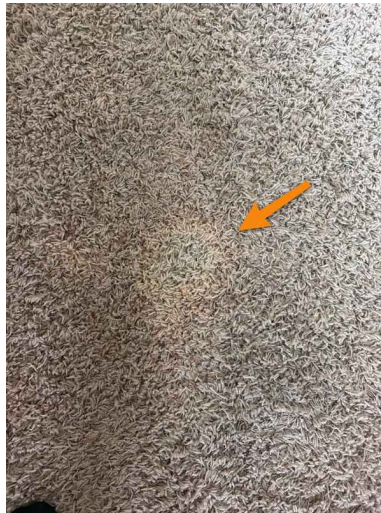
Carpet is stained at one or more locations.

Recommendation: Contact a qualified professional.

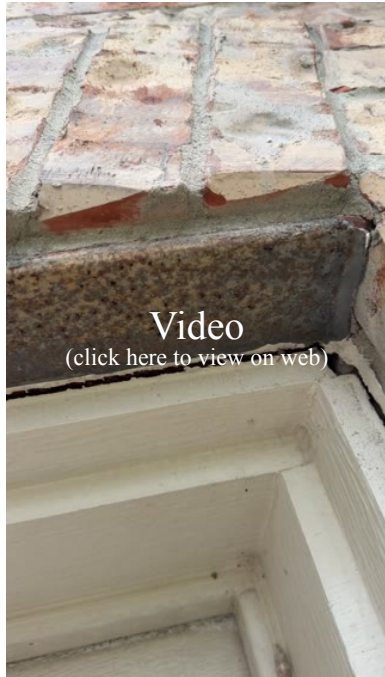
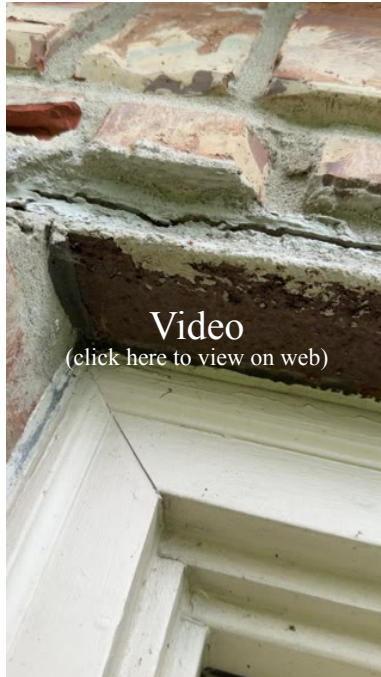
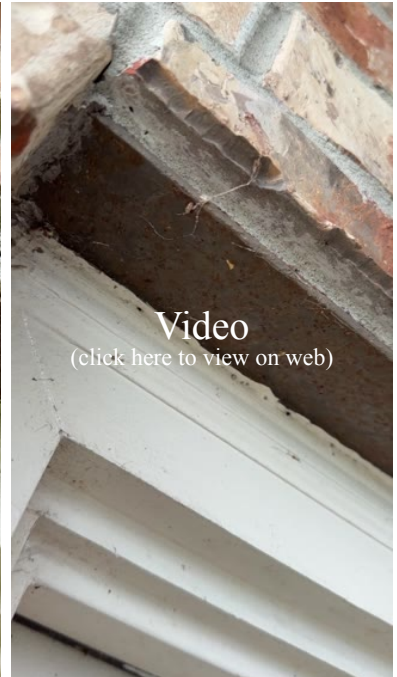
Rust was observed on the door lintels. A lintel is a structural piece of material that sits flat atop and over an opening in a wall. Lintels are most commonly made from steel. If left untreated it can rust and expand, creating cracks in brick. It is recommended to be evaluated and repaired by a qualified professional.

Recommendation: Contact a qualified professional.

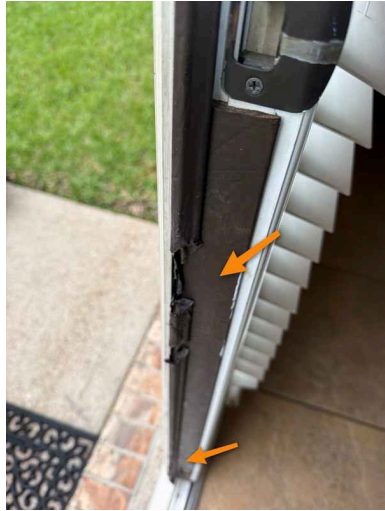
Side Door

Weather strip/seal damaged on one or more exterior doors, which can allow moisture and unwanted pest to enter residence.

Recommendation: Contact a qualified professional.

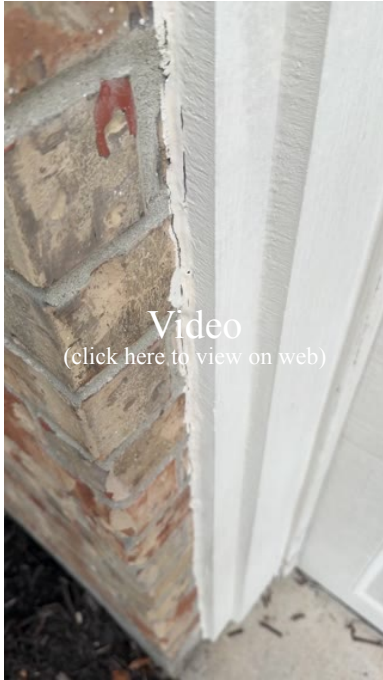
Garage

Caulking around doors is cracking, separating and/or missing at one or more locations.

Recommendation: Contact a qualified professional.

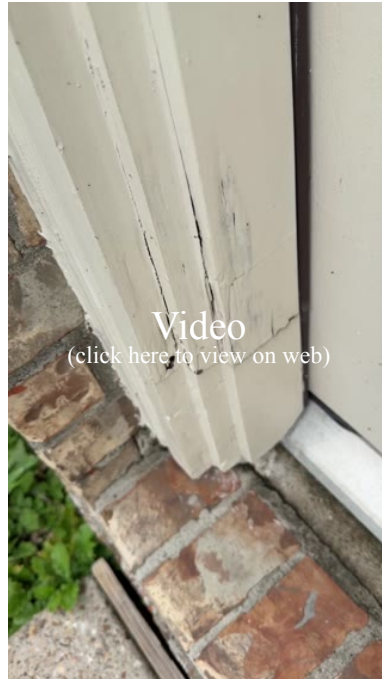
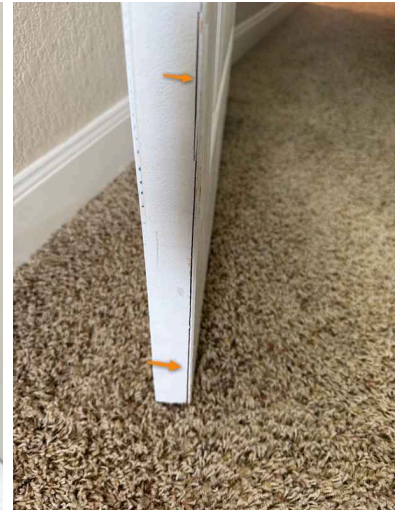
Bedroom #2

Separation/damage/peeling paint at one or more door and/or frames. It is recommended to be evaluated and repaired by a qualified professional.

Recommendation: Contact a qualified professional.

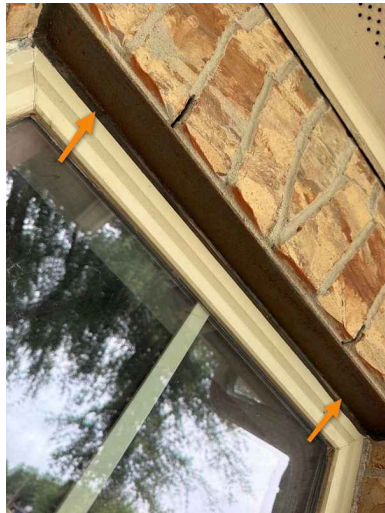
Front

Rust was observed on the window lintels. A lintel is a structural piece of material that sits flat atop and over an opening in a wall. Lintels are most commonly made from steel. If left untreated it can rust and expand, creating cracks in the brick.

Recommendation: Contact a qualified professional.

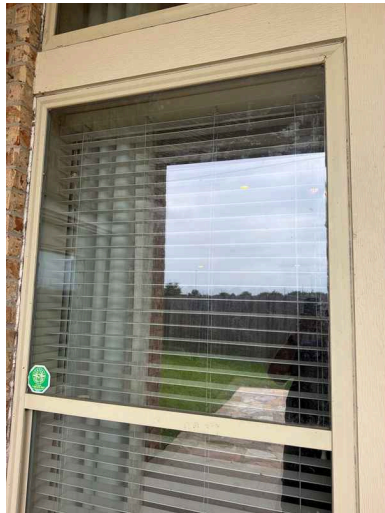
Living Room

One or more of the thermal pane windows were observed to have lost their seals. This has resulted in condensation or a fog like film to develop between the panes of glass. While keeping out wind and water, the windows are no longer functioning as designed when the seal is lost. It is recommended to be properly replaced by a window specialist.

Recommendation: Contact a qualified professional.

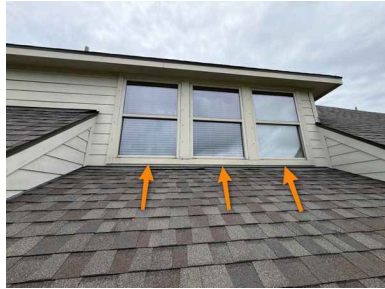
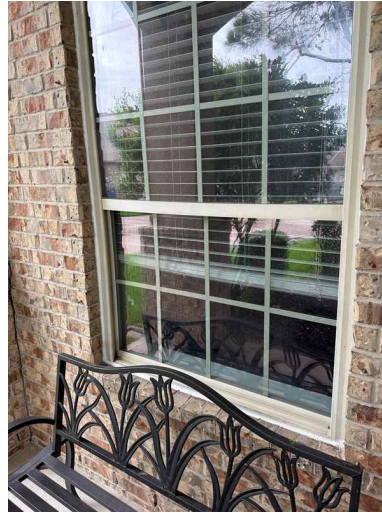
One or more window screens have been damaged, worn or missing.

Recommendation: Contact a qualified professional.

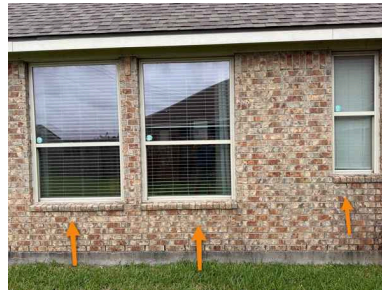
Left Side

Caulking around windows is cracking, separating and/or missing at one or more locations.

Recommendation: Contact a qualified professional.

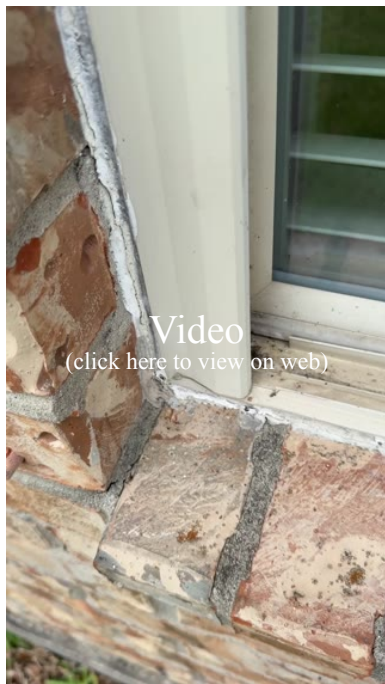
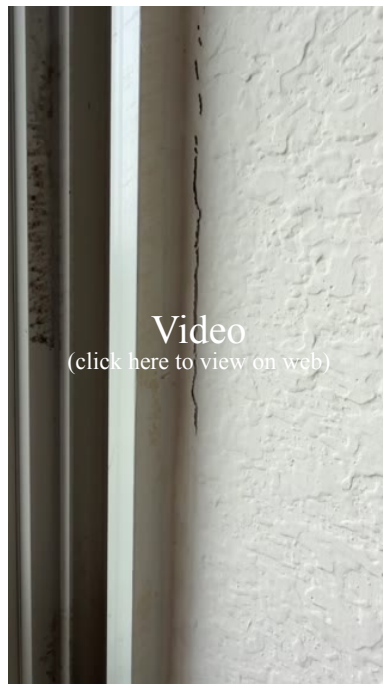
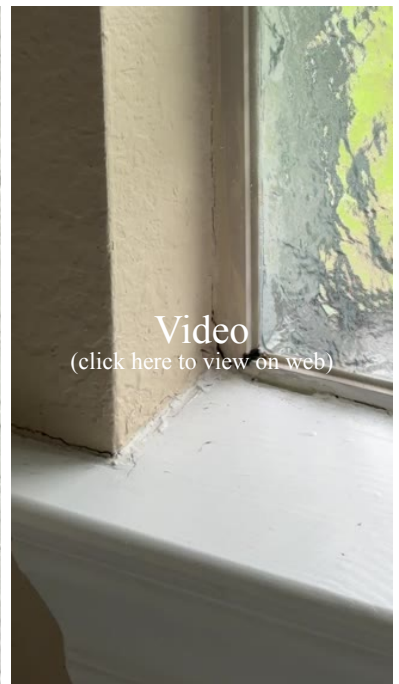
Window balance is damaged at one or more locations. If both are broken the window will not stay up. It is recommended to be evaluated and repaired by a qualified professional.

Recommendation: Contact a qualified professional.

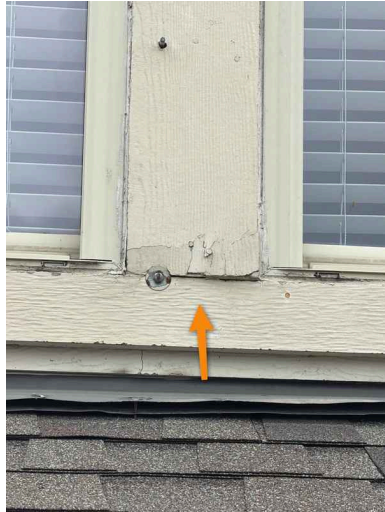
2nd Floor Right Side

Exterior trim is damaged/missing at one or more locations. It is recommended to be evaluated and repaired by a qualified professional.

Recommendation: Contact a qualified professional.

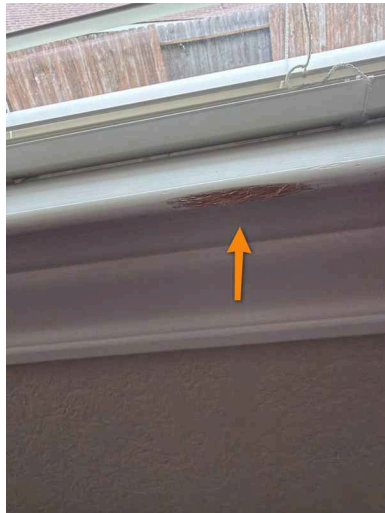
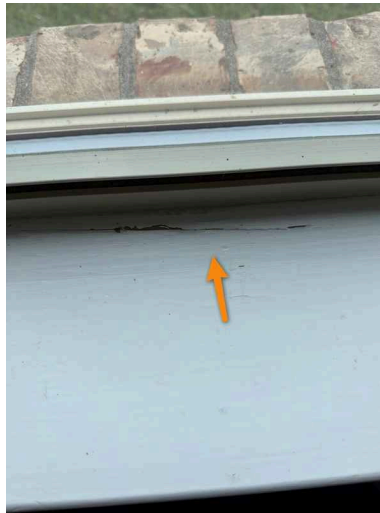
Formal Dining

Interior windowsill is damaged at one or more locations.

Recommendation: Contact a qualified professional.

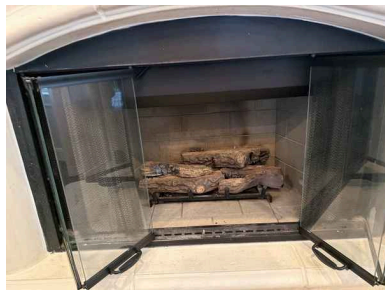
1: Separation

Separation at sides of fireplace and mantle. It is recommended to be evaluated and repaired by a qualified professional.

Recommendation: Contact a qualified professional.

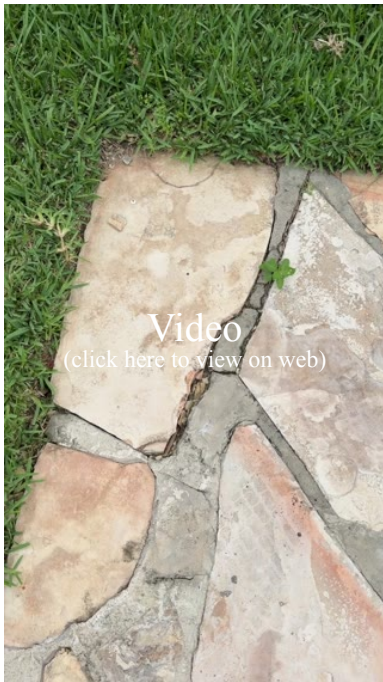
Front and/or back porch slabs are cracked/damaged.

Recommendation: Contact a qualified professional.

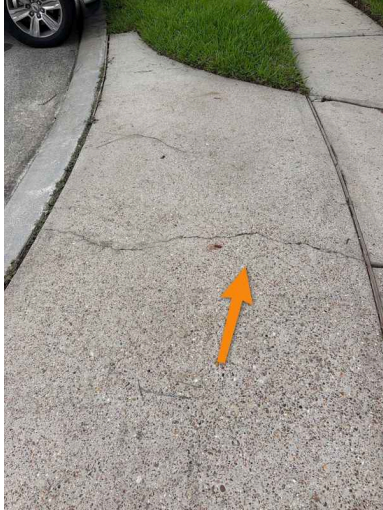
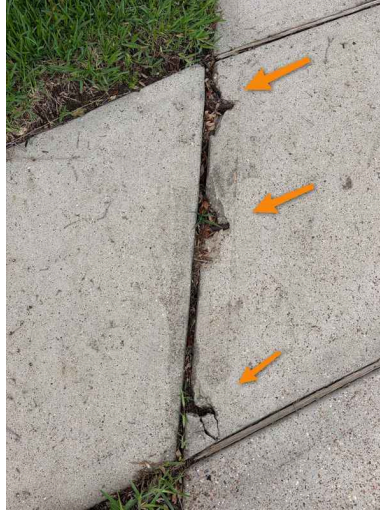
Driveway/walkway/curb concrete is cracking, damaged and/or uneven in one or more locations. It is recommended to be evaluated and repaired by a qualified professional.

Recommendation: Contact a qualified professional.

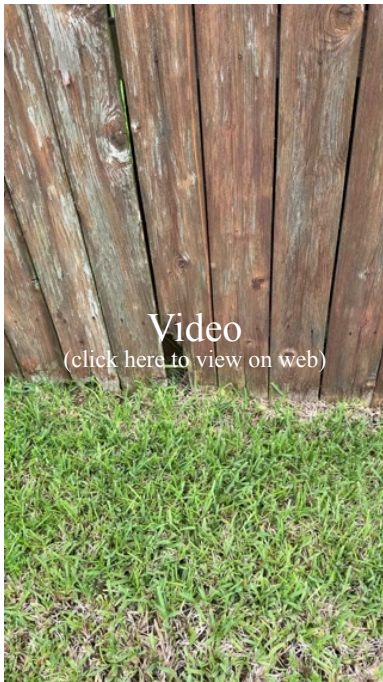
Left Side

Fence/gate is damaged and/or leaning at one or more locations.

Recommendation: Contact a qualified professional.

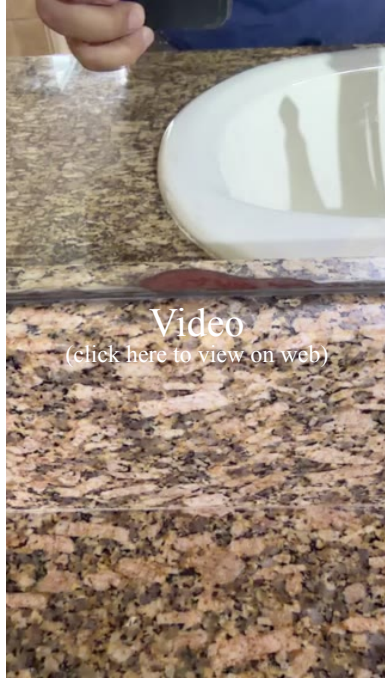
Bathroom #3

Mirrors in one or more bathrooms are damaged.

Recommendation: Contact a qualified professional.

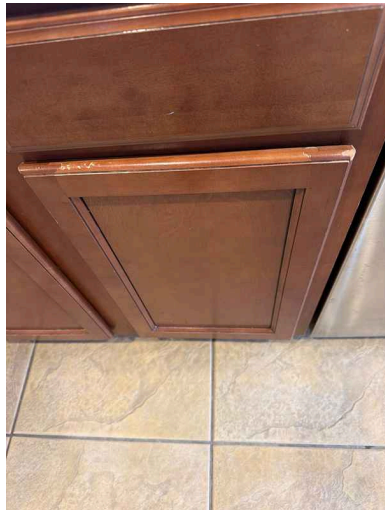
Kitchen Kitchen

Damaged cabinetry/countertop/backsplash at one or more locations.

Recommendation: Contact a qualified professional.

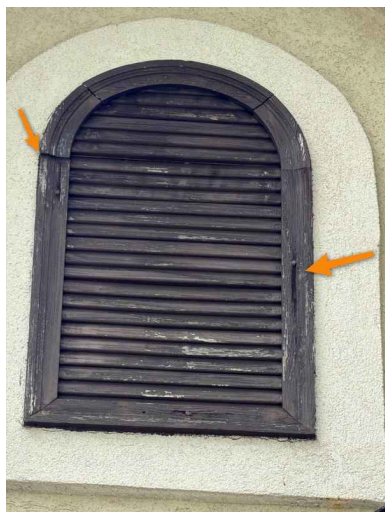
Gable vent is damaged at one or more locations.

Recommendation: Contact a qualified professional.

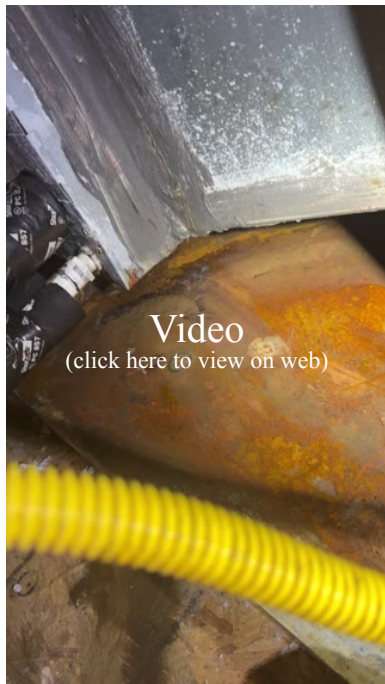
Rust and/or water was observed in A/C over flow pan, this usually indicates that possibly at onetime there was or is a restriction in the primary drain. It is recommended to be evaluated by a licensed HVAC technician.

Recommendation: Contact a qualified HVAC professional.

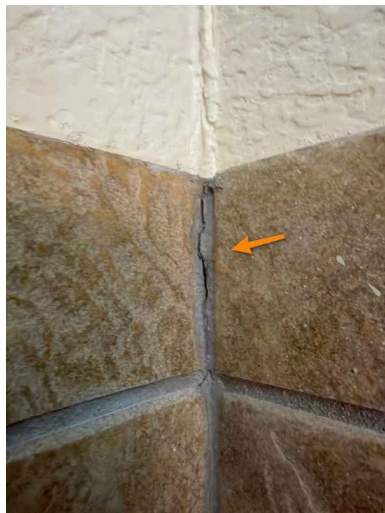
Bathroom #1

Bathtub, shower and/or sink grout or caulk is separating/missing in one or more locations.

Recommendation: Contact a qualified professional.

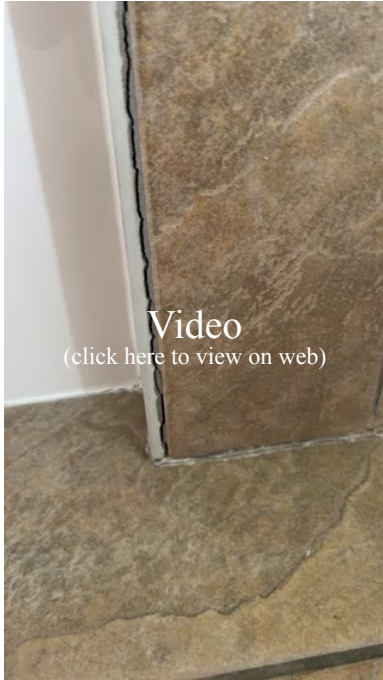
Bathroom #3

Shower tile is cracked/damaged in bathroom #3. It is recommended to be evaluated and repaired by a qualified professional.

Recommendation: Contact a qualified professional.

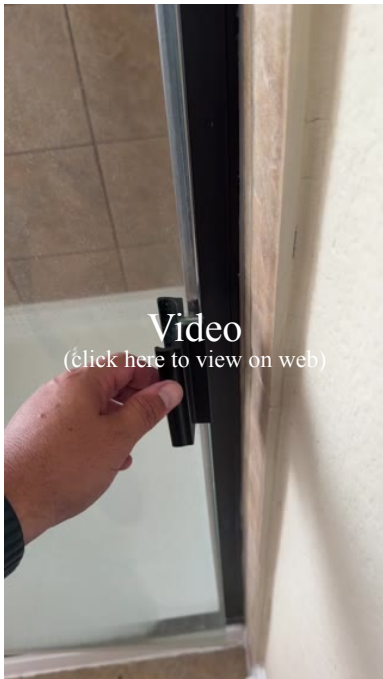
Bathroom #3

Shower door does not properly shut due to rusted/damaged magnet.

Recommendation: Contact a qualified professional.

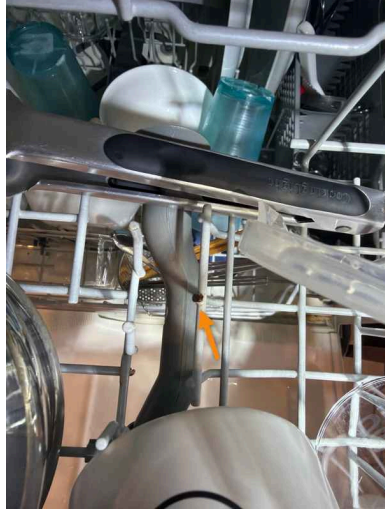
Dish rack is rusted in one or more locations.

Recommendation: Contact a qualified professional.

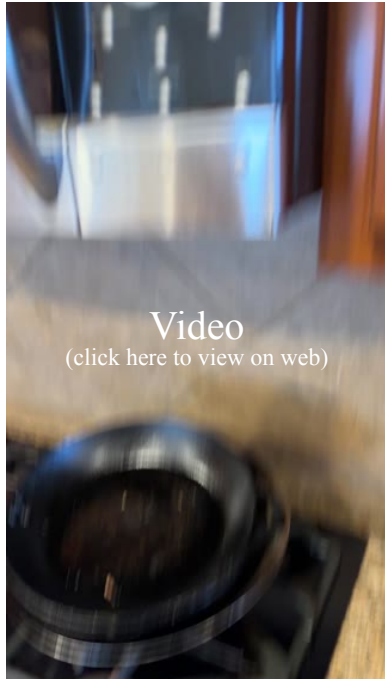
Unit is loosely attached to cabinetry.

Recommendation: Contact a qualified professional.

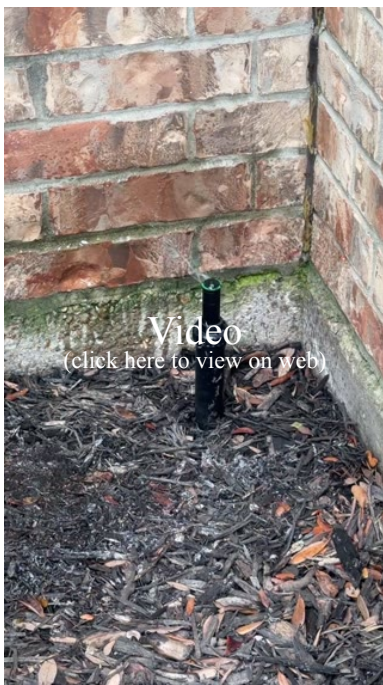
Zone 1

One or more sprinkler heads are damaged and/or misaligned. It is recommended to be evaluated by a qualified professional.

Recommendation: Contact a qualified professional.

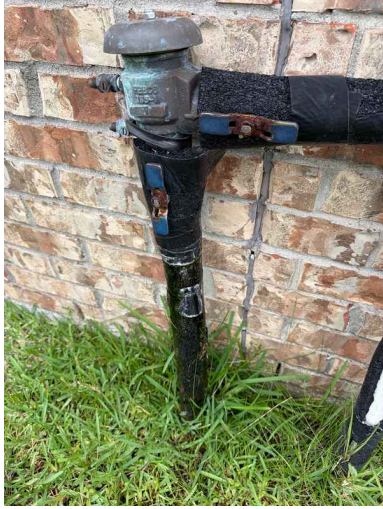
Leak at vacuum breaker. It is recommended to be evaluated and repaired by a qualified professional.

Recommendation: Contact a qualified professional.

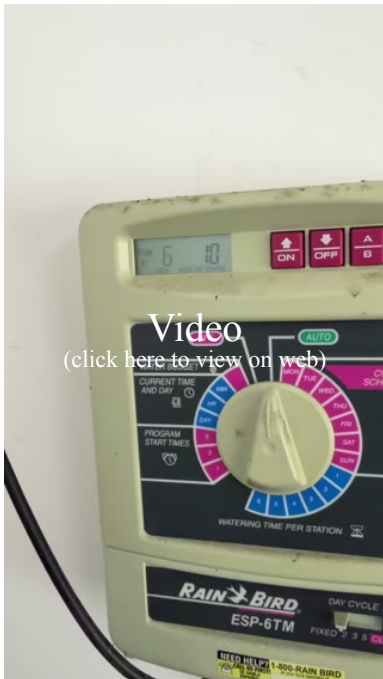
Error code at control panel while running system. It is recommended to be evaluated and repaired by a qualified professional.

Recommendation: Contact a qualified professional.
