RESIDENTIAL INSPECTION REPORT

2135 Quenby St  
Houston, TX 77005

# PROPERTY INSPECTION REPORT FORM

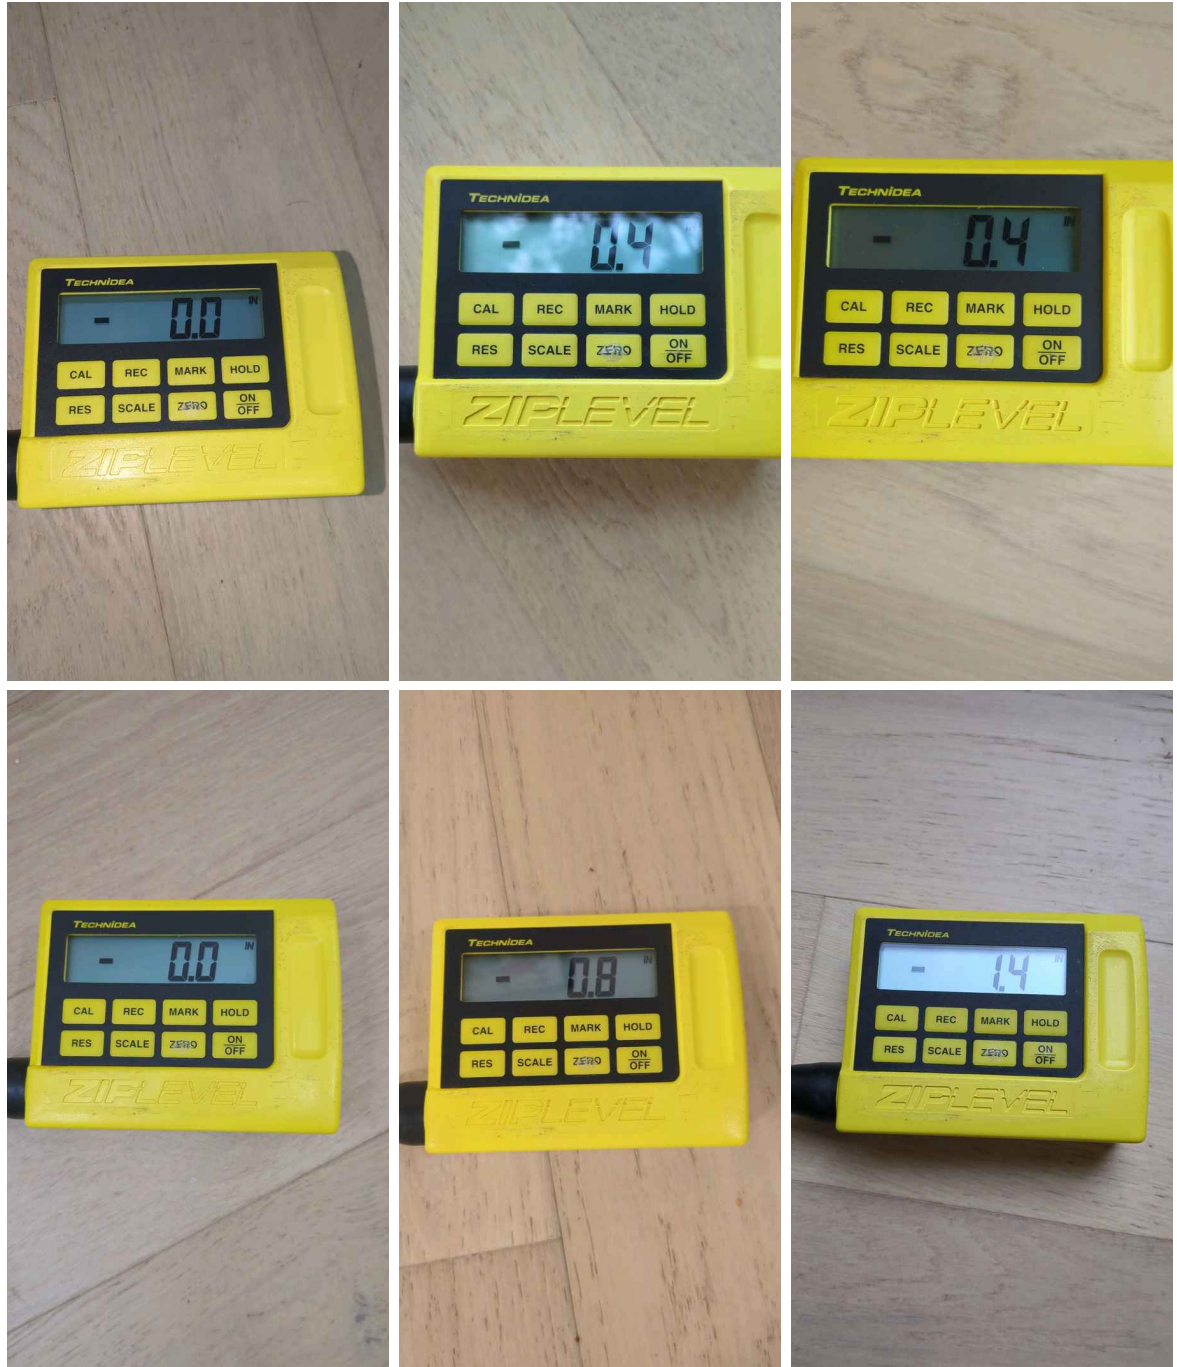
*Digital Level Pictures:*

This foundation was measured with the use of an electronic digital measurement tool. Multiple elevation points were registered on the foundation throughout the property to determine if there were elevation variations that indicated excessive movement of the foundation.

The foundation was measured with the use of an electronic digital measurement tool. Multiple elevation points were registered on the foundation throughout the property. At the time of this inspection observations were noted that (in this inspectors OPINION) indicate excessive variance of the foundation at the dining area and laundry area towards the rear. Further evaluation by a structural engineer and/or qualified foundation repair contractor is recommended.

Recommendation: Contact a qualified structural engineer.

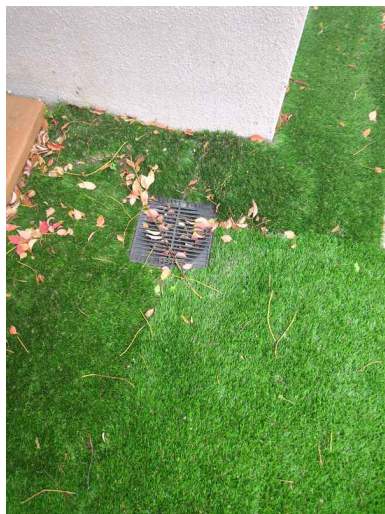
The inspector did not determine effectiveness or condition of any below grade downspout extension(s) or drainage system(s), nor did the inspector determine the location of a discharge outlet.

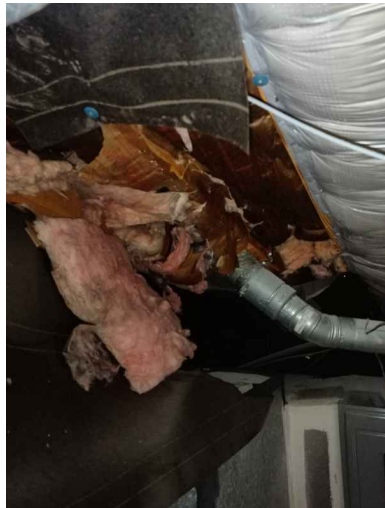
**1: Insulation: Voids**

Gaps or areas of poor insulation coverage were observed in one or more locations of the attic. This may reduce the R value of the insulation system. Evaluate and remedy as needed.

Recommendation: Contact a qualified insulation contractor.

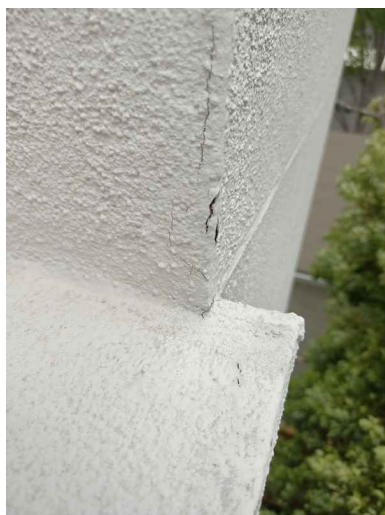
**1: Stucco: Deficiencies Were Present**

Surface Cracks, Lath and Trim Corroded, Inadequate Clearance From Grade - Deficiencies were present. (See example photos) To ensure a more thorough understanding of any potential underlying issues, I recommend scheduling an invasive stucco inspection. This type of inspection is designed to detect hidden concerns that may not be visible during a standard visual assessment, providing a more detailed evaluation of the siding's true condition.

3rd Floor cracks

Recommendation: Contact a stucco repair contractor

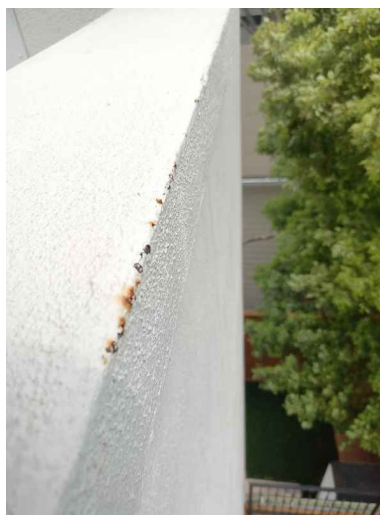
3rd Floor corrosion

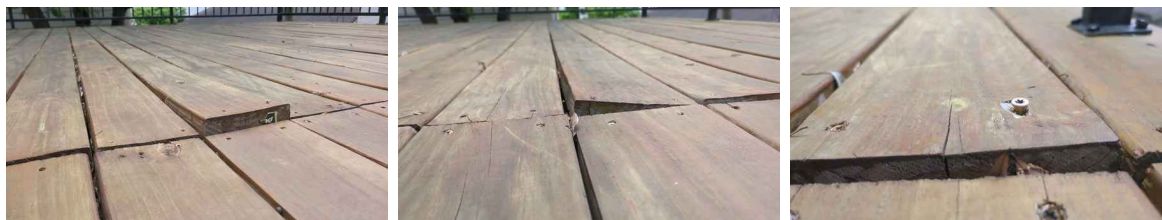
**1: Porch/Balcony Flooring Lifted**

Porch or balcony exterior flooring showed signs warping. Evaluate and remedy as needed.

Recommendation: Contact a qualified professional.

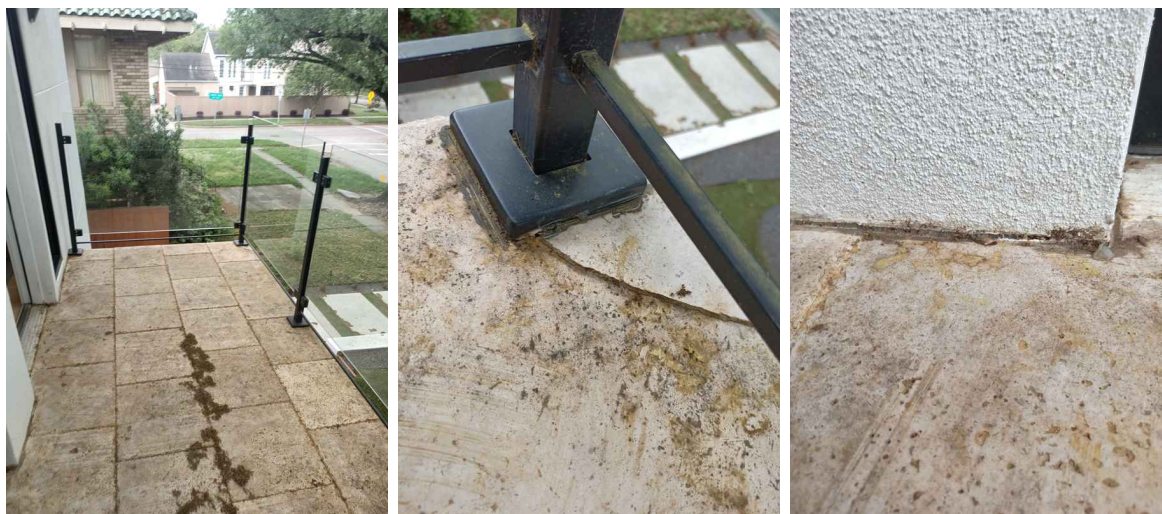
**2: Cracked tile**

Cracked tile and open joints were observed on front balcony flooring. Evaluate and remedy as needed.

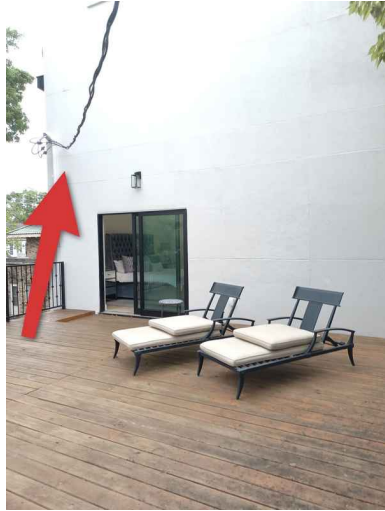
**2: Service Entrance Wires: Insufficient Clearance**

Service drop overhead wires were too low, not giving enough clearance. Contacting your local electric utility company or licensed electrician to see if they can remedy is recommended.

Recommendation: Contact a qualified electrical contractor.

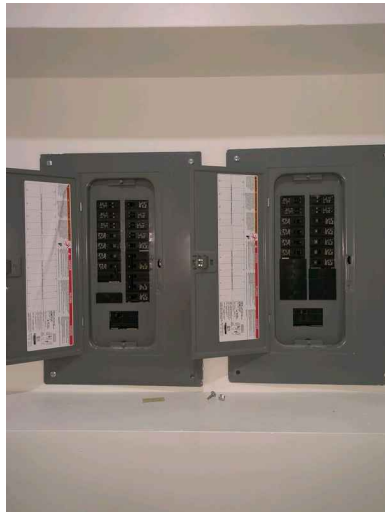
**1: Receptacles: AFCI Protection Inadequate/Missing**

The absence of arc-fault circuit interrupt (AFCI) protection was observed in one or more of the following locations:

The Texas Real Estate Commission requires inspectors to report as deficient the absence of arc-fault circuit interrupt protection in the areas listed above, even if these devices were not required by code when the home was constructed, due to the safety impact these devices provide. Evaluate and remedy as needed.

Recommendation: Contact a qualified electrical contractor.

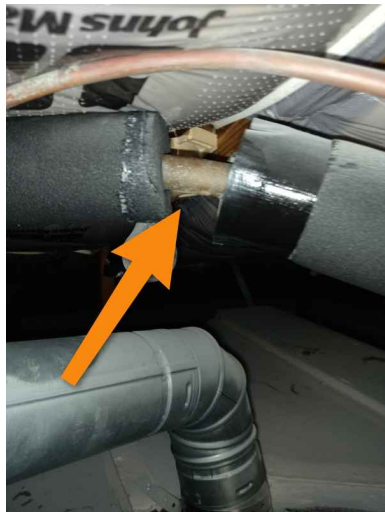
**1: Condenser: Insulation Missing/Damaged on Refrigerant Lines**

Missing or damaged insulation on refrigerant lines can cause energy loss and condensation. Evaluation and remediation is recommended.

Attic unit

Recommendation: Contact a qualified HVAC professional.

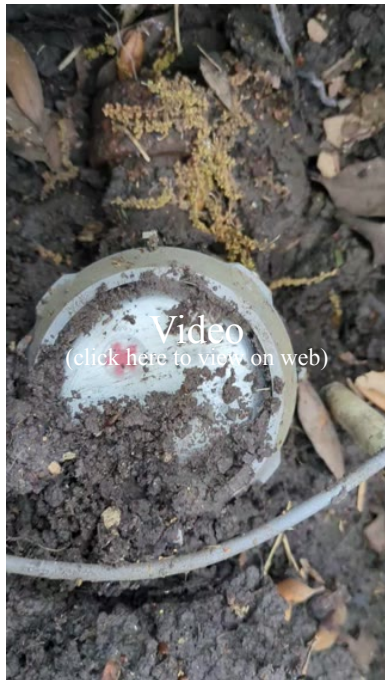
- A. Plumbing Supply, Distribution Systems, and Fixtures**  
*Location of Water Meter: Front Yard Near Street*  
*Water Meter Video:*

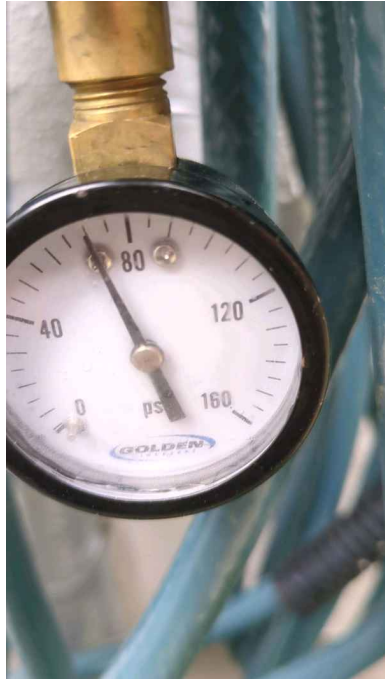
*Static Water Pressure Reading: 70 PSI*

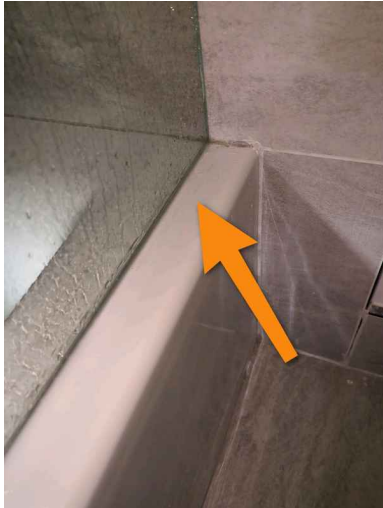
**1: Shower: Water Leaked Under Shower Glass**

Water leaked underneath the shower stall glass panel. This can indicate a poor seal. Evaluation and remediation is recommended.

2nd Floor Hall Shower

Recommendation: Contact a qualified professional.

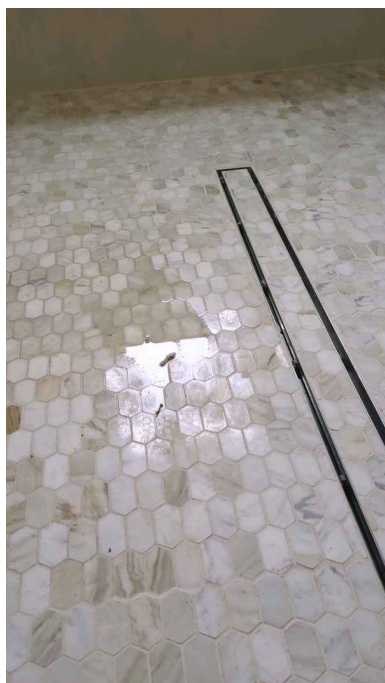
**2: Shower/Tub: Poor Slope and/or Drainage at Enclosure Floor**

Floors should be free of standing water when fixtures are not in use to prevent slip hazards, reduce maintenance requirements, and prolong overall life of bathtub/shower surfaces. Evaluation and remediation is recommended.

Primary Bathroom

Recommendation: Contact a qualified plumbing contractor.

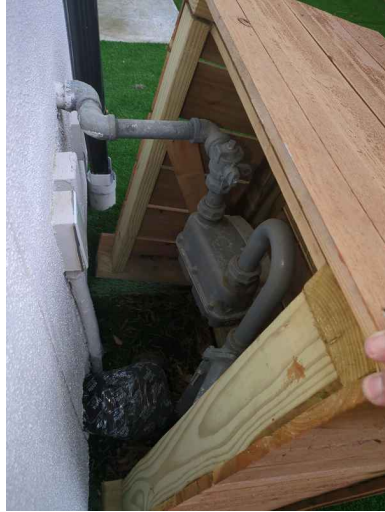
*Location of Gas Meter:* Right Exterior

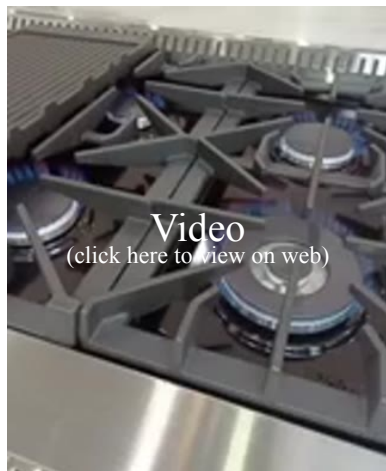
Range makes a whistling sound when all burners are on. Evaluate and remedy as needed.
