## MOLD ASSESSMENT

2135 Quenby St  
Houston, TX 77005

Maja Djukic  
04/03/2025

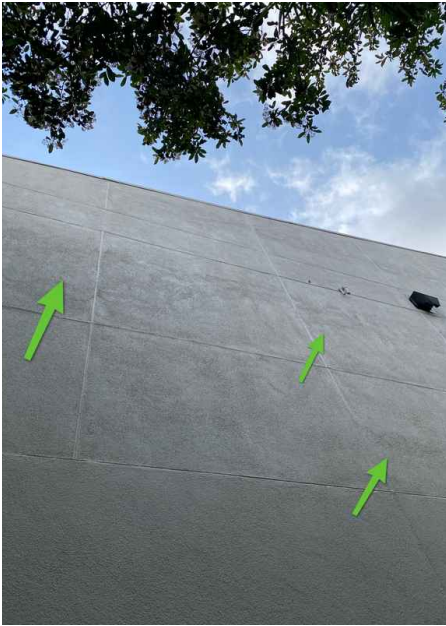
Right Exterior

Previous repairs were observed. It is recommended that all existing repair documentation and warranties are reviewed by client and his or her representatives.

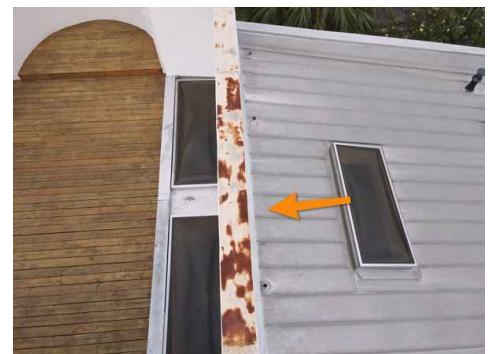
## 5.3.1 Roof Covering Issues

**FLASHING DEFICIENCIES**

Rusted

One or more flashing deficiencies were present. Further evaluation by a qualified roofing contractor is recommended.

Contact a qualified roofing professional.

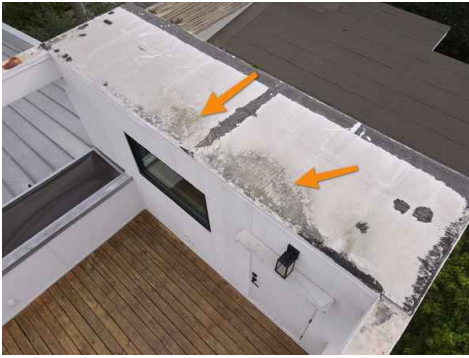
## 5.3.2 Roof Covering Issues

**FLAT ROOF: PONDING**

Ponding was observed in one or more areas of the roof. Ponding can lead to accelerated erosion, deterioration, and moisture intrusion. Further evaluation by a qualified roofing contractor is recommended. Remedy as needed.

Contact a qualified roofing professional.

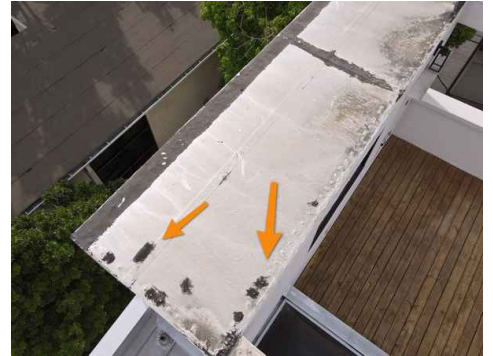
### 5.3.3 Roof Covering Issues

#### **PATCHED ROOFING MATERIALS**

Previous repairs or patched areas of the roofing were observed. Repair documentation from the seller/property owner is recommended in case warranty protections apply.

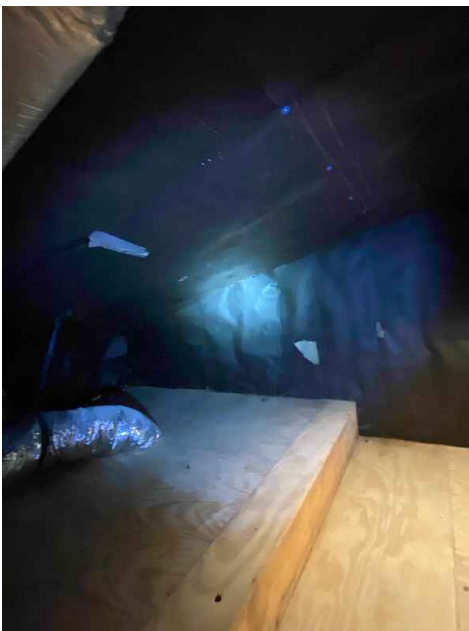
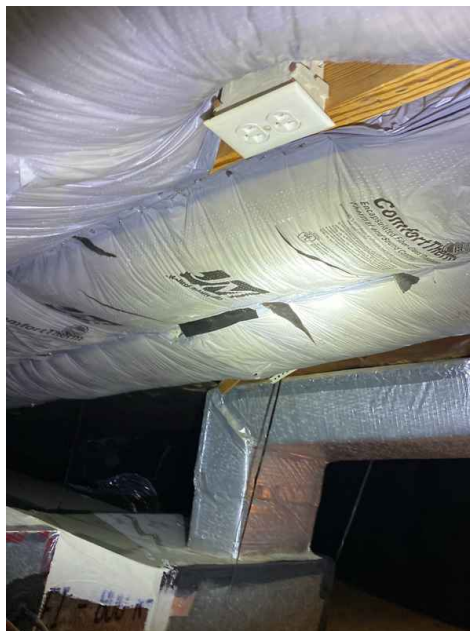
### 5.4.1 Attic Issues

#### **VENTING: INADEQUATE**

The attic ventilation appears to be inadequate in one or more areas. Proper ventilation is critical to controlling excess humidity, condensation issues, and mold growth in an attic space. Further evaluation by a qualified roofing professional is recommended. Remedy as needed.

Contact a qualified roofing professional.

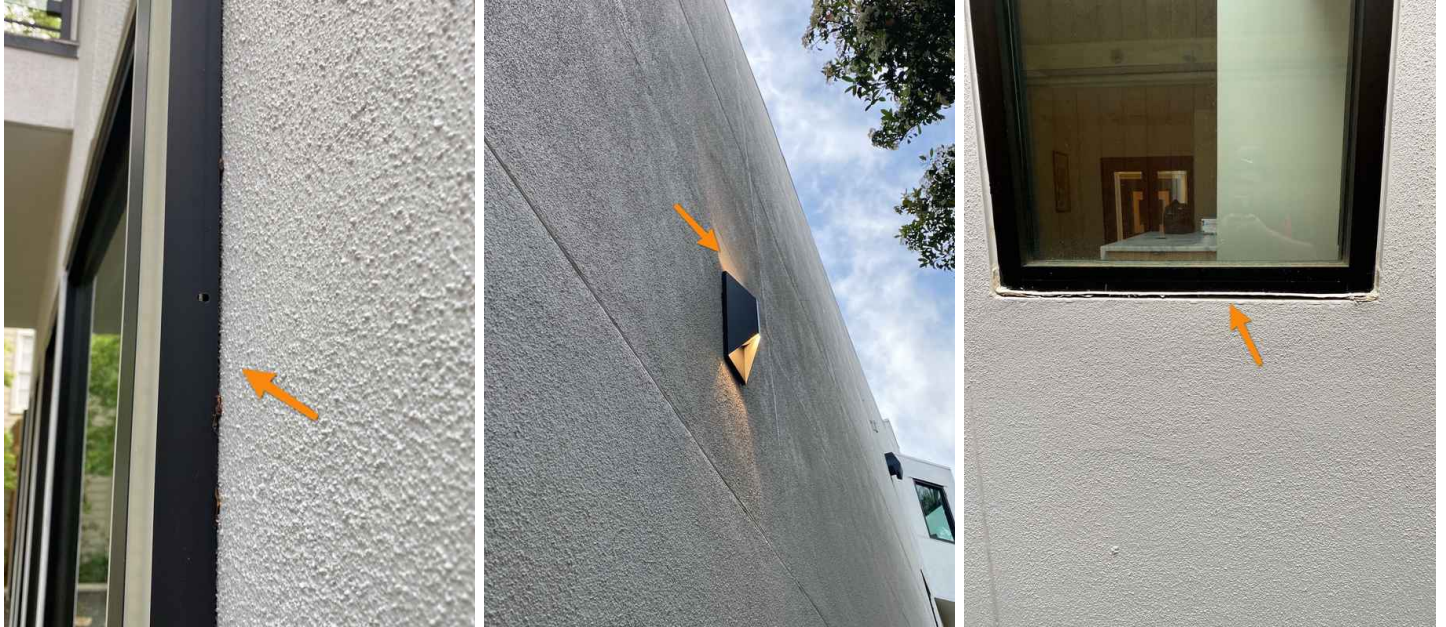
## 5.5.1 Exterior Wall &amp; Surface Issues

**SEAL AREAS VULNERABLE TO MOISTURE INTRUSION**

Light Fixture(s), Window Frames

All fixtures, electrical boxes, joints, and wall penetrations should be sealed. Modern building practices recommend sealing around components that are mounted on or pass through the exterior wall surfaces to limit moisture intrusion.

Recommended DIY Project

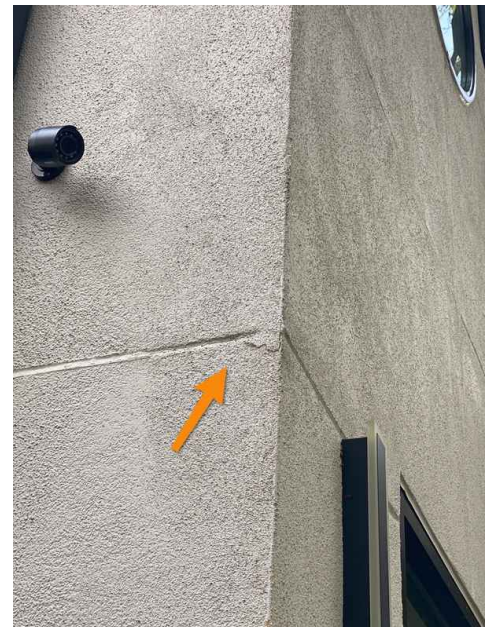
Left Front Exterior

**EXTERIOR MASONRY: DAMAGE**

MULTIPLE LOCATIONS

There was damaged to brick/masonry surfaces. Evaluate and remedy as needed.

Contact a qualified masonry professional.

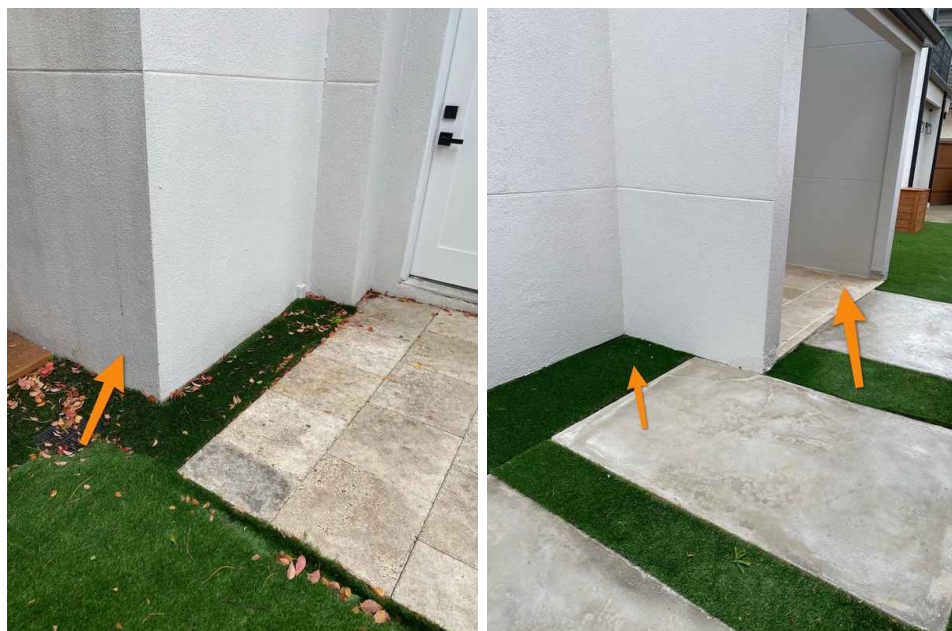
## 5.5.3 Exterior Wall &amp; Surface Issues

**EXTERIOR MASONRY OR SIDING: TOO CLOSE TO GRADE**

MULTIPLE LOCATIONS

Building standards require 4" to 8" of clearance between the grade and masonry walls & siding. Evaluate and remedy as needed.

Contact a qualified professional.

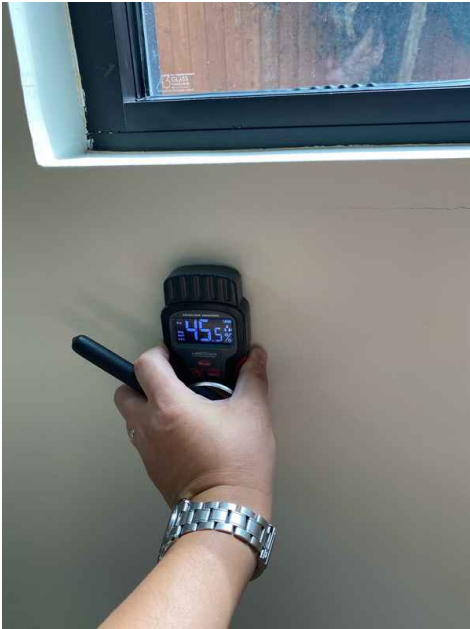
Under the Living room window

### **EXCESSIVE MOISTURE**

Excessive moisture levels were detected on one or more interior surfaces and confirmed with electronic equipment. These levels indicate active moisture, which can cause mold to grow or appear. The key to controlling mold is controlling moisture. As long as moisture is present, microbial growth will usually continue unabated until the moisture source is remedied.

Moisture levels needed for mold growth vary with the type of mold and is dependent on the building material. The inspector uses industry guidelines in determining if moisture levels are excessive. Generally, any interior building materials with a moisture content greater than 15-20% are cause for further investigation.

The moisture source should be identified and corrected by qualified contractors. Any mold remediation that is needed should be performed by a Licensed Mold Remediation Contractor under the supervision of an Industrial Hygienist or licensed Mold Assessment Consultant.

Contact a qualified professional.

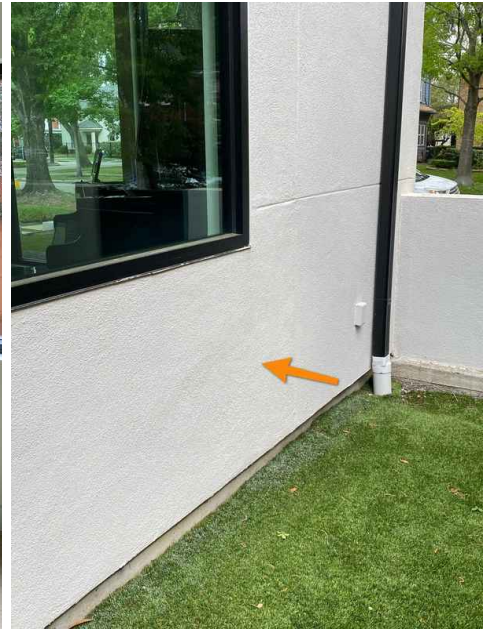
Opposite side of the wall/ possible previous repair

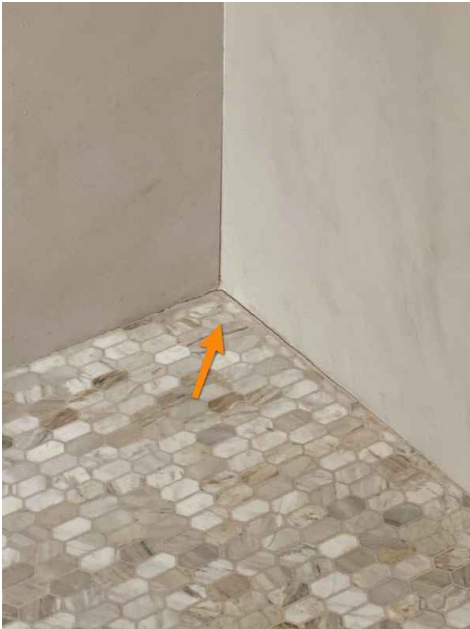
Primary Bathroom Shower

**PLUMBING PROBLEM**

Tub/Shower Enclosure Issues, Possible toilet leaks

Plumbing issues can cause excessive moisture in the home, which can promote mold growth. Further evaluation and correction by a qualified plumbing professional is recommended.

Contact a qualified plumbing contractor.
