# Inspection Report

**Property Address:**  
146 Snug Harbor Dr  
Montgomery TX 77356

**HG Home Inspection/Hilsher Group LLC**

# PROPERTY INSPECTION REPORT FORM

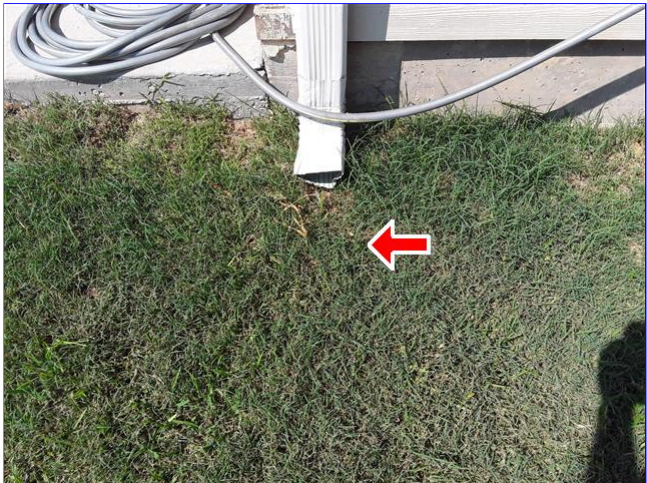
B. Item 1 (Picture) multiple locations

(1) The gutter downspout(s) missing deflector(s) at the exterior. Erosion can continue or become worse if not corrected. A qualified contractor should inspect and replace as needed.

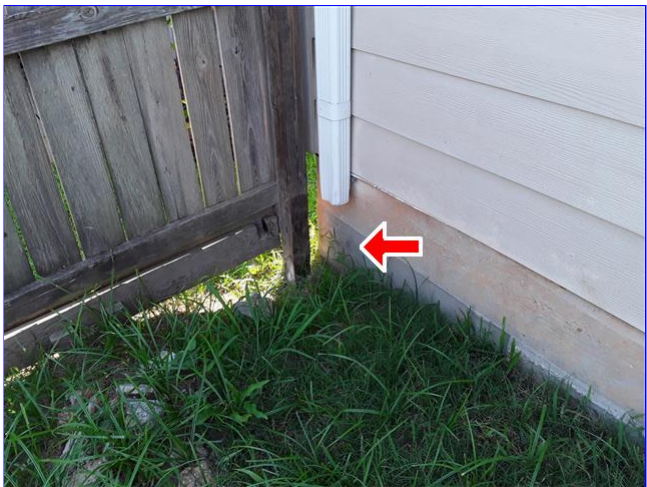
B. Item 2 (Picture) rear right corner of the foundation

(2) The downspouts need elbows and splash-blocks at the exterior areas.

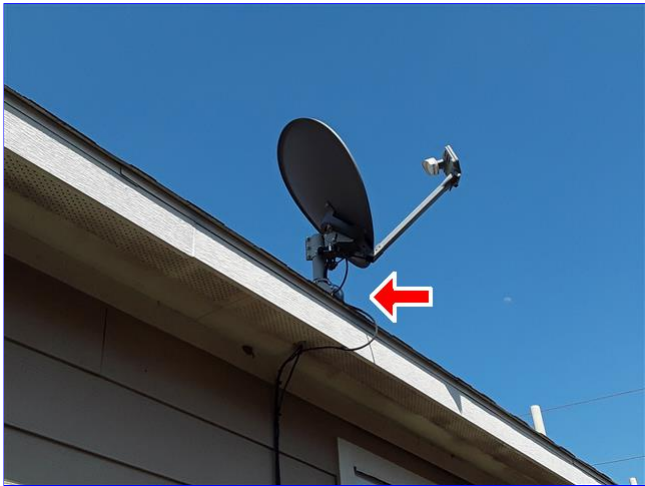
C. Item 1 (Picture) right side of the roof

- (1) This inspection does not warrant against roof leaks.
- (2) There is a satellite dish bracket mounted on roof that is screwed directly through roofing surface. This is not considered to be today's standard. I recommend having a qualified person remove and patch roofing as needed. (The area will need periodic maintenance)

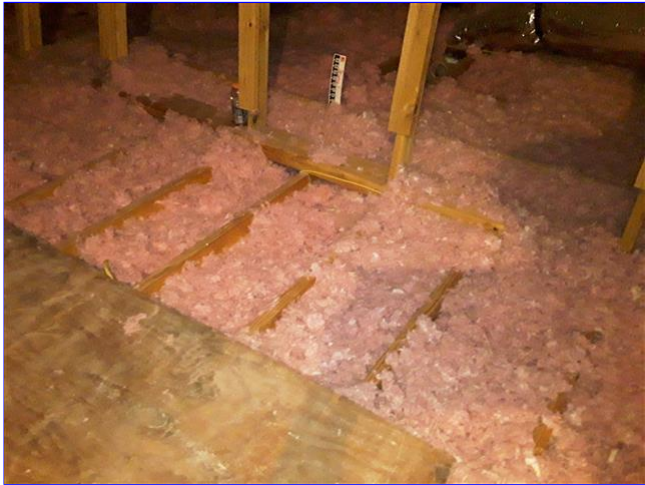
D. Item 1 (Picture) additional insulation needed in multiple locations

- (1) Attic inspection is limited to visibility from service decking that is safely accessible at the time of inspection.
- (2) The attic space has areas of thin insulation. This is causing energy loss and is not today's standard. I recommend having a qualified person evaluate and add insulation as needed.

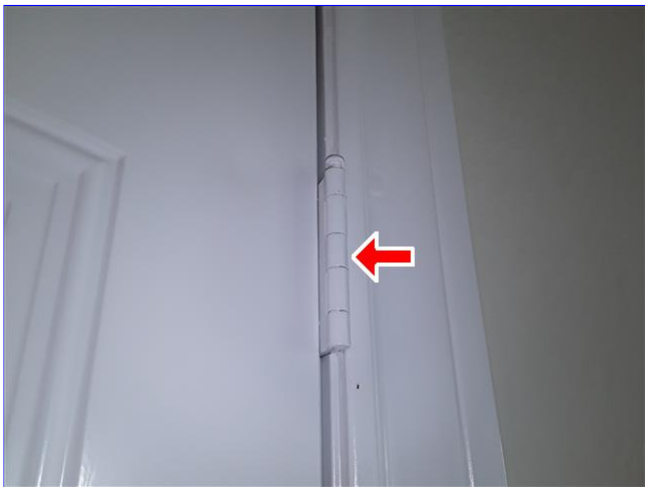
G. Item 1 (Picture)

(1) The interior garage door does not have the required self closing hinge. This is not considered to be today's standard. I recommend having a qualified person make repairs as needed.

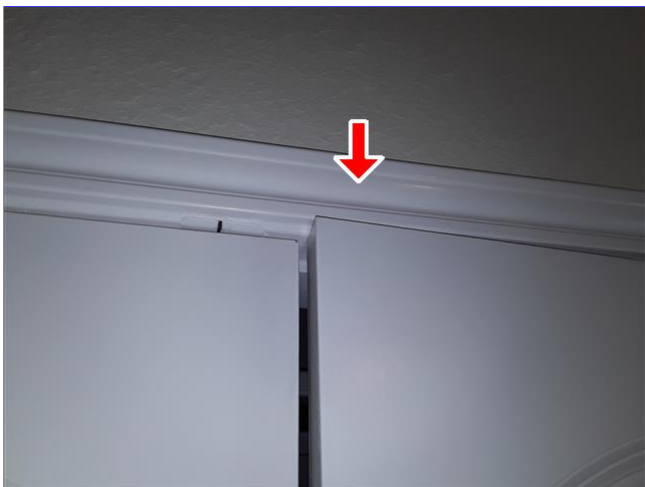
G. Item 2 (Picture) front bedroom closet door

(2) The interior door does not shut and latch properly. This is a maintenance issue and is for your information. A qualified contractor should inspect and repair as needed.

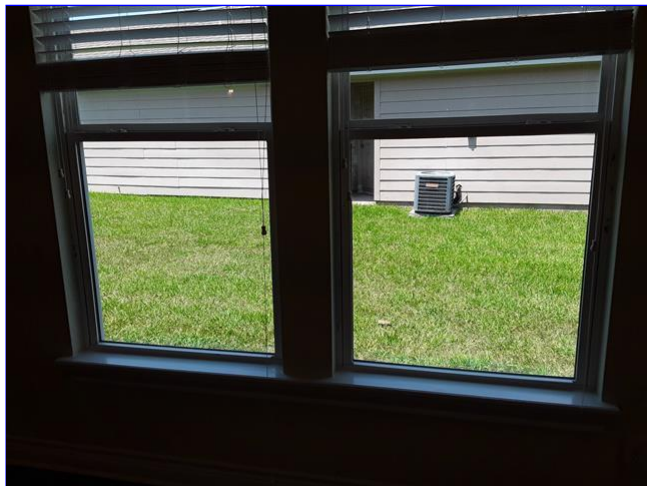
H. Item 1 (Picture)

(1) Windows have damaged or missing screens. This is not considered to be today's standards. I recommend having a qualified person make repairs as needed.

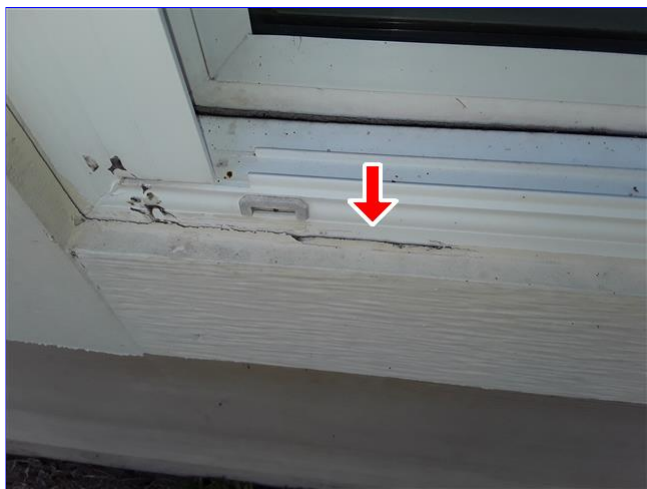
H. Item 2 (Picture) seal all windows where needed

(2) There are window frames that are not properly sealed. This can cause energy loss. I recommend having a qualified person seal and repair as needed.

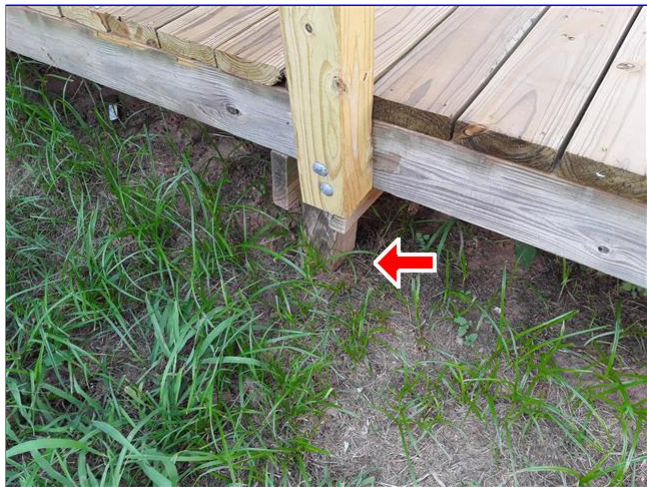
K. Item 1 (Picture)

- (1) The weight load capabilities are not part of this inspection.
- (2) The patio is built with wood to ground to structure contact. This creates conducive conditions for certain types of wood destroying insects. I recommend having a qualified pest control company inspect and treat as needed.

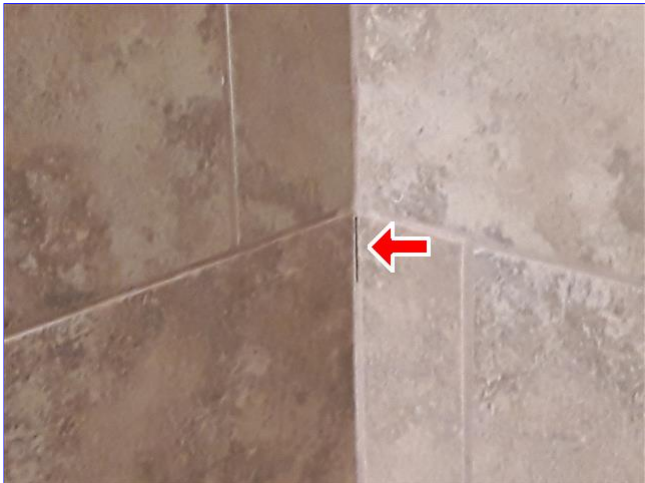
L. Item 1 (Picture) seal around the shared bathroom tub

Areas of the home have caulking or grout missing or damaged. Deterioration could occur if not corrected. I recommend having a qualified contractor inspect and make repairs as needed.

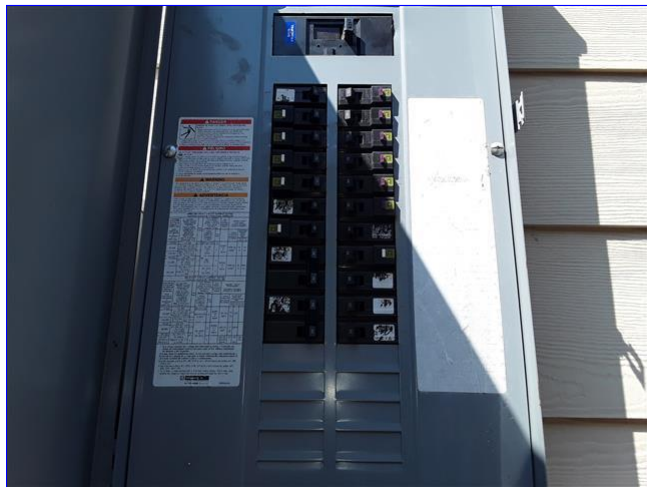
A. Item 1 (Picture)

(1) The panel is missing circuit identification. **This is a safety hazard.** I recommend having a qualified person mark circuits as needed.

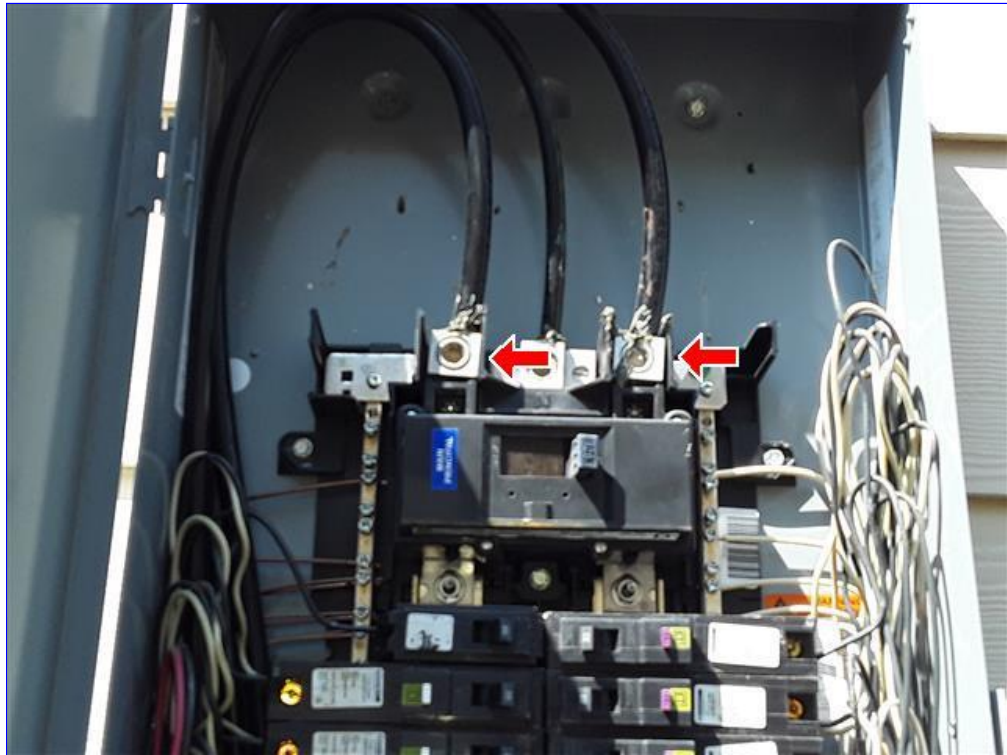
A. Item 2 (Picture) lug covers needed

(2) Lug covers were not installed at the service entrance wires. This is not considered today's standard.

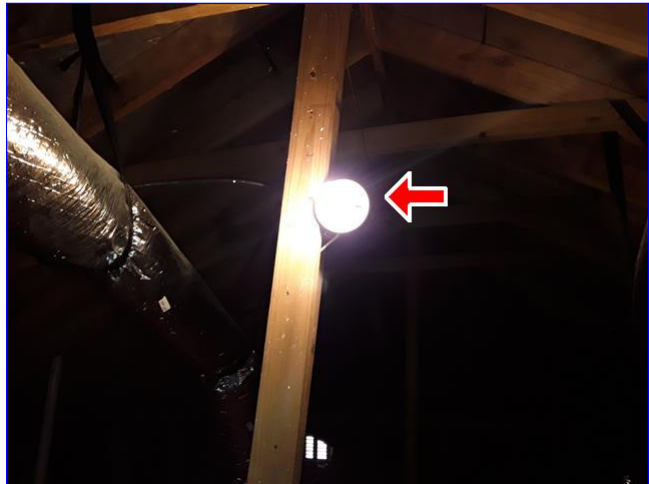
B. Item 1 (Picture)

move in. It is recommend to have smoke detection in each bedroom, hallways and living area. Carbon monoxide detection is recommended in all homes, especially if equiped with gas fired appliances. Some detectors may not be available for inspection due to limiting circumstances (ex. wired with alarm company).  
(2) Light fixture(s) is missing cover in the attic space. I recommend repair or replace as needed.

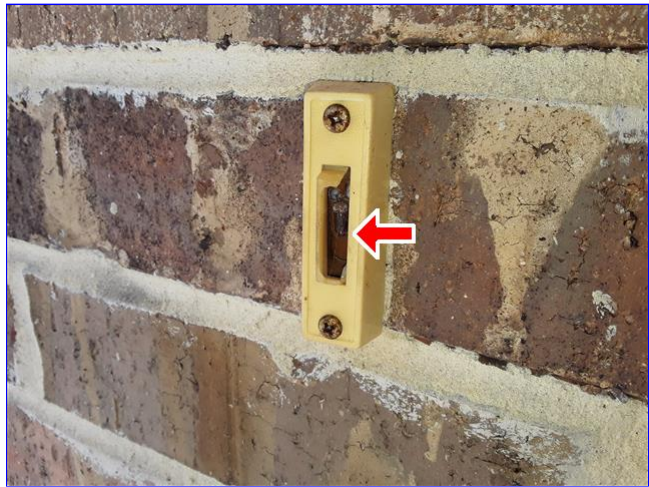
B. Item 2 (Picture) doorbell button is damaged

(3) Doorbell did not work properly at the time of inspection. I recommend having a qualified person repair.

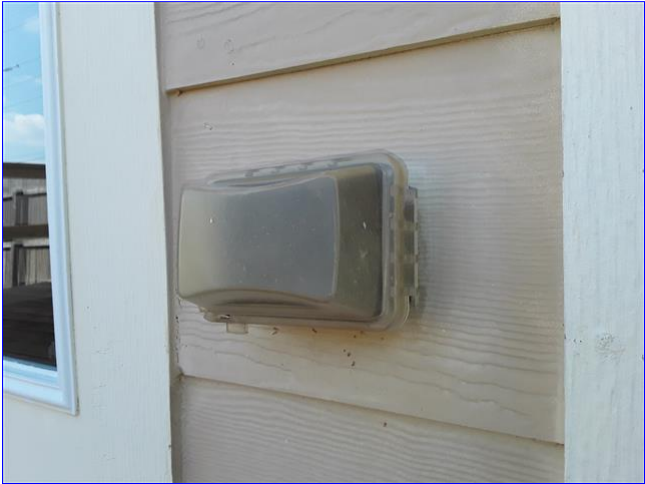
B. Item 3 (Picture)

(4) The electrical outlets located on the exterior of the home are not hot. No power. Recommend having a licensed electrician inspect and make all necessary repairs.

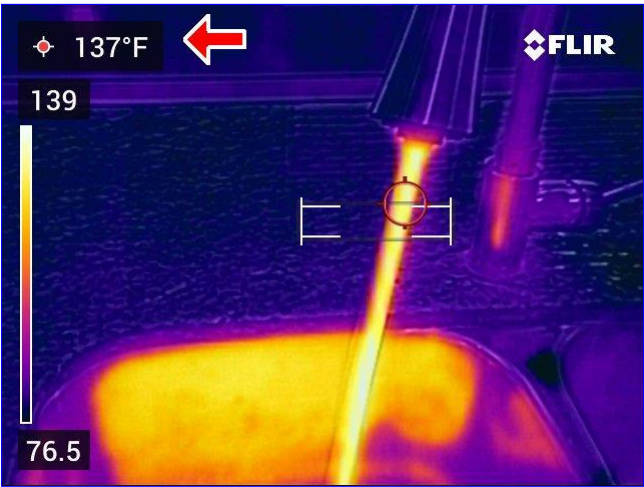
A. Item 1 (Picture) hot water temperature

- (1) All supply lines were not visible at time of inspection process due to cabinetry or construction materials. This is for your information.
- (2) Water temperature exceeds the recommend standard (120F). I recommend having a qualified plumber inspect and repair as needed.

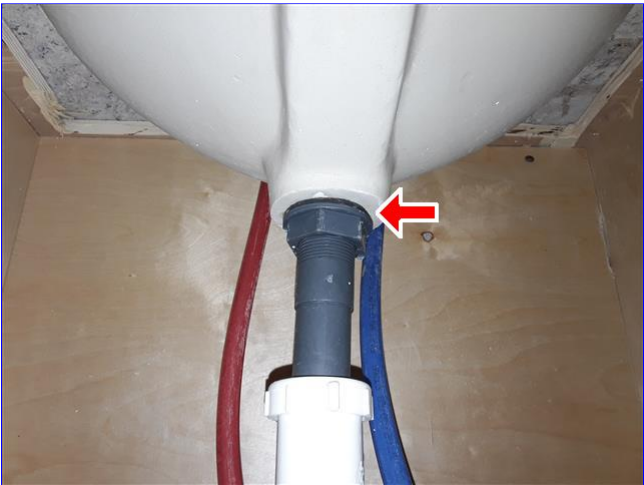
B. Item 1 (Picture)

- (1) All drainage piping was not visible at time of inspection process due to cabinetry or construction materials. This is for your information.
- (2) The front master bathroom lavatory drain is leaking at the bottom of the basin. Recommend having a licensed plumber inspect and make all necessary repairs.

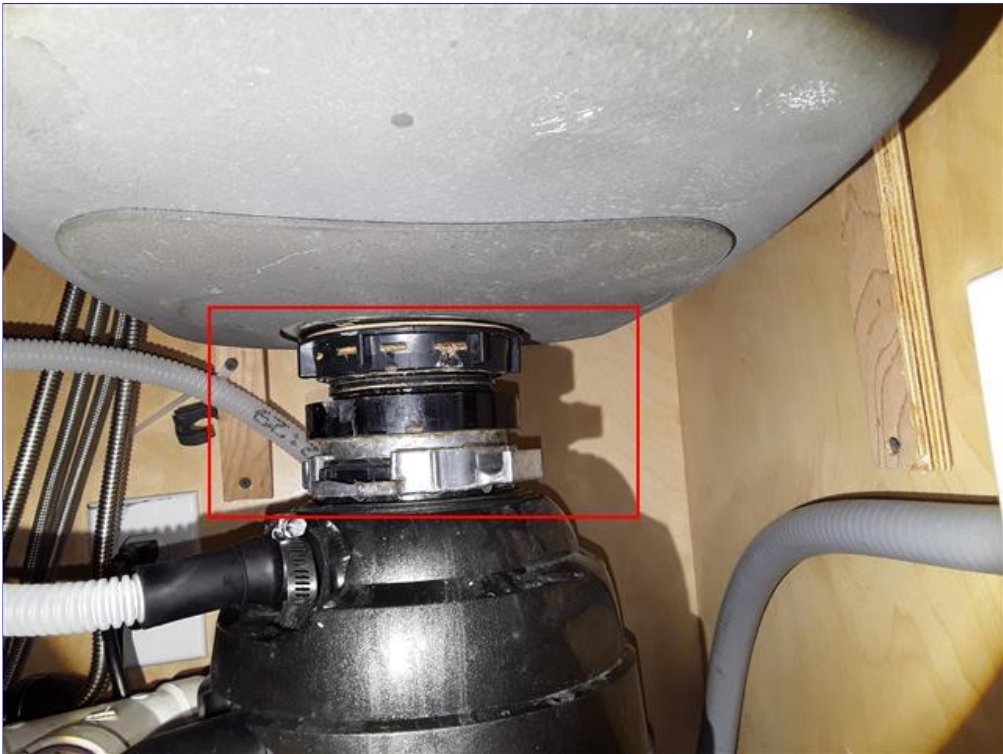
B. Item 1 (Picture)

The disposal is leaking water at the basket strainer. Recommend having a licensed plumber inspect and make all necessary repairs.

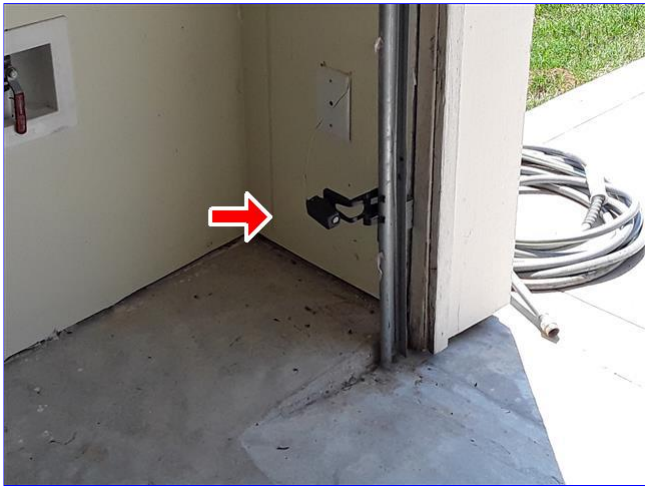
G. Item 1 (Picture)

- (1) The sensors are in place for garage door(s) and will reverse the door.
- (2) The garage door at the front of home has electronic sensors located higher than six inches off floor which may not be installed according to manufacturers specification. This is a small repair. A qualified contractor should inspect and repair as needed.
