## RESIDENTIAL INSPECTION REPORT

6330 Southwood South Ct  
Houston, TX 77035

# PROPERTY INSPECTION REPORT FORM

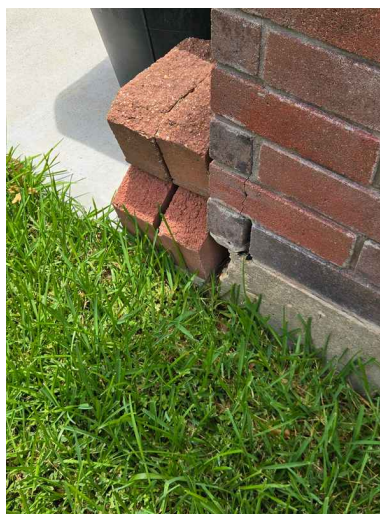
### 1: "Corner Pops" Observed

There was a crack observed at the corner of the foundation in the indicated location. These types of cracks are typically caused by expansion and contraction with the heat and cold of outdoor temperatures and are considered cosmetic. Typically, this is not a threat to the structural integrity and does not constitute a deficient foundation. However, it is recommended that they be repaired to prevent pests and water penetration. If left as is, the cosmetic crack has the potential to possibly grow into a damaging one.

Recommendation: Contact a foundation contractor.

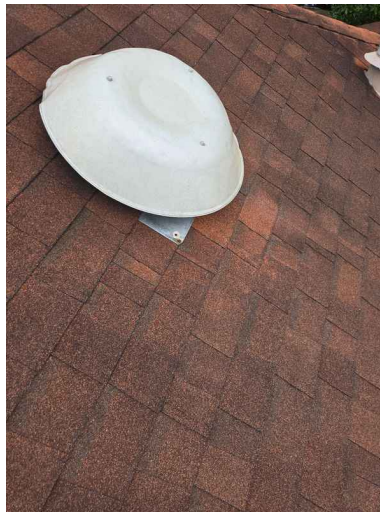
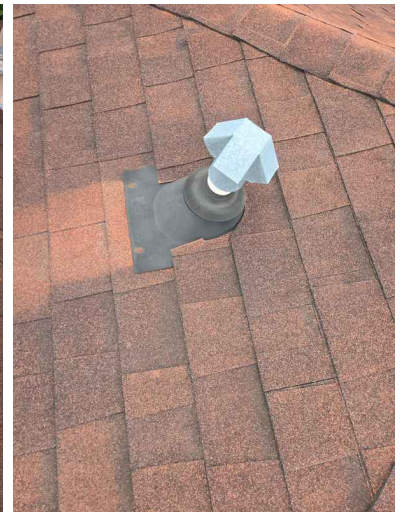
#### 4: Flashing Fasteners Exposed

The fasteners used to secure the flashing were exposed at the surface of the roof. Most, if not all, shingle manufacturers specifically state that nails/fasteners must not be exposed on the finished roof. When a nail is not properly sealed, it is exposed to precipitation which can cause the nail to rust and erode and with the natural expansion and contraction effect, the nail hole becomes larger. Each nail on a roof is a point of penetration that leads through the roof decking and into the attic or living space. Water can then use the same hole to make its way into the building and cause damage. Correction is recommended.

Recommendation: Contact a qualified roofing professional.

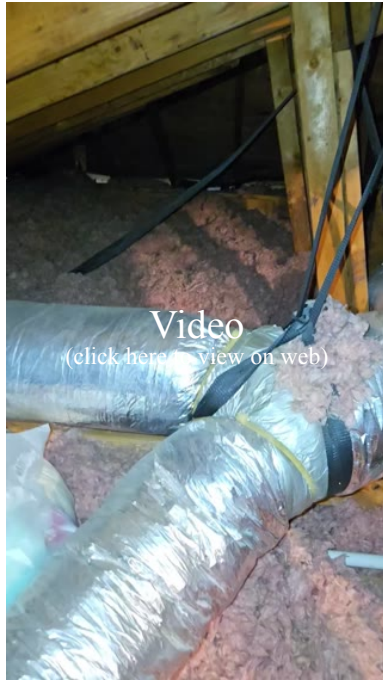
*Roof Framing Type and Information:* Stick-Framed, 2x6, Wood, Nominal Measurements -

Typically, roofs are framed using one of two methods: standard "stick" framing or the newer "truss" framing. Stick-framed roofs utilize individual rafters that span from the top of exterior walls to the ridge. Truss-framed roofs are built from triangular-shaped, pre-made truss units. The inspector does not verify or complete any roof truss or stick framing test procedures. This is the responsibility of the builder and the structural engineer of record/architect.

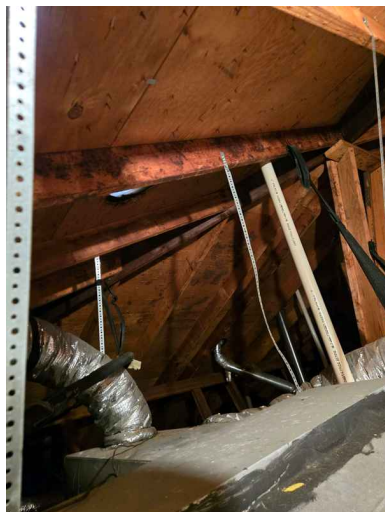
*Ventilation Type and Information:* Box vent, Soffit Vents -

Attic ventilation is designed to provide year-round benefits to help reduce potential heat buildup in the summer, moisture buildup in the winter, and ice dams in climates with snow and ice. Proper ventilation is essential as it helps prolong the life of the building materials including the shingles. It also helps to improve the comfort level inside the home and helps to lower the utility bills by reducing the load on the air conditioner and other appliances such as fans and refrigerators. Different types of roof vents are more effective than others, but each type of vent has the basic task of either removing stale air from your attic space (exhaust) or bringing fresh air into your home (intake).

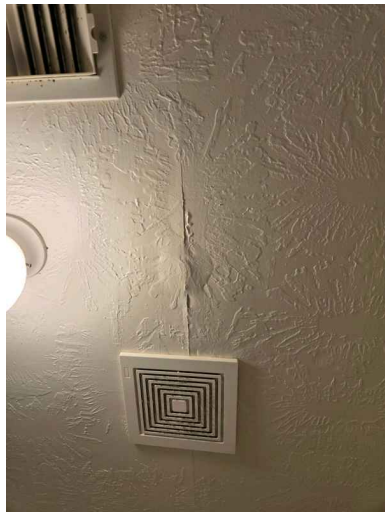
## 2: Ceilings: Sagging, Elevated Moisture Levels

Although this condition indicated that the source of moisture may have been corrected, further examination by a qualified professional (roofing professional/licensed plumbing contractor) would be required to provide confirmation.

Recommendation: Contact the seller for more info

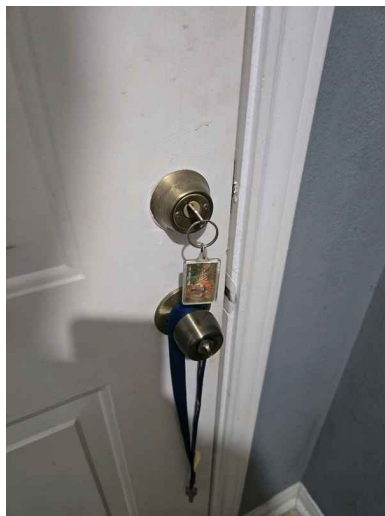
**2: Exterior Doors: Double cylinder deadbolt****▲Safety Hazard**

front Door

Recommendation: Contact a qualified door repair/installation contractor.

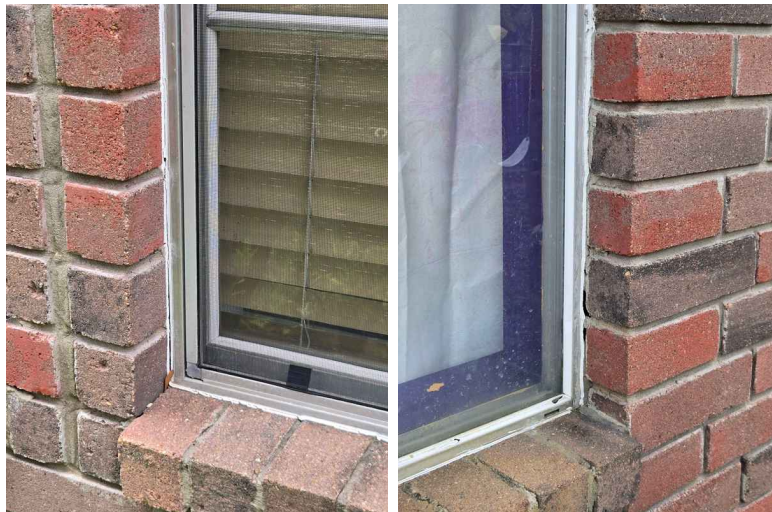
There were signs of deterioration in the caulk at the perimeter of the windows, resulting in gaps. This could allow water and insect between the materials. Window caulking is performed to reinforce the sealant covering the gaps between the window and its frames. The deteriorated caulk is recommended to be removed and replaced with new caulk.

Recommendation: Contact a qualified window repair/installation contractor.

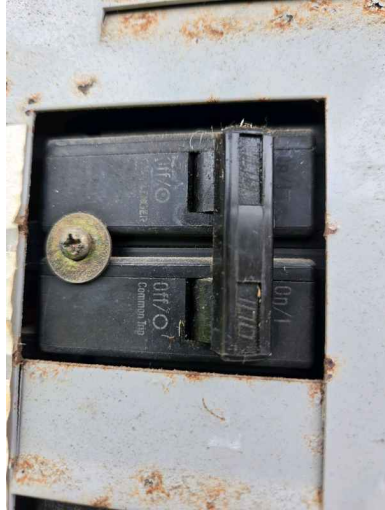
*Service Conductor Type and Information:* Below Ground -

The service conductors run from the service point to the service disconnecting means (the service equipment, not the meter). Service-entrance conductors can enter an installation from overhead (service drop) or underground (service lateral)

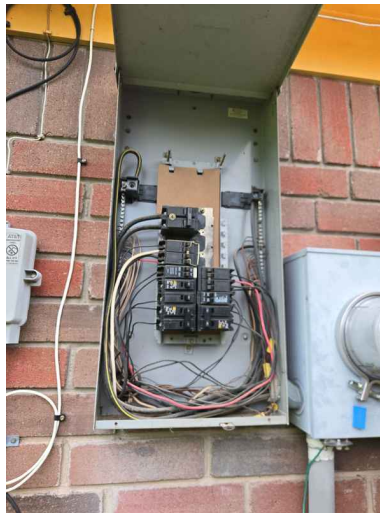
The service panel with the cover removed.

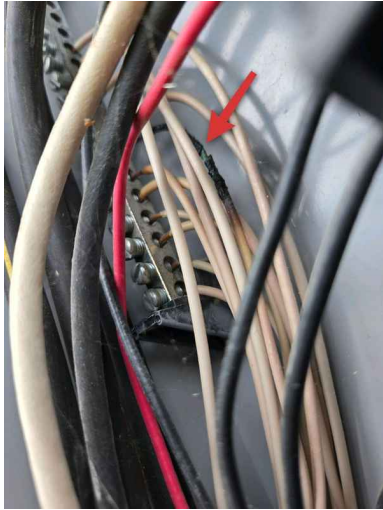
**2: Damaged Wire in Service Panel****🔴Safety Hazard**

Service Panel

Recommendation: Contact a qualified electrical contractor.

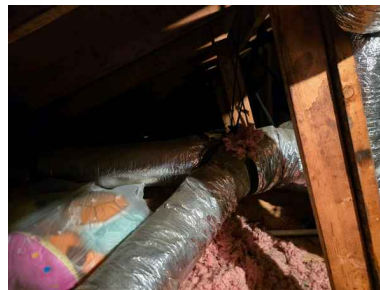
Basic Duct Configuration

A ductwork system is designed to transport and distribute airflow from your HVAC equipment to the entire home. A duct system contains both supply and return ducts. The system encompasses the air that is sucked from inside the home into the air conditioner/heater where it gets cooled or heated and then pushed back into the home via the ducts. Below is an infographic of a basic ductwork system.

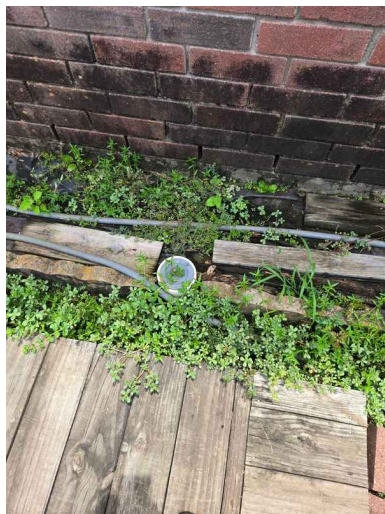
*Drain Clean Out Location(s) and Information:* Back Of The Home -

A drain cleanout provides easy access to your main sewer line. Should you have a backed-up drain, a licensed plumbing contractor can run a camera through the cleanout and into your main sewer drain to locate the problem.

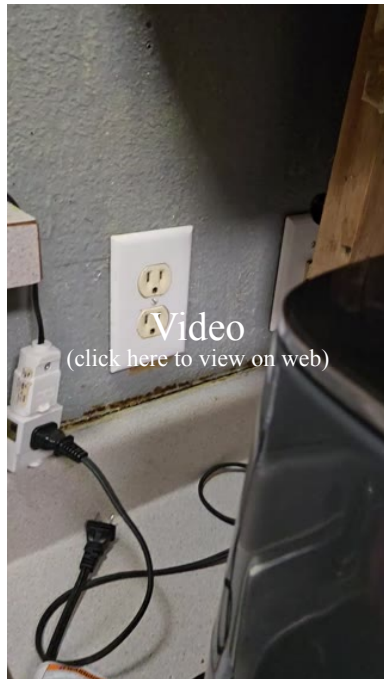
**2: Food Waste Disposer: Splash Guard Not Installed****Recommendation**

Kitchen

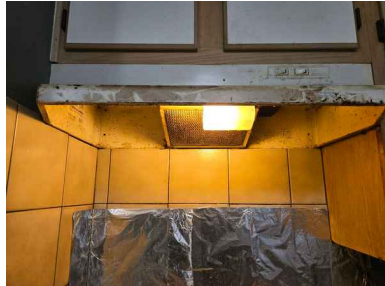
**Range Hood or Exhaust System Type and Information:** Range Hood -

The primary purpose of kitchen ventilation is to reduce cooking smells, heat, and condensation. Another important purpose of a range hood is to trap grease to prevent it from being deposited all over your kitchen. There are a few types of kitchen ventilation systems.

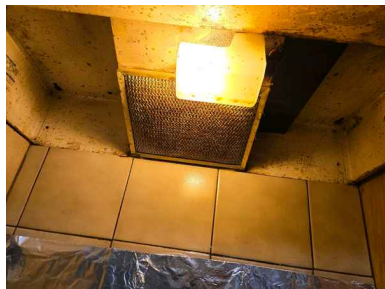
**1: Exhaust: Buildup Observed****▲Safety Hazard**

Kitchen

There was buildup observed on the exhaust vent. When left dirty, the grease vapor from cooking collects in the ductwork and exhaust hood. When high temperatures are present, the buildup is at risk of igniting and can cause a fire to spread through the ventilation system. Remedy as necessary.

Recommendation: Contact a qualified professional.

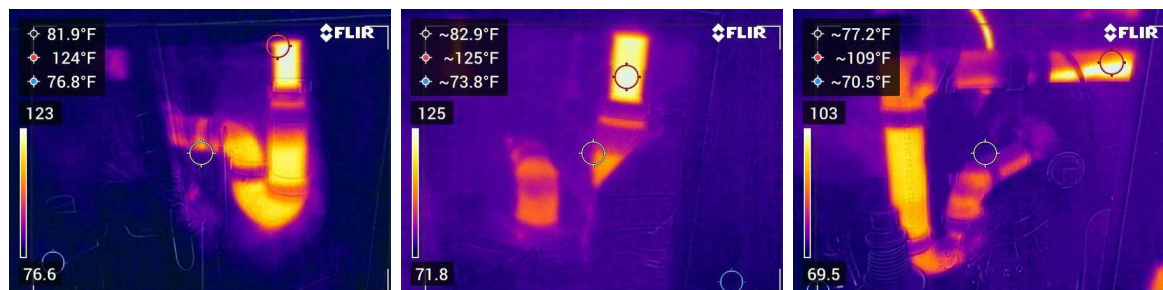
The inspector used a thermal imaging or infrared thermography device to help detect temperature differences within the plumbing supply, distribution, fixtures, drains, and pipes. The infrared camera can provide a thermal detail that detects small temperature changes. When inspecting pipes, the inspector is typically looking for hot spots, cold spots, or subtle temperature changes that could indicate a leak, blockage, or weakness in the pipe.

A blocked pipe can cause a delta in temperature around that area that can transfer to the external pipe casing. A blocked pipe can cause a delta in temperature around that area that can transfer to the external pipe casing. The area beyond the blockage will show a difference in temperature due to little or no flow. If the inside wall of the pipe is abraded, corroded, and thinning the temperature of the casing will be different than the uncompromised pipe. Sudden changes in temperature and pressure can cause excess wear and cracks in the pipe, elbows, and flanges, which may not be visible to the unaided eye. Using the infrared camera the inspector can also look for temperature variations along the run of pipe. Such temperature variations can help indicate a leak.

It is important to note that infrared cameras alone are not enough to accurately confirm a deficiency exists. The inspector will document differences in temperature that he/she believes may be caused by one of the following: an abraded, corroded, or thinning pipe; blocked pipe; or leaking pipe. If such temperature difference is documented, further evaluation by a licensed plumbing contractor will be recommended. The infrared camera inspection is limited to what is visible as the inspector cannot see concealed pipes.
