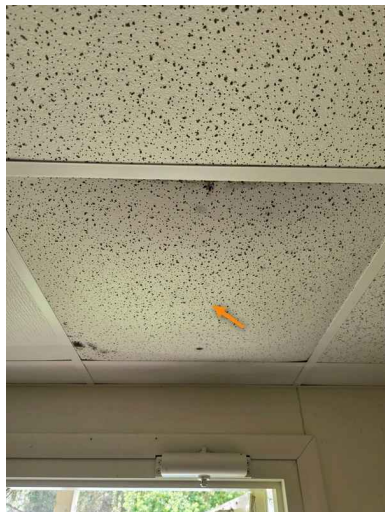
Bowed

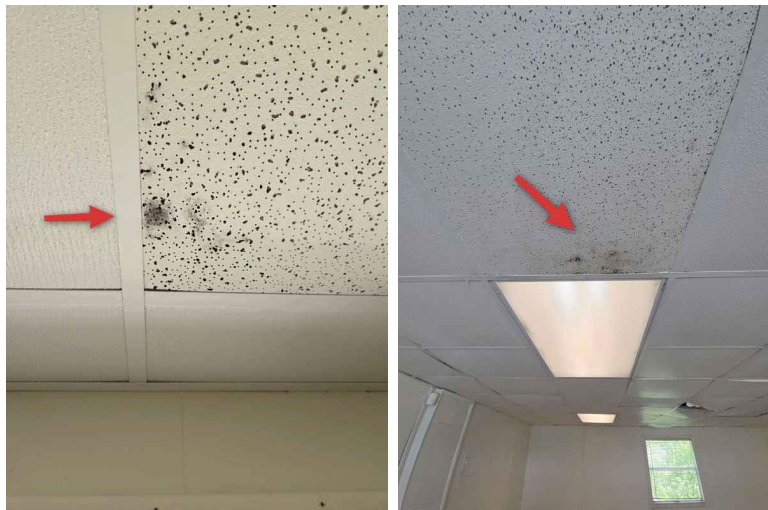
### 7: Organic black material

Organic black material consistent with mildew / mold was observed. Mildew/mold can be toxic and should be properly treated and/or removed.

Recommendation: Contact a qualified professional.

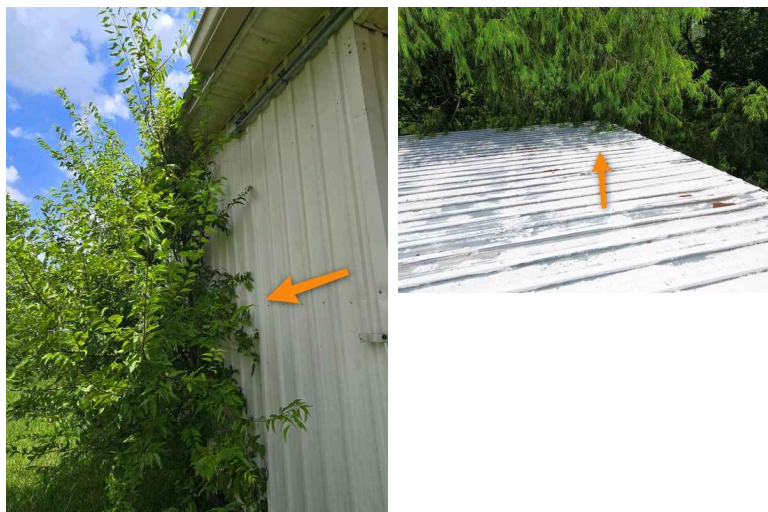
#### 8: Trees in contact with siding/roof

Tree limbs are observed to be in contact with the structures siding and/or roof. Recommend trimming to prevent damage.

Recommendation: Contact a qualified professional.
