### **Inspection Report**

**Prepared for David Munson  
4915 Glendower Dr, Spring, TX 77373  
Inspected by: John Leonard JR.  
TREC# 24516  
936.521.9205  
John@SunriseHomeInspectionsllc.com**

# PROPERTY INSPECTION REPORT FORM

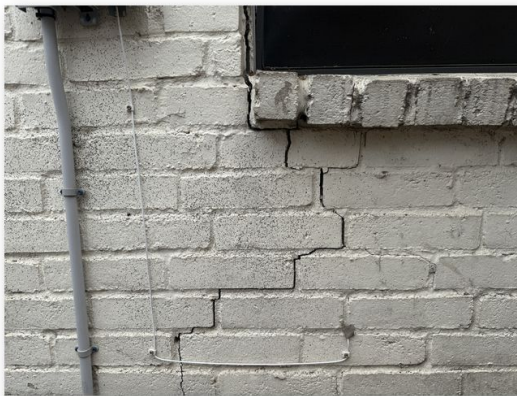
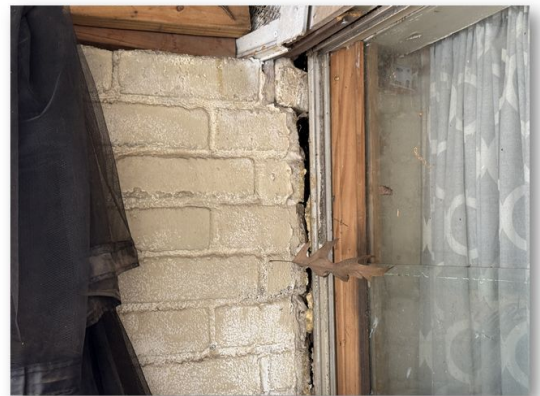
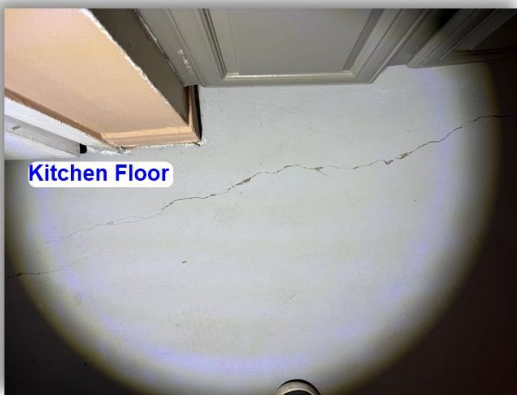
Cracks in brick and exposed concrete flooring.

Signs of structural movement noted; suggest that an expert in this field be consulted for further evaluation of the foundation and to provide suggestions as to what, if any, corrective actions

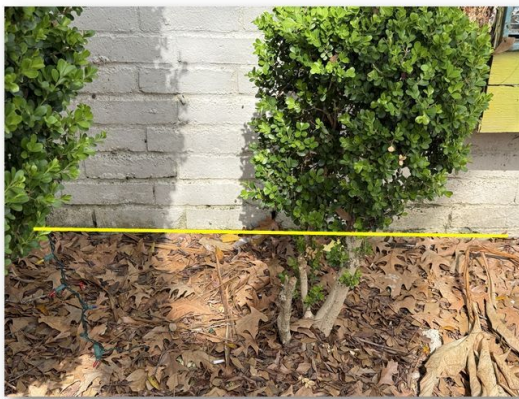
Bottom of brick shall have a 4 inch clearance between grade and bottom. This is conducive conditions for wood destroying organisms to enter structure, have evaluated for remedy.

Any area where the ground or grade does not slope away from the structure is to be considered an area of improper drainage. Six inches per 10 linear foot from foundation is the current standard. Drainage or grading corrections are recommended.

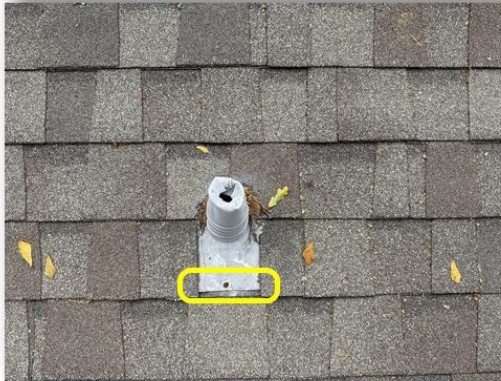
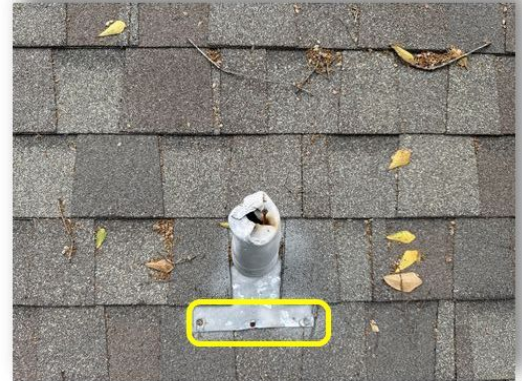
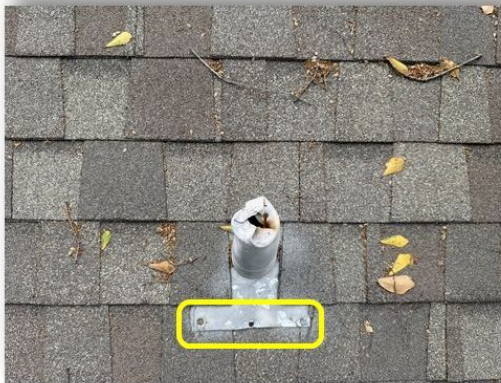
Exposed fasteners (Staples, bolts, and/or nail heads); Exposed fasteners should be properly sealed to help prevent fasteners from backing out and prevent moisture intrusion.

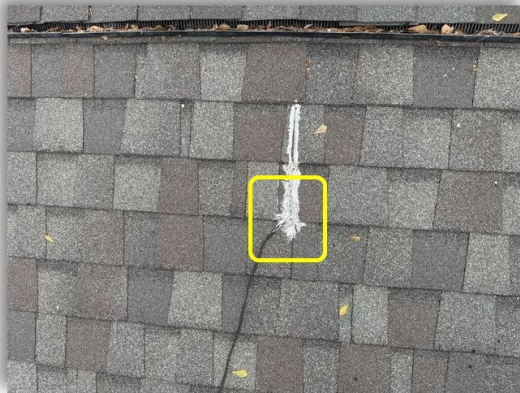
Communication wire protruding through decking and shingle material. have further evaluated by a qualified roofing company for repairs.

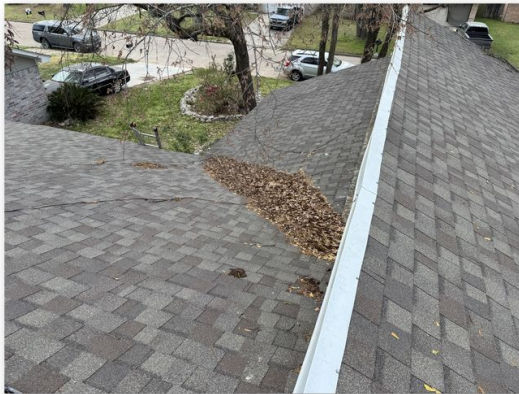
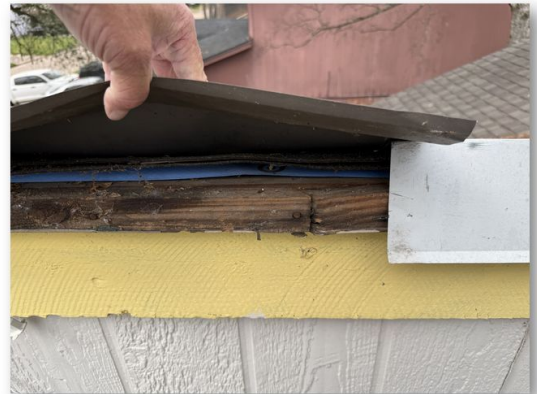
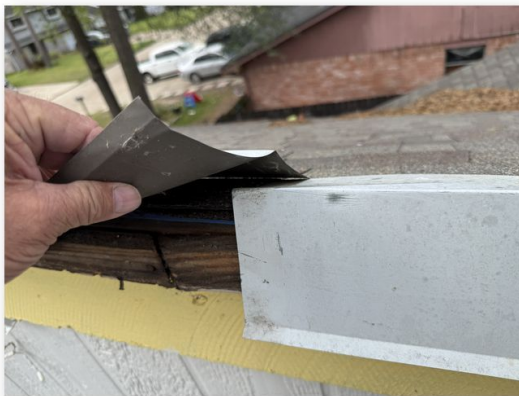
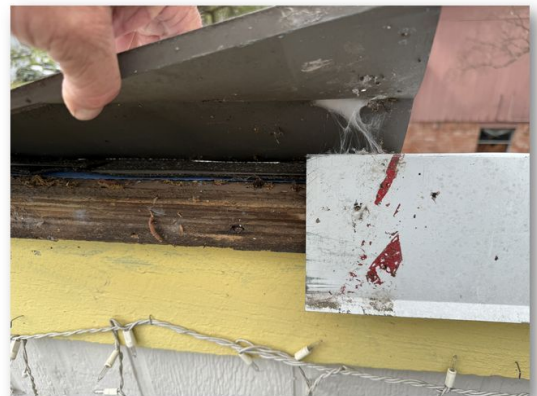
Flashing needs to be sealed and properly fastened at all overlaps to protect from water intrusion under shingles, have further evaluated by a qualified roofing company for repairs.

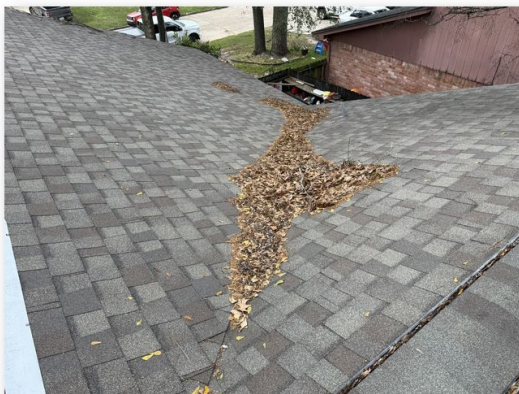
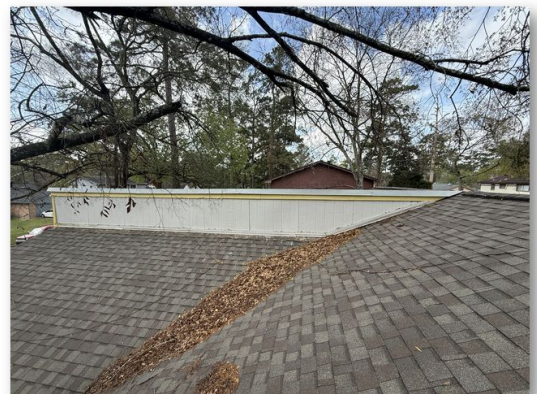
Leaves, sticks, branches and other debris were observed on the roof covering and may contribute to roof covering material damage and water penetration. The roof covering surfaces should be free of leaves, sticks, branches, and other debris.

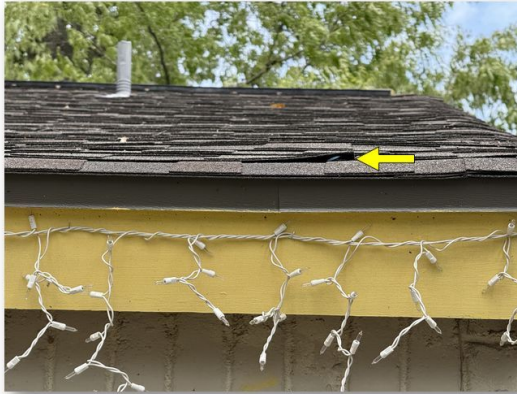
Nail head backing out front right corner.

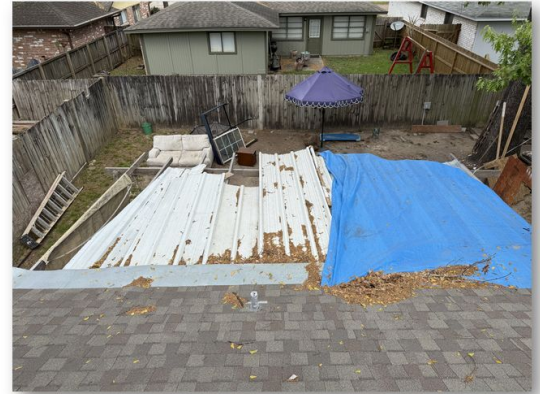
Metal roofing over back porch noted to be collapsing at time of inspection. Have all loose materials removed for reasons of safety and liability.

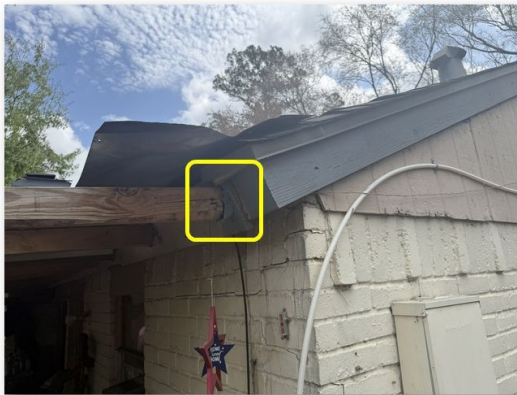
Porch rafters m(2X4 material) not properly seated in joist hangers.

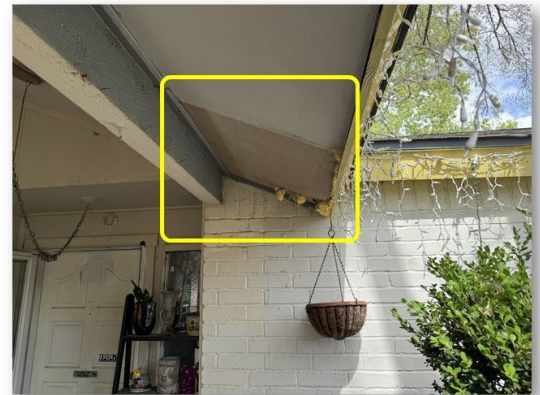
Soffit damage at front porch area, have further evaluated for repairs.

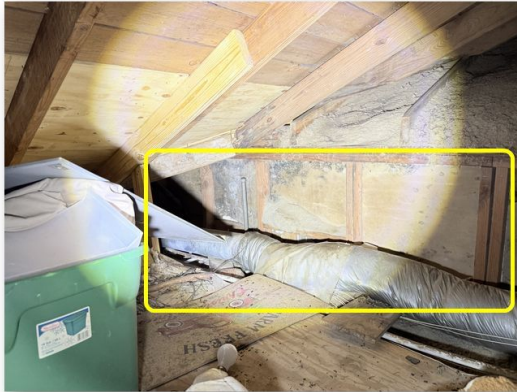
Missing vertical insulation and organic growth noted on Sheetrock, have further evaluated for repairs.

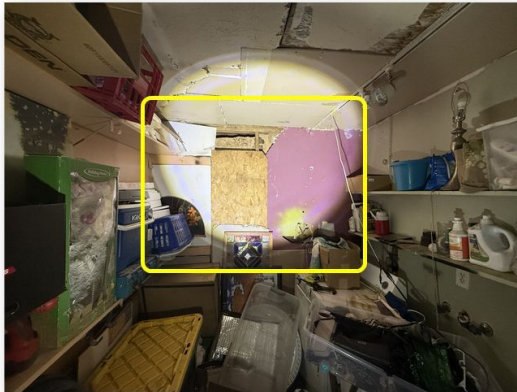
**Interior Walls:**

Cracks in Sheetrock noted throughout the structure and missing Sheetrock, tile, etc in many areas, have further evaluated for repairs.

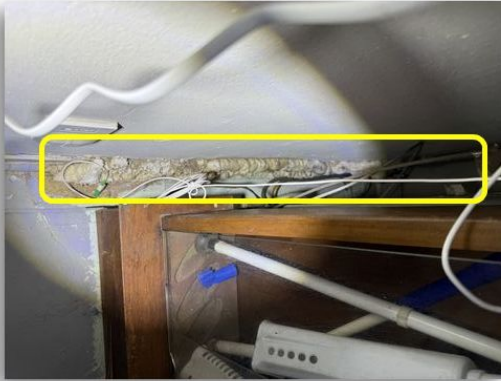
Unknown substance at baseboard.

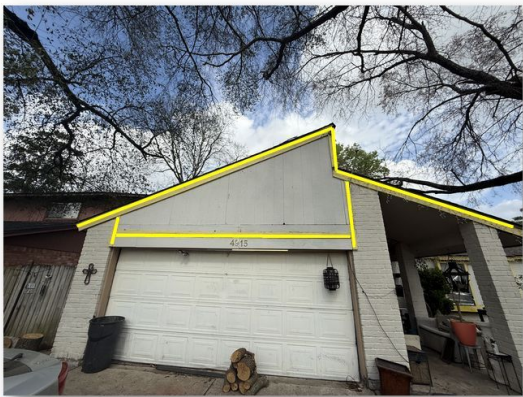
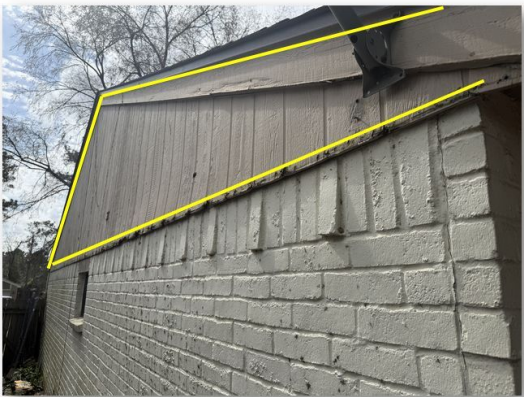
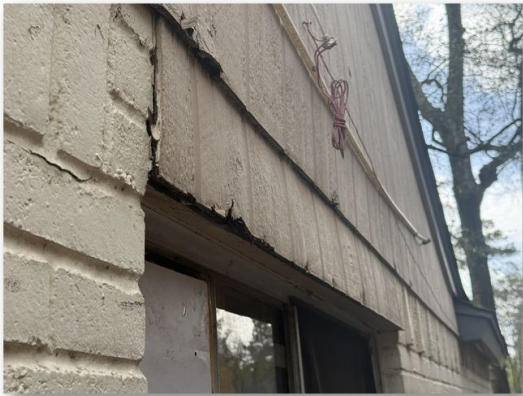
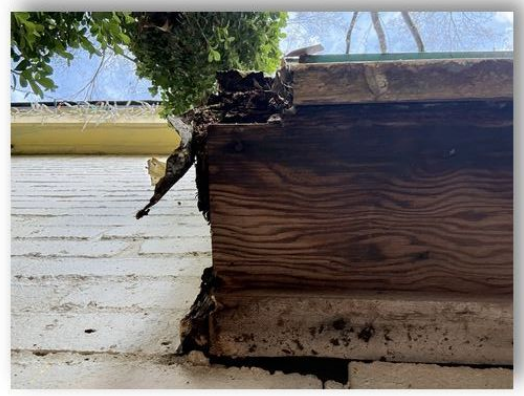
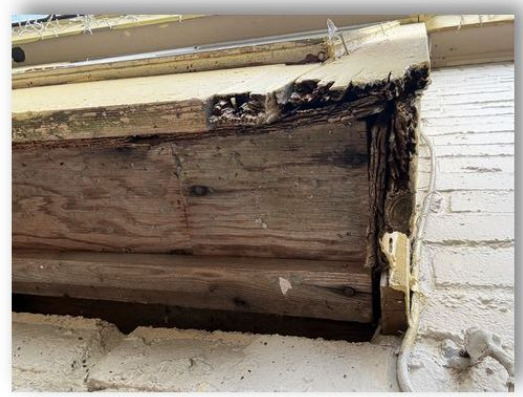
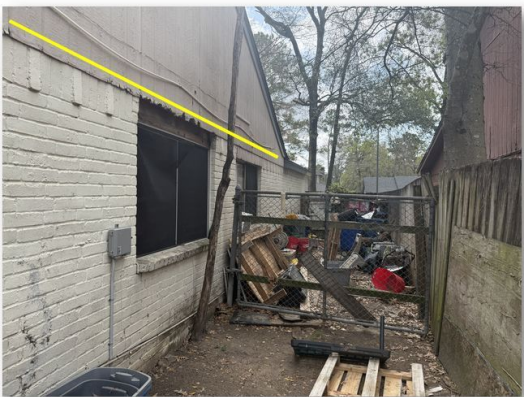
Most of the wood trim, siding, etc has some degree of rot, have all siding further evaluated by a qualified siding company for repairs.

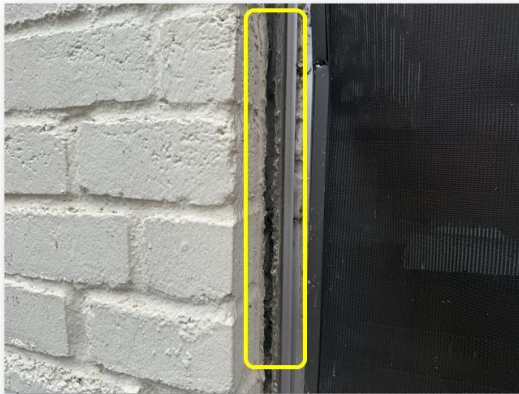
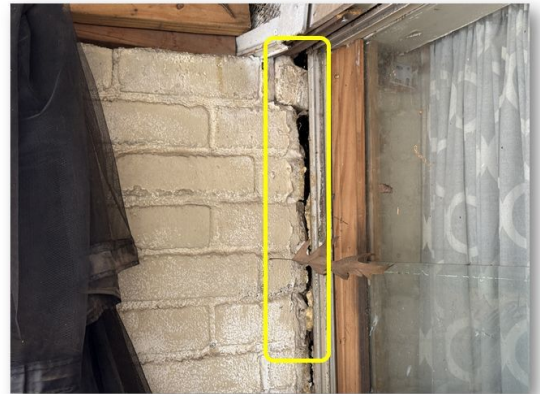
Brick pulling away from walls and windows around structure, have further evaluated by a qualified contractor for repairs.

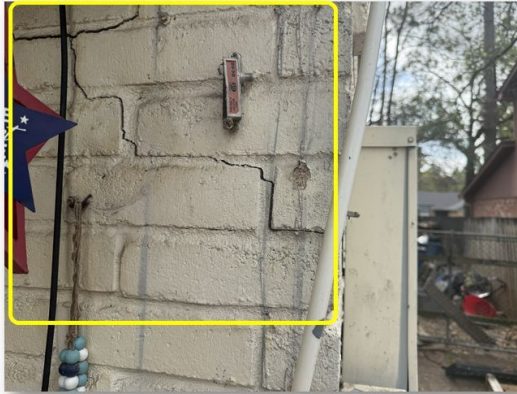
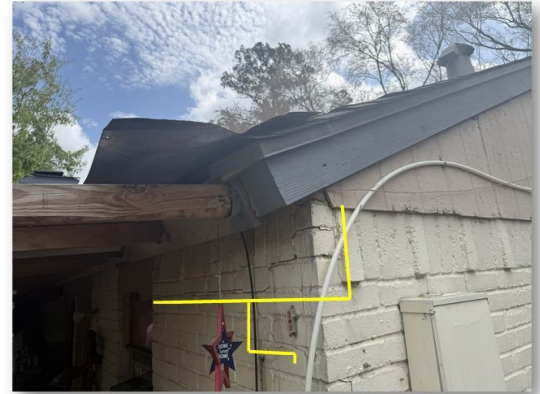
Mortar was observed to be separating in a few locations around the structure at time of inspection. I recommend having a qualified brick mason evaluate and repair as needed.

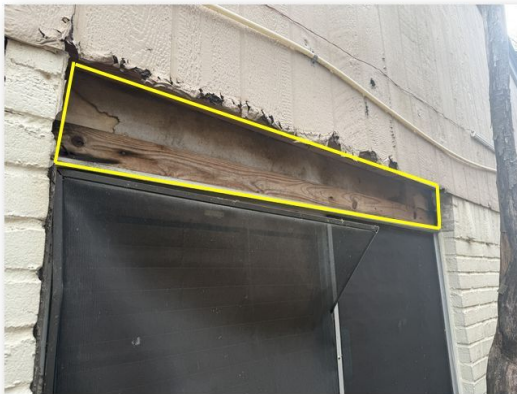
Header missing above window, have further evaluated by a qualified contractor for repairs.

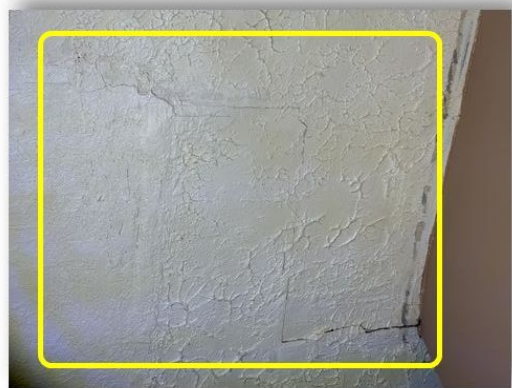
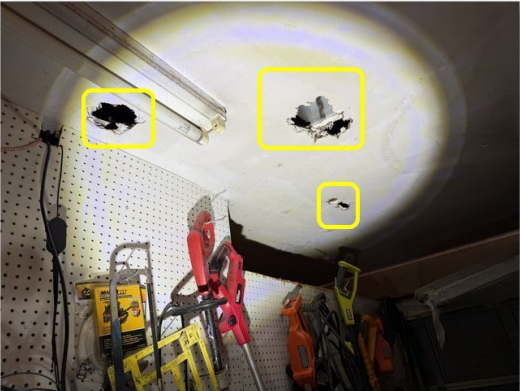
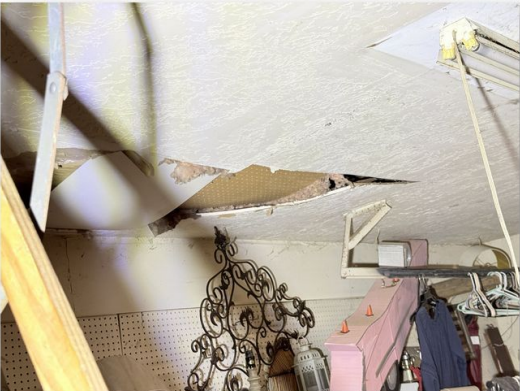
Ceiling damage noted throughout the structure at time of inspection, have further evaluated for repairs.

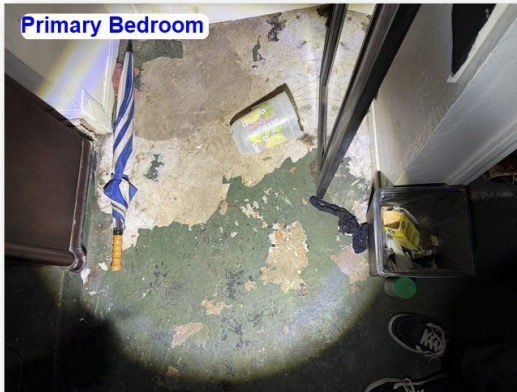
Flooring damage noted throughout the structure at time of inspection. Missing flooring, flooring buckling, cracked, broken, or missing tiles, have further evaluated for repairs.

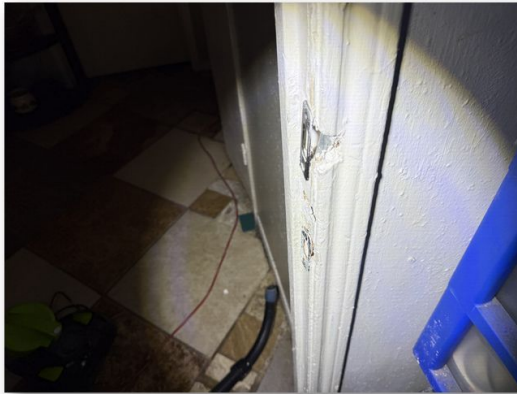
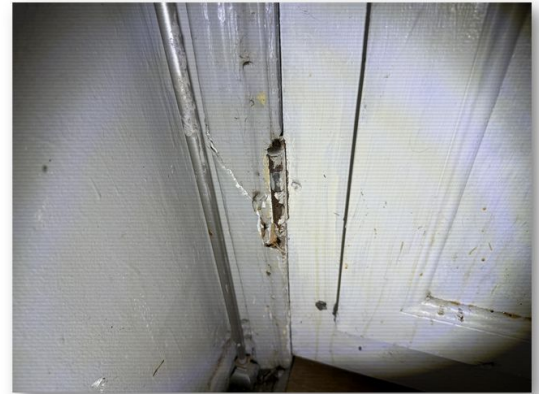
Door stops are missing, damaged or need repositioning in various locations. The installation of door stops on all interior doors helps prevent damage to walls.

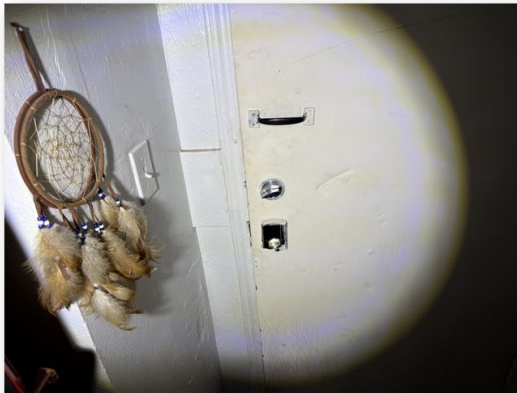
All interior doors and hardware have some degree of damage and need to be replaced.

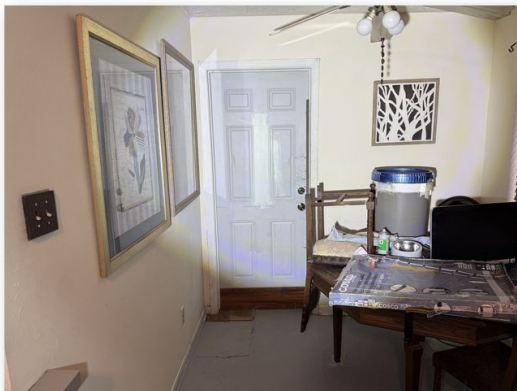
### Exterior Doors

The front and rear door have large weather gaps and are barely functional, have further evaluated by a qualified tradesman for repairs.

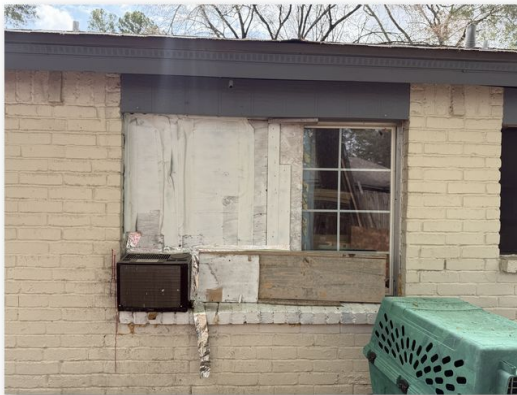
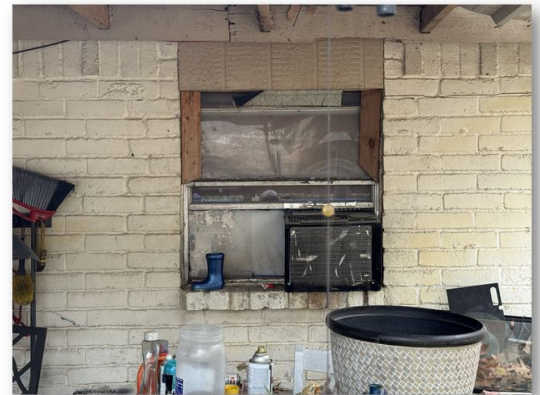
Examples of but not limited to window damage. All windows have some degrees of damage or completely missing glass, have further evaluated by a qualified window company for repairs.

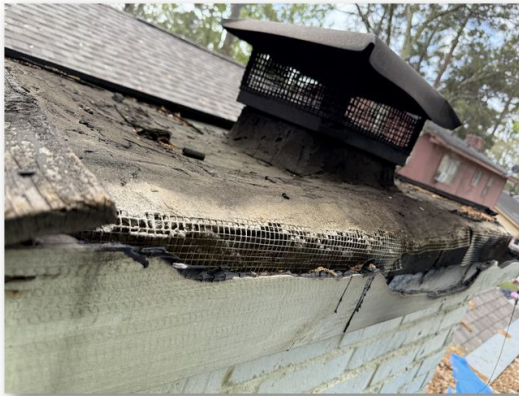
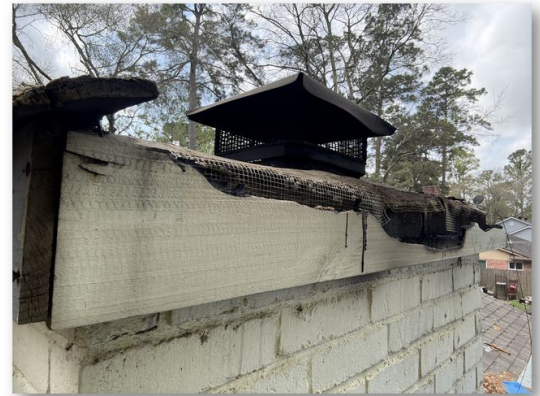
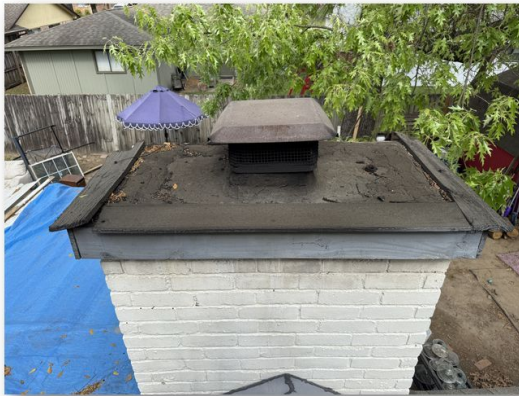
Improper chimney cap using tar like substance that is considered flammable, have further evaluated by a qualified contractor for repairs.

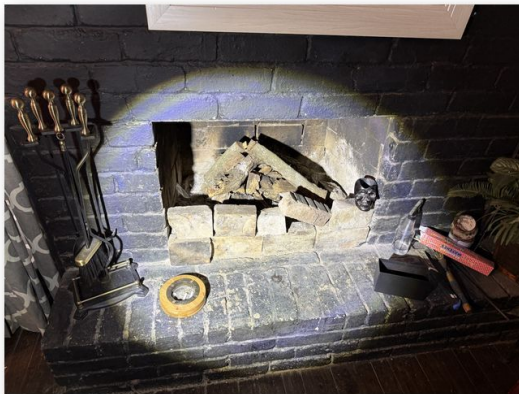
The fireplace and chimney flue needs to be cleaned by a qualified chimney sweep. A creosote or soot build-up was observed in the visible areas and was a SAFETY HAZARD at the time of the inspection. A creosote or soot build-up may be flammable and should be corrected prior to fireplace use.

Note: If usage of the fireplace is routine, I recommend having a qualified chimney sweep evaluate and clean every two years.

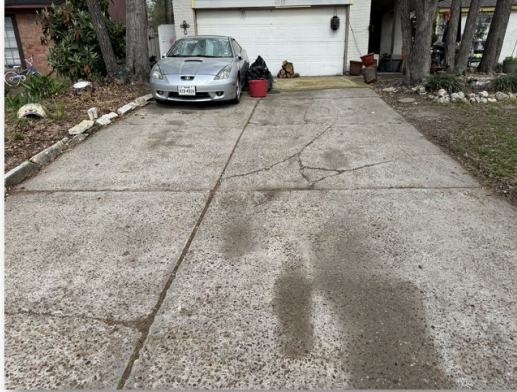
The driveway was noted to be cracked in several locations. the back porch could no t be inspected due to occupants belongings obstructing area.

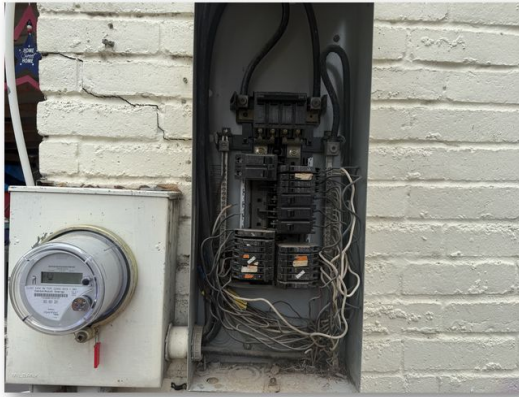
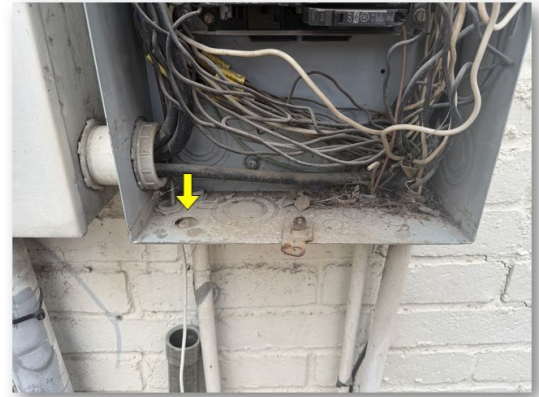
Missing cover plate.

The electric service panel breakers were not labeled properly. Each electric service panel breaker should be adequately labeled as to what appliance or circuit it serves. I recommend having this panel labeled for reasons of safety and liability.

Missing plug at bottom left corner, have added.

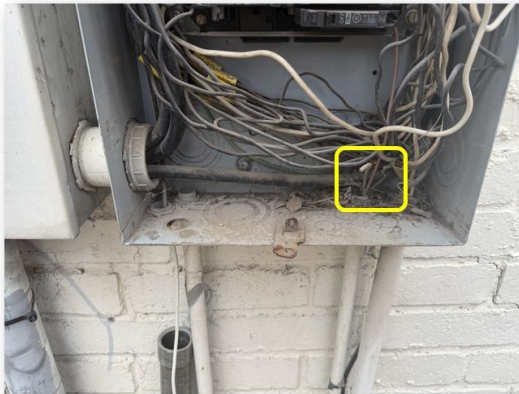
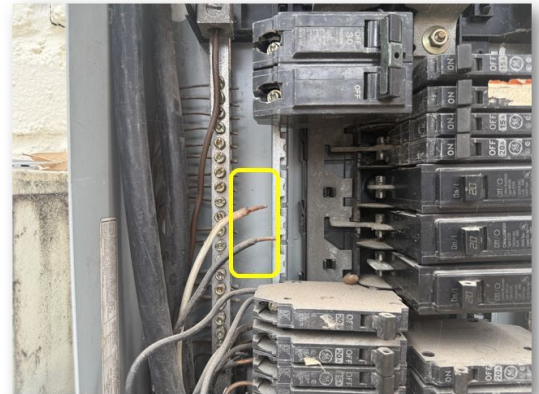
Loose and cut wires in electrical panel with missing breakers. I highly recommend having a licensed electrician evaluated electrical system for reasons of safety and liability.

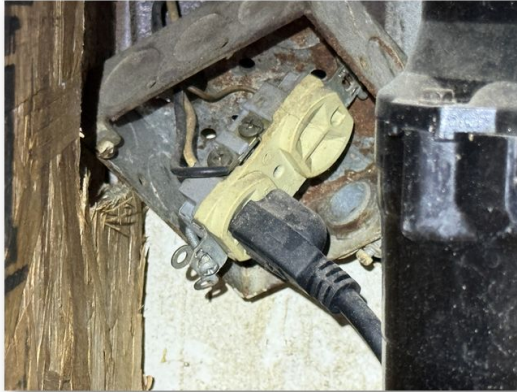
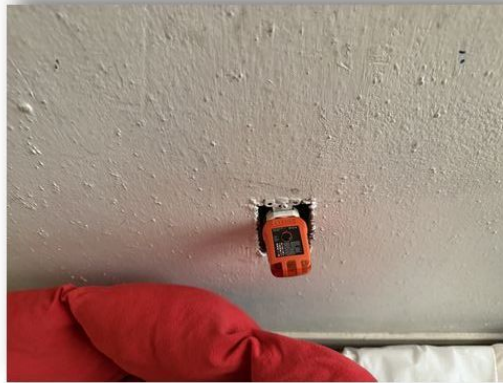
### Outlet and Switches

Examples of but not limited to areas of loose or dangling outlets, missing cover plates, outlets without power, etc. A large portion of the structure did not have electricity due to unknown issues. I highly recommend having a licensed electrician evaluated and repair all issues as these are considered a fire and shock/electrocution hazard.

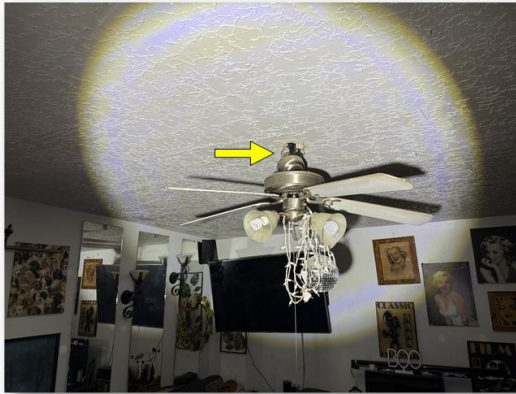
Fan electrical covers loose at ceiling, have further evaluated for repair.

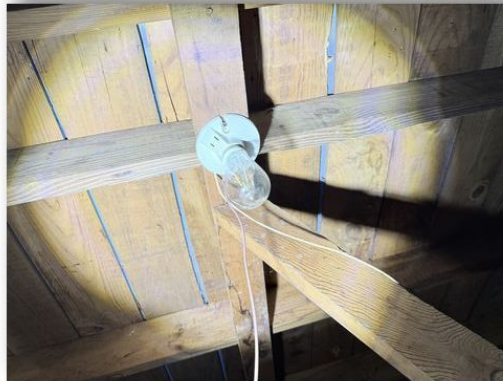
Exposed or partially exposed incandescent or LED lamps (bulbs) are not allowed in closets or attic spaces. All light bulbs must be fully enclosed in a globe or other housing.

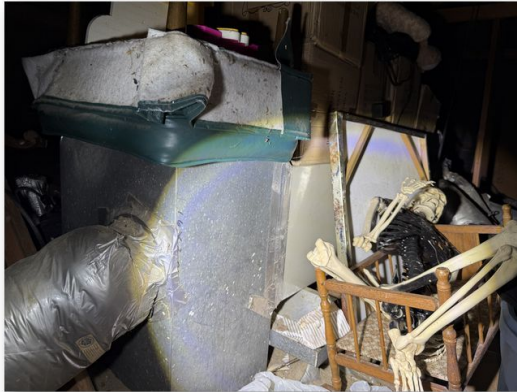
The heating system was noted to be inoperable at time of inspection. I recommend having a licensed HVAC company evaluate entire system for replacement.

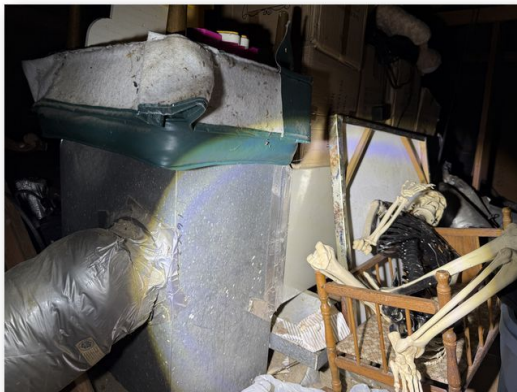
Condenser missing and air handler was noted to be covered with occupants belongings and could not be thoroughly inspected.

The HVAC system was noted to be missing the condenser and unit has not operated in a long time. I recommend having a licensed HVAC company evaluate the entire HVAC system for

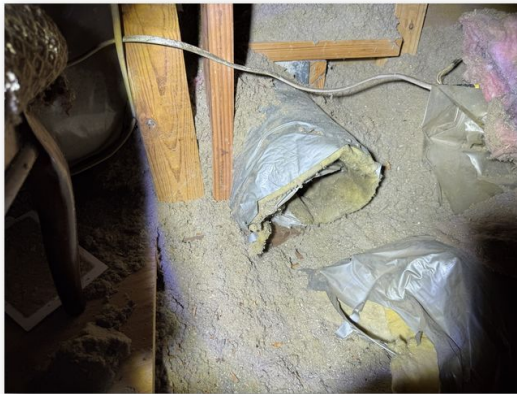
Example of but not limited to areas of duct work separation in attic space. Unit has not been in use for several years.

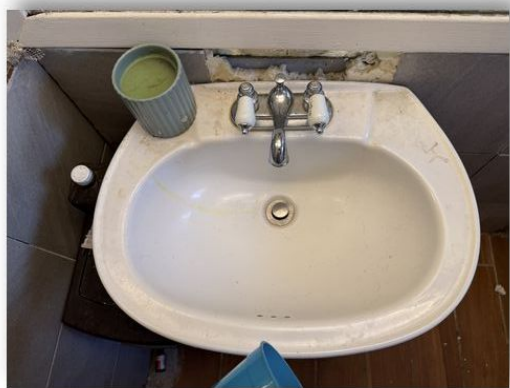
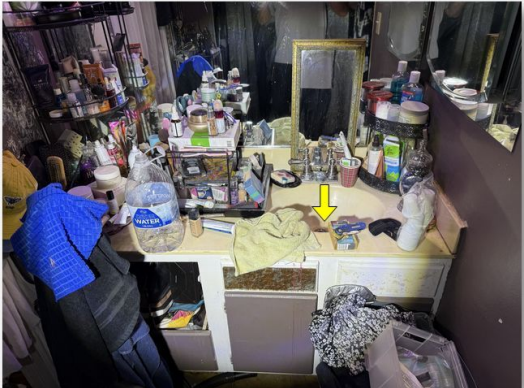
Inoperable drain stop have further evaluated for repair.

Missing drain stop in primary bathroom, have further evaluated for repair.

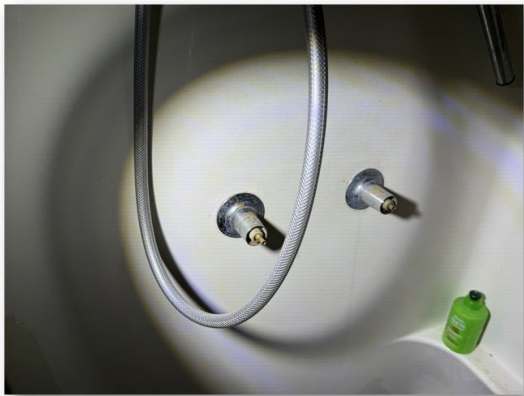
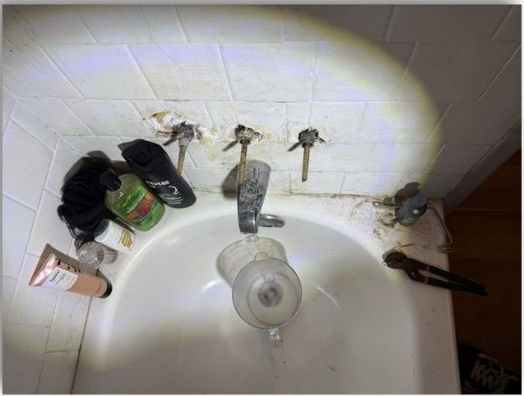
Missing handles in primary shower and secondary bathroom, have further evaluated for remedy.

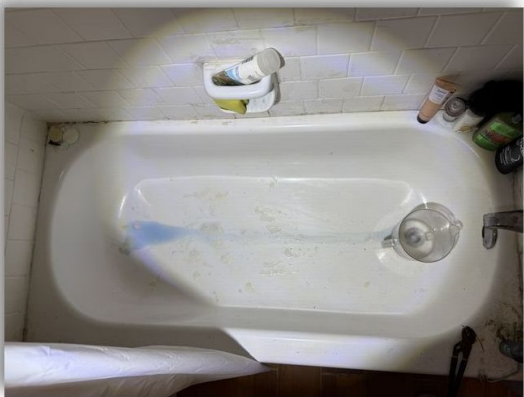
Drain stop missing in secondary bathtub and caulking peeling from tub to tile transition.

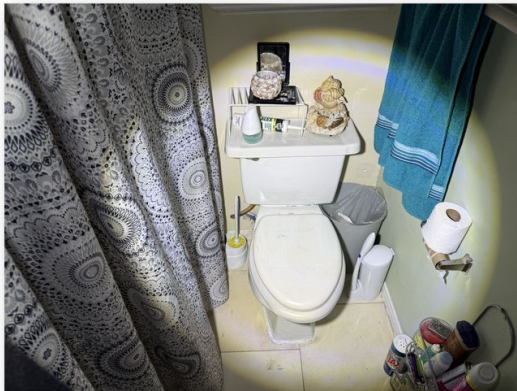
Toilets loose at floor and need to be properly sealed, have further evaluated by a licensed plumber for repairs.

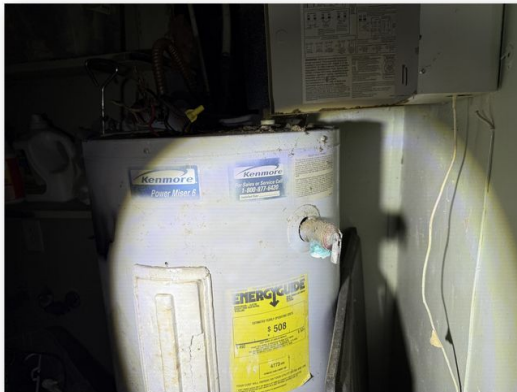
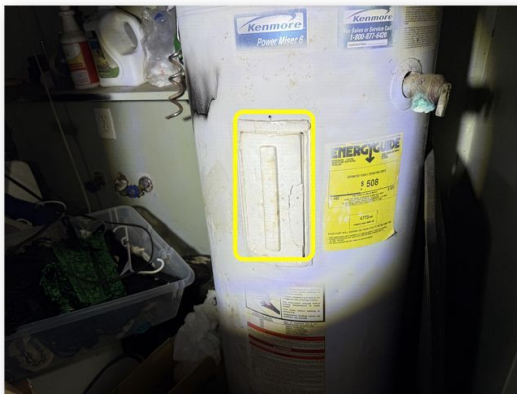
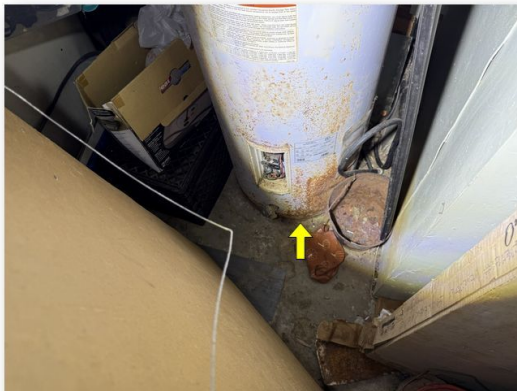
Missing drain pan and proper drain pipes to the exterior. The drain pan must be made of galvanized steel, aluminum (minimum 0.0236 inch thick), or approved plastic (minimum 0.036 inch thick), except plastic pans can't be used under gas-fired water heaters. The drain pan must be at least 1.5 inches deep and fitted with a drain pipe at least 3/4 inch in diameter. The pan drain must be piped to either a suitable indirect waste receptor (like a floor drain) or directly to the exterior. If piped outdoors, it must terminate no less than 6 inches and no more than 24 inches above the adjacent ground surface. The discharge pipe from the TPR valve must not be directly connected to the drainage system and must discharge through an air gap in the same room as the water heater or to the outdoors.

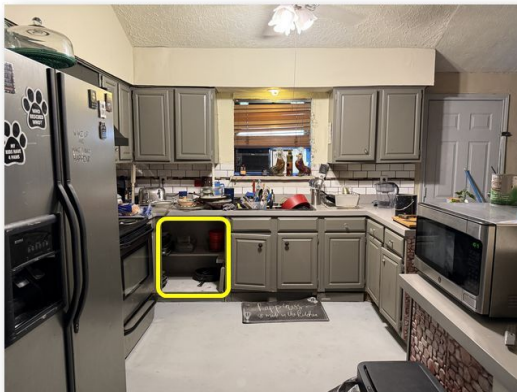
Note: Dishwasher not installed at time of inspection.

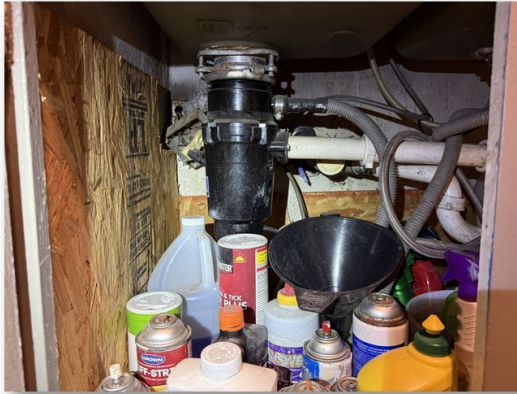
The food waste disposer appeared to be in good working order at the time of inspection.

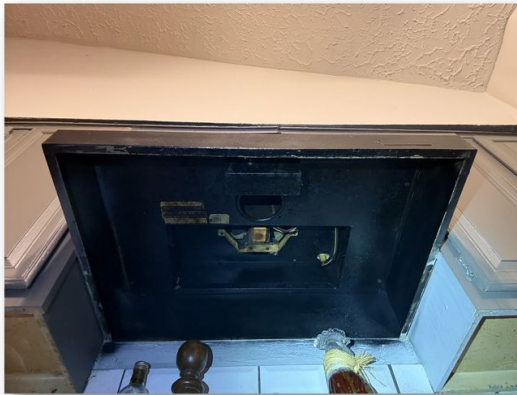
Range hood noted to be inoperable at time of inspection, have further evaluated for repair/replacement.

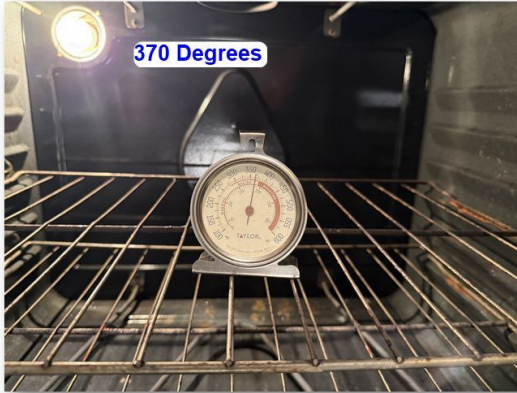
Tested at 350°F, Variance noted: >20 °F (max 25°F)

Burners did not heat up to optimal heat range, have further evaluated for repair.

An anti-tip device was not installed on the oven, this is a safety hazard. It provides protection when excess force or weight is applied to and open oven door, preventing the range/oven from tipping over. I recommend adding this device for reasons of safety.

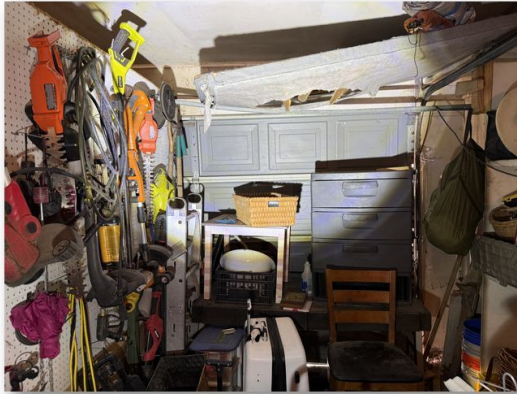
Note: Garage door opener present but could not operate due to occupants belongings blocking roller rails.

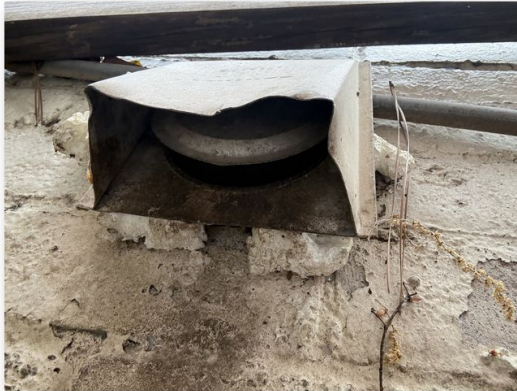
Vent damaged, have replaced.

Note: I recommend having the dryer vent cleaned out every two years for fire safety reasons.
