MOMENTUM STRUCTURAL ENGINEERING LLC.

Project No.: MSE-232-25

12014 RAINFOREST LN., MONTGOMERY TX 77356

FOUNDATION & STRUCTURAL INSPECTION REPORT:

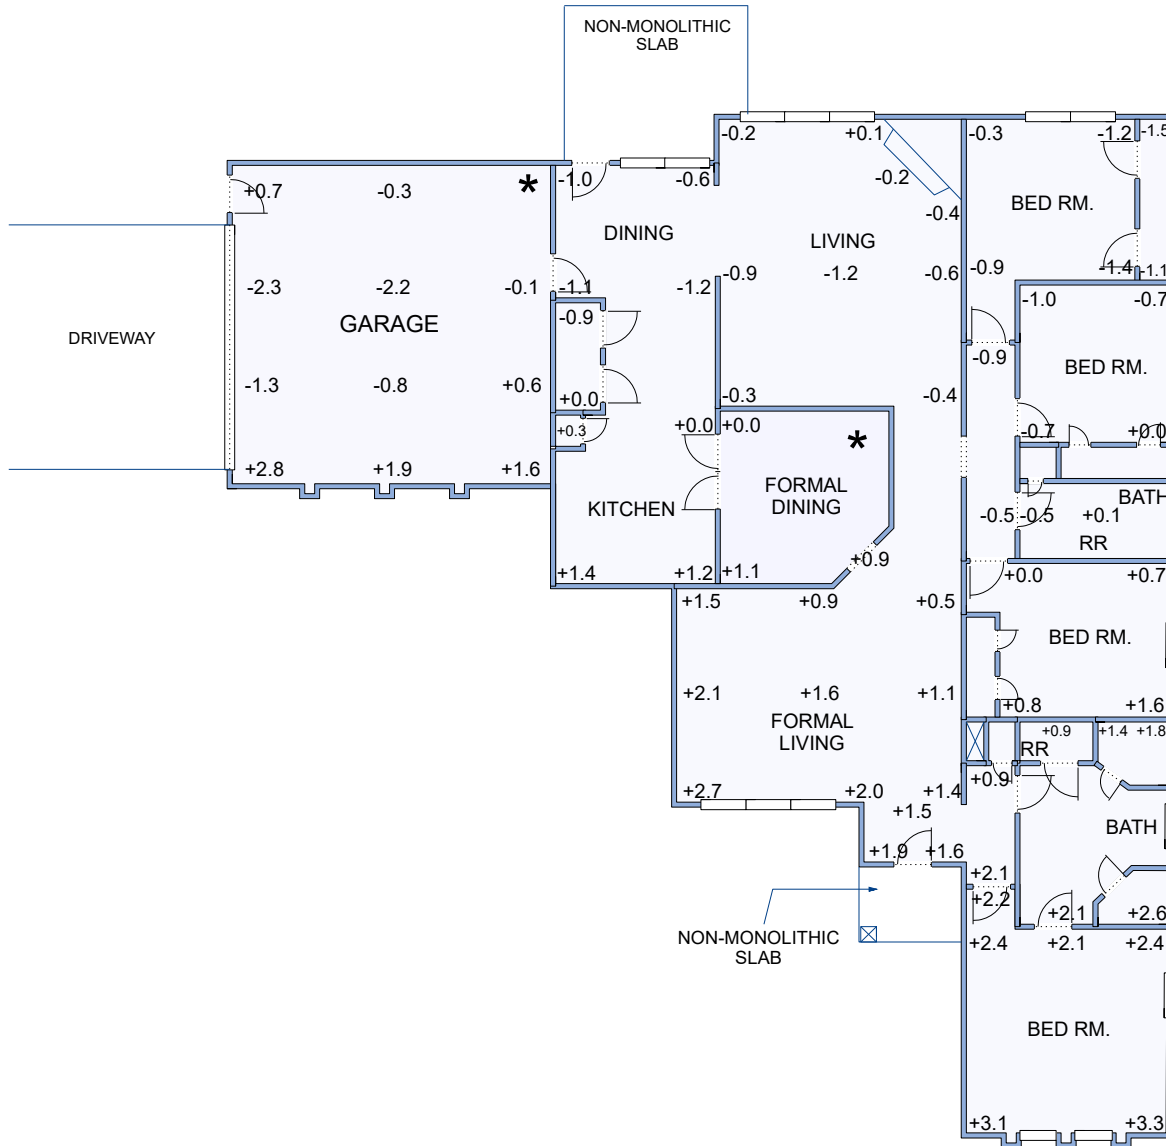
ZIP LEVEL PLACED IN LOCATION MARKED: *

Following the completion of the foundation and structural inspection, we observed evidence of subsidence & heaving. While no major structural concerns were identified at this time, we recommend that the corrective measures outlined below be implemented to prevent further movement or potential deterioration of the foundation & structural system.

<p>We recommend installing 71 piers at the indicated locations to lift, level, and stabilize the foundation of the home. NOTE: If piers already exist in that area, shim the existing piers to lift, level, and stabilize the foundation of the home. (PLEASE SEE EXISTING FOUNDATION PIER PLAN</p>
	<p>We recommend injecting polyurethane foam at the location(s) marked to fill any voids or gaps that may occur after the lift. Note: Extreme caution should be exercised during the process to prevent any damage to the home's slab or foundation.</p>

Note: Install the ZipLevel at the location marked "Z" and lift the foundation to level. We recommend performing hydrostatic and pressure tests to determine if there is a possible water or plumbing leak beneath the home.
