HEDDERMAN ENGINEERING. INC.

## FOUNDATION INSPECTION

6115 Lymbar Dr  
Houston, TX 77096

09/23/2025

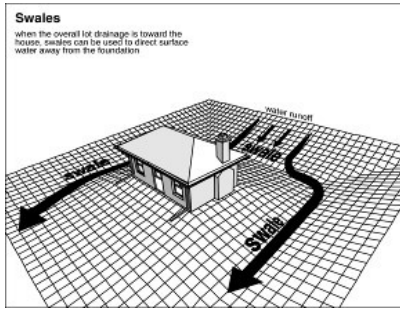
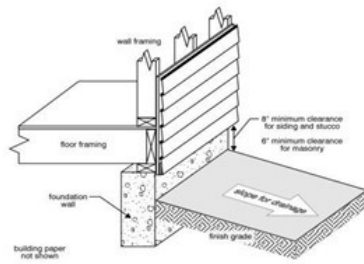
Trees and/or foliage were observed in the vicinity of the house which can contribute significantly to differential movement of the house foundation. Care should be taken to prevent the trees and foliage from removing an excessive amount of water from near the foundation of the house.

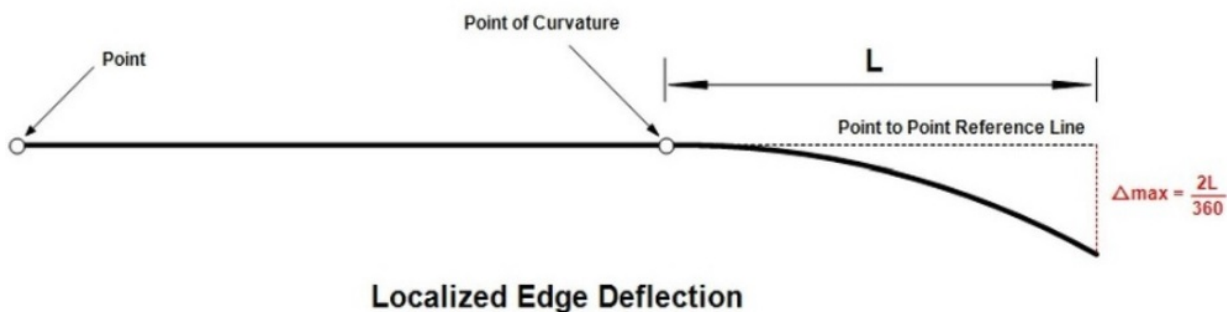
#### Foundation Deflection Analysis - Single: Edge Deflection Analysis - Some Deflection - OK

According to the ASCE Guidelines, the evaluation of localized **localized edge-condition deflections** shall be evaluated as a cantilevered member (allowable deflection = one inch deflection in a 15-foot horizontal distance ( $2L/\Delta = 360$  per the building code)).

From the point of curvature located at the northeast bedroom (west) to the northeast bedroom (east) ( $L = 12$  feet), the maximum allowable deflection is 0.80 of an inch. We calculated a deflection of 0.56 of an inch at the time of inspection across this span, which is **less than the maximum allowable deflection, and is acceptable**. This observation can be observed along the **Red Line** in the sketch below.

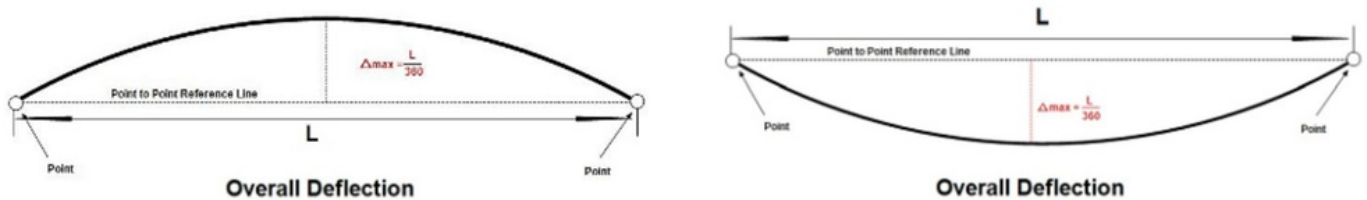
**Foundation Deflection Analysis - Single: Overall Deflection Analysis - Some Deflection - OK**

According to the ASCE Guidelines, the evaluation of overall deflections shall have a maximum deflection of  $L/360$ .

From the utility room to the south bedroom (L = 50 feet), the maximum allowable deflection is 1.67 inches. We calculated a deflection of 0.41 of an inch at the time of inspection across this span, which is **less than the maximum allowable deflection, and is acceptable**. This observation can be observed along the Blue Line in the sketch below.
