PROPERTY INSPECTION REPORT FORM

Rosa Caffarena <i>Name of Client</i>	11/11/2023 <i>Date of Inspection</i>
5638 Briar Dr., Houston, TX 77056 <i>Address of Inspected Property</i>	
Will Worthen <i>Name of Inspector</i>	24920 <i>TREC License #</i>
<i>Name of Sponsor (if applicable)</i>	<i>TREC License #</i>

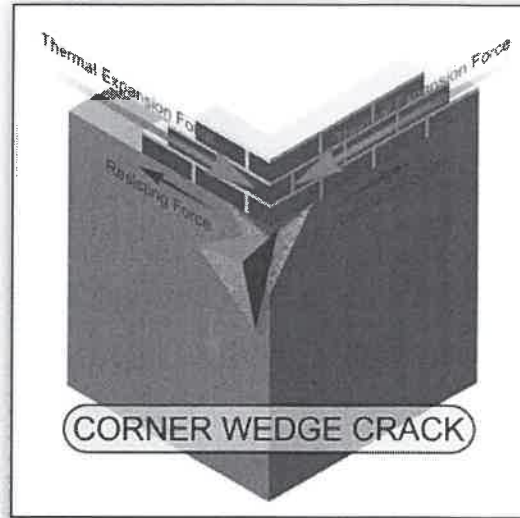
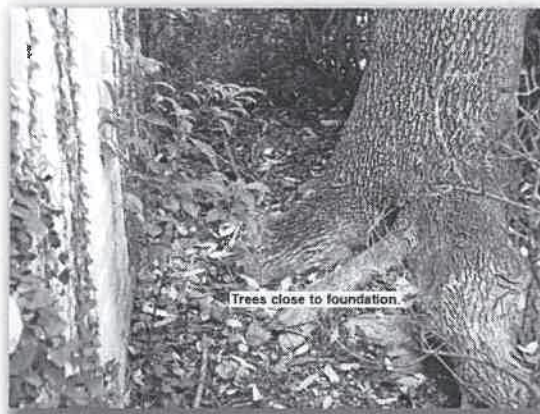
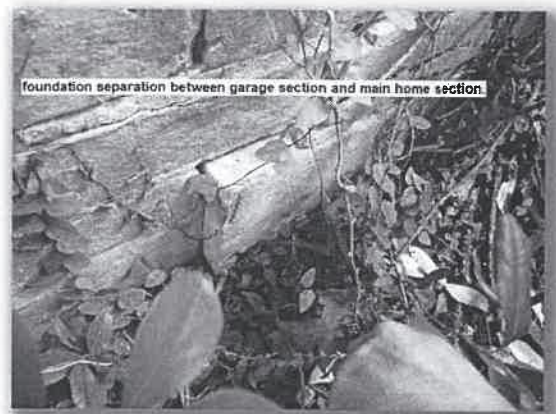
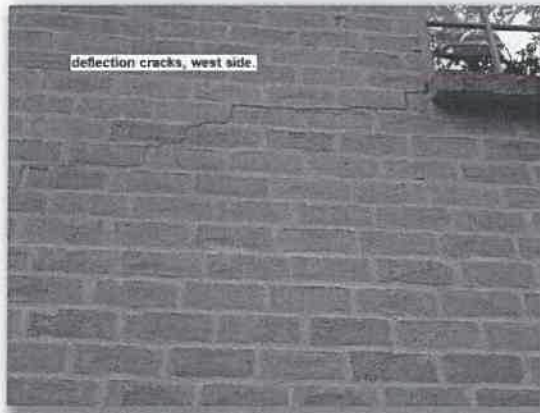
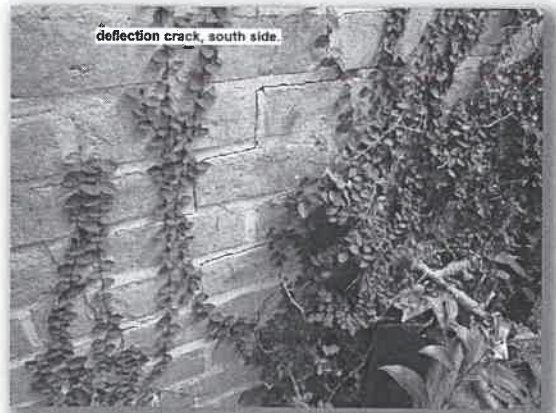
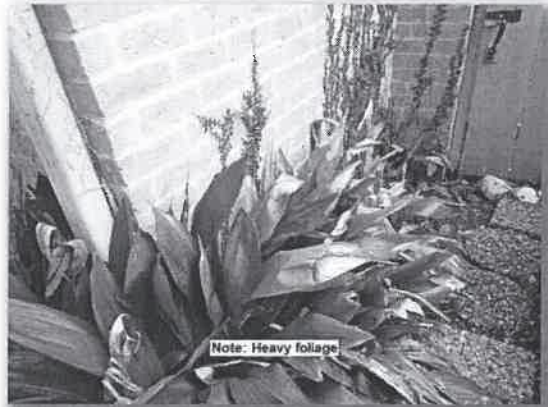
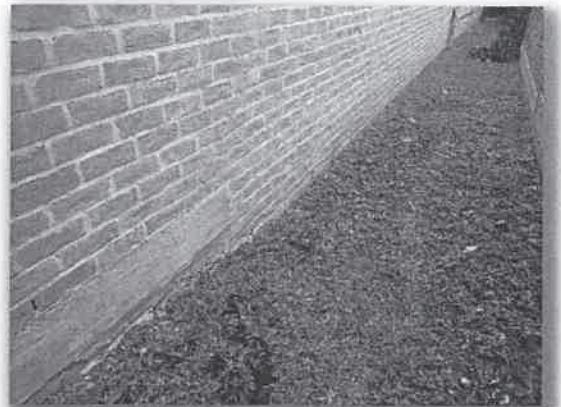
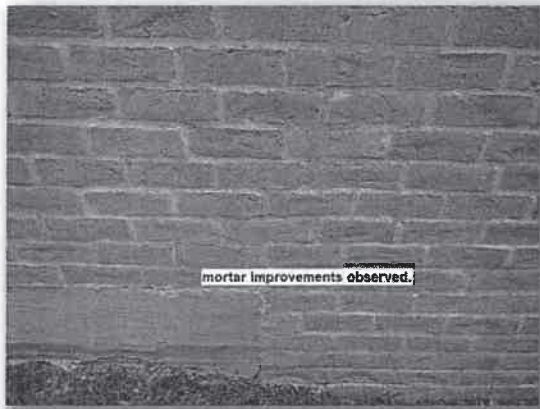
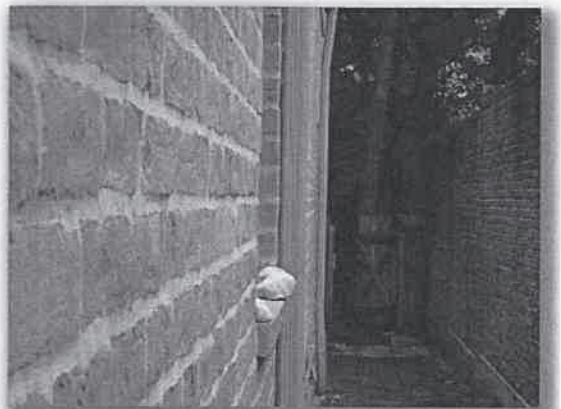
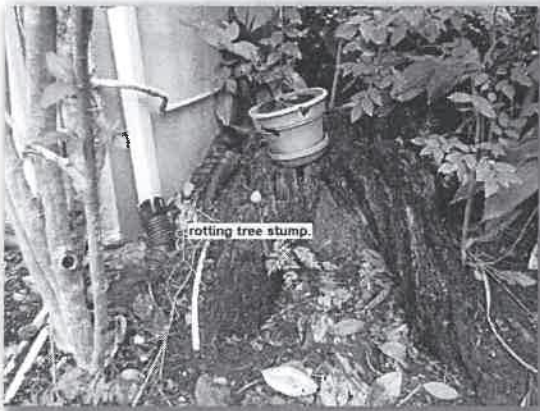
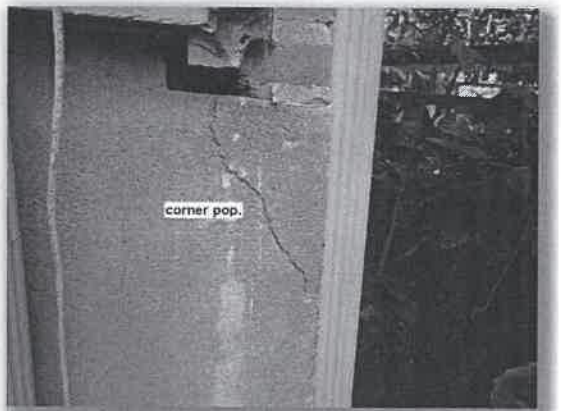
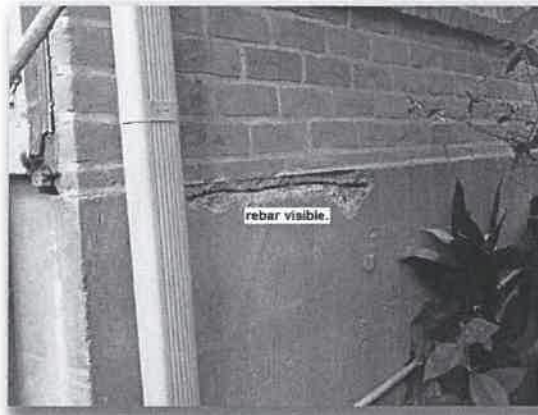
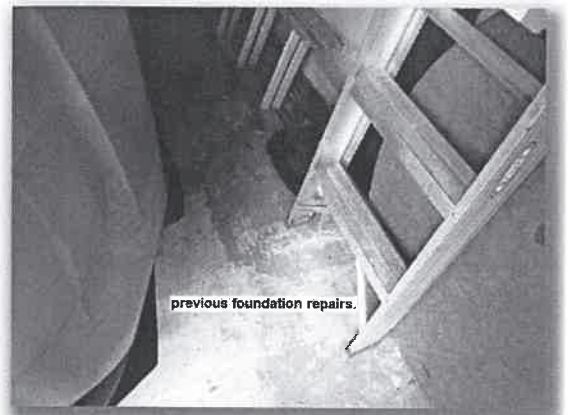
- Interior drywall cracks and/or stress indicators.
- Deflection cracks were observed in the exterior veneer.
- Foundation sections were observed to be separating between the garage and main house sections.
- The foundation rebar is visible at the edge of the foundation beam and needs to be properly covered on the south side of the bedroom wing of the structure.

Note: One or more of the foundation perimeter beam corners were observed to be sheared off (corner pop). This is a common condition to observe and is due to thermal expansion and contraction of the different building materials. This condition does not adversely affect the foundation performance. However, in some cases, some cosmetic improvements may be necessary.

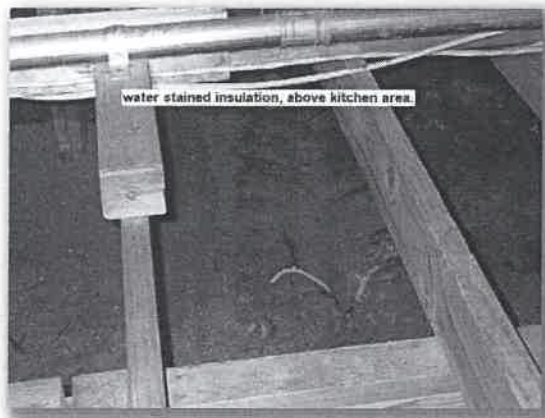
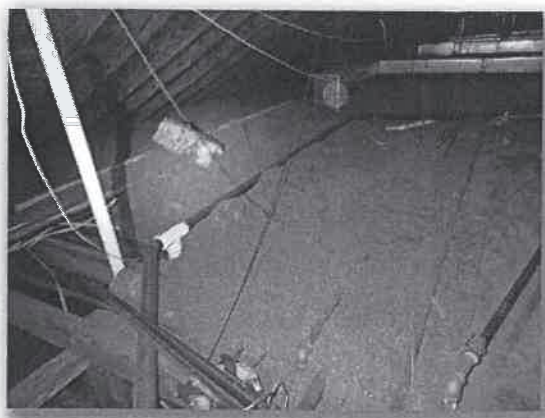
- The attic floor insulation should be redistributed in one or more locations.

Note: There are visible water stains on the loose fill insulation above the kitchen area.

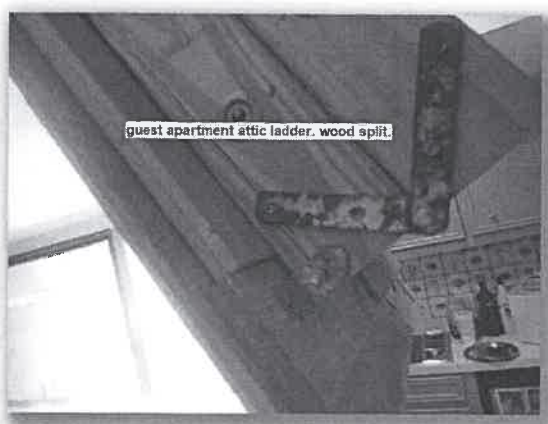
Attic Ladder/Hatch Opening

- One or more of the attic ladder components were observed to be damaged. This condition should be corrected for reasons of safety.

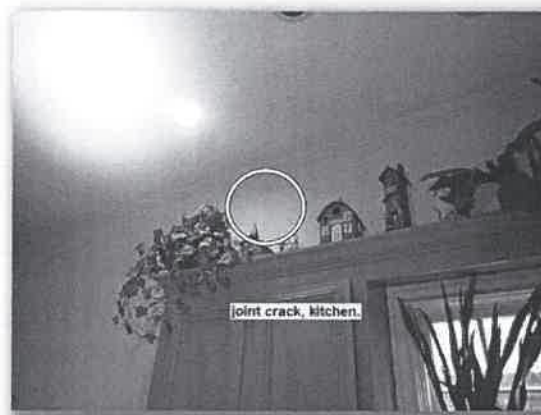
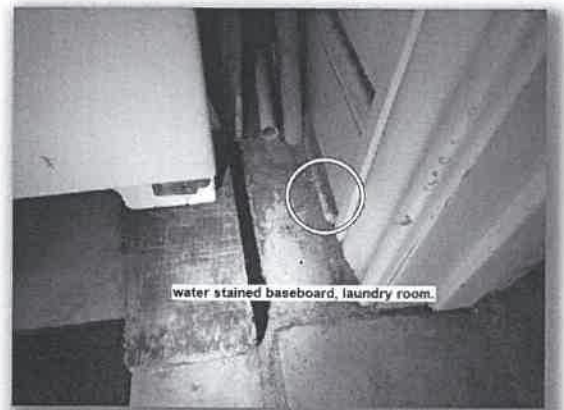
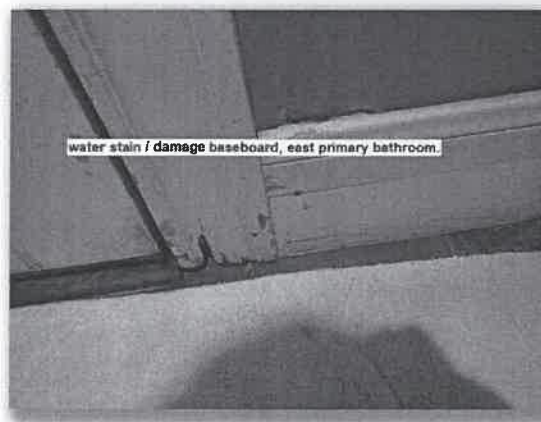
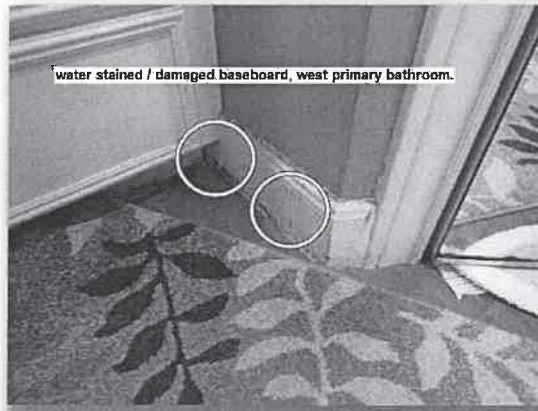
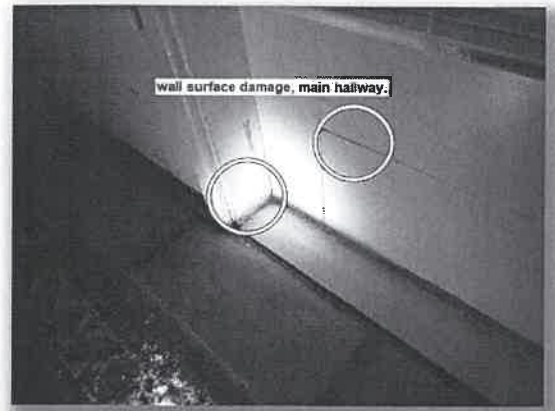
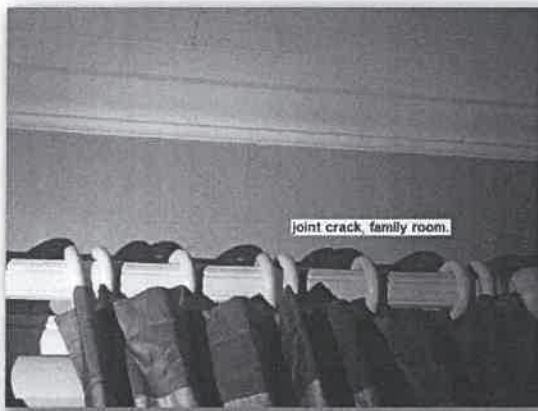
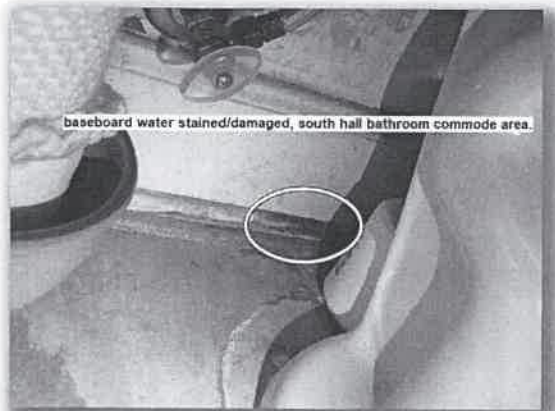
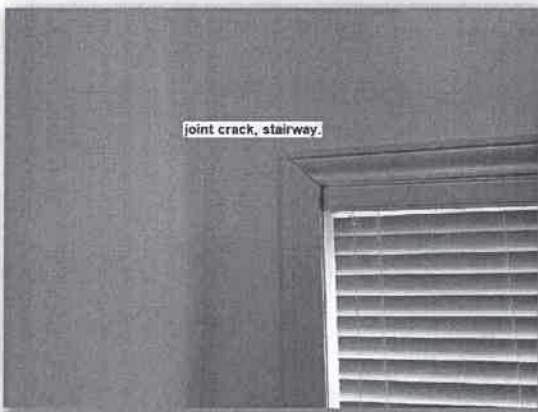
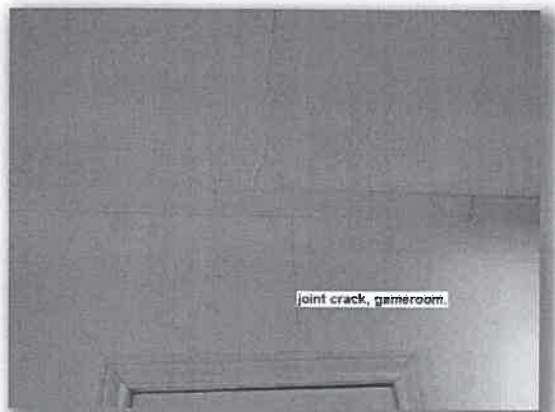
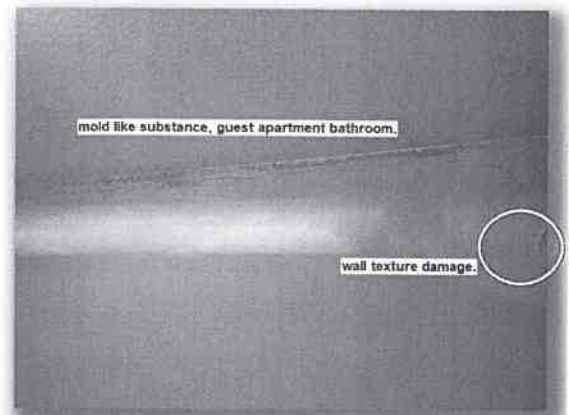
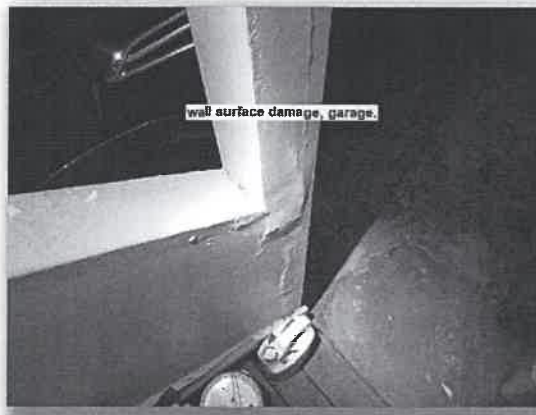
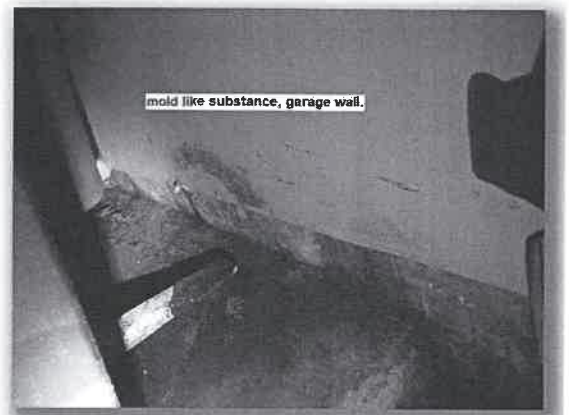
- The wall texture has some deterioration and/or damage in the several locations throughout the house.
- Several locations of cosmetic repair (texture, caulk, paint) are recommended.
- The baseboards were observed to be water stained and/or damaged in the primary bathroom, laundry room, hall bathroom. The cause and remedy should be further evaluated and corrected as necessary.
- Water stains and water damage was observed on the wall finishes in the main hallway. The cause and remedy should be further evaluated and corrected as necessary.

- Interior wall joint cracks were observed in the family room.
- There was an unknown mold like substance observed in Jack and Jill bathroom, guest bathroom, garage. Evaluation of this substance is beyond the scope of this inspection. If any concerns exist on the type and/or nature of this substance, we recommend further evaluation by a professional in the Air Quality sampling field.
- Wall surface damage was observed in the garage.

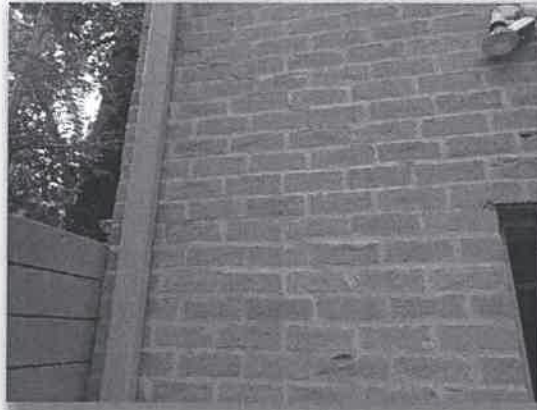
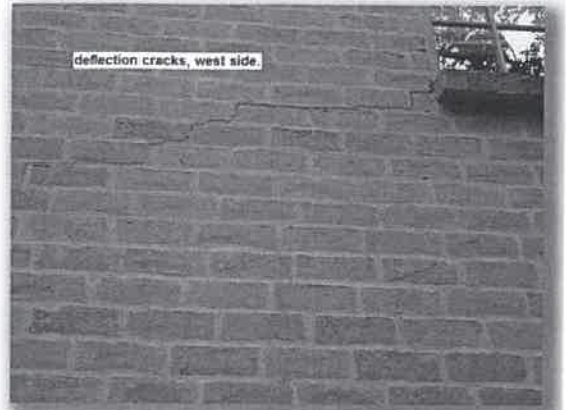
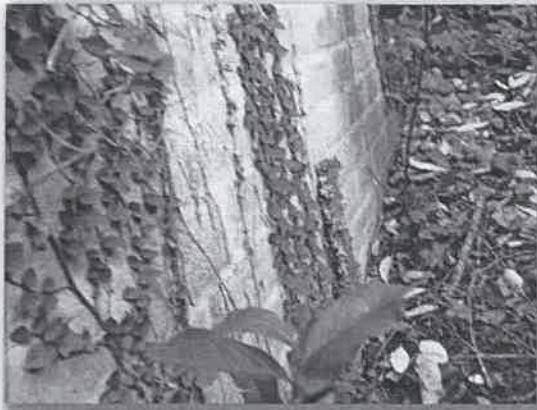
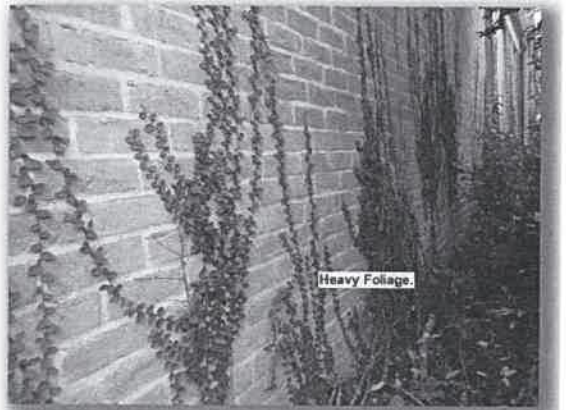
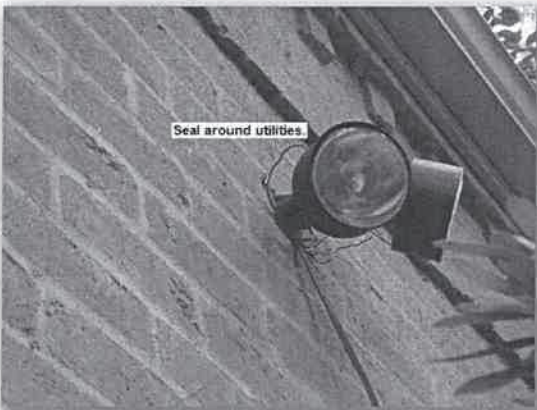
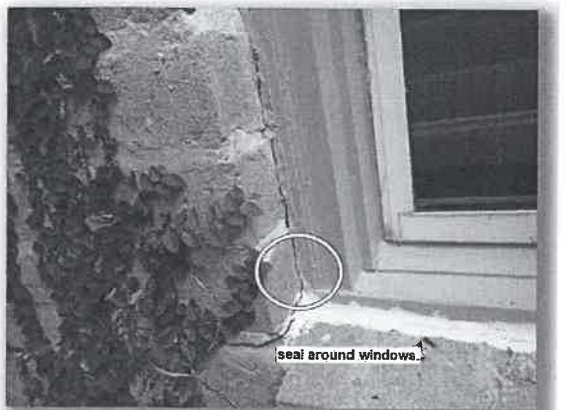
Exterior Walls & Surfaces

- Caulking improvements are recommended for the area between the exterior veneer and the window frames. It is recommended to use an elastomeric sealant.

- The area between the exterior cladding / veneer and all of the wall penetrations / openings should be properly sealed. Areas such as utility connections, downspouts, hose bibbs, lighting fixtures, receptacles, vent termination covers, etc. It is recommended to use an elastomeric sealant.

- There are visible cracks in the brick and/or mortar at the front arch. This type of cracking may compromise the integrity of the arch. It is recommended to have this condition further evaluated and corrected as necessary.

- Deflection cracks were observed in the exterior veneer on the east side, west side, south side of the structure.
- The exterior veneer / cladding has some deterioration and/or damage on the north side of the structure.

- The exterior veneer / cladding was observed to be pulling loose and should be better secured on the north side of the structure.
- The wood veneer trim has some deterioration or damage on the north, east, west and south sides of the structure.

- The exterior wood window casing has some deterioration and/or damage on the west side, south side, east side of the structure.
- The primary bathroom porch exterior walls and windows were observed to be damaged. Wood rot was observed.

Note: Mortar and/or brick cracks were observed in the exterior veneer on the north, east, west and south sides of the structure.

Note: Previous repairs to the exterior masonry mortar / grout was observed on the east side, west side of the structure.

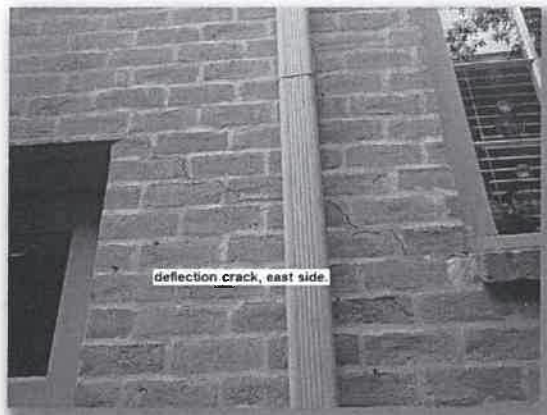
deflection crack, east side.

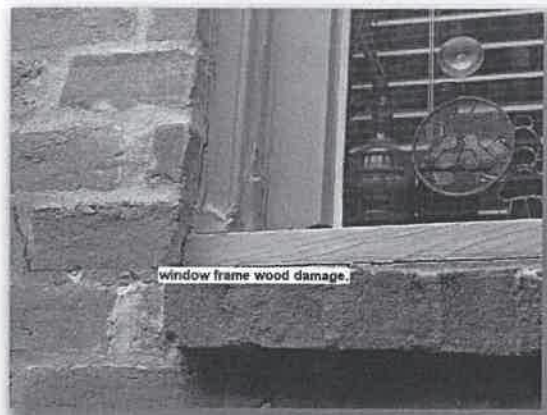
window frame wood damage.

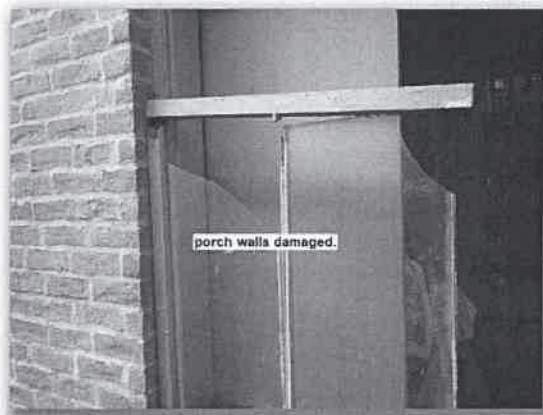
porch walls damaged.

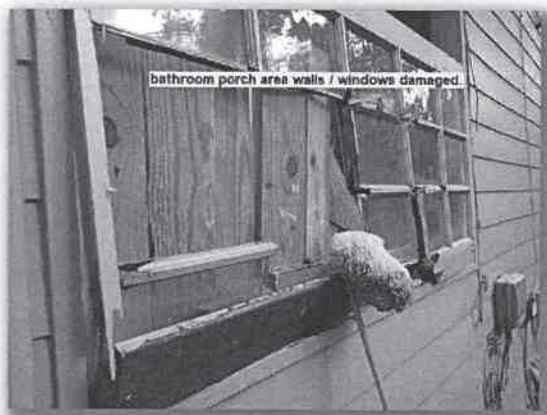
bathroom porch area walls / windows damaged.

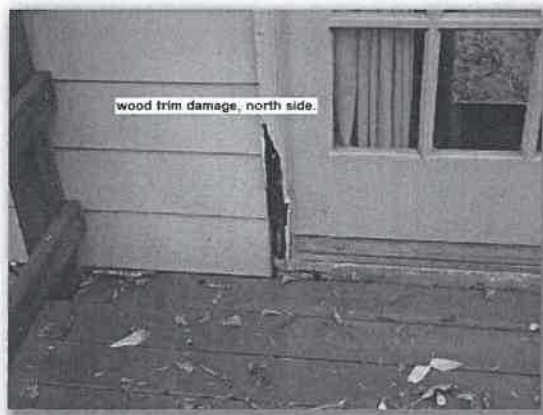
wood trim damage, north side.

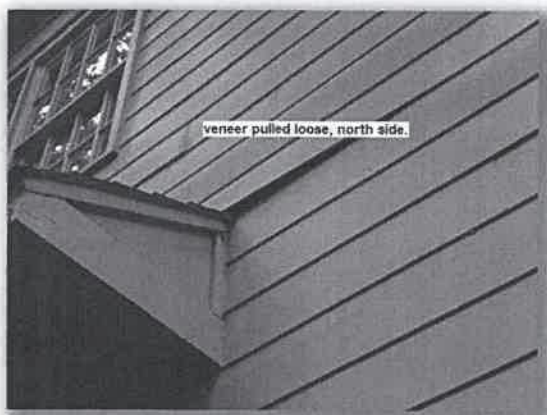
veneer pulled loose, north side.

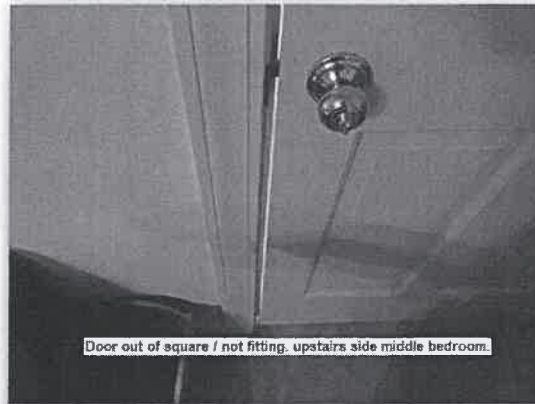
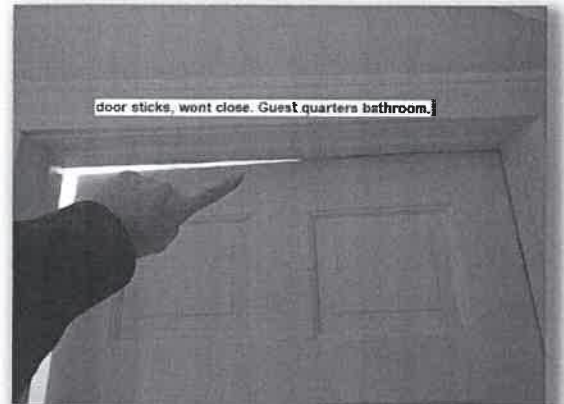
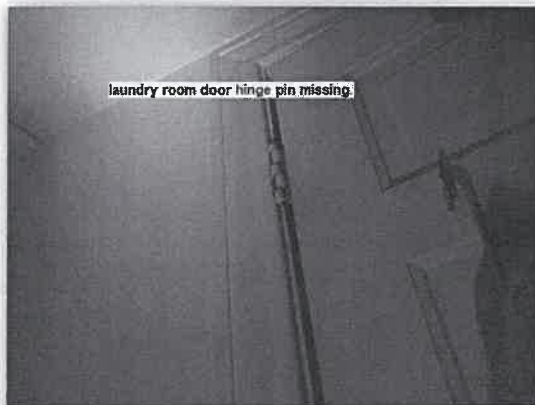
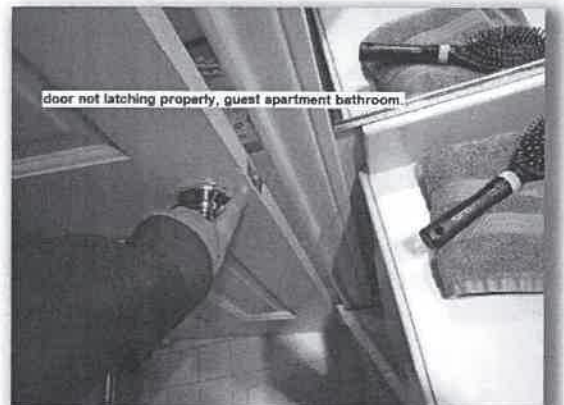
- The door is sticking and will not close properly to the primary bathroom, guest quarters closet.
- Surface damage was observed to the door in the primary bathroom.
- The upstairs side middle bedroom door was not fitting the opening properly. Adjustments may be needed.
- The door is not latching properly to the guest apartment bathroom.
- The laundry room door hinge is missing its pin.

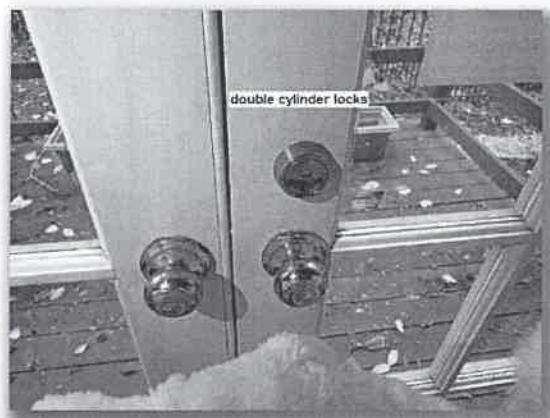
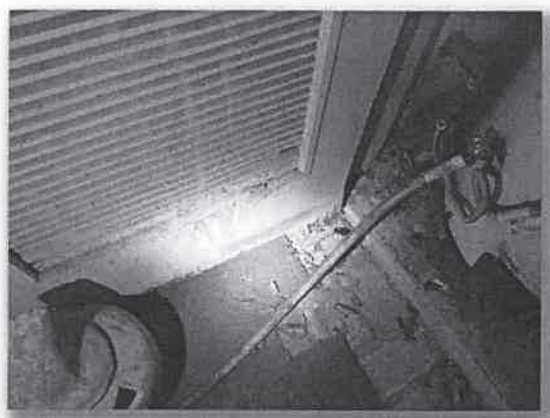
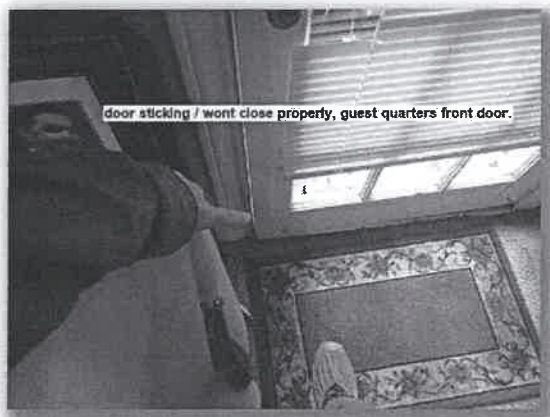
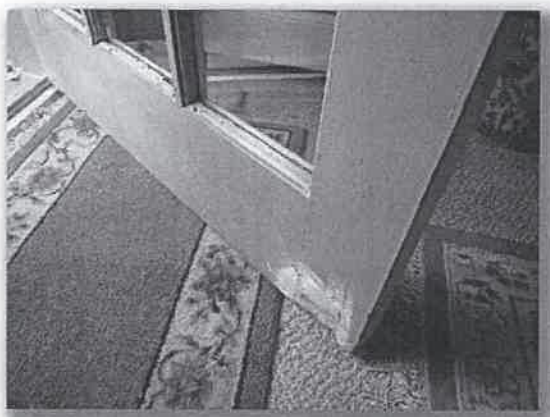
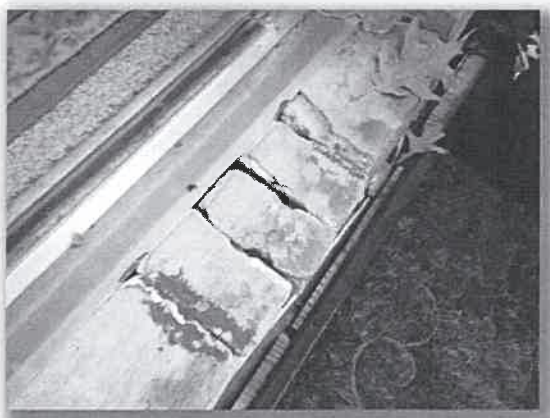
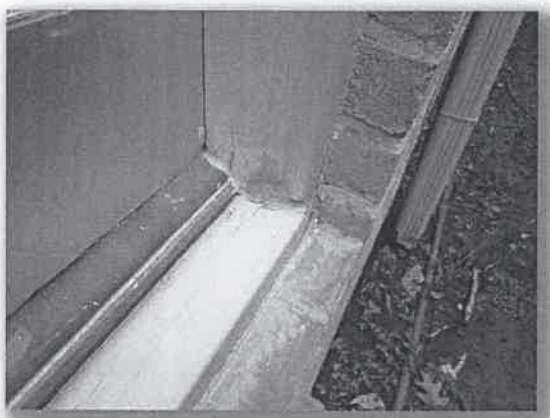
Exterior Doors

- Double cylinder locks were observed on one or more of the exterior exit (egress) doors. All exterior egress doors should be readily operable from the side from which egress is to be made without the use of a key or special knowledge or effort.
- The water heater utility room exterior door is water damaged. Repairs are recommended.
- The door is sticking and will not close properly to the guest quarters entry.
- The guest bedroom, family room, living room exterior door is water damaged. Repairs are recommended.
- The bricks supporting the threshold were observed to be loose at the guest apartment entry door.

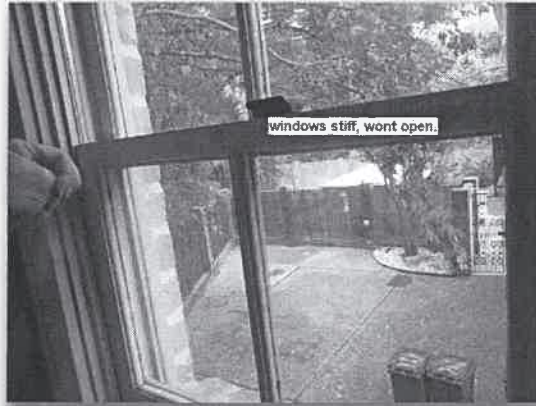
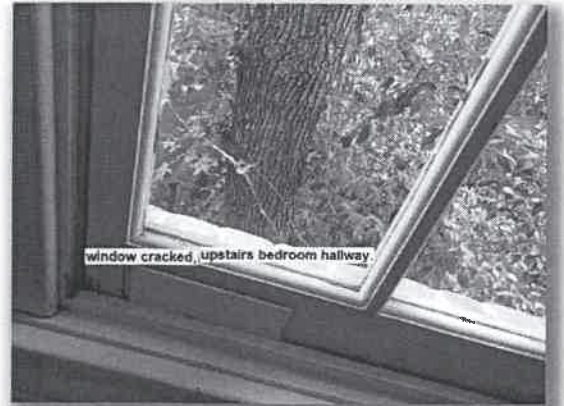
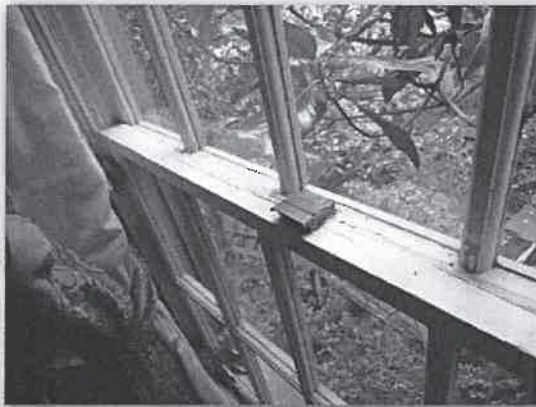
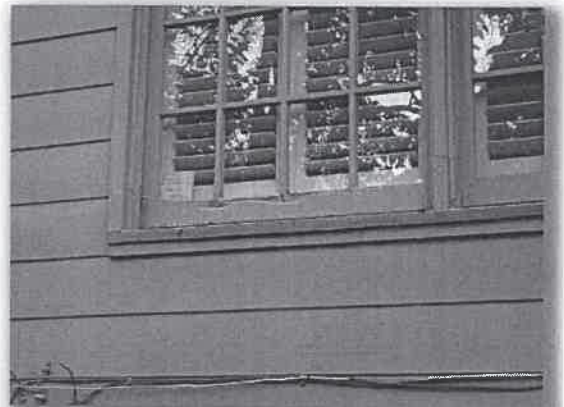
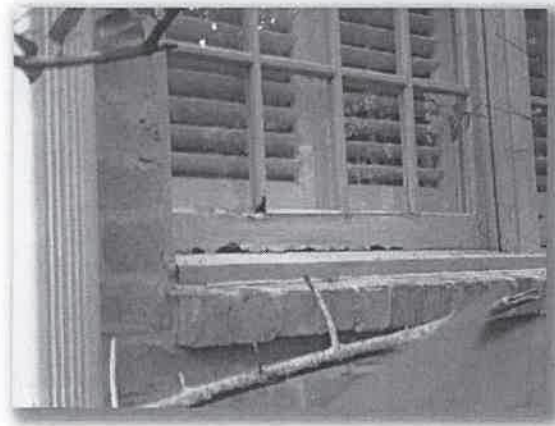
- One or more of the windows are stiff and hard to operate in several locations.
- Cracked and/or broken window glass was observed in the upstairs bedroom hallway.
- One or more of the bedroom windows are painted shut. At least one window in each bedroom should open fully, with free access to the outdoors, for safety reasons.
- The window frame is damaged in the several locations throughout the house.

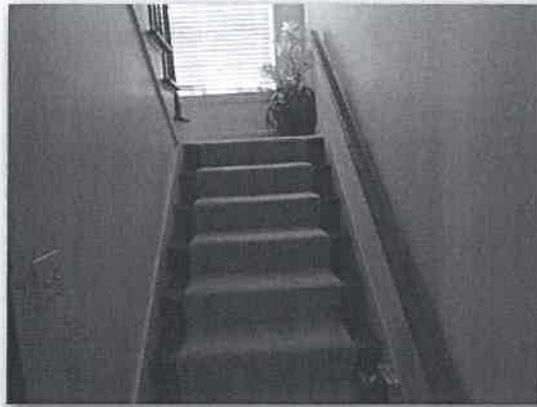
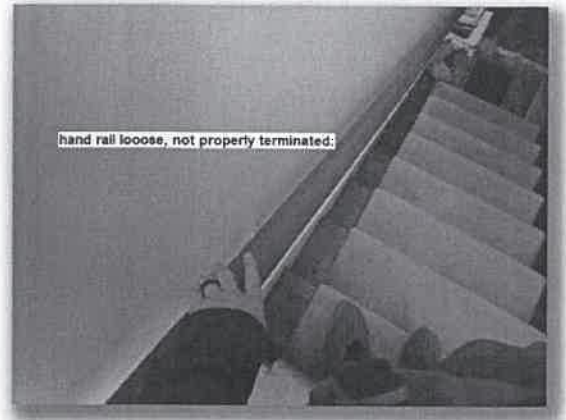
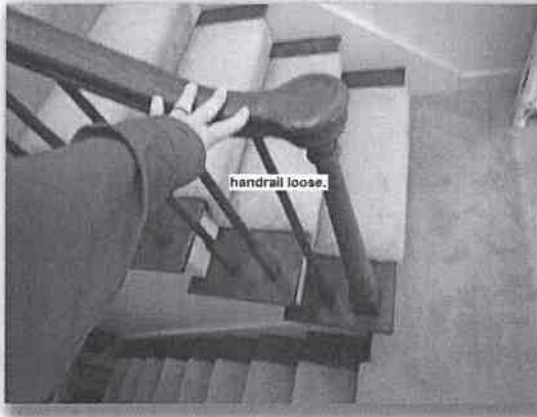
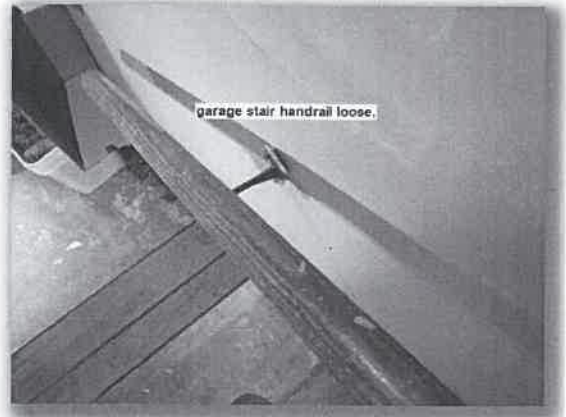
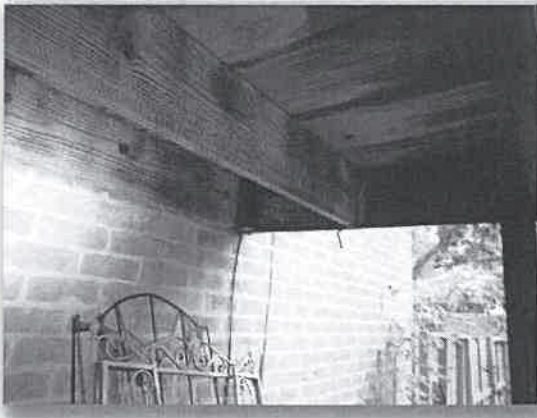
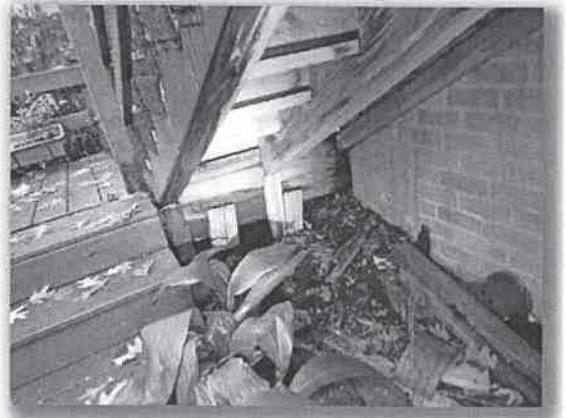
I. Stairways (Interior and Exterior)

- The handrail and/or guardrail for the stairway is loose and should be better secured for reasons of safety.
- The handrail does not terminate into the wall or a newel post. This condition does not meet current building standards.

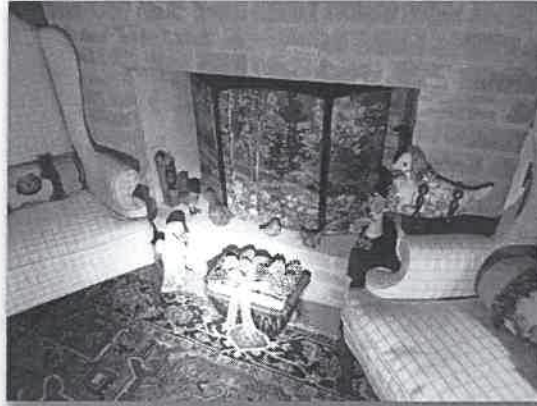
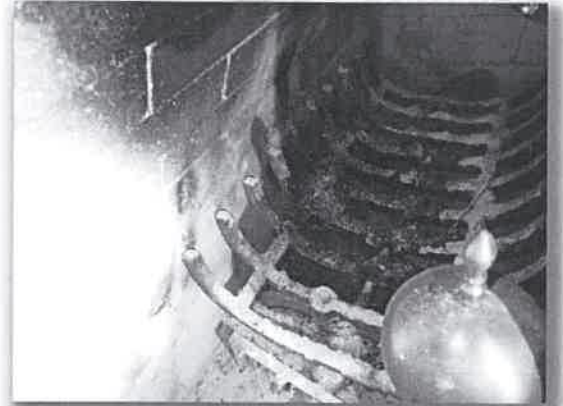
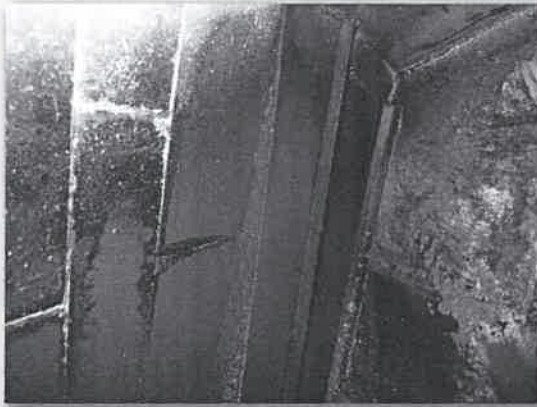
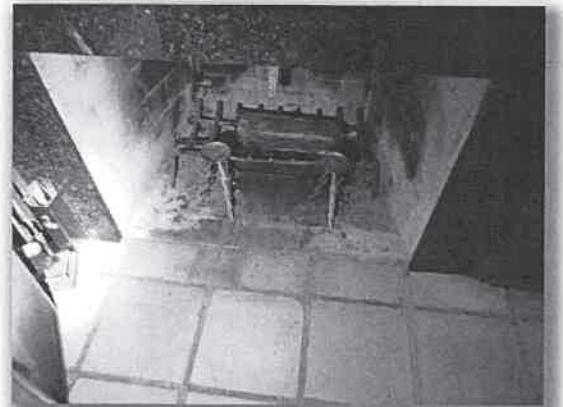
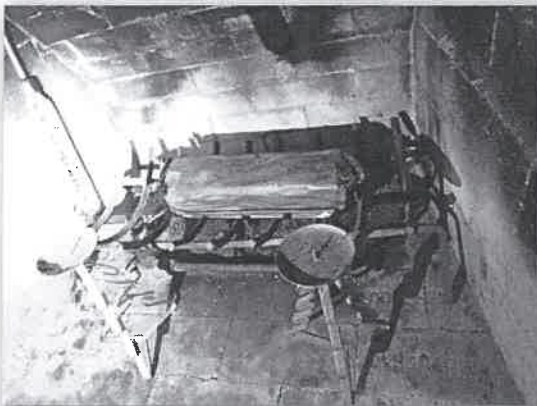
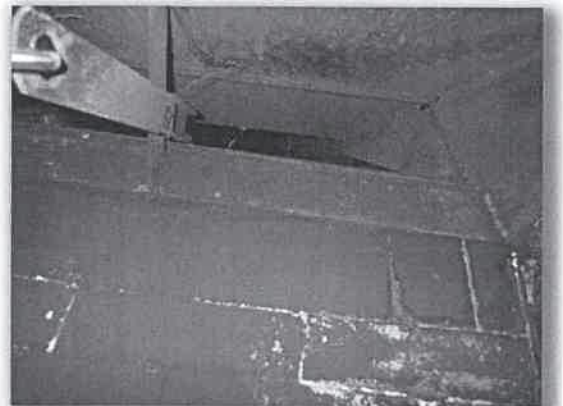
J. Fireplaces and Chimneys

- The chimney flue should be cleaned by a Qualified Chimney Sweep. A creosote / soot build-up was observed in the visible flue area.

Note: The floor of the firebox is dirty and should be cleaned. I was unable to view the floor of the firebox at the time of this inspection.

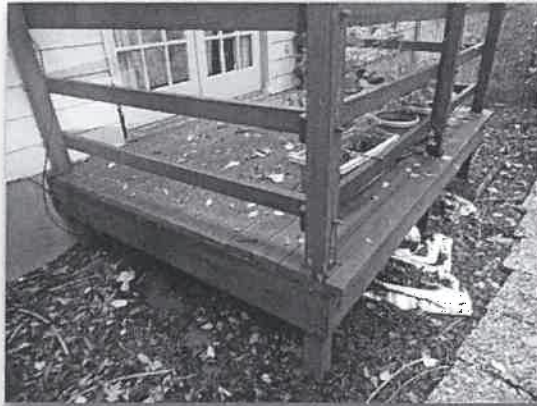
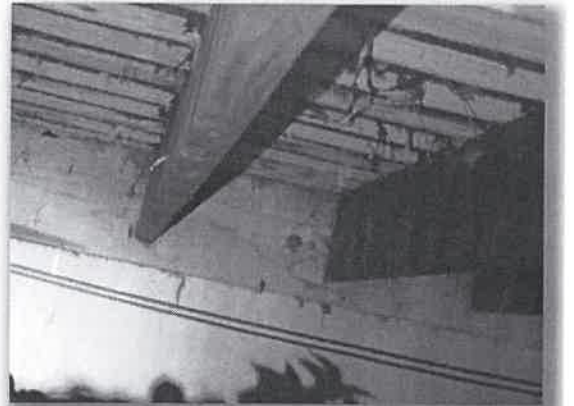
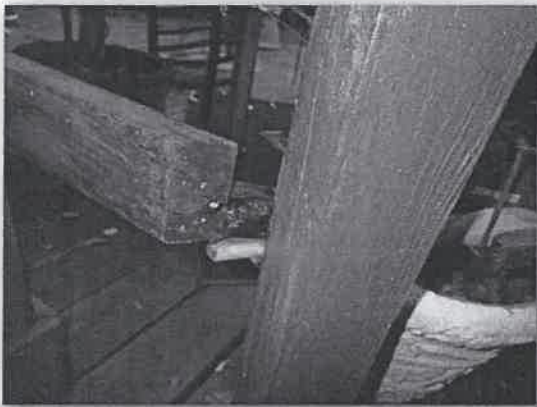
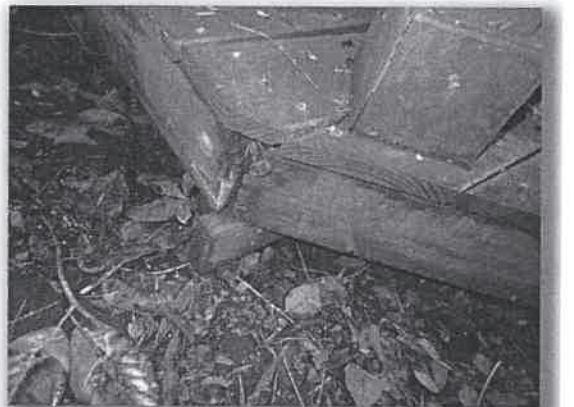
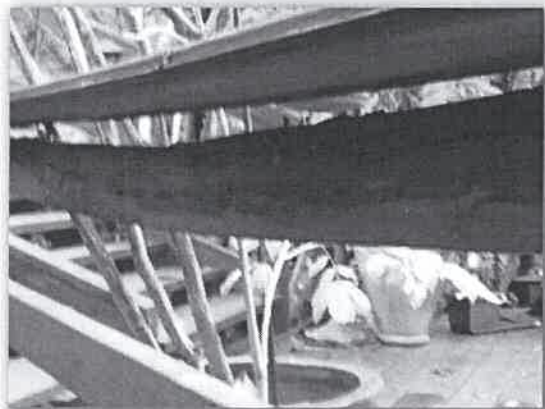
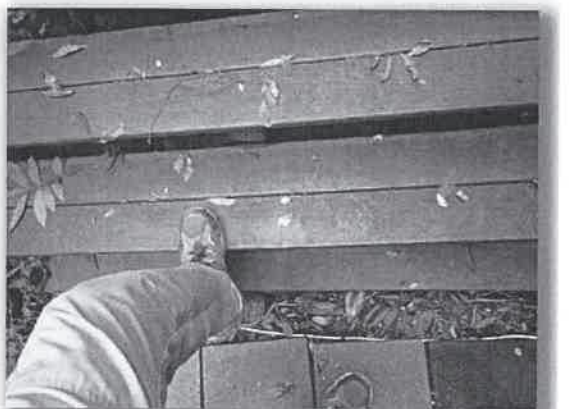
K. Porches, Balconies, Decks, and Carports

- Some of the deck boards were observed to be warped and/or damaged.
- The deck material has some deterioration and/or damage. Repairs may be necessary to improve the deck quality.

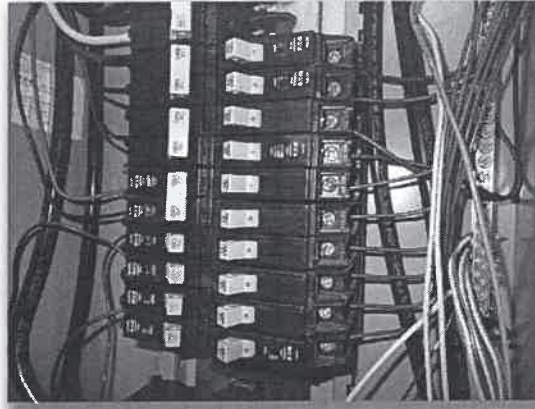
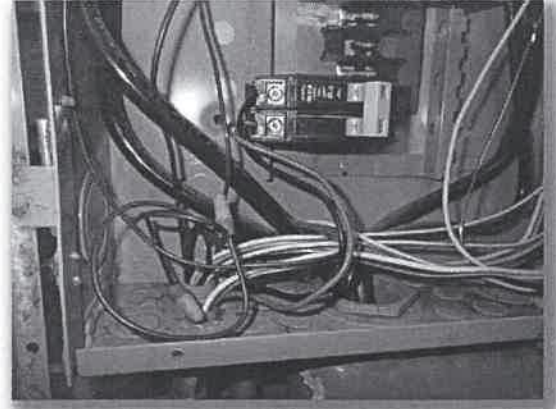
Arc-Fault Circuit Interrupter Protection (AFCI)

- None of the required dwelling unit devices, receptacle and lighting outlets (switches, receptacles and fixtures) are connected to an arc-fault circuit-interrupter (AFCI) circuit device. AFCI devices were first required under the 1999 National Electrical Code and under the 2014 NEC, all living space, kitchen and laundry room devices, receptacle and lighting outlets (switches, receptacles and fixtures) should be connected to an arc-fault circuit interrupter (AFCI) device.

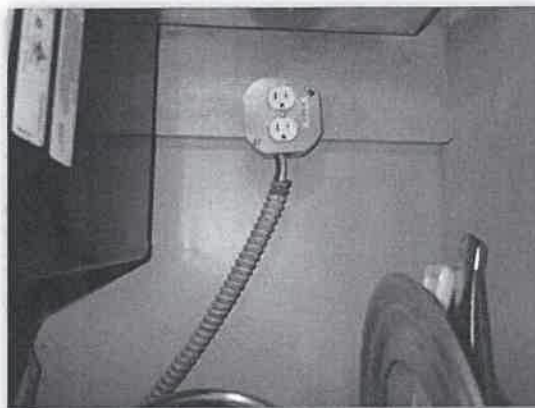
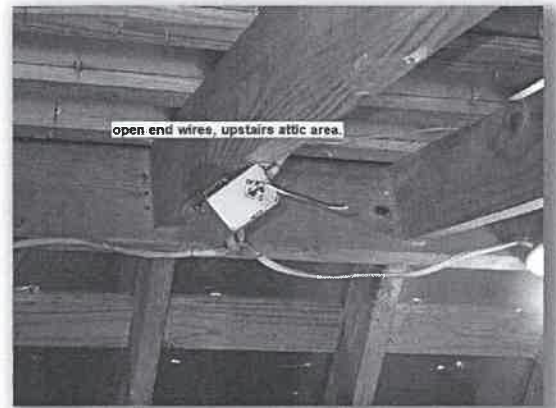
Distribution Wiring

- All exposed distribution wiring should be properly enclosed in conduit. Exposed wiring was observed in the kitchen.
- Open end wires were observed in the attic area. Open end wires should be properly enclosed in a junction box for reasons of safety.
- The junction box is corroded / damaged on the west exterior wall.
- Wires exposed to the outside elements (i.e. outside weather conditions) should be protected by rigid conduit. There are exposed wires located on the west side of the structure.

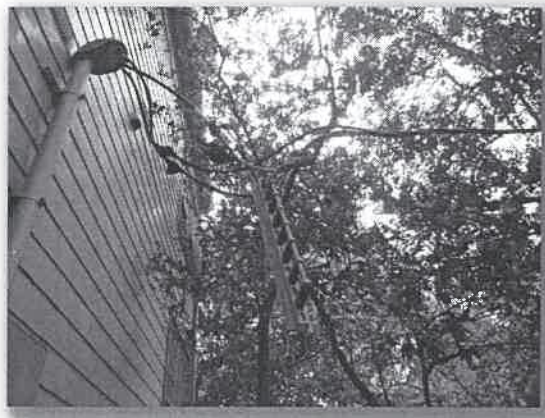
Service Entrance

- The electrical service weather head has pulled loose from the structure and should be re-secured.

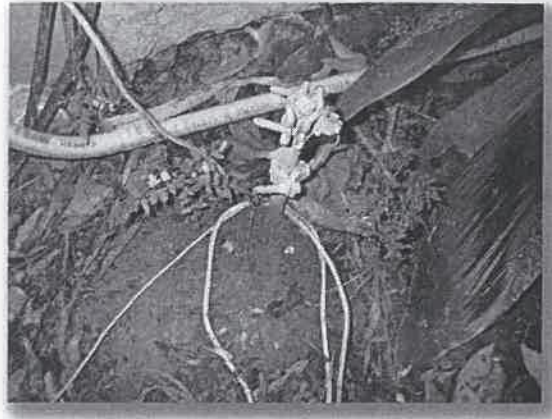
Grounding / Bonding

- I was unable to locate the electrical bond connection for the gas piping back to the grounding electrode system. All bond connections should be accessible for inspection, repair or replacement. This condition should be further investigated and corrected if necessary.
- The ground electrode system connection to the cold water line could not be located. Under current electrical standards the connection should be accessible.

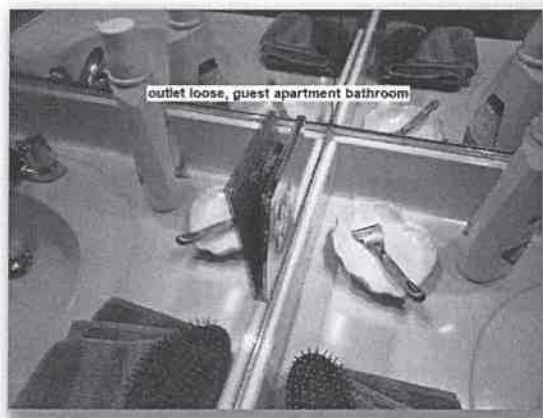
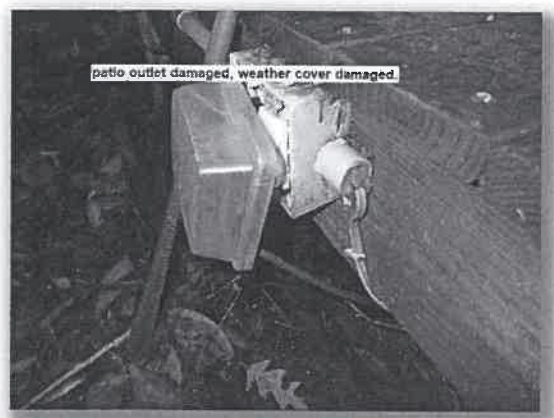
- One or more of the receptacles were observed to be loose at the wall mount in the guest bathroom.
- One or more of the receptacles were observed to be damaged in the back porch.

- All exterior receptacles should have weather tight covers. The receptacle weather cover plate is damaged and/or missing on the back porch.
- One or more of the receptacles are inoperative. This receptacle(s) and circuit should be investigated and corrected as necessary. Receptacle(s) were located in the back porch.

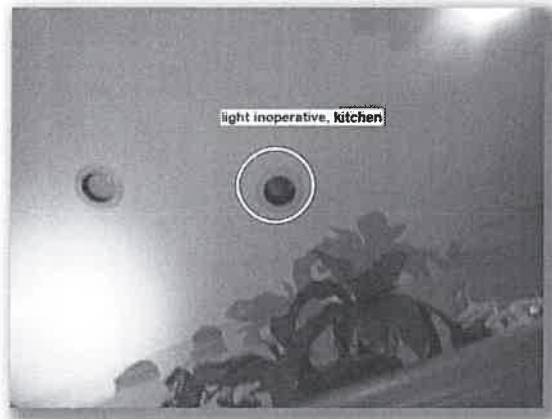
Fixtures

- One or more of the light fixtures are inoperative in the kitchen, Jack and Jill bathroom. This may be due to a bad bulb or some other unknown condition. This condition should be further evaluated and corrected as necessary.
- One or more of the closet light fixtures are installed without globes and/or covers. Safety precautions should be taken around these light fixtures.
- One or more of the light fixtures are loose at the mount in the pantry.
- One or more of the light fixture globes and/or covers are missing in the north hall bathroom, primary bathroom.

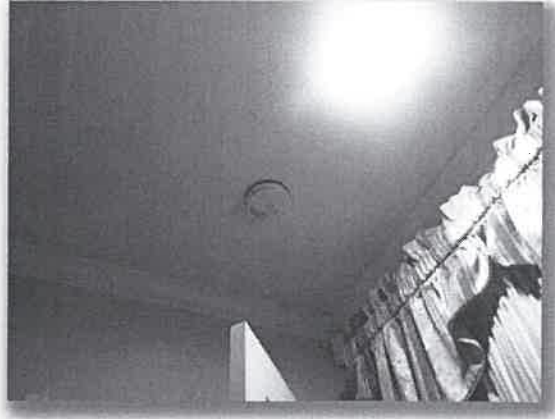
Smoke Alarms

- There are not enough smoke alarms located in the home. Under current building standards, there should be a smoke alarm located in each sleeping room, outside each separate sleeping area in the immediate vicinity of the sleeping rooms, and on each additional story of the dwelling.

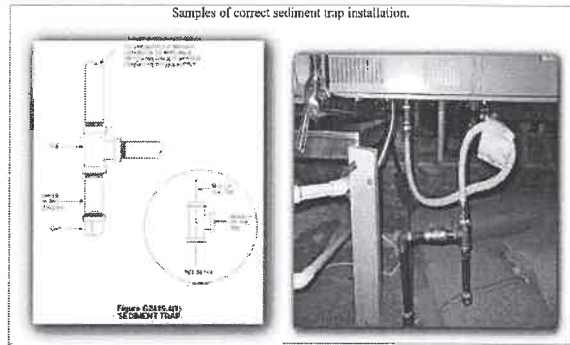
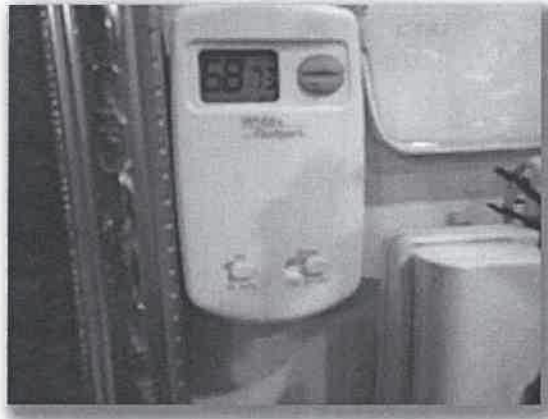
- The heater flue was observed to be terminated at the roof level into a bonnet type vent. This configuration is susceptible to back drafting which could emit Carbon Monoxide into the attic area, which is a known safety hazard.
- The heater gas supply line is not equipped with a sediment trap just before the gas appliance connector. This condition does not meet current installation requirements and should be corrected.

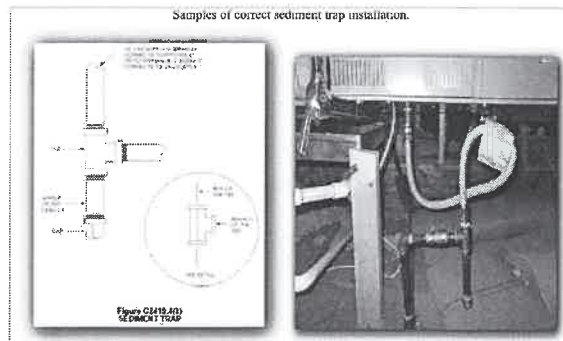
South Central Heating System – Energy Source: Gas
Brand Name: Unable To Determine

- The heater flue was observed to be terminated at the roof level into a bonnet type vent. This configuration is susceptible to back drafting which could emit Carbon Monoxide into the attic area, which is a known safety hazard.
- The heater gas supply line is not equipped with a sediment trap just before the gas appliance connector. This condition does not meet current installation requirements and should be corrected.
