PROPERTY INSPECTION REPORT FORM

Rosa Caffarena <i>Name of Client</i>	11/11/2023 <i>Date of Inspection</i>
5638 Briar Dr., Houston, TX 77056 <i>Address of Inspected Property</i>	
Will Worthen <i>Name of Inspector</i>	24920 <i>TREC License #</i>
<i>Name of Sponsor (if applicable)</i>	<i>TREC License #</i>

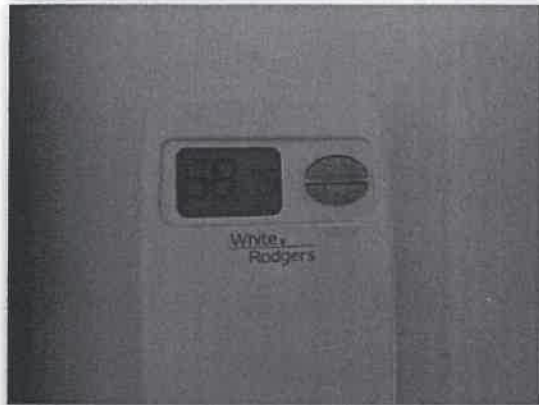
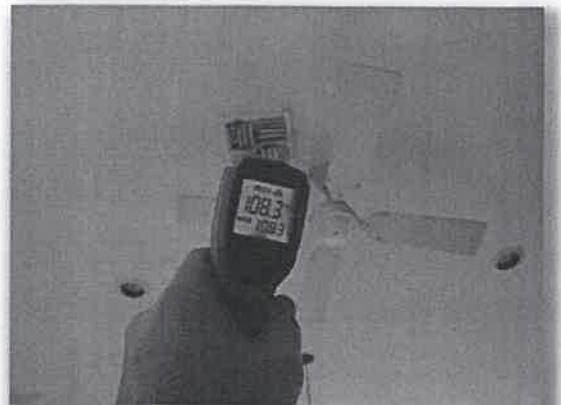
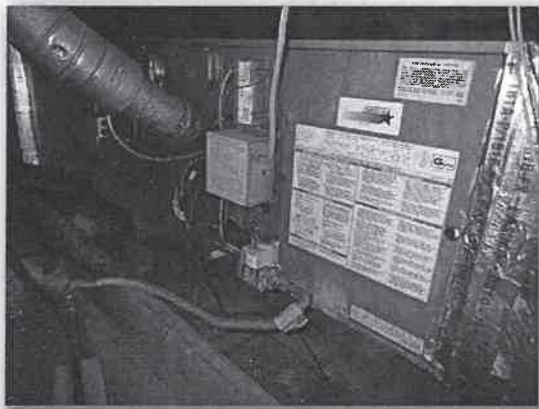
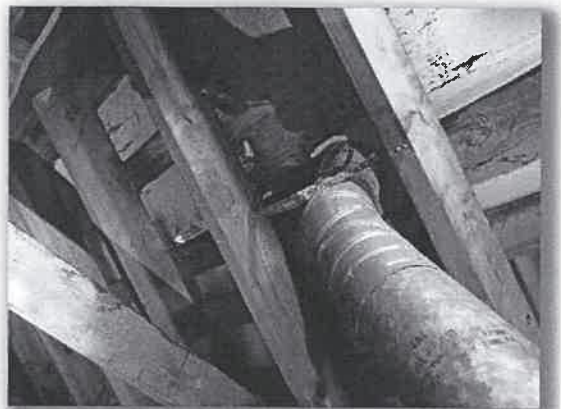
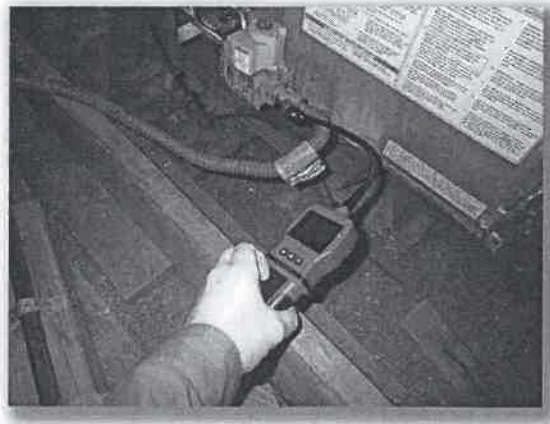
Upstairs Central Heating System – Energy Source: Gas

- The dirty air filter should be replaced.
- The heater gas supply line is not equipped with a sediment trap just before the gas appliance connector. This condition does not meet current installation requirements and should be corrected.

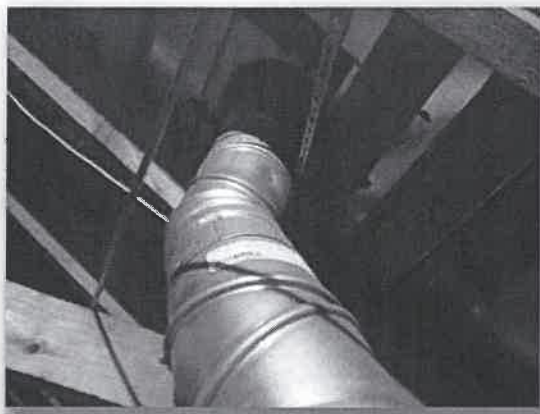
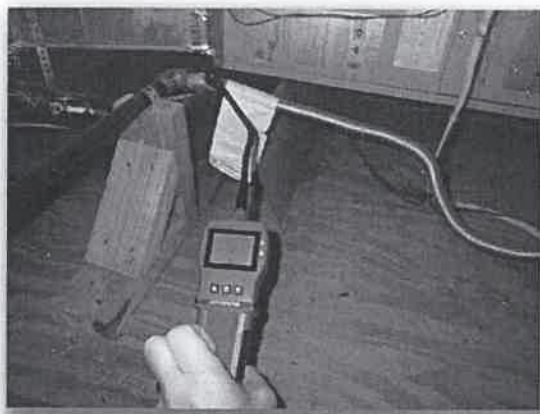
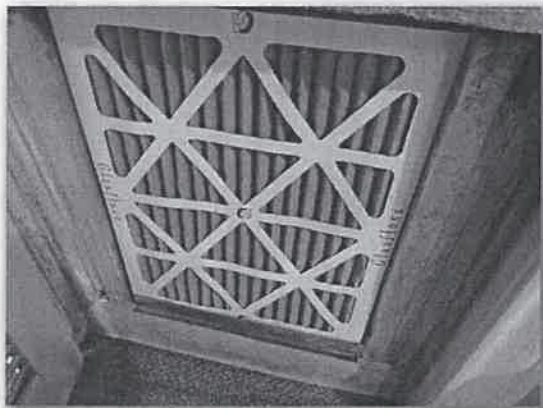
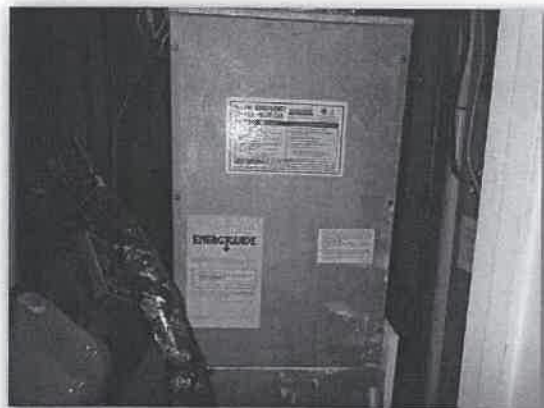
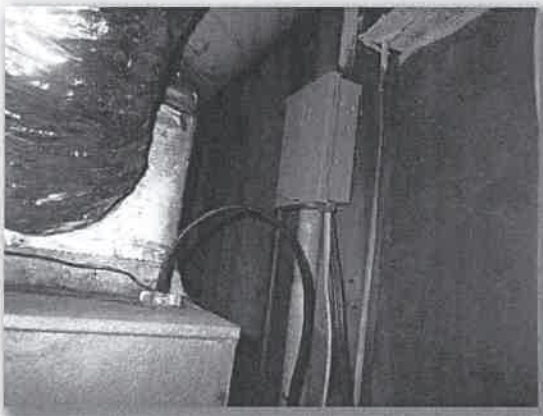
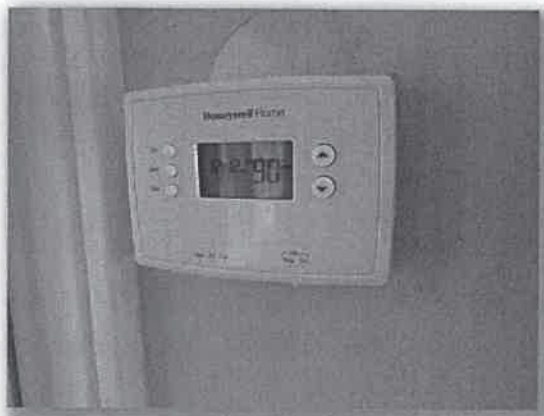
Guest Quarters Central Heating System – *Energy Source: Electric*
Brand Name: Payne

- The dirty air filter should be replaced.

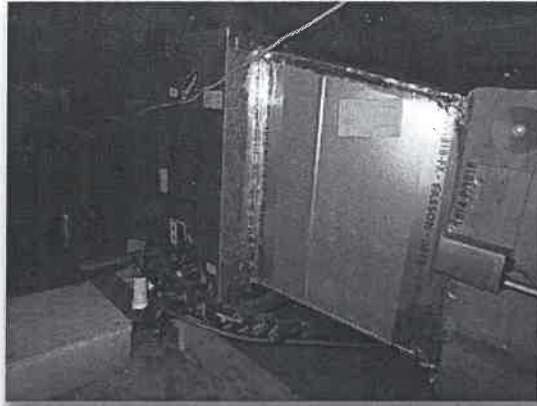
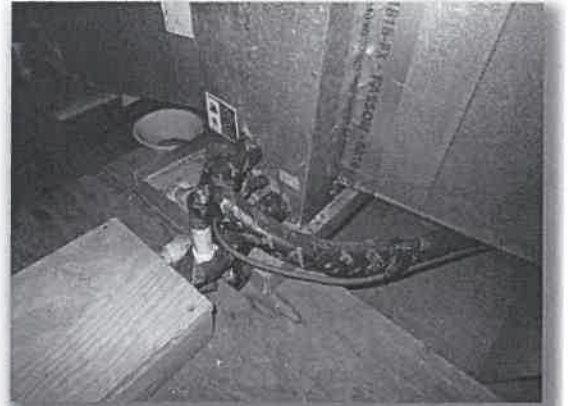
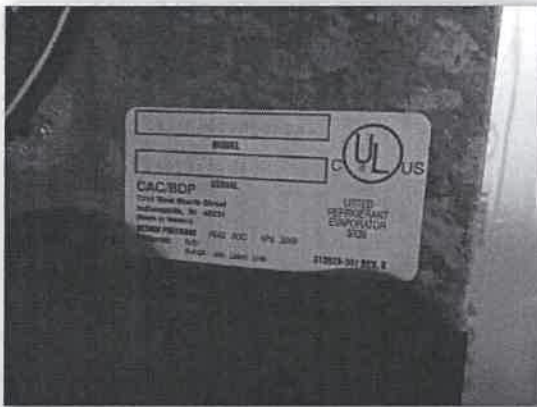
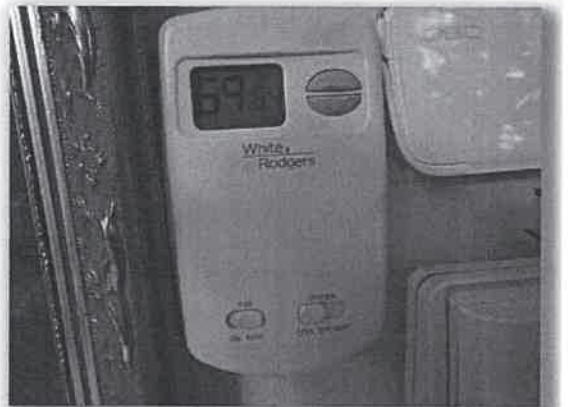
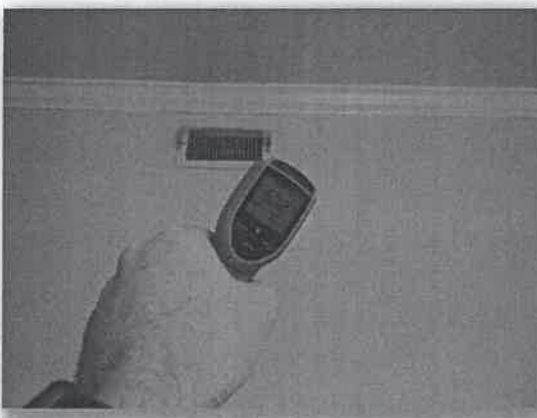
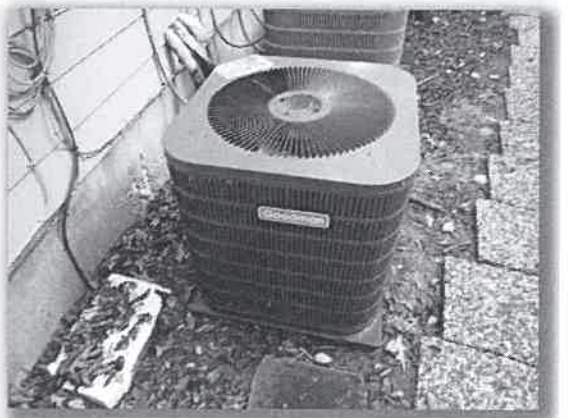
Additional Notice from the Inspector: The cooling equipment in place uses R-22 refrigerant. R-22 refrigerant is currently being phased out and is becoming progressively more expensive to obtain. You should be aware that R-22 components and their future life expectancy cannot be determined. You can continue to use and service these components until replacement is necessary.

Note: The auxiliary/secondary drain pan under the coil housing has some water staining and/or a rust build-up. This would indicate that the pan has held water in the past and should be closely monitored.

It would be wise to budget for replacement of the older freon system and to make a conversion over to a newer type of freon system as soon as it is financially feasible.

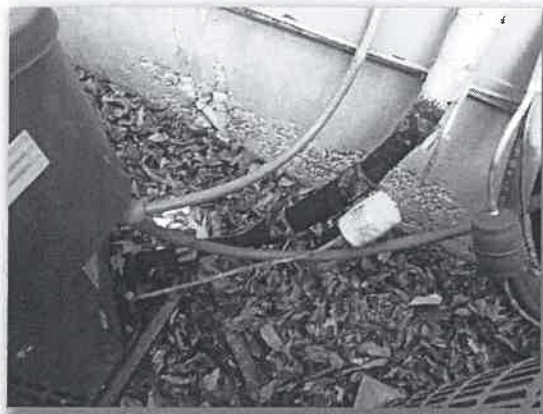
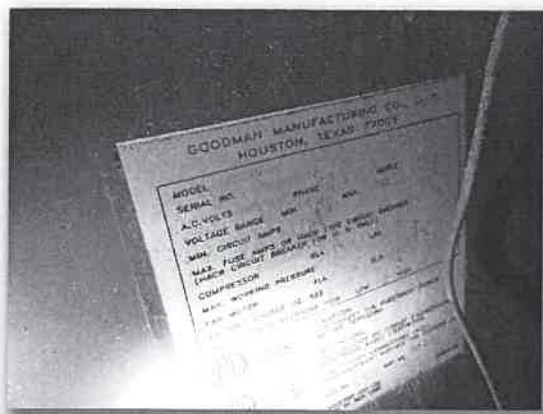
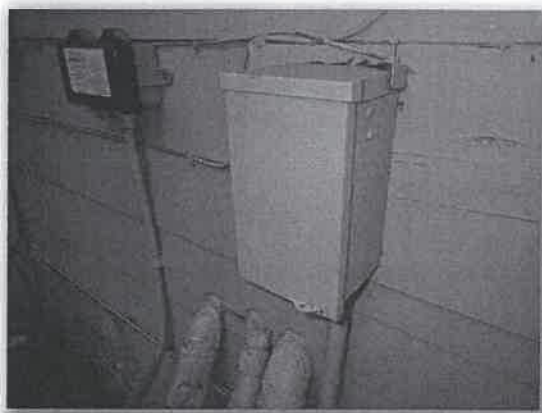
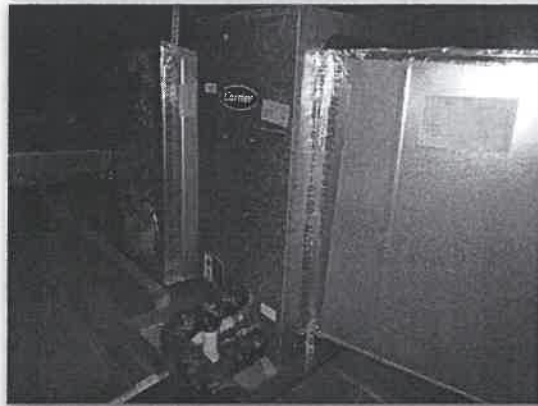
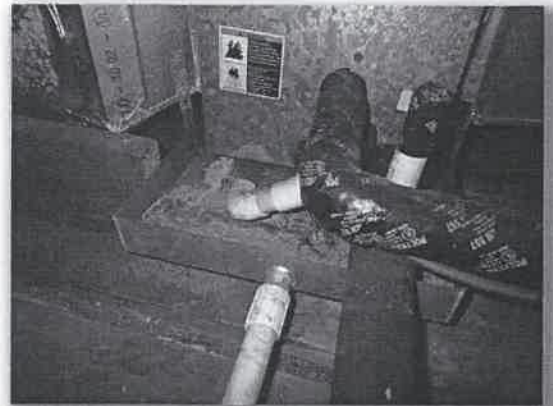
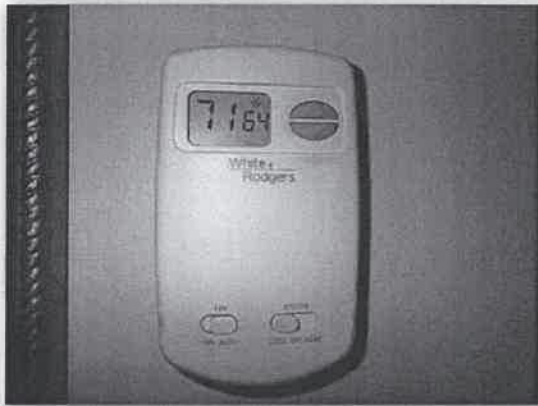
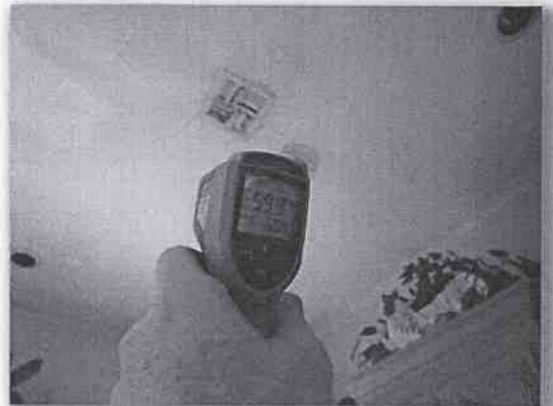
South Central Cooling System

Note: The auxiliary/secondary drain pan under the coil housing has some water staining and/or a rust build-up. This would indicate that the pan has held water in the past and should be closely monitored.

Additional Notice from the Inspector: The cooling equipment in place uses R-22 refrigerant. R-22 refrigerant is currently being phased out and is becoming progressively more expensive to obtain. You should be aware that R-22 components and their future life expectancy cannot be determined. You can continue to use and service these components until replacement is necessary.

It would be wise to budget for replacement of the older freon system and to make a conversion over to a newer type of freon system as soon as it is financially feasible.

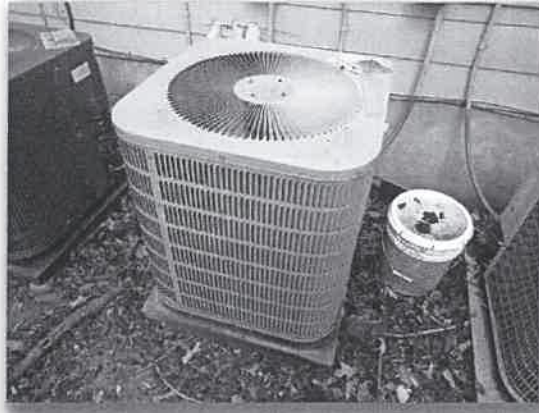
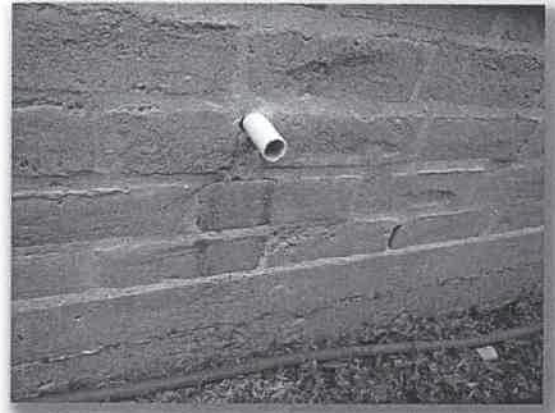
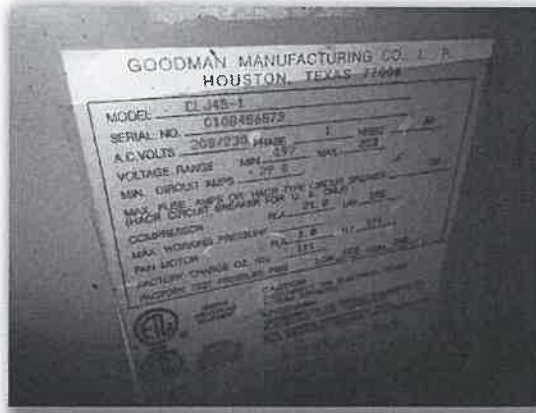
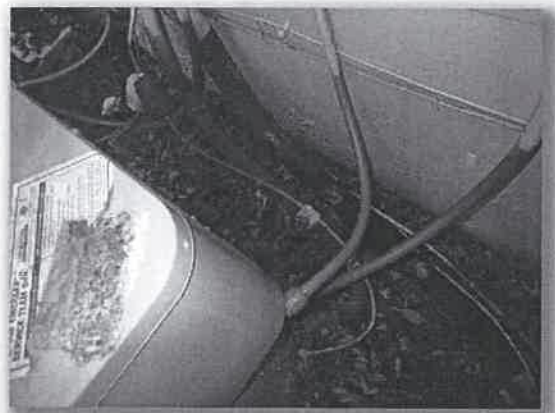
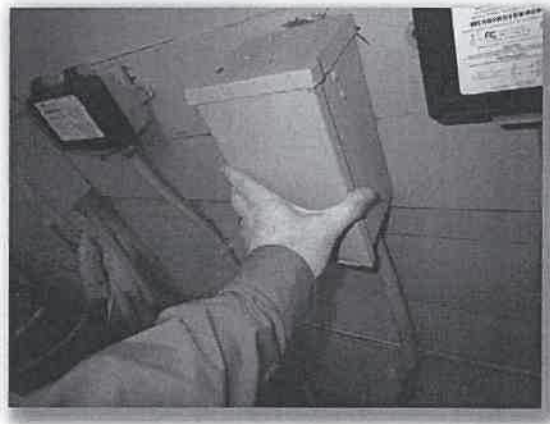
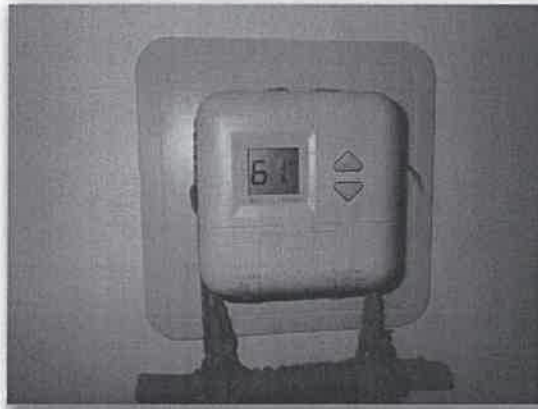
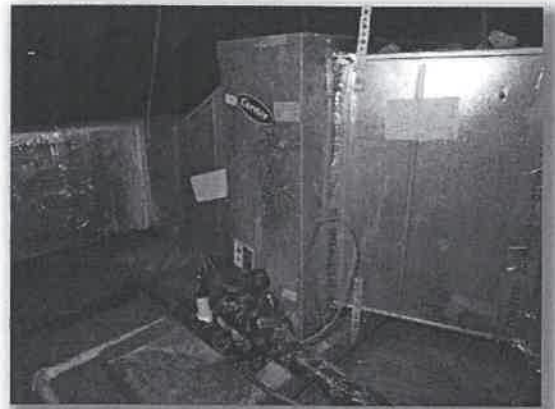
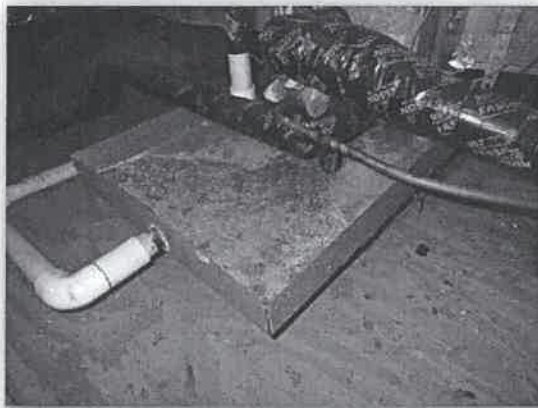
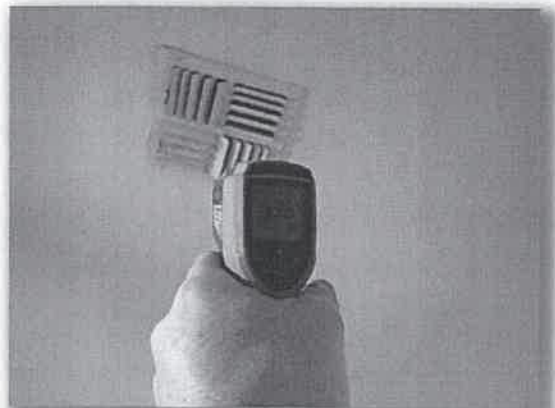
Upstairs Central Cooling System

- The outside condenser show signs of rust and/or deterioration. This condition should be further evaluated and corrected as necessary.

Note: The auxiliary/secondary drain pan under the coil housing has some water staining and/or a rust build-up. This would indicate that the pan has held water in the past and should be closely monitored.

Additional Notice from the Inspector: The cooling equipment in place uses R-22 refrigerant. R-22 refrigerant is currently being phased out and is becoming progressively more expensive to obtain. You should be aware that R-22 components and their future life expectancy cannot be determined. You can continue to use and service these components until replacement is necessary.

It would be wise to budget for replacement of the older freon system and to make a conversion over to a newer type of freon system as soon as it is financially feasible.

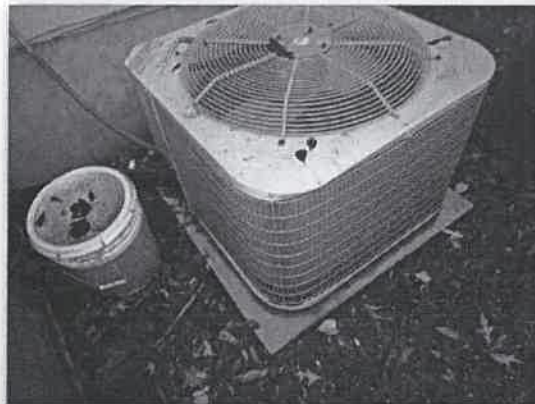
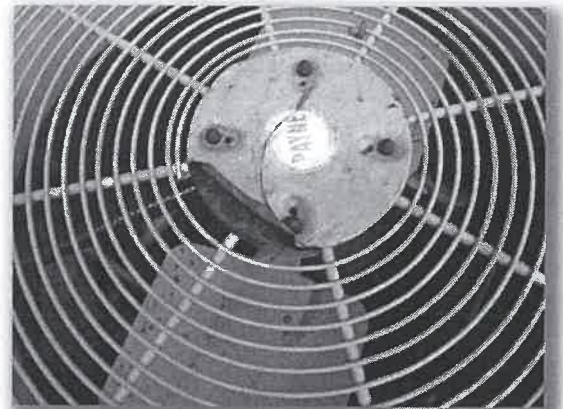
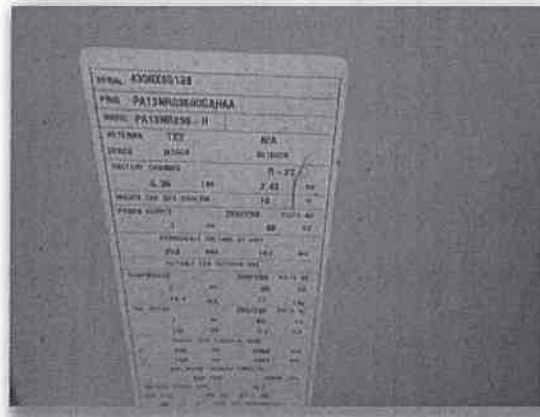
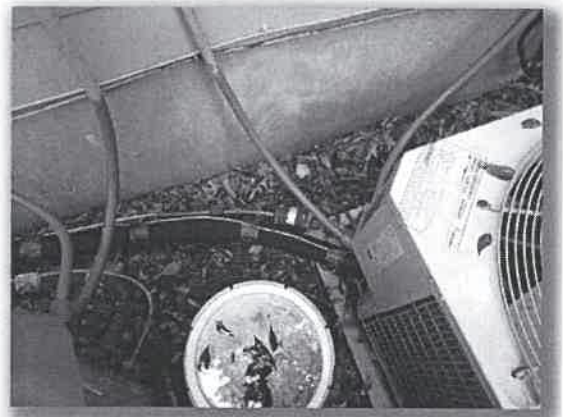
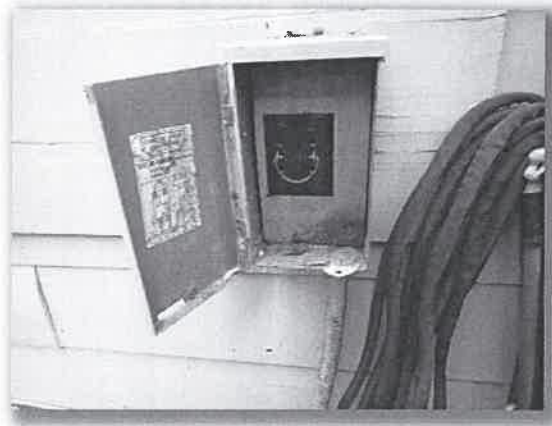
Guest Quarters Central Cooling System

Today's Temperature Differential (Delta-T): Unable to check Delta-T due to outdoor temperature.

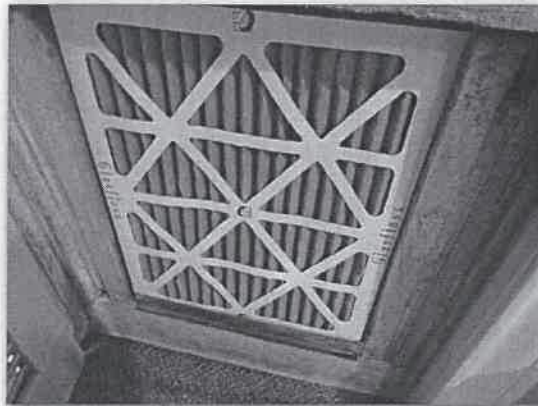
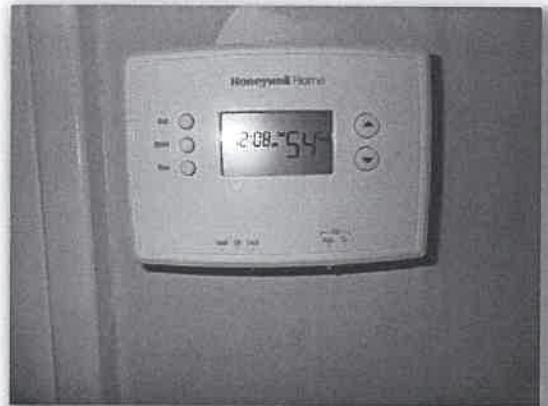
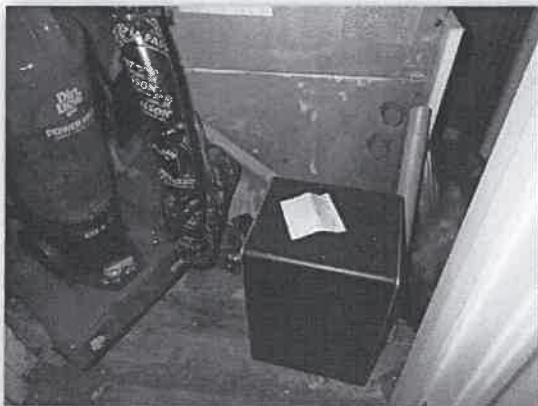
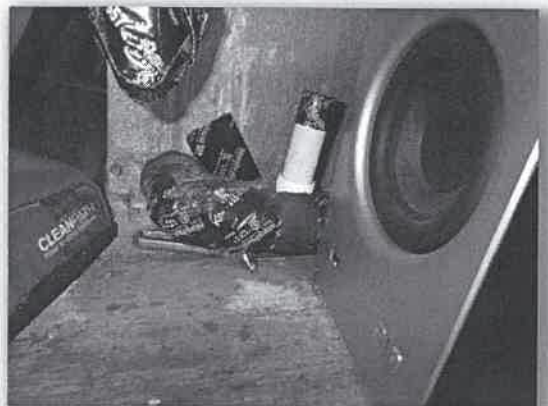
Note: Previous water leakage was observed from around the base of the indoor coil housing. This condition should be closely monitored and corrected if necessary.

Additional Notice from the Inspector: It is the opinion of this inspector that although this component may be functioning as intended or in need of minor repairs, you should be aware that this is an older component and the future life expectancy cannot be determined. You can continue to use and service this component until replacement is necessary.

Additional Notice from the Inspector: The cooling equipment in place uses R-22 refrigerant. R-22 refrigerant is currently being phased out and is becoming progressively more expensive to obtain. You should be aware that R-22 components and their future life expectancy cannot be determined. You can continue to use and service these components until replacement is necessary.

Note: The temperature differential of the cooling system could not be accurately checked due to the outside ambient temperature being below 60 Degrees. If any concerns exist about the system achieving a proper differential or the future operation of the cooling equipment, then it is recommended that a Qualified HVAC Technician further inspect and give an evaluation on the operation of the equipment and any further concerns that may exist with this equipment.

It would be wise to budget for replacement of the older freon system and to make a conversion over to a newer type of freon system as soon as it is financially feasible.

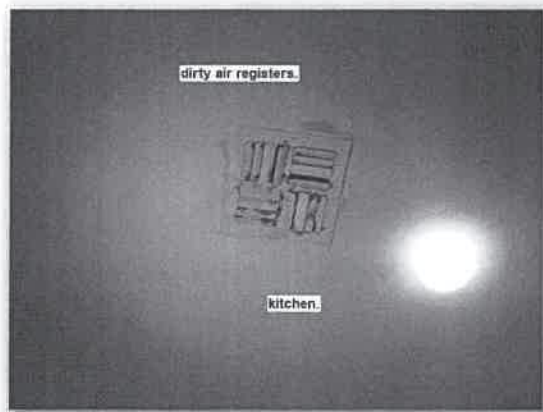
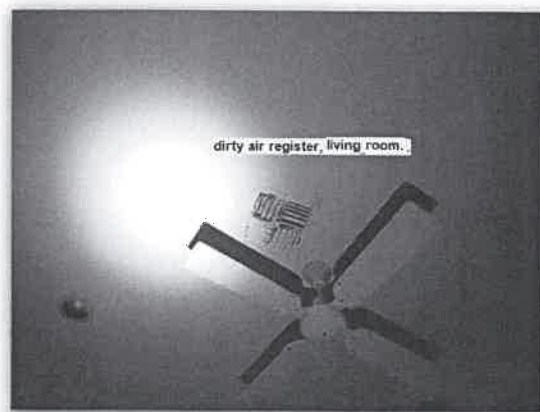
C. Duct Systems, Chases, and Vents

- There is visible dust and/or mildew on the air registers in the several locations throughout the house. The cause and remedy should be further evaluated. It is recommended to have the air registers and duct system cleaned for air quality purposes.
- The air register is loose at the ceiling in the primary bathroom closet.
- Condensation and/or water stains were observed around the air register in the kitchen, guest apartment. This condition should be further evaluated and corrected if necessary.

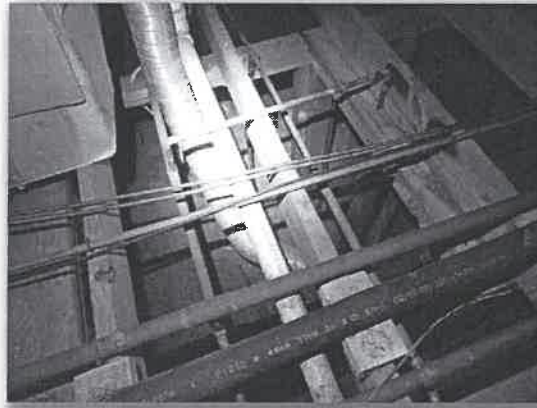
Water Supply System

- The main water shutoff is difficult to reach on the south side of the structure.

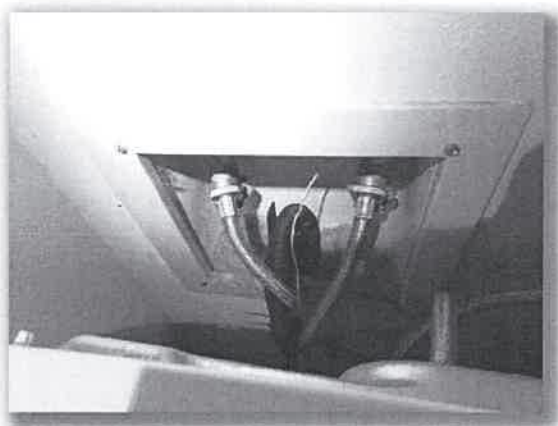
Laundry Connections

All components were found to be performing and in satisfactory condition on the day of the inspection.

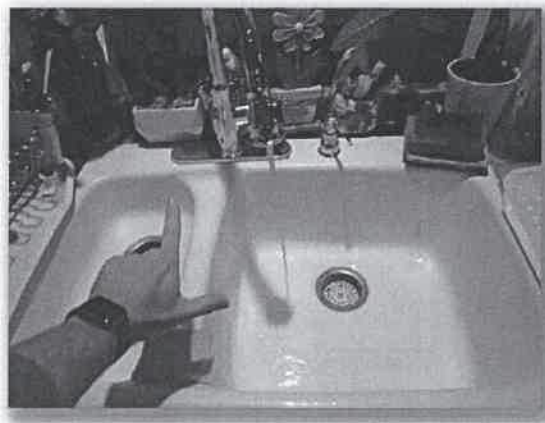
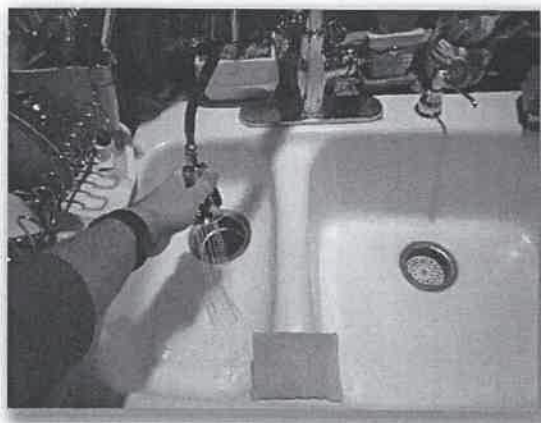
Kitchen Sink

- The faucet has low water pressure on the hot and cold sides of the faucet when operated. The cause and remedy should be further evaluated and corrected as necessary.

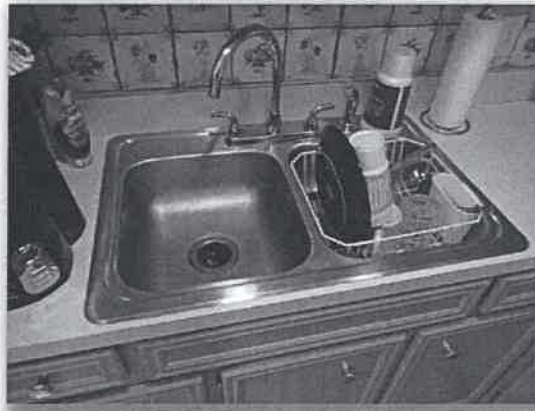
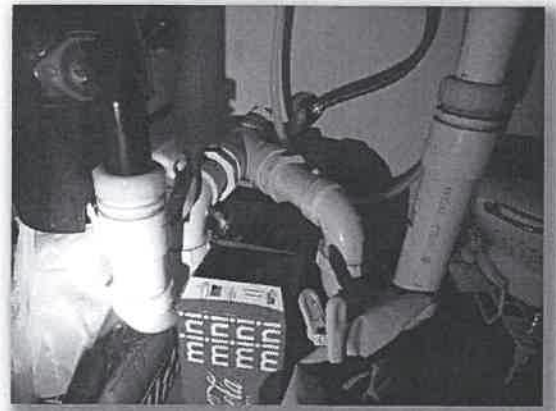
Guest Quarters Kitchen Sink

All components were found to be performing and in satisfactory condition on the day of the inspection.

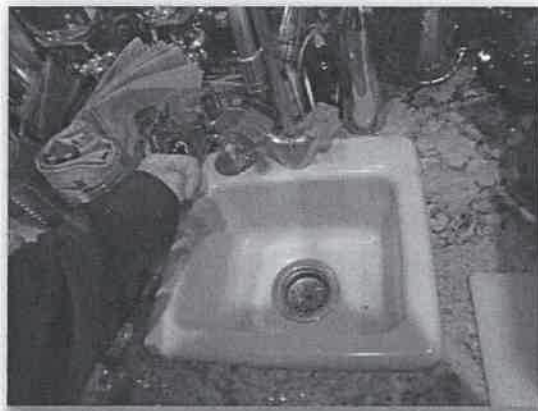
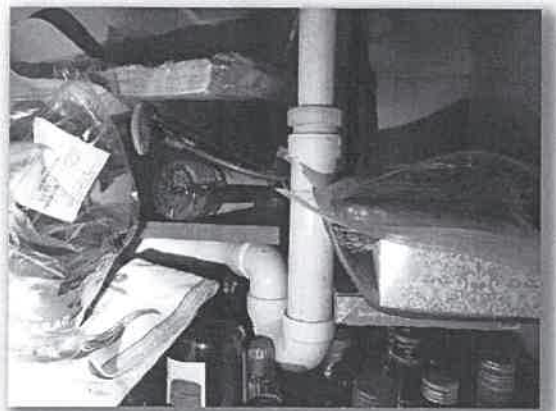
Wet Bar Sink

- The wetbar sink faucet was inoperative at the time of inspection.

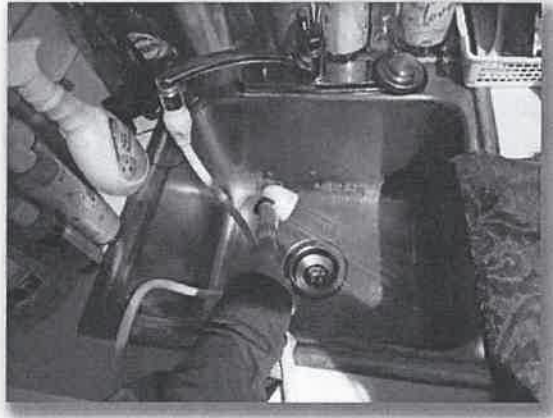
Laundry Sink

All components were found to be performing and in satisfactory condition on the day of the inspection.

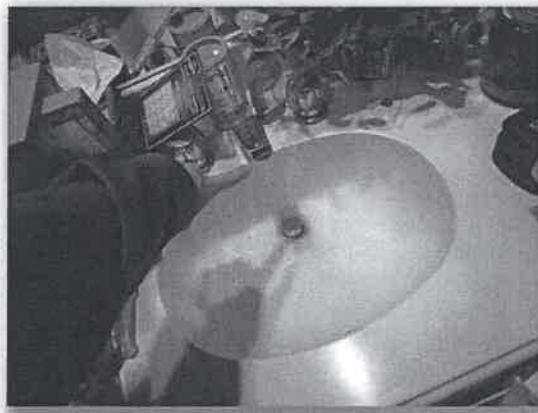
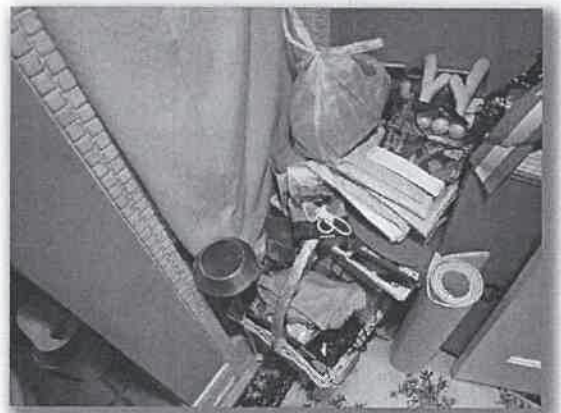
Lavatory / Sink

- The stopper does not function properly.
- The faucet aerator was observed to be clogged and should be cleaned to improve the faucet performance.

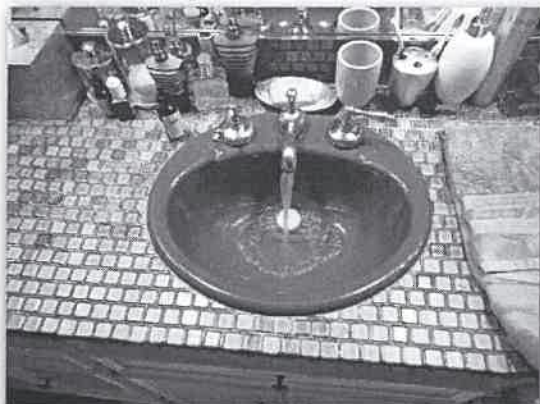
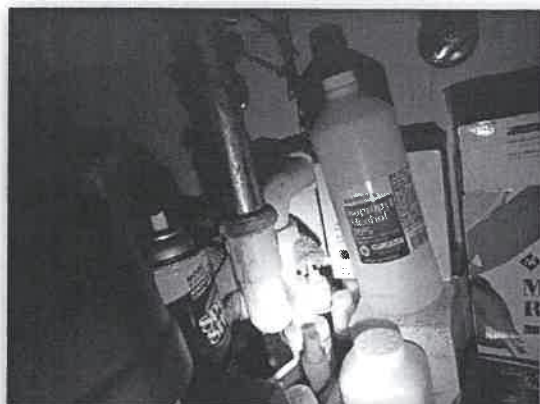
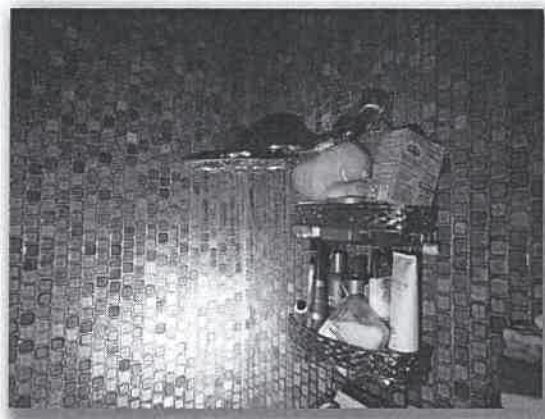
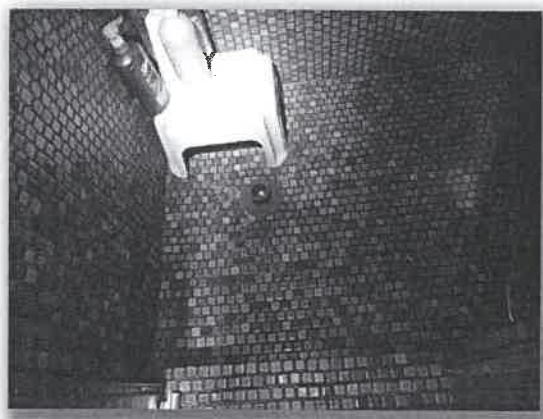
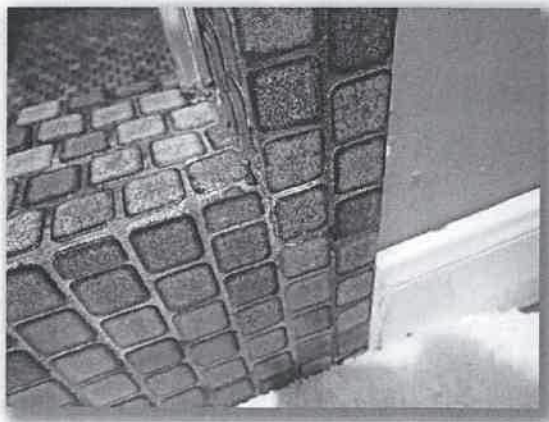
West Primary Bathroom

Bathtub

- Some of the enclosure tiles were observed to be cracked.

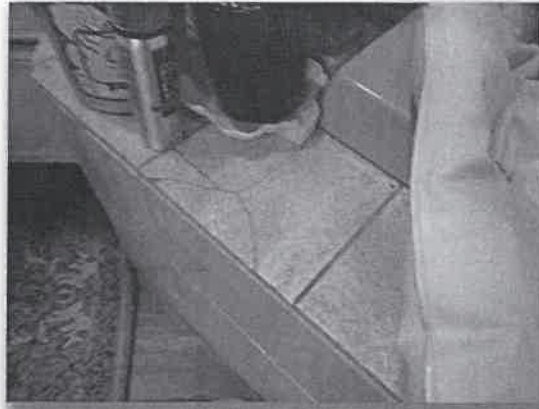
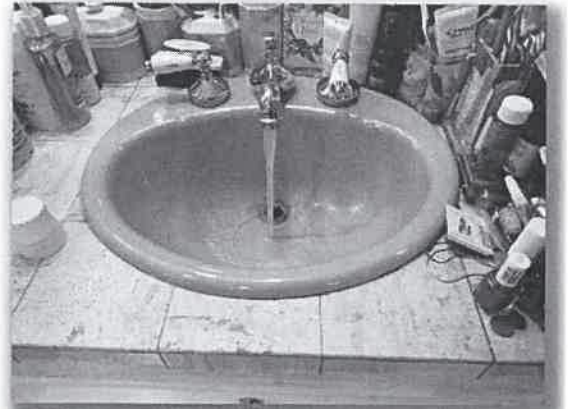
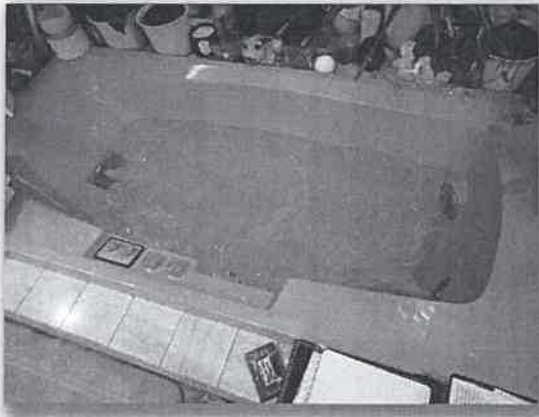
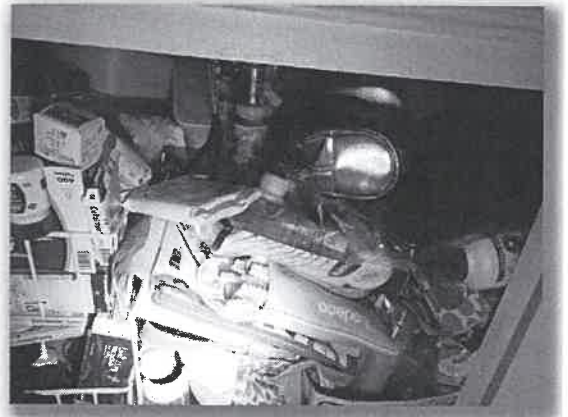
South Hall Bathroom

Commode / Toilet

- The commode is loose at the floor mount.

- The faucet aerator was observed to be clogged and should be cleaned to improve the faucet performance.
- Corrosion was observed at one and/or both of the water supply flex lines.

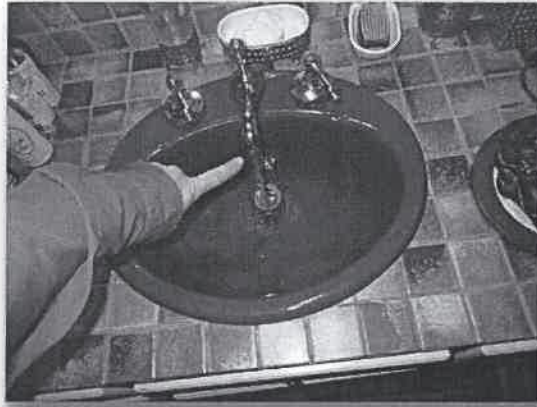
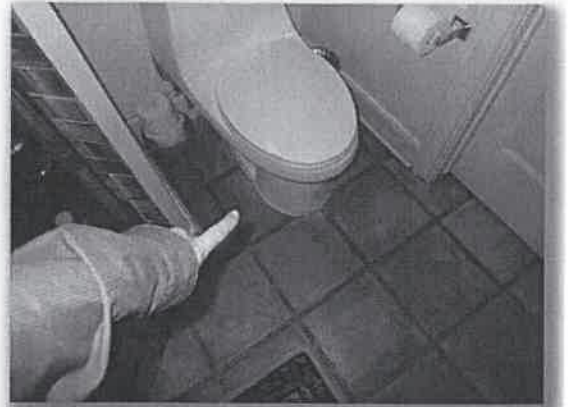
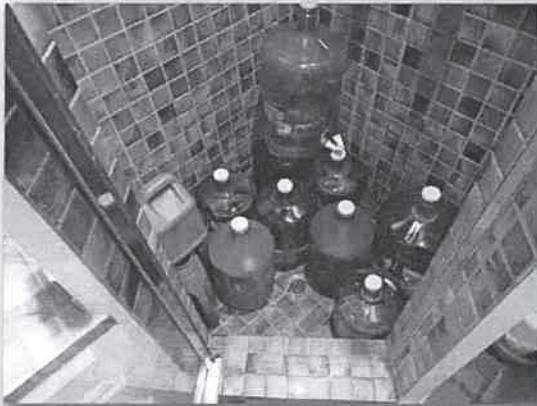
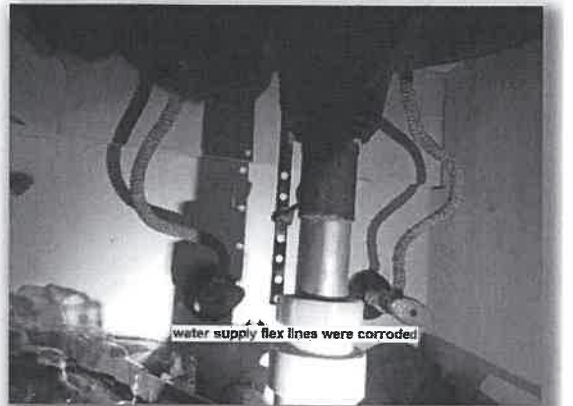
Gameroom Bathroom

Lavatory / Sink

- The faucet aerator was observed to be clogged and should be cleaned to improve the faucet performance.
- The faucet has no water on the cold side of the faucet when operated. The cause and remedy should be further evaluated and corrected as necessary.

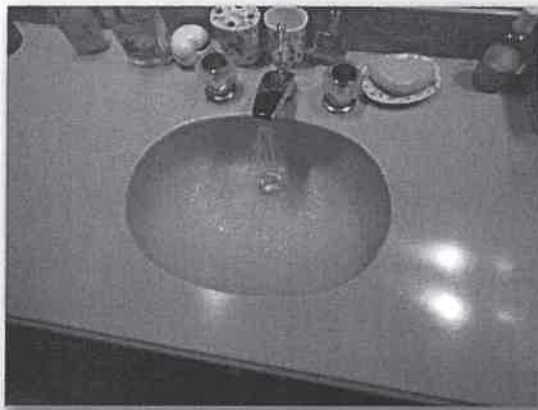
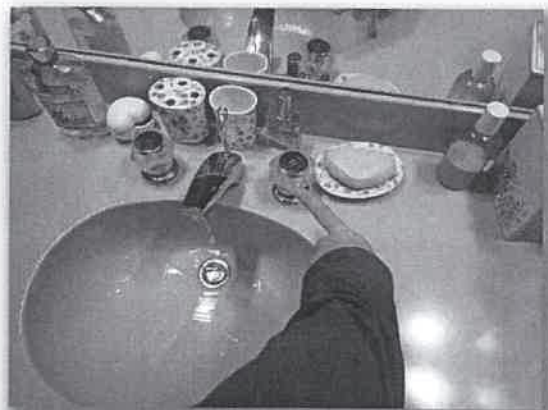
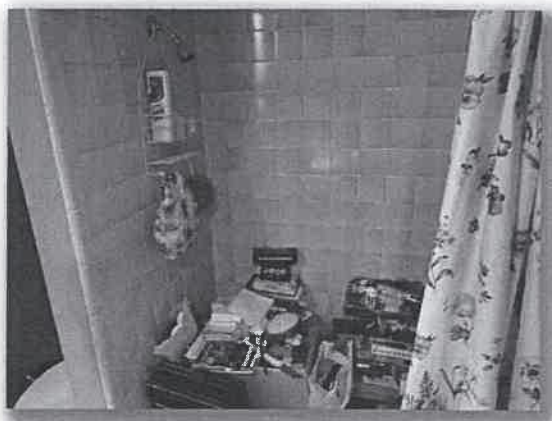
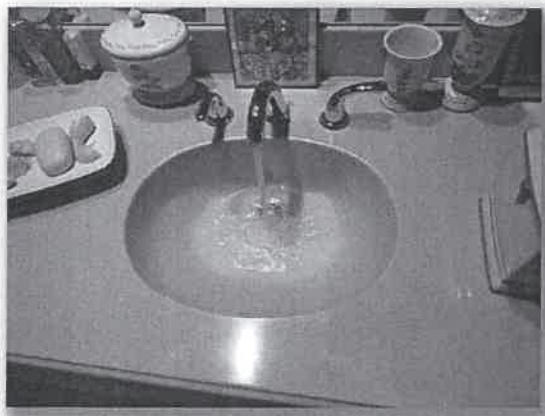
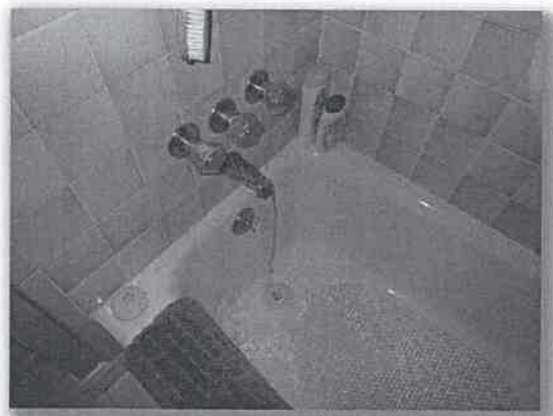
Bath Between Rooms – “Jack & Jill Bath”

Commode / Toilet

- The commode is loose at the floor mount.

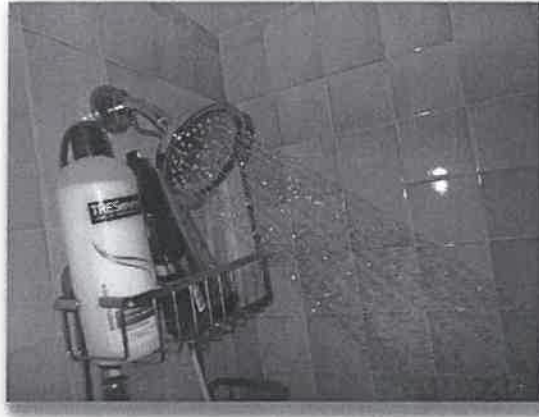
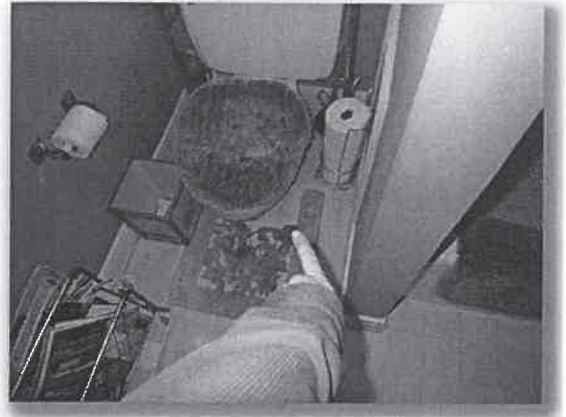
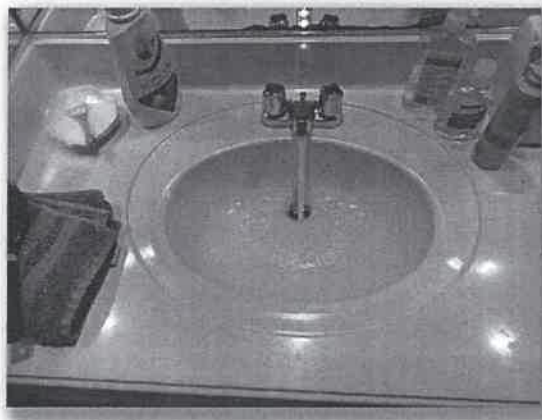
Guest Apartment Bathroom

Shower

- The shower spout is leaking at the neck connection.

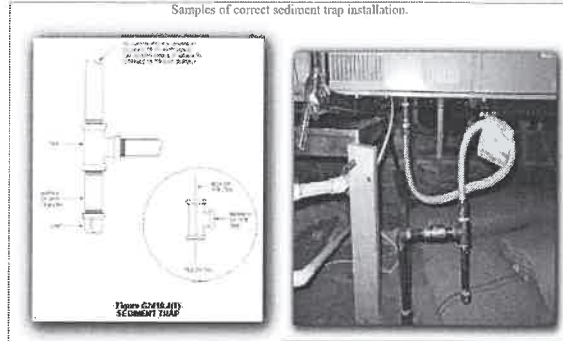
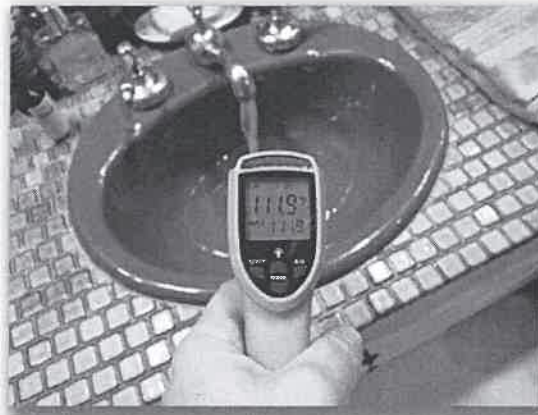
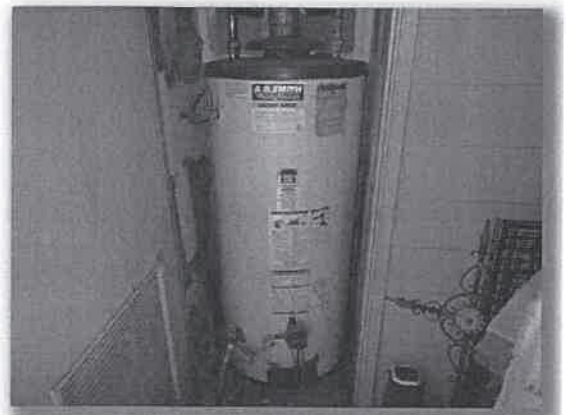
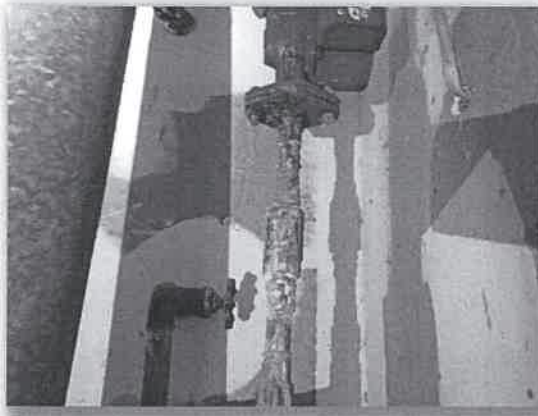
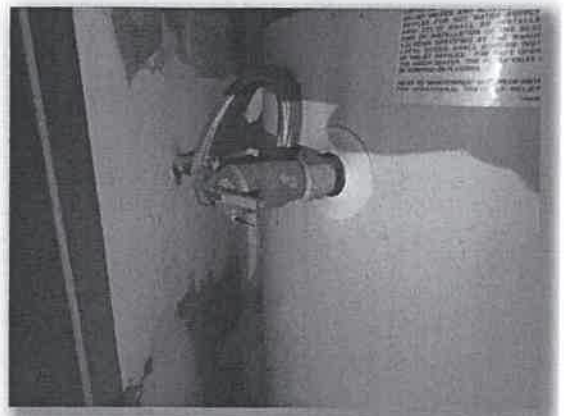
- Some corrosion was observed at the water supply connections at the top of the water heater.
- The water heater gas supply line is not equipped with a sediment trap just before the gas appliance connector. This condition does not meet current installation requirements and should be corrected.
- The temperature and pressure relief (TPR) valve discharge pipe is running in an upwards direction in one or more locations. The TPR discharge pipe should run gravitationally downwards at all points.
- The temperature and pressure relief (TPR) valve discharge pipe is running in an upwards direction in one or more locations. The TPR discharge pipe should run gravitationally downwards at all points.
- There is no pan installed under the water heater.

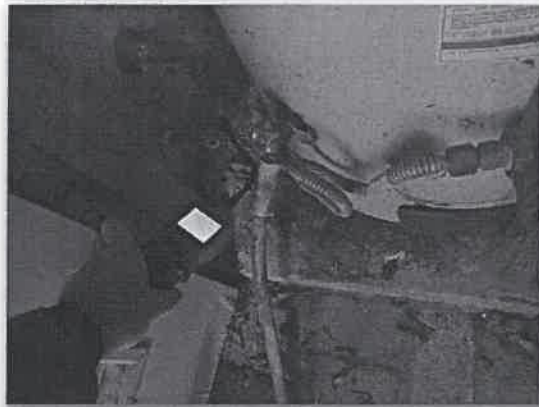
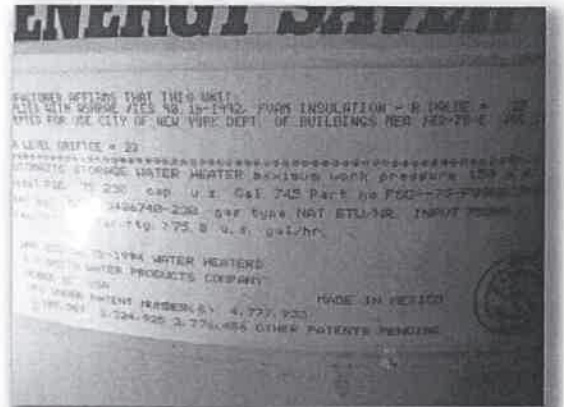
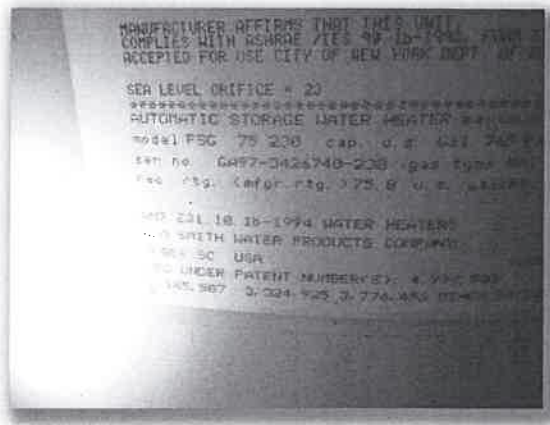
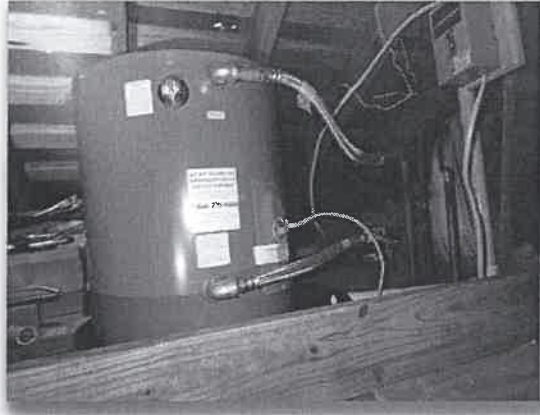
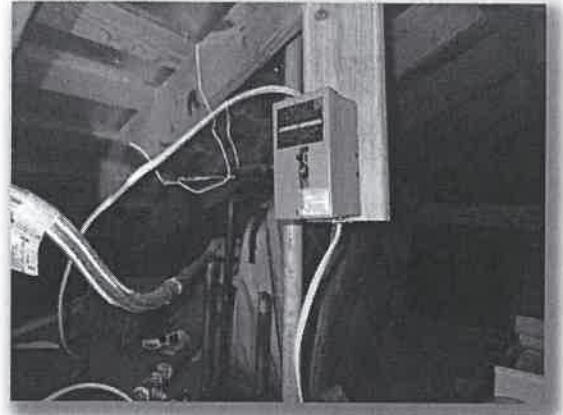
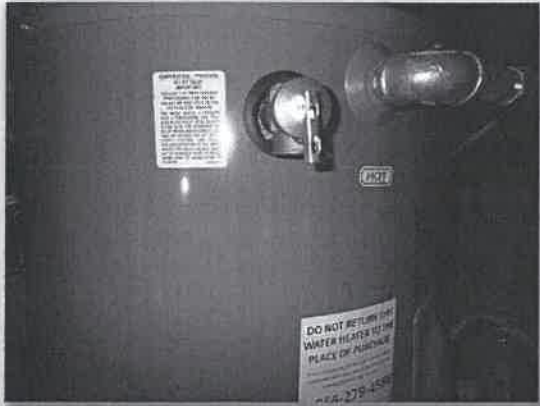
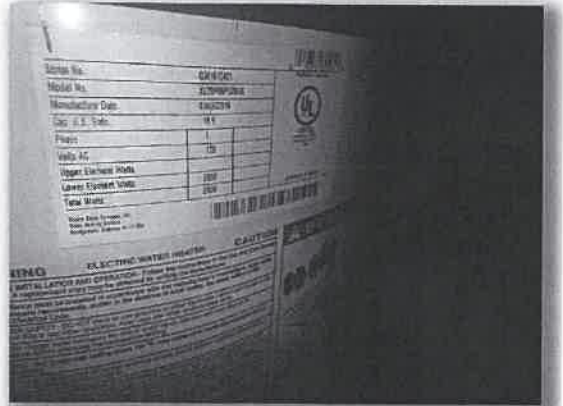
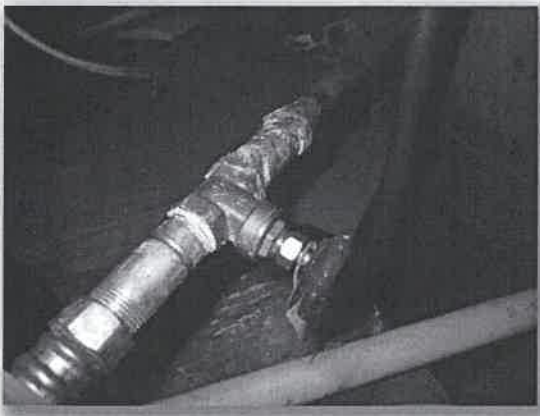
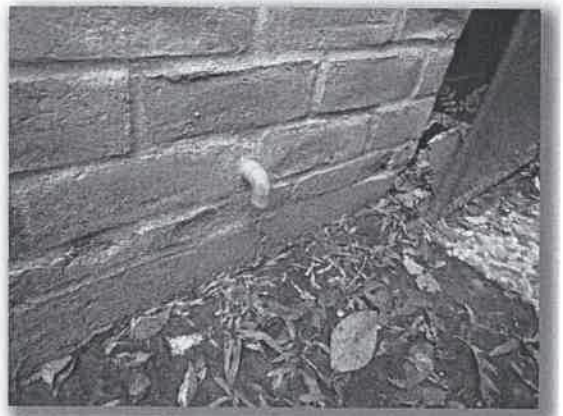
Guest Quarters Water Heater – Energy Source: Electric

- There is no temperature and pressure relief valve (TPR) discharge pipe in place at the time of this inspection. For safety reasons, it is recommended that a TPR valve discharge pipe be installed. Under current building standards, the discharge pipe should run downward to the exterior of the structure, turn downward, and terminate within 6-inches of the ground.
- Some corrosion was observed on the water supply shutoff valve.
