PROPERTY INSPECTION REPORT FORM

Rosa Caffarena <i>Name of Client</i>	11/11/2023 <i>Date of Inspection</i>
5638 Briar Dr., Houston, TX 77056 <i>Address of Inspected Property</i>	
Will Worthen <i>Name of Inspector</i>	24920 <i>TREC License #</i>
<i>Name of Sponsor (if applicable)</i>	<i>TREC License #</i>

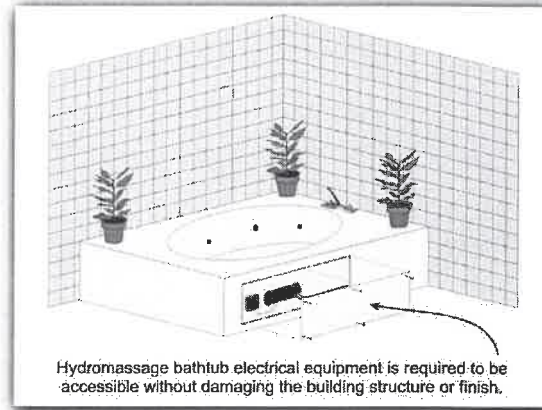
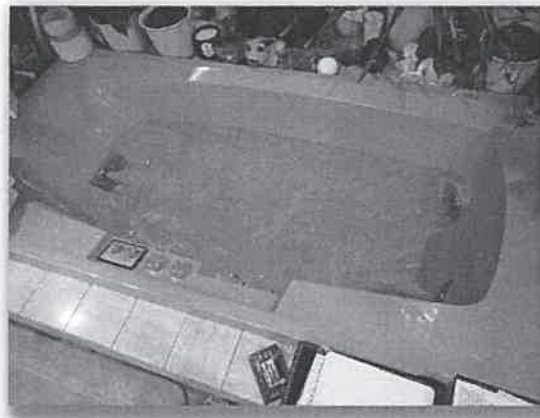
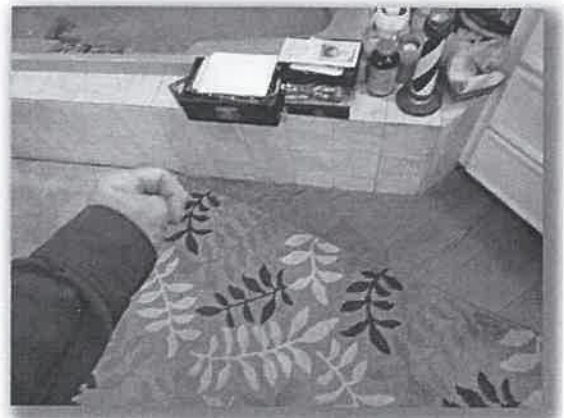
D. Hydro-Massage Therapy Equipment

- I was unable to locate a ground fault circuit interrupter (GFCI) receptacle or breaker for the hydro-massage therapy equipment. The homeowner should be consulted on the location of this GFCI device. If there is no GFCI device installed on the hydro-massage therapy equipment circuit, a GFCI receptacle or breaker should be installed for reasons of safety.

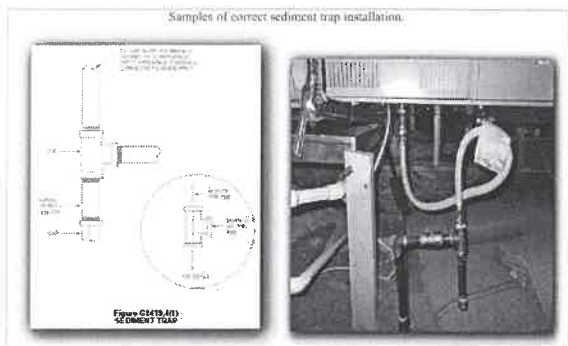
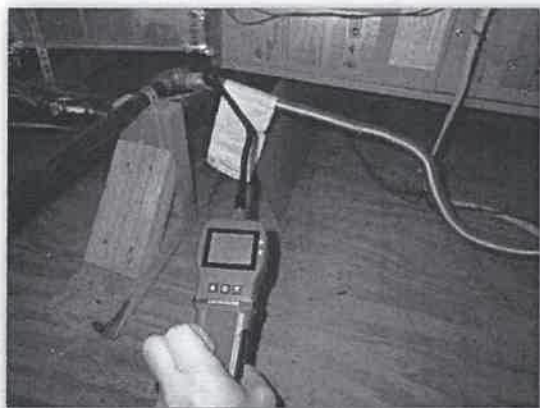
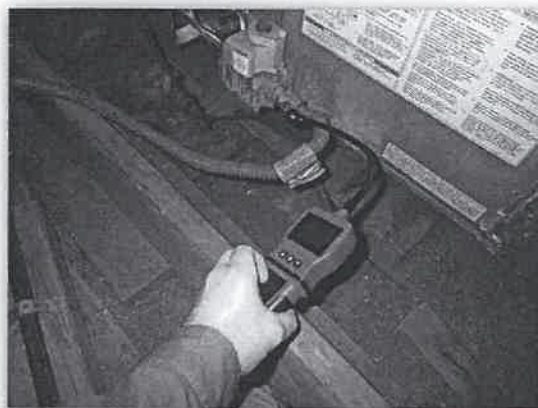
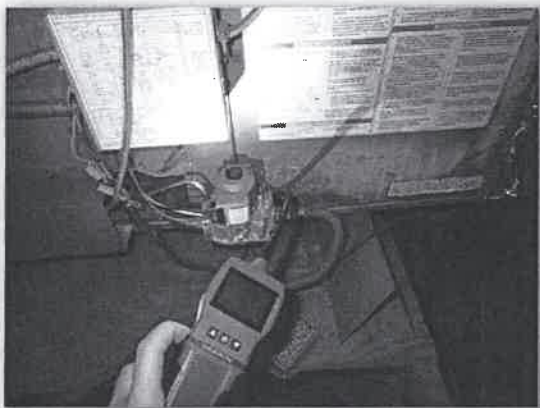
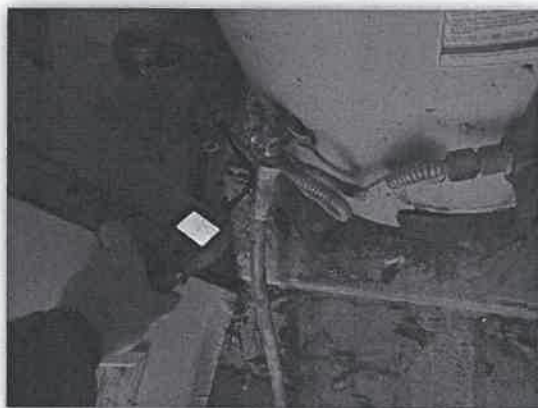
- The Water Heater, Heater gas supply line is not equipped with a sediment trap just before the gas appliance connector. This condition does not meet current installation requirements and should be corrected.
- There is an improper copper connection at the gas service meter.

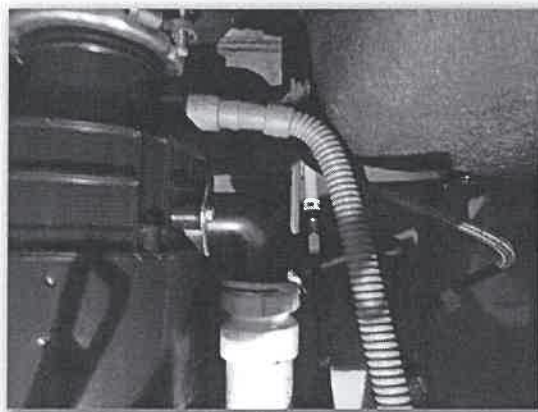
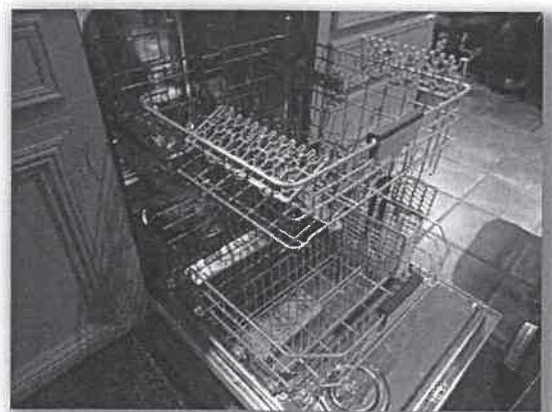
- The dishwasher was inoperative at the time of this inspection.
- The dishwasher drain hose is not properly installed to prevent back flow or anti-siphoning. It is recommended that an air gap device or high drain loop be installed in the drain line.

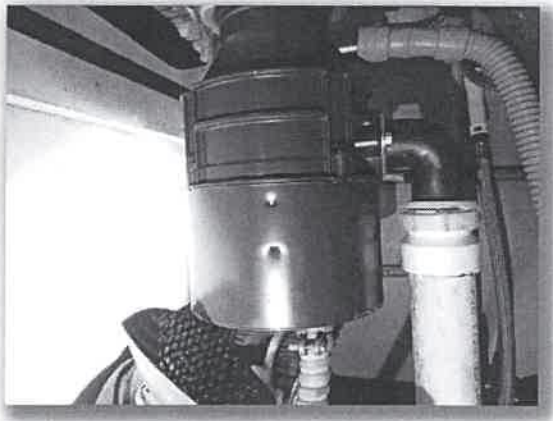
Guest Apartment Food Waste Disposer

- The electrical wiring to the food waste disposer is not properly secured to the disposer housing.

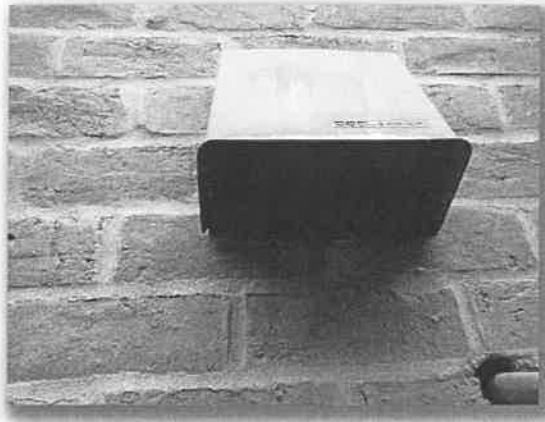
Guest Apartment Range Exhaust Systems

- The range exhaust vent fan is inoperative.
- The range exhaust vent pipe termination is not properly sealed in the cabinet.

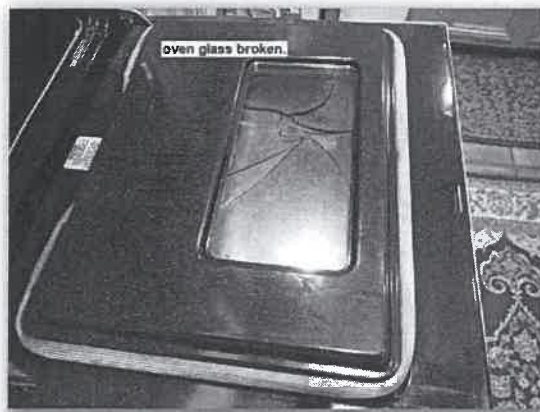
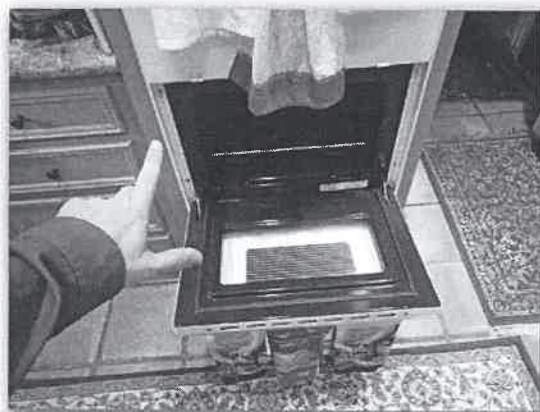
- One or more of the cooktop burners are inoperative and should be further evaluated.
- The ignition device is not functioning properly at the time of this inspection. One or more of the cooktop burners would not light by the pilot and should be further evaluated.
- The top oven door glass was damaged.
- The bottom oven light is inoperative.

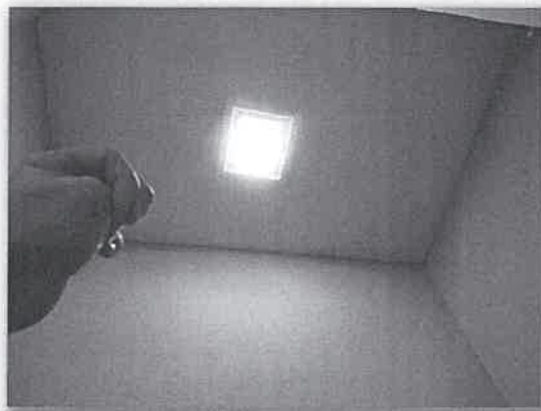
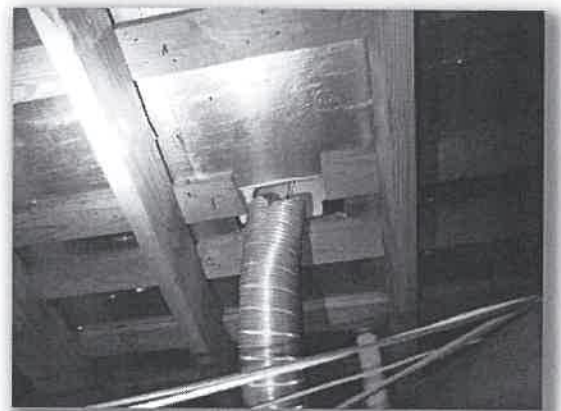
- The mechanical exhaust vent fan was noisy in the west primary bathroom, primary bathroom.
- The mechanical exhaust vent fan is loose at the ceiling in the guest apartment bathroom.

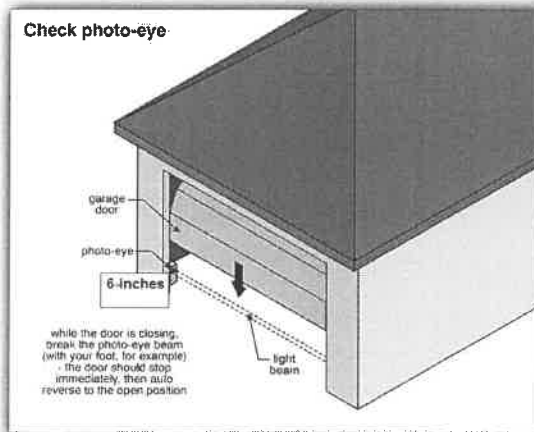
- When an automatic garage door opener is in use, the manual lock should be disabled or removed.
- The garage door reverse sensors are not properly installed. The garage door reverse sensors should be installed within 6-inches of the garage floor.

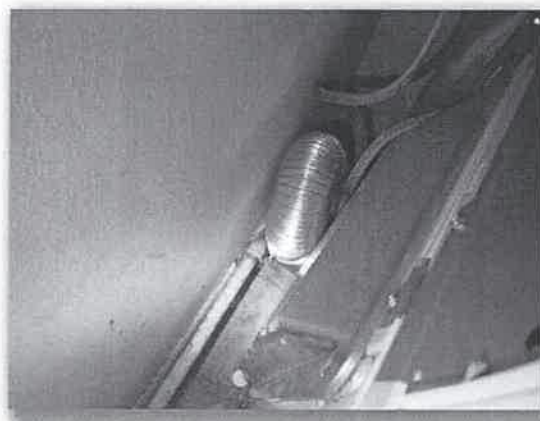
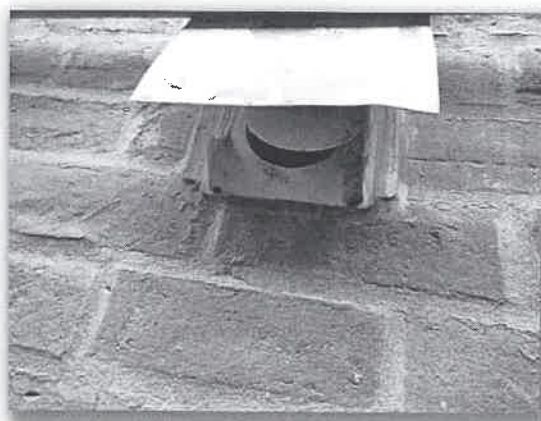
- The damper at the dryer exhaust termination does not function properly. The damper does not reset to the closed position when not in use.

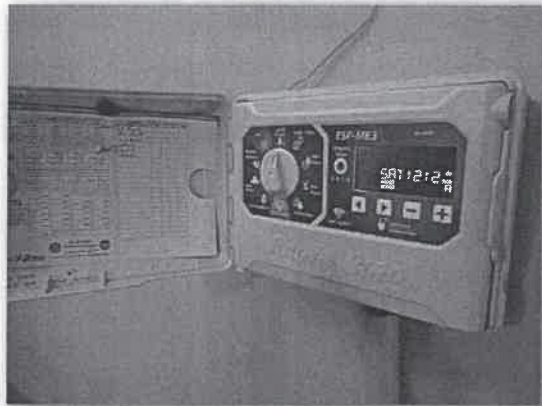
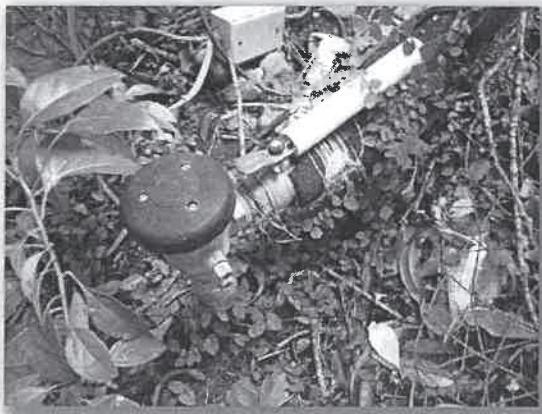
Sprinkler System and Associated Components

- I was unable to locate a moisture (rain / freeze) sensor device for the sprinkler system. This is an “*as-built*” condition, but Per TREC standards of practice we are required to report this condition as a deficiency.
- One or more of the sprinkler heads should be adjusted so not to disperse water onto concrete flatwork (such as; roadways, sidewalks, porches, patios or driveways) in station(s); 2, 3.
- One or more of the sprinkler heads were observed to be damaged and/or missing in station(s); 4.

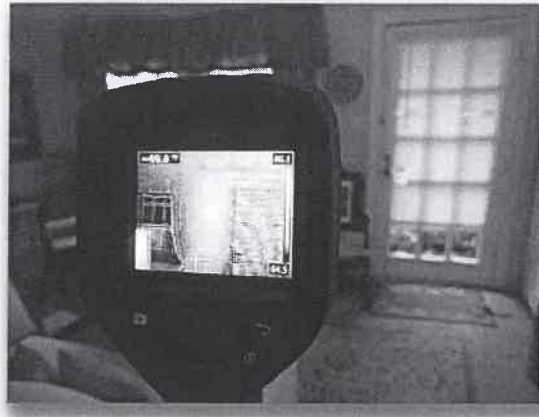
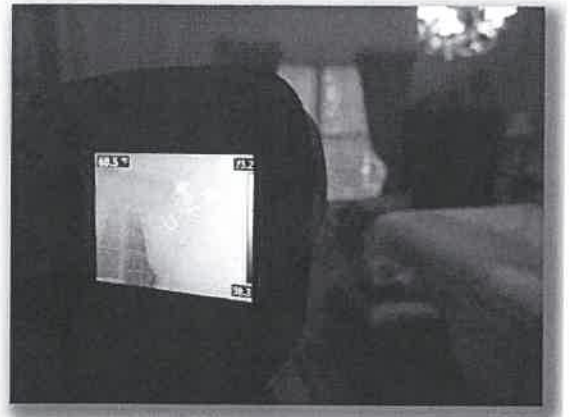
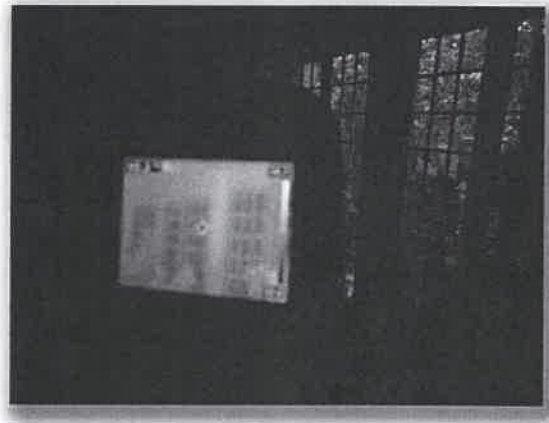
All components were found to be performing and in satisfactory condition on the day of the inspection.

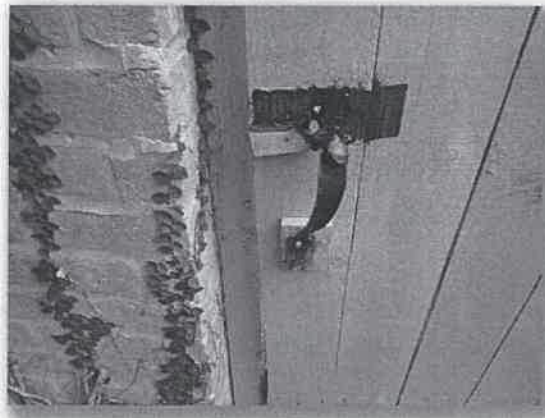
- The gate for the fence does not function properly and repairs are recommended.
