True Grit Home Inspection

Property Inspection Report

12726 Shady Knoll Ln, Cypress, TX 77429

Date of Inspection: 2/6/2021 Time: 10:00 AM

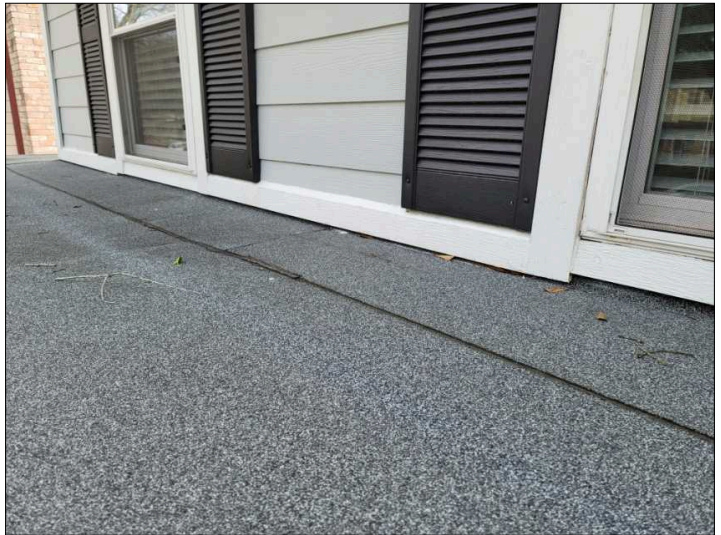
- Felt paper is not on top of drip edge. Should be under drip edge to provide "shingling" effect, to all water to flow off house, not under drip edge.
- Missing kick out flashing to divert water away from house or areas of possible damage.
- Lifted flashing. Should be flat and prevent water and wind penetration.
- **Low sloped section appears to be holding water, lifted flashing, may leak.. over garage**

Roll roofing at low sloped section.. front over garage

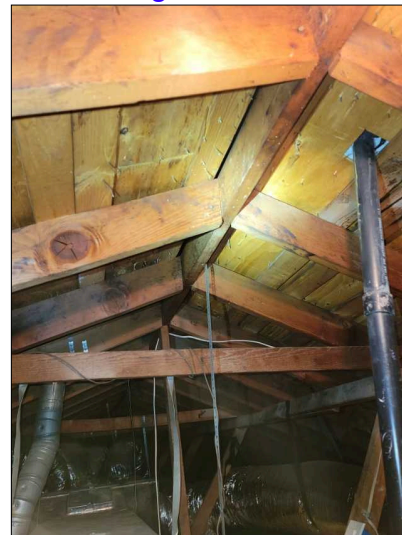
Ridge beam too small, lack of adequate ventilation..upper attic

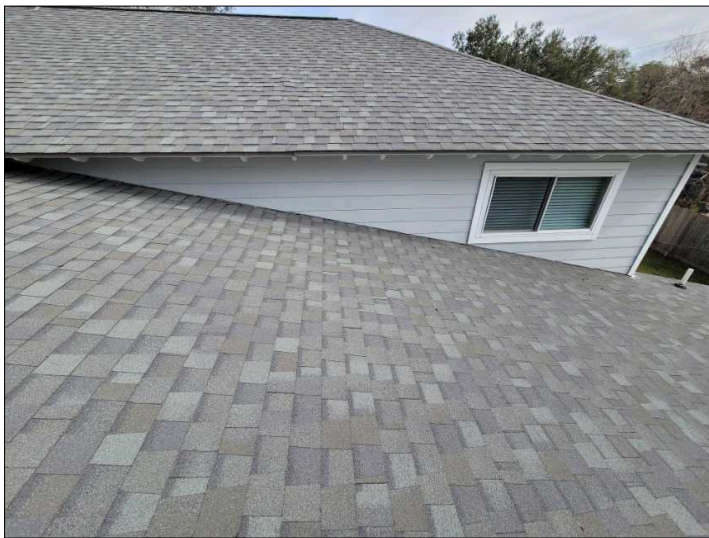
Wall lacks minimum 1" clearance from shingles..right side

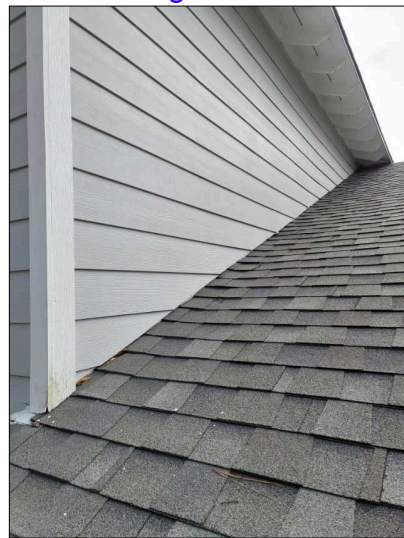
Wall lacks minimum 1" clearance from shingles..right side

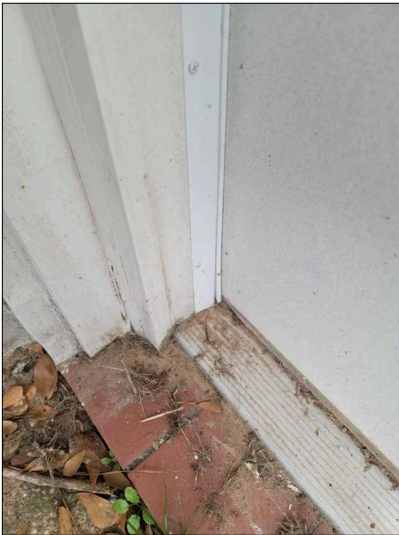
Rotted wood trim..rear garage door

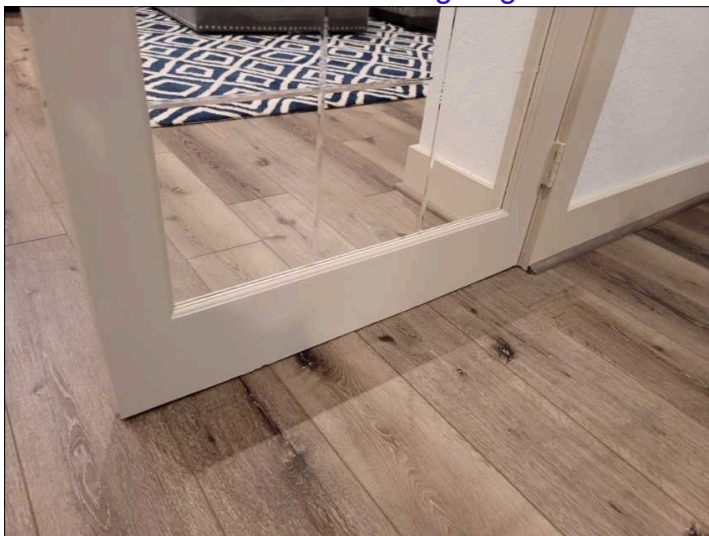
Dining/living room door rubs at floor

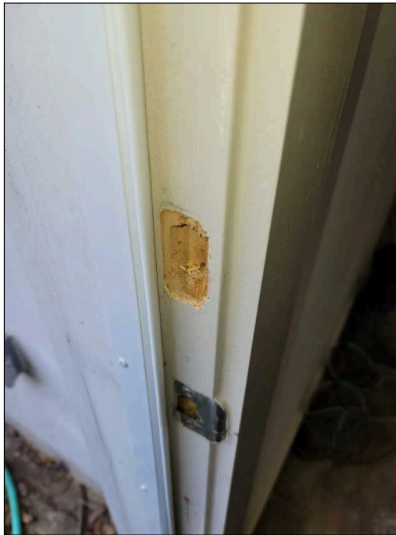
Missing deadbolt strike plate.. garage rear door

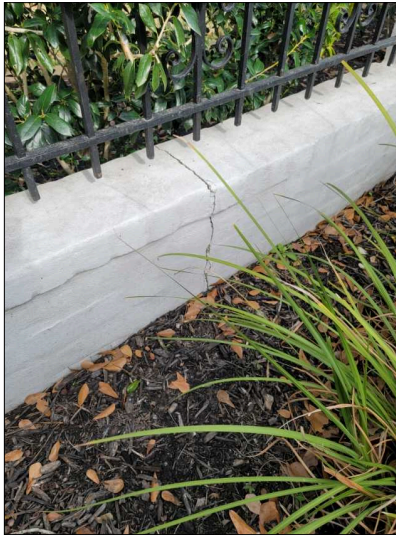
Brick crack at front patio wall.. front

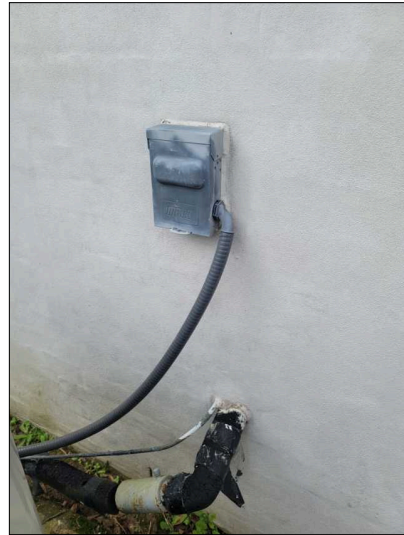
Disconnect behind unit..left side

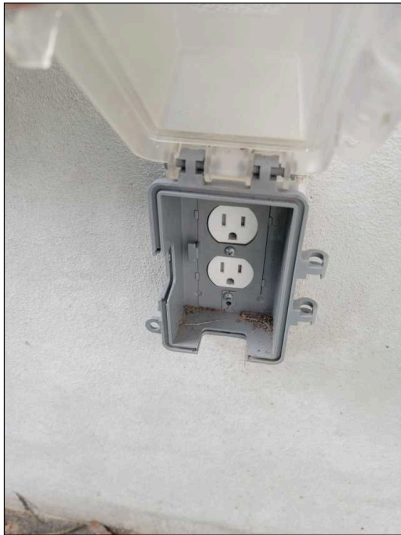
No GFCI protection at outdoor outlet..rear garage door

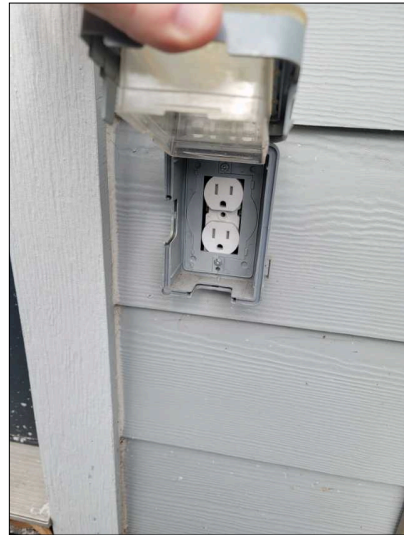
No GFCI protection..back door

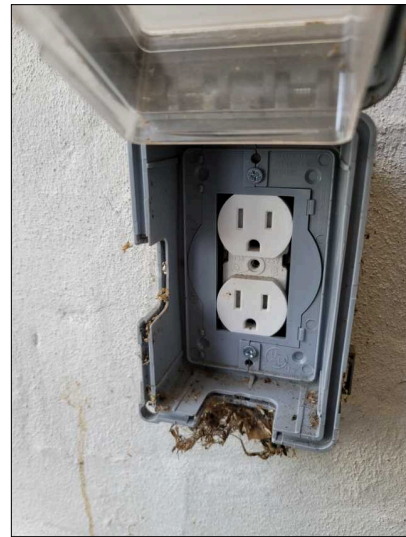
No GFCI protection..front door

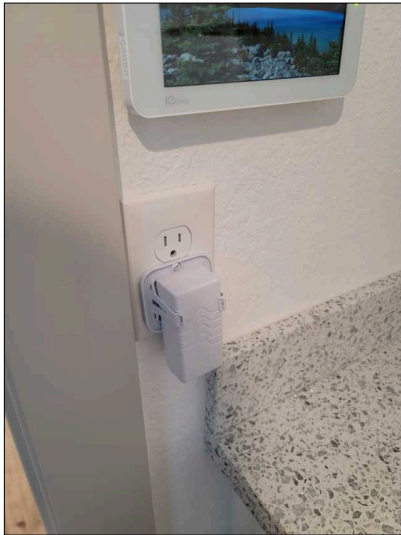
No GFCI protection at laundry sink

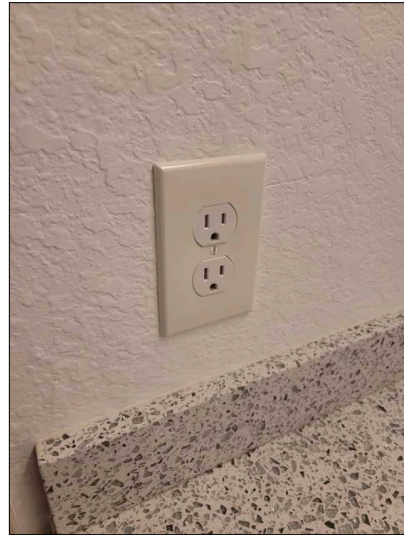
No GFCI protection at garage bathroom outlet

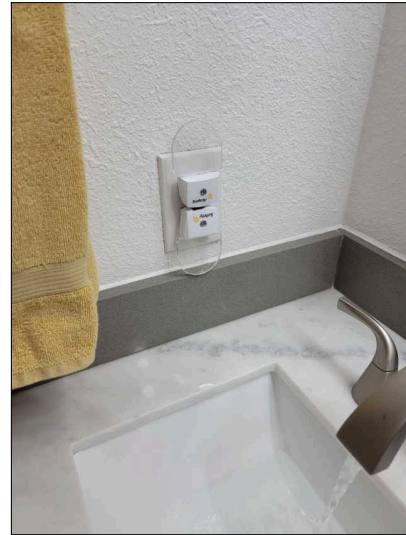
No GFCI protection at sink outlets.. left upstairs bathroom

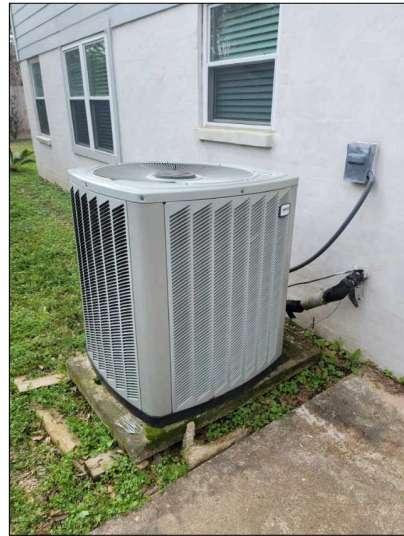
Upstairs (left side) AC compressor, label indicates R22 refrigerant, 4 ton unit, manufactured July 2006. Rated for 40 amp maximum, may be fed by 50 amp breaker.

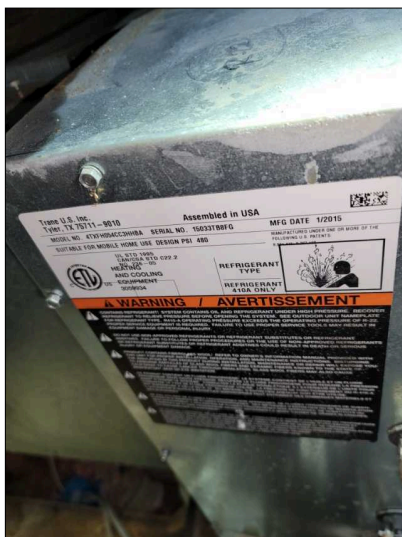
Upstairs (upper attic) AC evaporator coil, label indicates R410A refrigerant, manufactured Jan 2015, approx 18F temperature differential

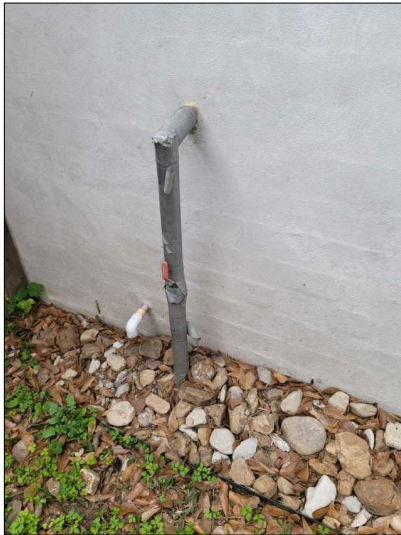
Water shutoff..left side

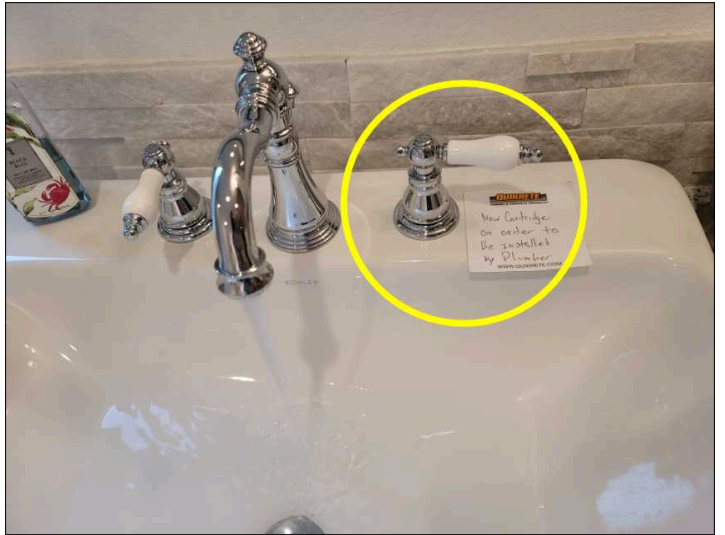
Left side sink, no cold water supply..primary bathroom

- Rolled asphalt was replaced on the flat roof section
- 3 Ton HVAC was replaced, which rules out most of the red items
- Smaller items like door stops have been taken care of
- The fence was extended by 18' on one side and a double gate
- The cold water to one sink was just the wrong valve in the faucet, so it was an easy fix.

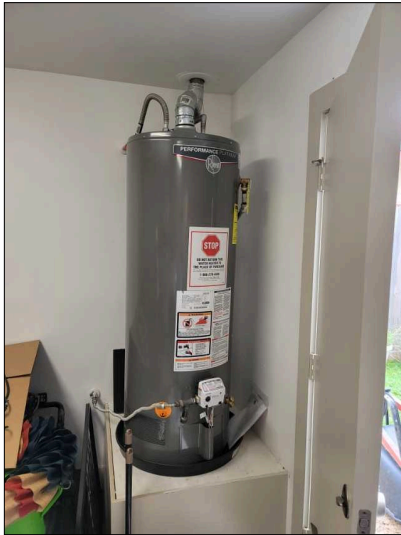
50 gallon gas water heater in garage, manufactured Nov 1019.

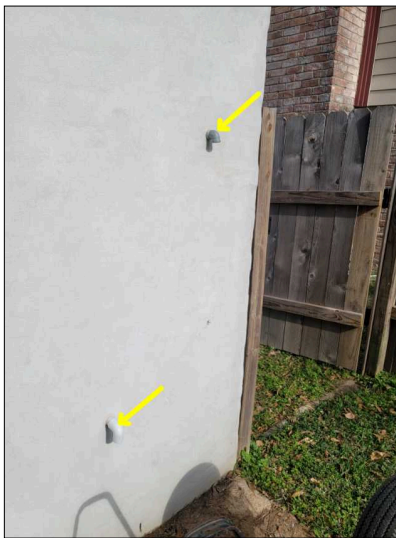
Water heater drain lines too high, should be within 6" of grade to avoid scalding.. rear of garage

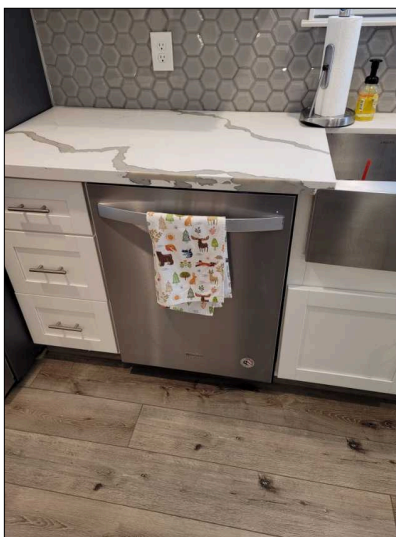
Comments:
• Operated.
• Lacks electrical disconnect

Dishwasher operational, lacks electrical disconnect

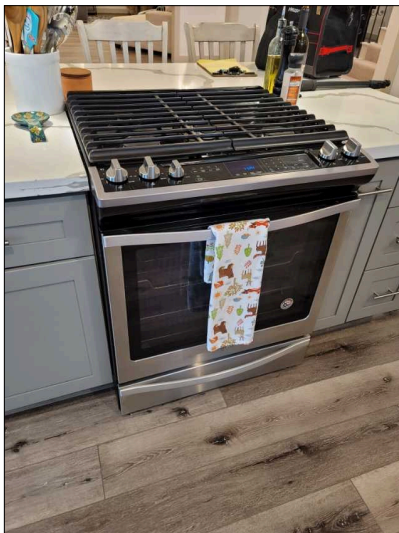
- Gas shutoff behind oven/range not accessible in an emergency.
- All heating elements operated when tested.
- Oven(s) operated when tested.
- Oven: gas burners
- Range: Natural gas burners

Gas oven/range, shutoff appears to be behind unit. Inaccessible in an emergency.

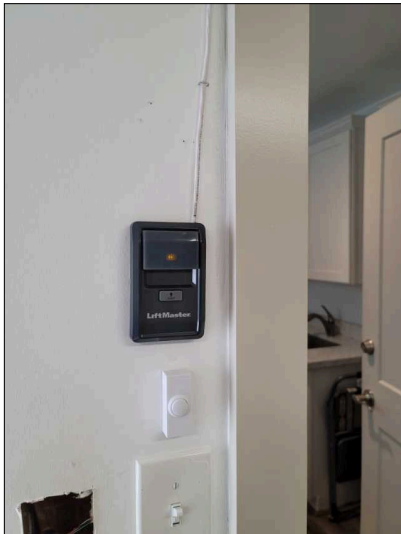
- Missing safety test instructions on wall next to the operators.
- Only one operator installed at time of inspection.

Missing safety instructions
