NOBLE PROPERTY INSPECTIONS

PROPERTY INSPECTION REPORT

51 Orchid Ct
Lake Jackson, TX 77566

Rachel Minter <i>Name of Client</i>	12/15/2025 2:00 pm <i>Date of Inspection</i>
51 Orchid Ct, Lake Jackson, TX 77566 <i>Address of Inspected Property</i>	
Jake Bullock <i>Name of Inspector</i>	Professional Home Inspector (#26806) <i>TREC License #</i>
<i>Name of Sponsor (if applicable)</i>	<i>TREC License #</i>

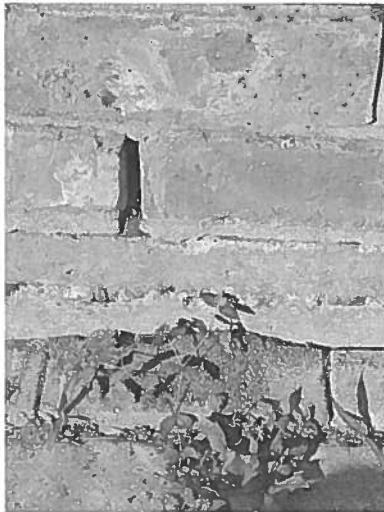
Garage Right Front

There is evidence of active fire-ant mounds around the property. Recommend a pest control specialist to further evaluate and provide recommendations. Pest control services may be warranted.

Recommendation: Contact a qualified pest control specialist.

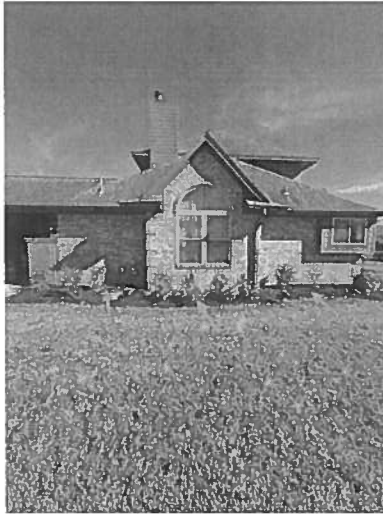
Left Front

Some areas of the foundation are not visible due to overgrowth and the natural ground being built-up too high. In these areas, the inspector is not able to evaluate the foundation from the exterior and is limited to walking the interior for visible foundation problems.

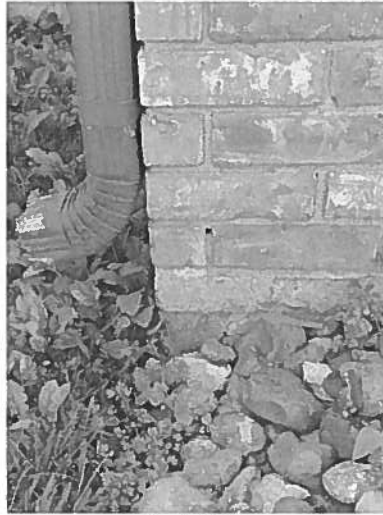
Back Right

Corner cracks are visible in the foundation slab but are of minimal structural concern. Shrinkage is a natural part of the curing process of concrete and cracks located in corners of structures are common. Recommend patching the corner cracks to prevent moisture/pest intrusion. Also recommend monitoring to confirm the cracking does not worsen.

Recommendation: Recommend monitoring.

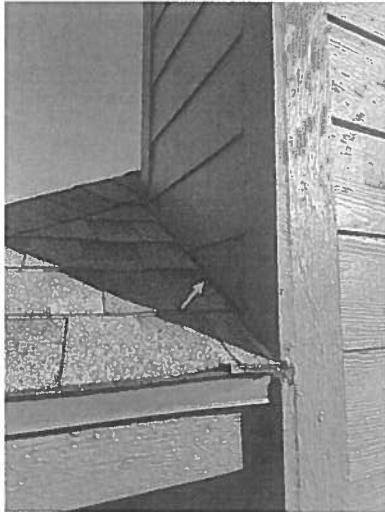
Chimney Back

Areas of the roof need re-caulking to prevent water intrusion. Recommend hiring a contractor to re-caulk with approved roofing caulk and/or silicon sealant as necessary.

Recommendation: Contact a qualified roofing professional.

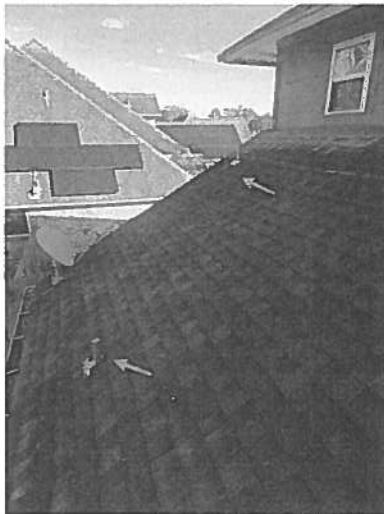
Back Right

Roof vents are unpainted or should be repainted with a rust preventative paint (typically matching the roof color or black). Unpainted vents are more likely to cause discoloration of the roof by runoff as vents rust and rubber deteriorates.

Recommendation: Contact a qualified roofing professional.

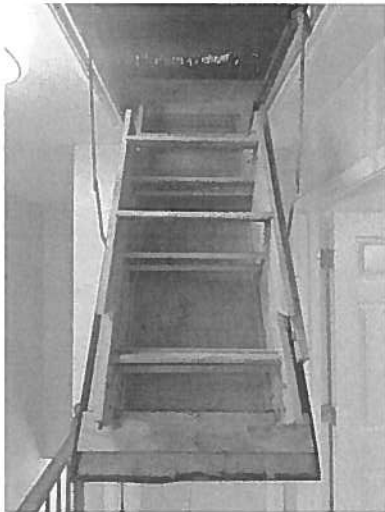
2nd Floor

The attic ladder/door/entry is missing insulation and considered inefficient. Recommend installing insulation to improve efficiency of the structure.

Recommendation: Contact a qualified insulation contractor.

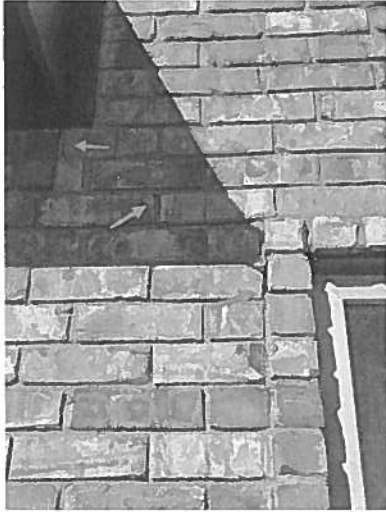
Front Left

recommend monitoring. The best way to monitor a crack is to patch it (with mortar or caulk) and repaint it, to see if the crack reappears.

Recommendation: Recommended DIY Project

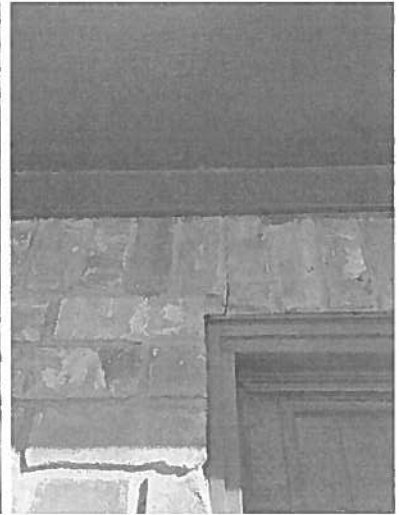
Garage Front Left

3: Exterior cracks minor

Minor cracking was observed in wall structure. This is common in structure this age and is often determined to be cosmetic. That said, cracking is a first sign of foundation failure and cracks can grow over time;

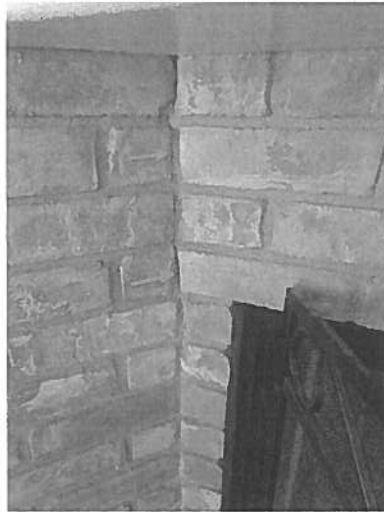
Fireplace Left

4: Interior wall/sheetrock cracks minor

Minor interior wall/sheetrock cracking was observed in wall structure. This is common in structure this age and is often determined to be cosmetic. That said, cracking is a first sign of foundation failure and cracks can grow over time; recommend monitoring. The best way to monitor a crack is to patch it (with a sheetrock repair) and repaint it, to see if the crack reappears.

Recommendation: Recommended DIY Project

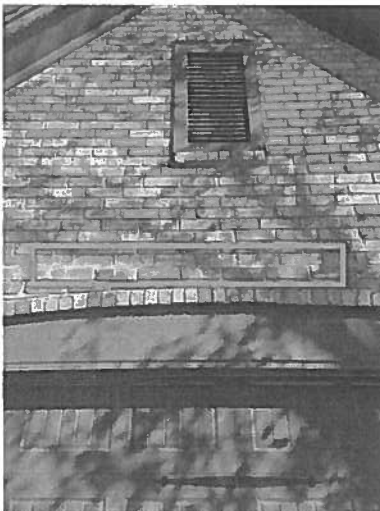
Garage Front Middle

5: Cracks patched minor

Cracking patches were observed in wall structure. This is common in structures of this age and is often determined to be cosmetic. That said, cracks could conceal current foundation problems. Cracks that have been patched can also be a sign of previous foundation work (as foundation repair companies also patch

structural cracks). Recommend monitoring and discussing with the owner the possibility of previous foundation work completed. Monitor these areas for future cracking.

Recommendation: Recommend monitoring.

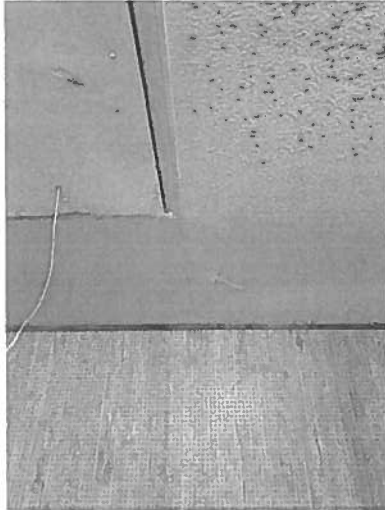
Garage Right

1: Ceiling - sheetrock cracks minor

Minor sheetrock cracking was observed on the ceiling. This is common in structures this age and is often determined to be cosmetic, most often the separation of drywall tape joints. Recommend patching, repainting, monitoring these locations for further cracking.

Recommendation: Contact a qualified painting contractor.

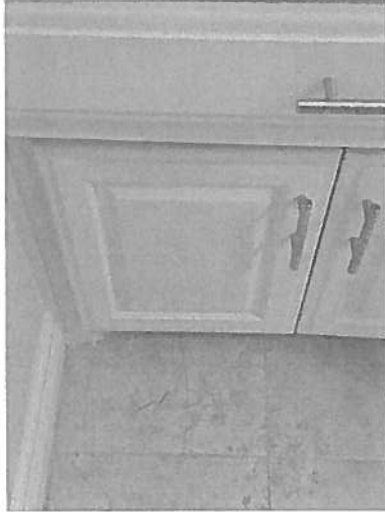
Laundry Bathroom

2: Flooring - tiles loose / cracked or missing

Loose tiles that are popped or missing and/or cracking was observed. This is possibly due to structural foundation issues and is considered evidence of a structural deficiency if on the interior of the structure. Recommend a qualified foundation repair company / contractor evaluate and advise on course of action prior to repair of the flooring.

Recommendation: Contact a qualified flooring contractor

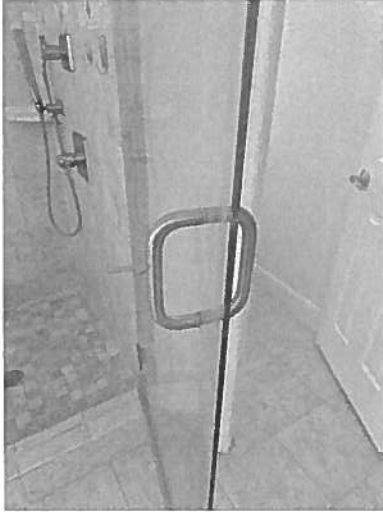
Primary Bathroom

1: Doorknob/handle loose

Doorknob is loose. Recommend tightening.

Recommendation: Recommended DIY Project

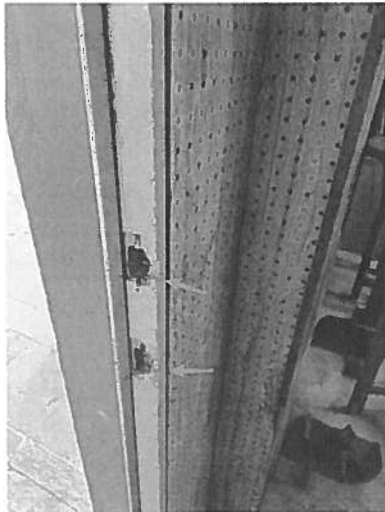
Garage Door

2: Doorknob latch hardware missing

The door is missing metal hardware that is installed on the door frame where the door will latch. The missing hardware is used to support the doorknob in the frame and can be ripped from the wood frame without the support. Recommend installation of the missing hardware by a door repair contractor or do-it-yourself.

Recommendation: Contact a qualified door repair/installation contractor.

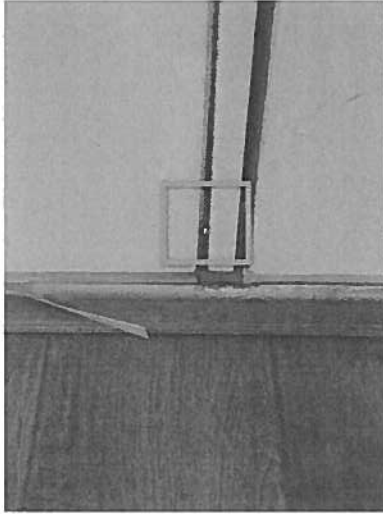
Back Door Left

3: Door has noticeable gap

One or more gaps could result in energy loss. Recommend handyman or door contractor evaluate.

Recommendation: Contact a qualified door repair/installation contractor.

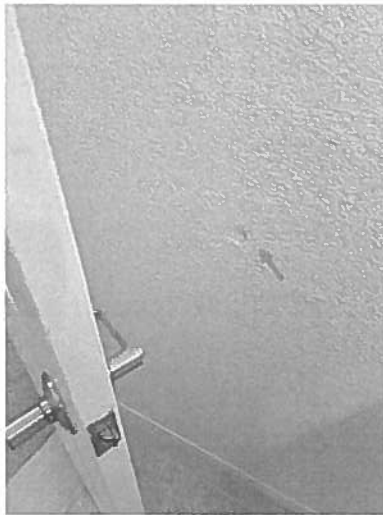
2nd Floor Bathroom

4: Doorknob wall hole

A wall hole is present from a doorknob that was unsupported and forced into the wall. This is primarily considered a cosmetic deficiency but is noted.

Recommendation: Recommended DIY Project

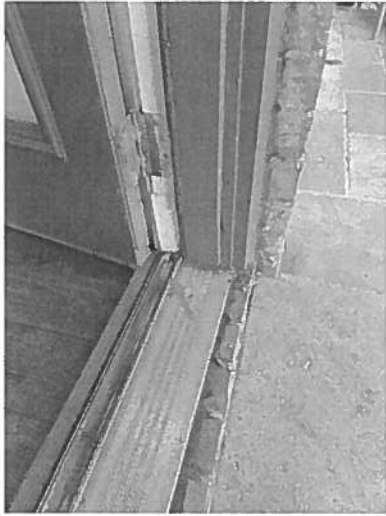
Back Door Left

5: Door is rotting

The door and frame have been exposed to the outdoor elements and are rotting. This could include the door and associated frame elements (header, jamb, sill, etc.) Recommend a door repair and installation contractor to replace the door and the associated rot to the

Recommendation: Contact a qualified door repair/installation contractor.

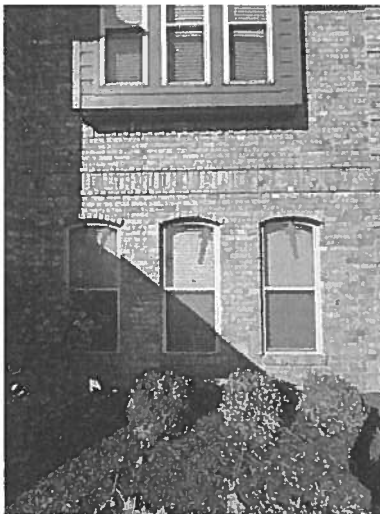
Front Right

The property has windows that have aged, cracked, and/or missing caulking that should be replaced. Inspector notes noticeable gaps around most/all windows of the property. This can lead to water penetration and insect intrusion. Windows should be recaulked with a silicone based sealant.

Recommendation: Contact a qualified window repair/installation contractor.

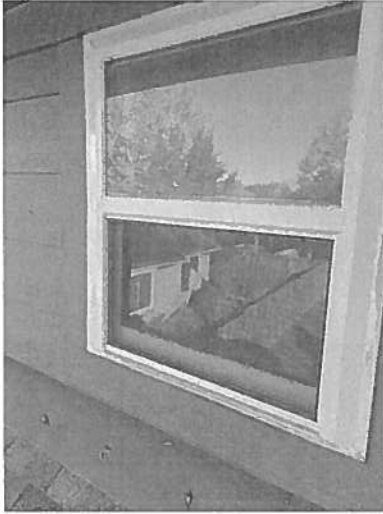
2nd Floor Back Right

3: Window glass is broken

One or more windows appears to have broken glass. Recommend a window professional replace the window glass as necessary.

Recommendation: Contact a qualified window repair/installation contractor.

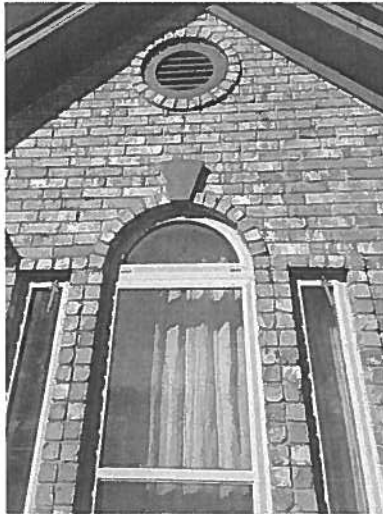
Front Middle

4: Lintel rusting

Window lintel is rusting. Recommend lintel be painted to prevent further rusting.

Recommendation: Contact a qualified professional.

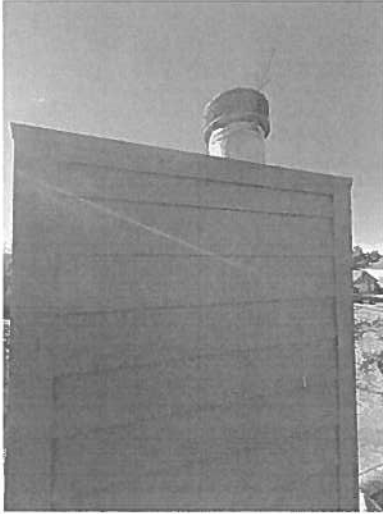
1: Re-paint and caulk spark arrestor and chimney top

The spark arrestor, top of chimney, and metal flashing components are rusting and should be repainted and recaulked.

Recommendation: Contact a qualified painting contractor.

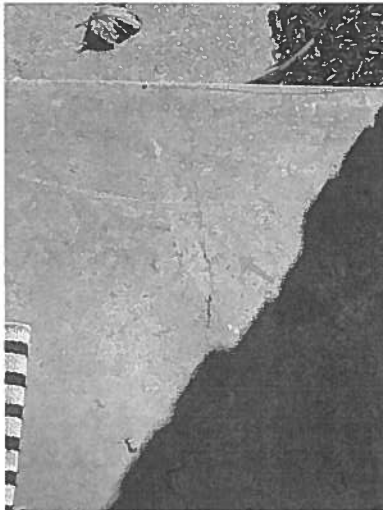
Front Porch

1: Old concrete - porch cracks, separation, or heaving

The porch show signs of aged cracking, separation, heaving, and/or deterioration. This is common in areas of the state that have clay-based soils. Compromised concrete will continue to exhibit decay, failure, collapse, and uplift if not remediated. Recommend caulking larger cracks and applying a concrete sealer. Cracking can also be a safety tripping hazard for pedestrians.

Recommendation: Recommend monitoring.

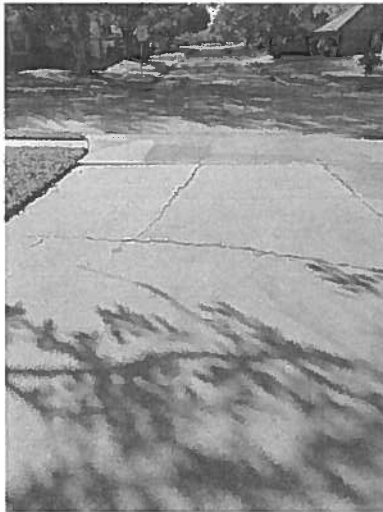
Driveway

1: Old concrete - cracks, separation, and heaving

The driveway and/or sidewalks show signs of aged cracking, separation, heaving, and/or deterioration. This is common in areas of the state that have clay-based soils. Compromised concrete will continue to exhibit decay, failure, collapse, and uplift if not remediated. Recommend caulking larger cracks and applying a concrete sealer. Cracking can also be a safety hazard for pedestrians if it becomes (or is currently) a trip hazard.

Recommendation: Contact a qualified painting contractor.

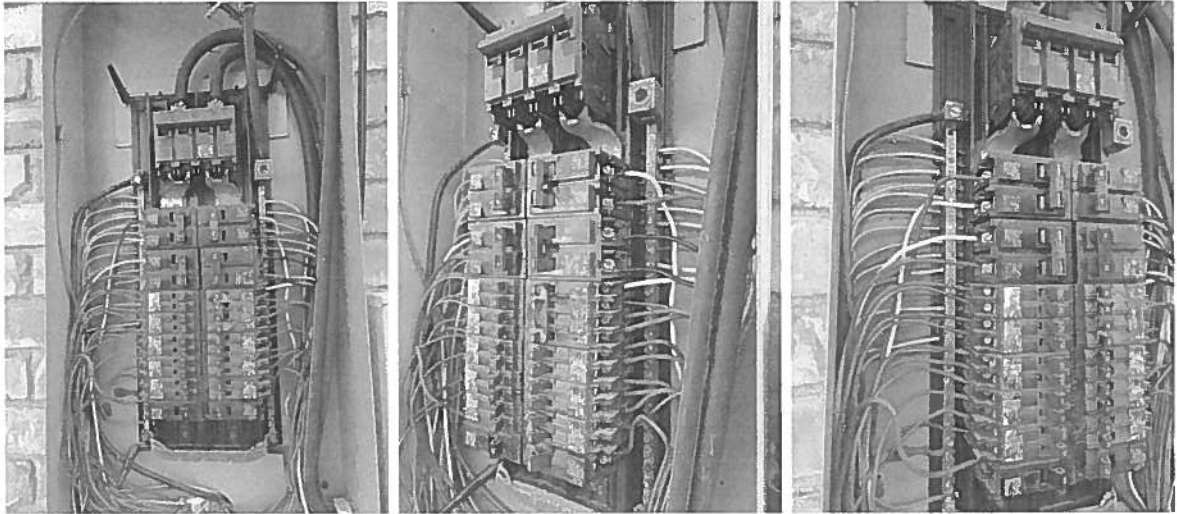
Branch circuit wiring: Copper -

Branch wiring (wiring throughout the structure) should be copper for all circuits within structure. Aluminum wire is considered a fire hazard and is caused by oxidation and other factors that lead to overheating where the wire is connected at splices, outlets and light fixtures. Aluminum wire is OK and very common for the main electrical service from the meter.

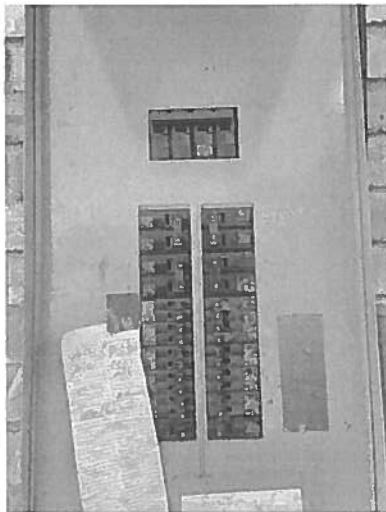
1: Panel missing AFCI breakers

Regulations in most states require inspectors, regardless of the structure's age, to mark as "deficient" where any (AFCI) protection is not installed in these areas.

Recommendation: Contact a qualified electrical contractor.

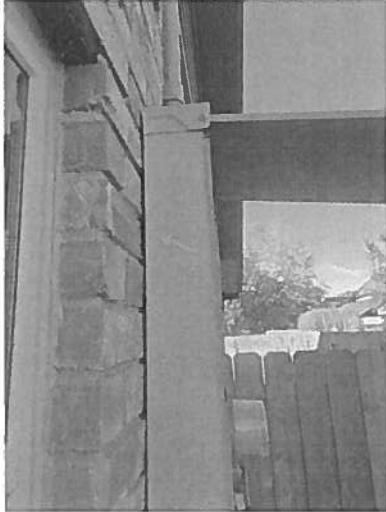
2: Panel not sealed at the wall

The electrical panel is not sealed at the wall. This can result in water intrusion down the back of the electrical panel and into the wall or panel itself. This should be resolved by sealing the panel against the wall to prevent water intrusion, electrical issues, and structural rot. Recommend an electrical or siding contractor to resolve the issue.

Recommendation: Contact a qualified electrical contractor.

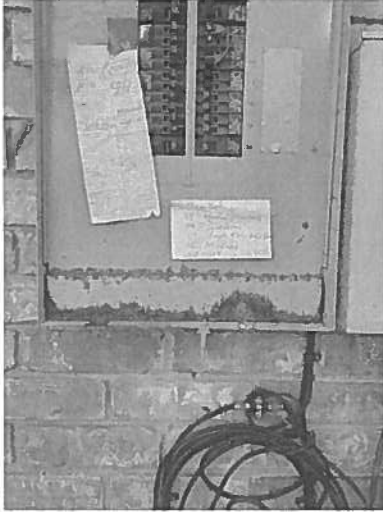
4: Panel is corroded / rusted

The electrical panel is corroded / rusted. Corrosion in the panel indicates that the box is likely an older model and the presence of moisture. Recommend replacing the box or repainting.

Recommendation: Contact a qualified electrical contractor.

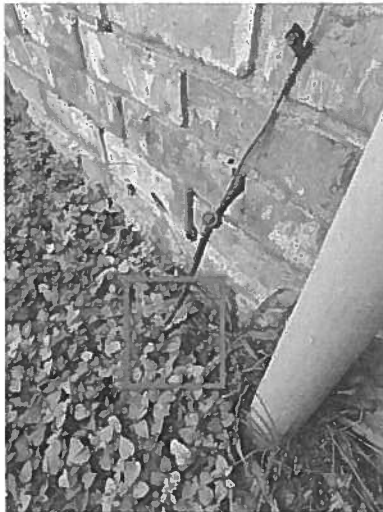
5: Grounding rod missing or disconnected

The grounding rod is missing and/or disconnected from the main service panel. Recommend an electrical contractor re-establish local grounding to the panel by correcting the grounding deficiency.

Recommendation: Contact a qualified electrical contractor.

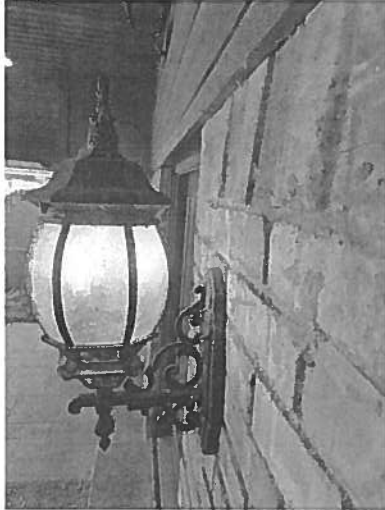
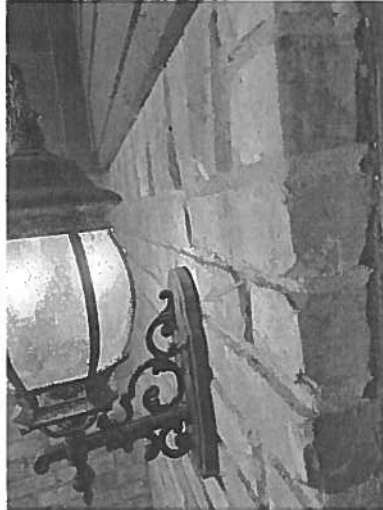
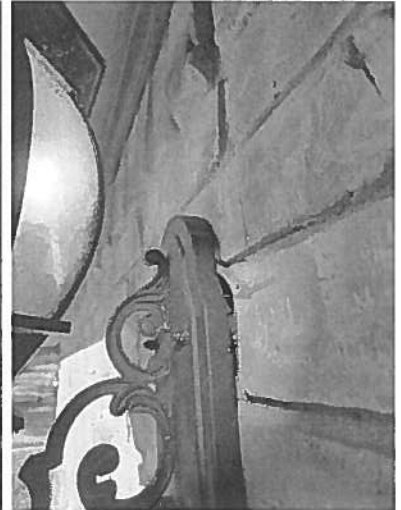
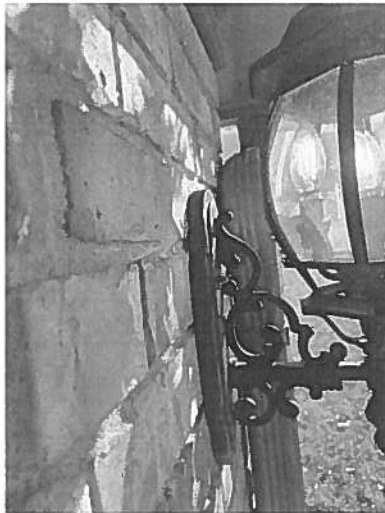
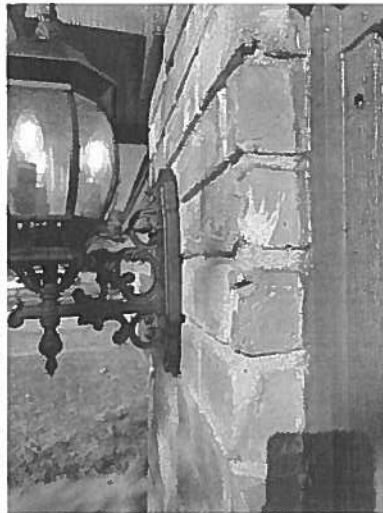
3: Fixture - improperly sealed

Light fixture improperly sealed from the outdoor elements. Will allow for water penetration and could cause interior damage to structure. Recommend reinstallation using approved caulking, sealants, etc.

Recommendation: Contact a qualified handyman.

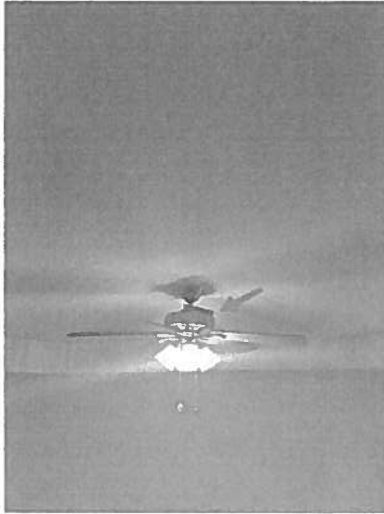
Primary Bedroom

4: Fixture - improperly mounted

Lighting fixture and/or ceiling fan is improperly mounted, damaged, and/or loose. Recommend tightening and sealing, or replacement by an electrical professional.

Recommendation: Contact a qualified electrical contractor.

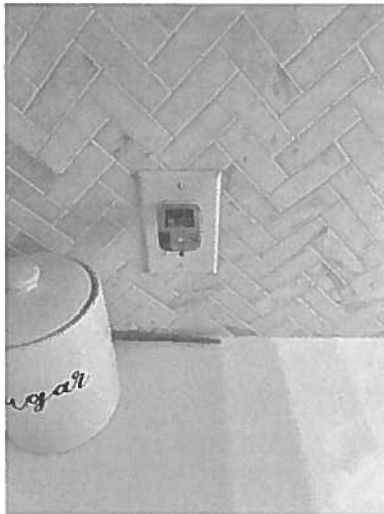
Kitchen Front Left

5: Outlet - no grounding

All outlets have a hot wire that delivers electricity from your local power source to the structure, and a neutral wire that sends electricity back to the power source. If an outlet has only these two wires, but has no ground wire, it is a non-grounded, or ungrounded, outlet. If the outlet has a third wire called a ground wire, it is a grounded receptacle, or outlet, and will have the familiar three slots. A ground wire is an important safety feature. If the electrical system, or an individual outlet, get a surge of excess electricity, this can raise the risk of fire, shock, or electrocution.

Recommendation: Contact a qualified electrical contractor.

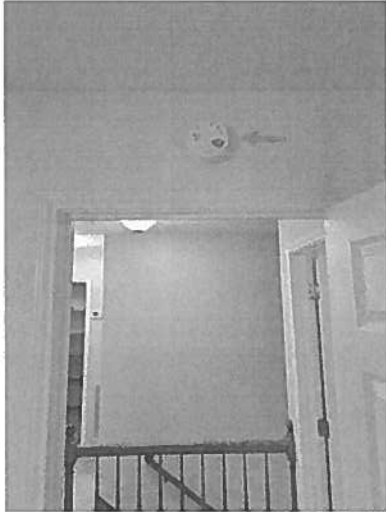
2nd Floor Back Left Bedroom

One or more of the fire alarms are emitting an audible low-battery alert. All fire alarms should be tested and low-batteries should be replaced.

Recommendation: Recommended DIY Project

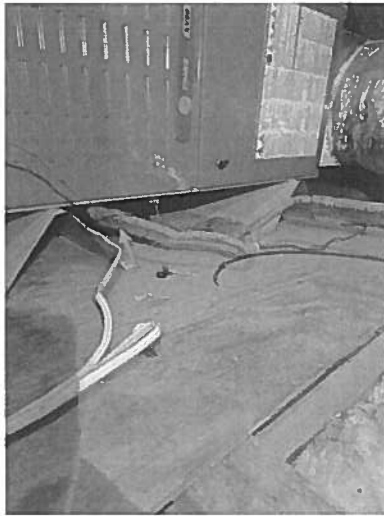
2nd

1: Furnace - sediment/drip trap missing or incorrectly oriented

The sediment/debris and drip trap/leg on the gas line is incorrectly oriented or is missing. The trap should allow for condensation or sediment in the gas line to fall into the trap. Additionally the shut-off valve should be located before the trap to allow for cleanout. Recommend installing a correctly oriented sediment/debris trap on the gas line prior to entering the unit.

Recommendation: Contact a qualified plumbing contractor.

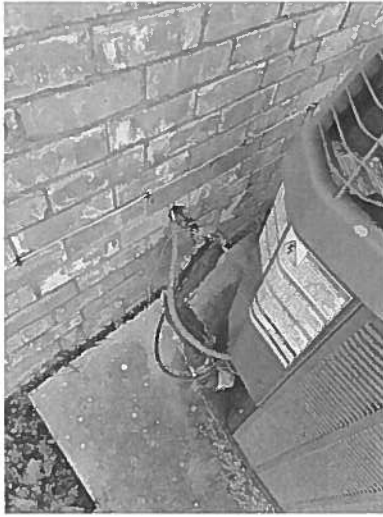
1st

1: Condenser - freon insulation missing or damaged

Missing or damaged insulation on the refrigerant line can cause energy loss and condensation. Recommend contacting an HVAC professional to replace the missing or damaged insulation.

Recommendation: Contact a qualified HVAC professional.

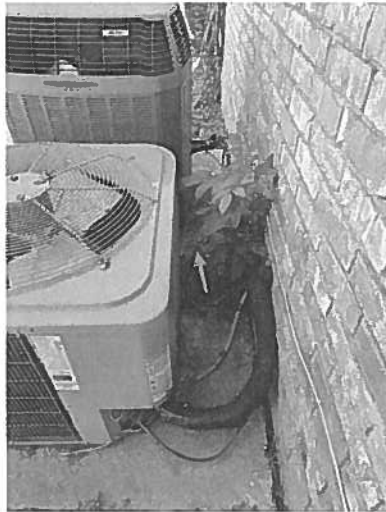
2nd

A tree and/or vegetative growth is too close to the condenser unit. The condenser utilizes the air-space around it to release heat from the structure. Growth around the condenser will lower the efficiency and/or could cause the unit to overheat. Recommend removing or trimming the growth away from the condenser by at least 3-feet on the sides and 10-feet above the unit.

Recommendation: Contact a qualified landscaping contractor

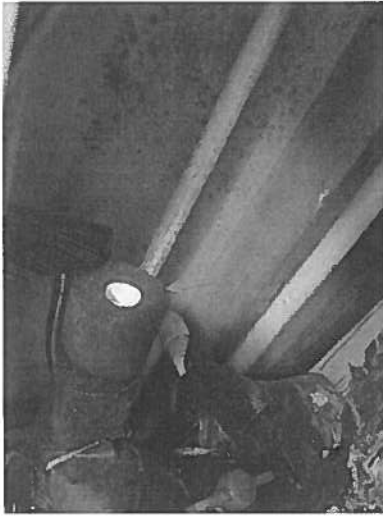
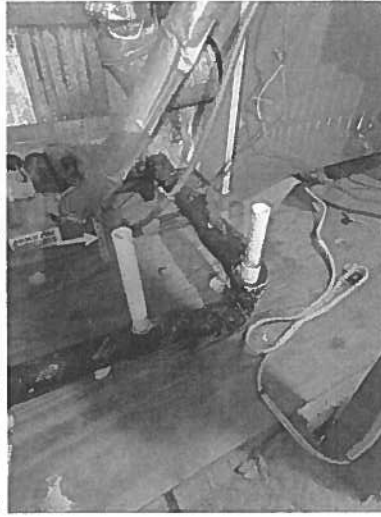
3: Evaporator - cap missing

A cap on the evaporator condensation cleanout will prevent insects from entering the pipe for water (wasps in particular) and will improve efficiency of the system. Recommend installing a cap.

Recommendation: Contact a qualified HVAC professional.

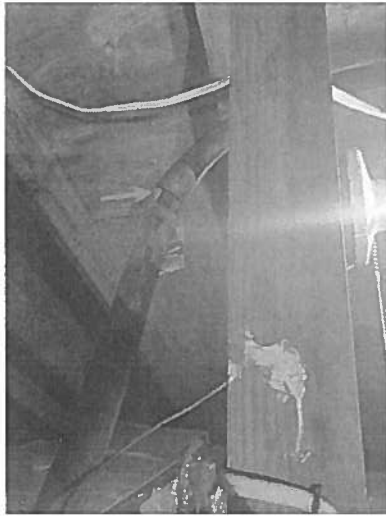
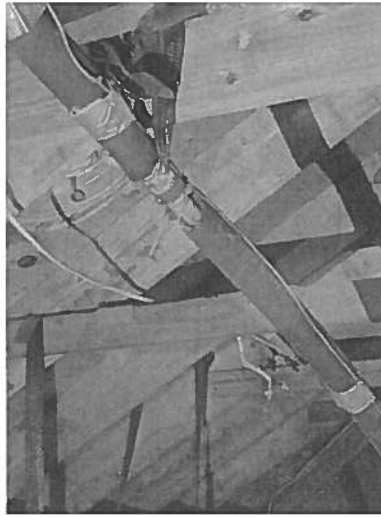
5: Evaporator - freon line insulation missing or damaged

Missing or damaged insulation on refrigerant line can cause energy loss and condensation buildup in the attic. Recommend contacting an HVAC professional to replace the missing or damaged insulation.

Recommendation: Contact a qualified HVAC professional.

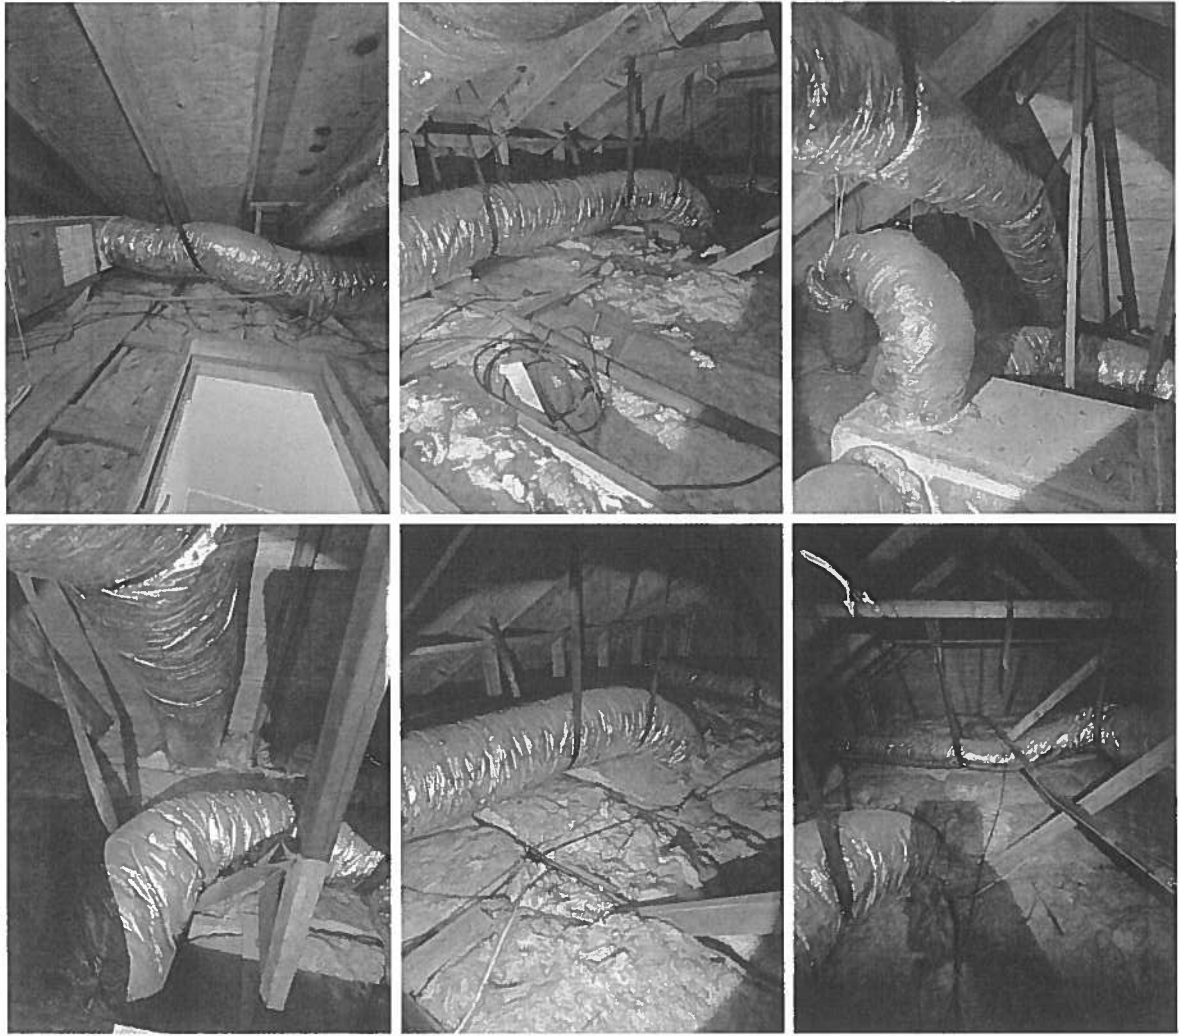
6: Evaporator - mildew is present

Mildew (or black mildew-like substance) is present in areas of HVAC evaporator. Areas that have mildew are often higher in moisture content and will need to be cleaned more frequently. Recommend cleaning areas with a antimicrobial and possibly testing for the presence of mold.

Recommendation: Recommended DIY Project

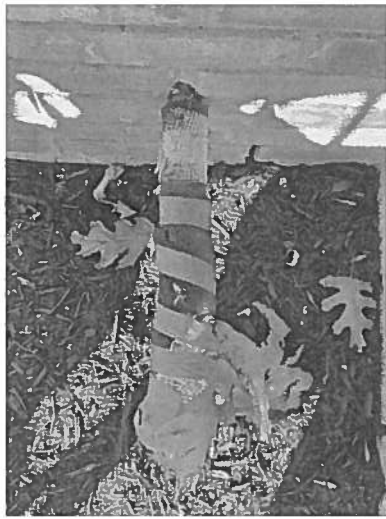
Front Left

2: Spigot insulation missing

The water spigot is missing insulation. Some owners decide to install thermal protection as necessary when freeze warnings are in-place. Client should consider installing insulation on piping that is permanent and will help prevent pipe burst.

Recommendation: Recommended DIY Project

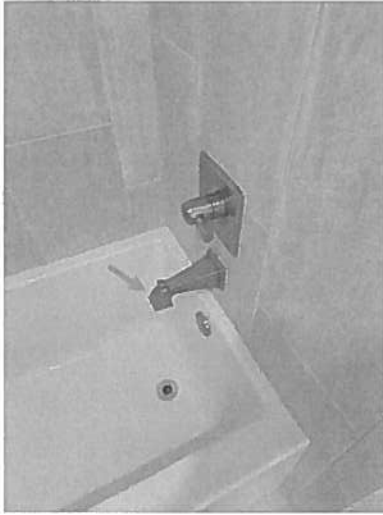
2nd Floor Bathroom

3: Faucet / spigot drain pull issue

The faucet / spigot drain pull is not functioning properly or missing. Recommend plumbing contractor to resolve issue.

Recommendation: Contact a qualified plumbing contractor.

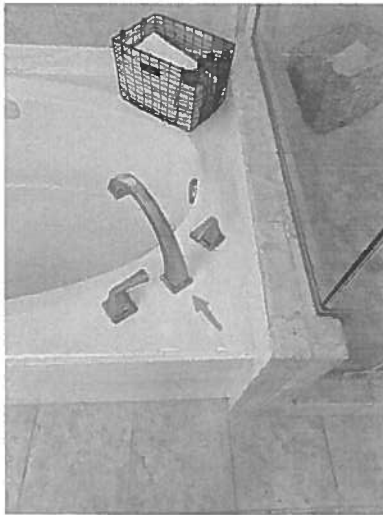
Primary Bathroom

4: Loose fixture

Plumbing fixture is loose. Recommend hiring a plumber to tighten fixture.

Recommendation: Contact a qualified plumbing contractor.

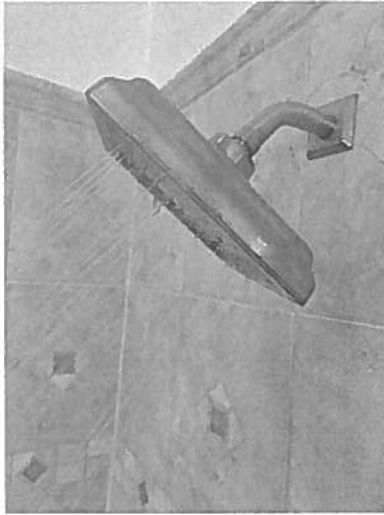
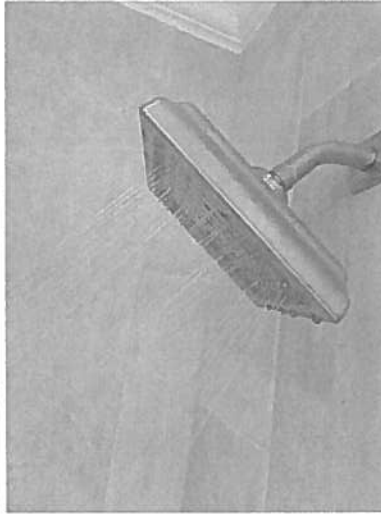
5: Shower head spews

The shower head spews and is not uniformly distributing water into the shower. This is the cause of a clogged shower head on the faucet. Recommend cleaning the shower head distributor (typically with a CLR-type product) or replacing it.

Recommendation: Recommended DIY Project

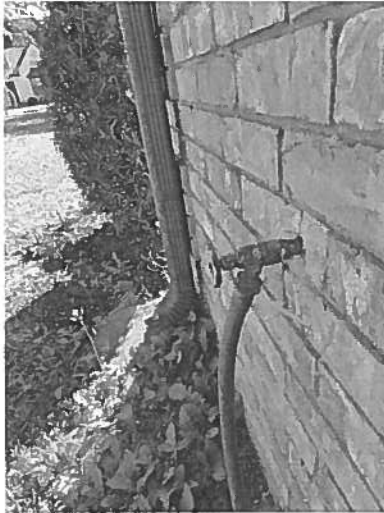
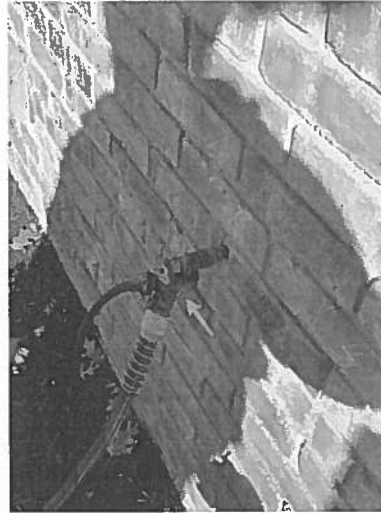
6: No backflow preventer on spigot

A backflow preventer or vacuum breaker is required on all outdoor waterhose spigots to prevent the potential backflow of surface water from your yard into the public water supply in the event there is a municipal water supply problem. A vacuum breaker is acquired at a minimal expense and can be purchased in bulk online.

Recommendation: Recommended DIY Project

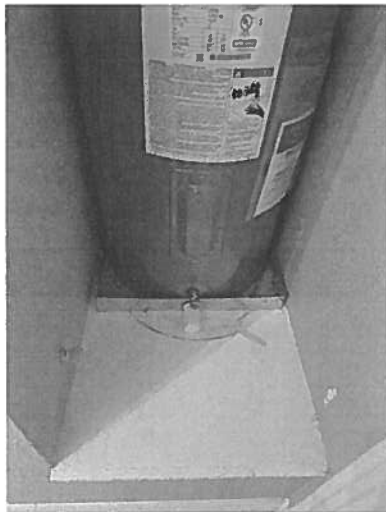
Laundry 1st Floor

1: Pressure relief valve and/or drip pan not routed outside

Water heater drip-pan and pressure relief valve must be routed externally. Recommend plumber to route outside.

Recommendation: Contact a qualified plumbing contractor.

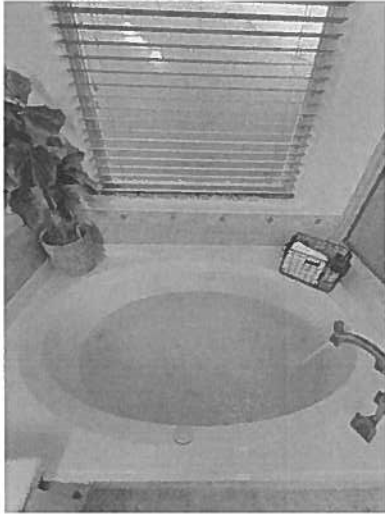
The hydrotub mechanical components (pump and possibly blower) and plumbing fixtures are inaccessible. A hydrotub is required to have a removable front panel or side entry (through a cabinet) to access components that may need to be repaired or replaced. Recommend adding a way to access the underside of the hydrotub.

Recommendation: Contact a qualified general contractor.

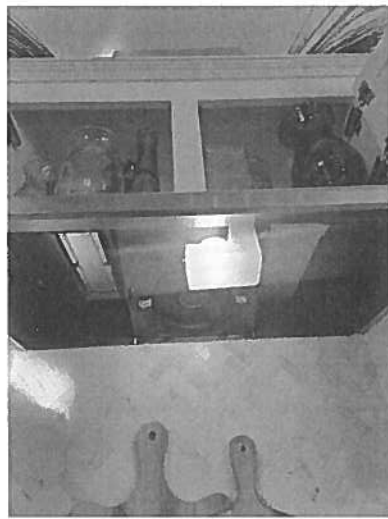
1: Filter needs cleaning/missing

The vent hood filter is dirty and/or missing. It needs to be cleaned or replaced.

Recommendation: Recommended DIY Project

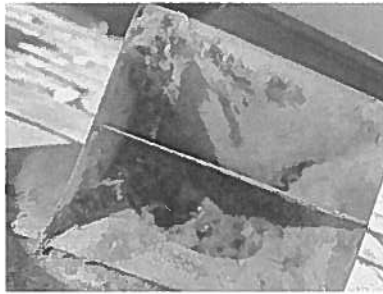
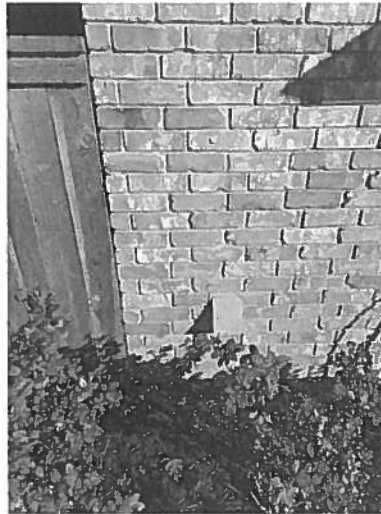
1: Vent is dirty

The dryer vent is dirty and may be partially clogged. Consider cleaning the vent prior to use to prevent the buildup of debris and possible fire hazard.

Recommendation: Contact a handyman or DIY project

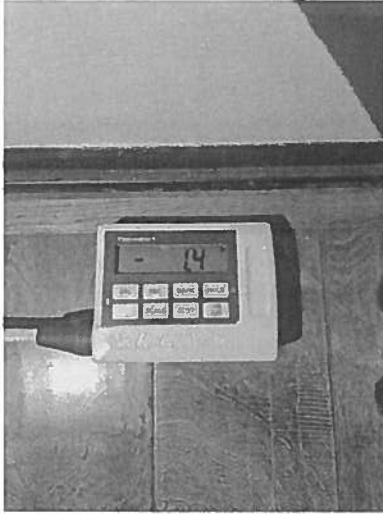
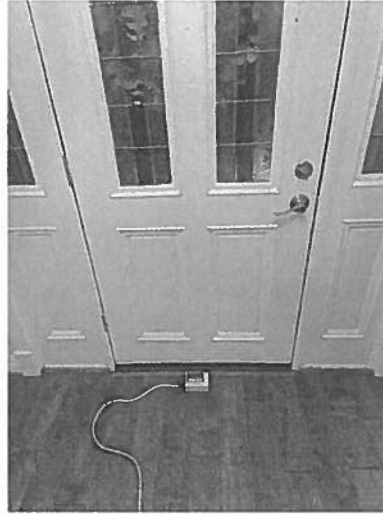
-1.4"

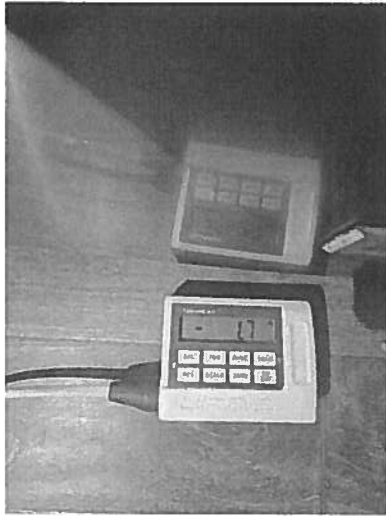
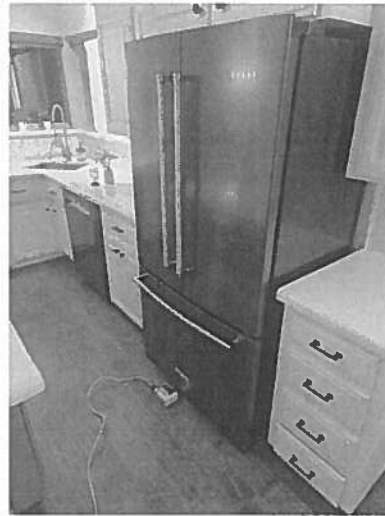
-1.7"

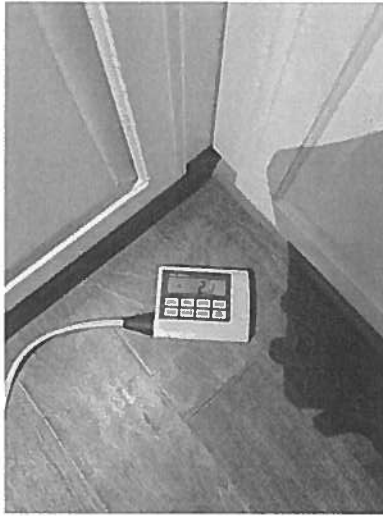
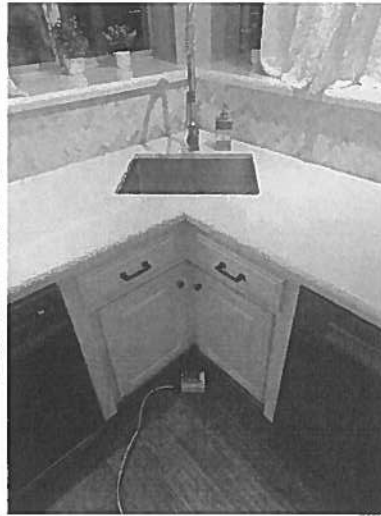
-2.1"

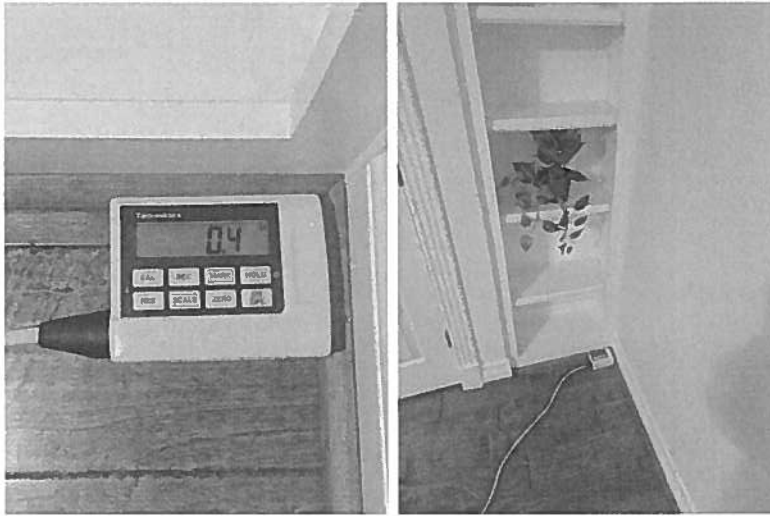
-0.4"

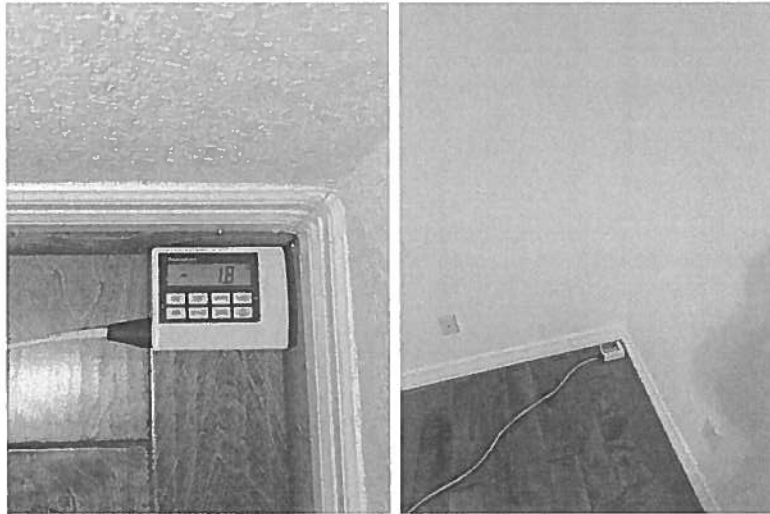
-1.8"

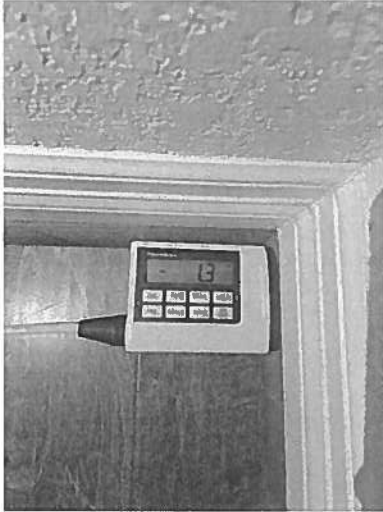
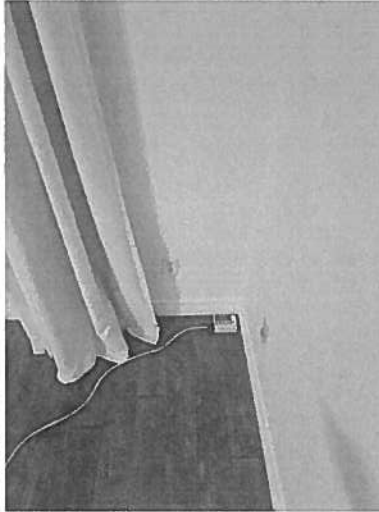
Front-left elevation & photo:

-1.3"

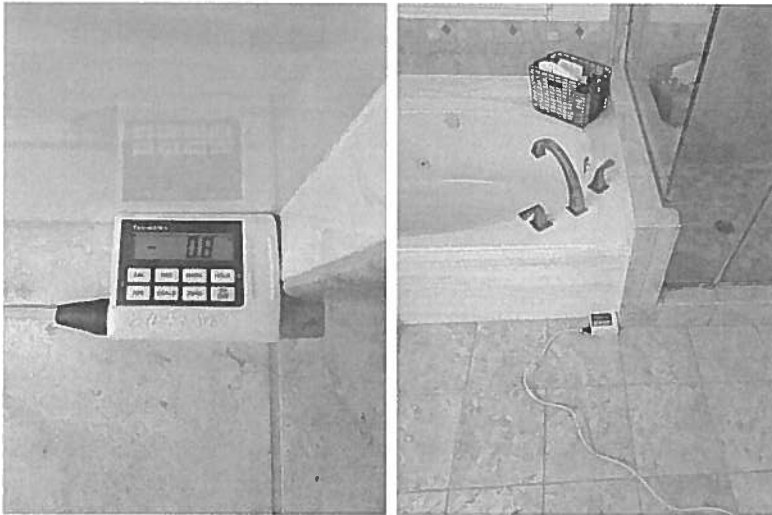
Front shower/bath elevation & photo:

-0.8"

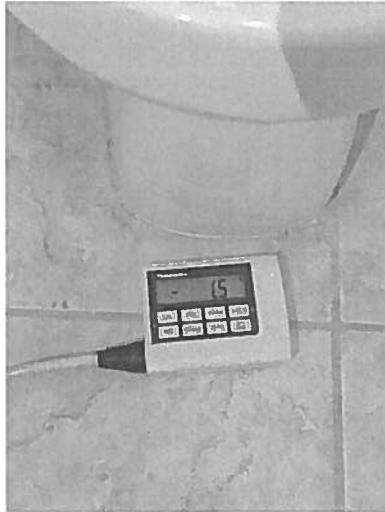
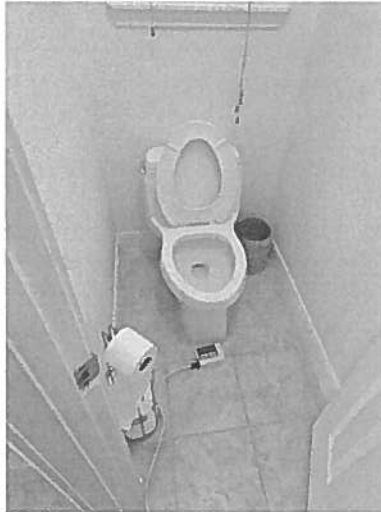
Front of toilet elevation & photo:

-1.5"

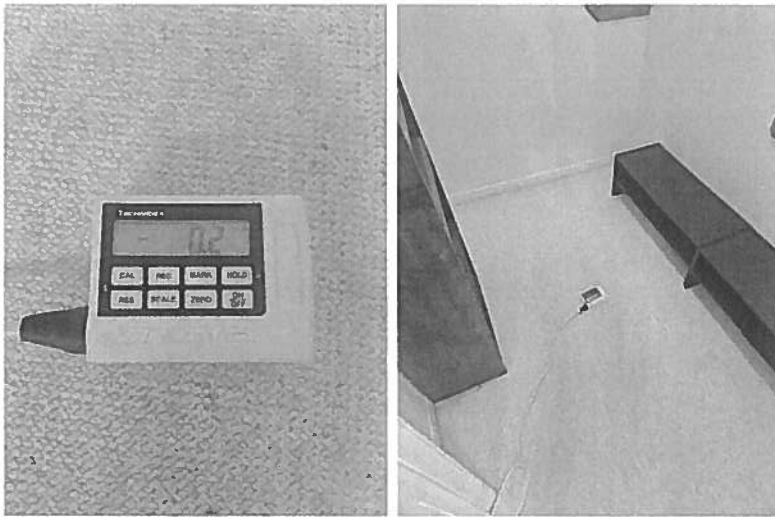
Primary closet elevation 1 & photo:

-0.2"

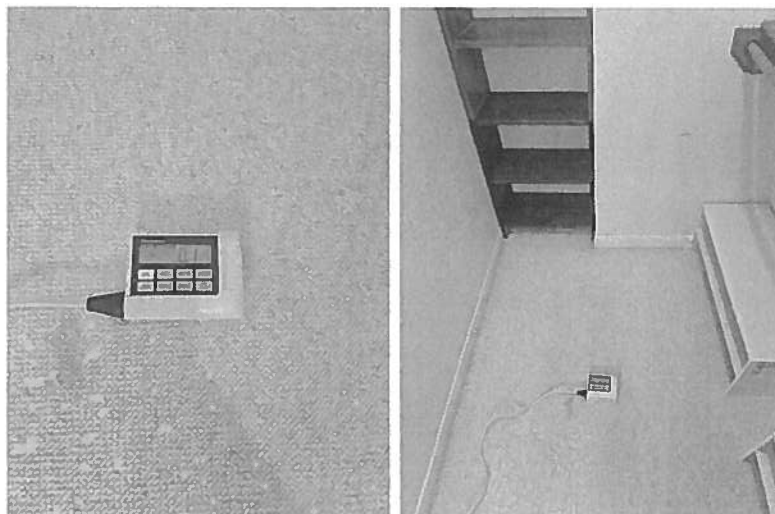
Primary closet elevation 2 & photo:

-0.1
