**BPG Inspection, LLC**

**21022 Waymare Lane  
Spring TX 77388**

Client(s): Wedemeyer  
Inspection Date: 7/1/2024  
Inspector: Murray Campbell , TREC #22455 (TX)

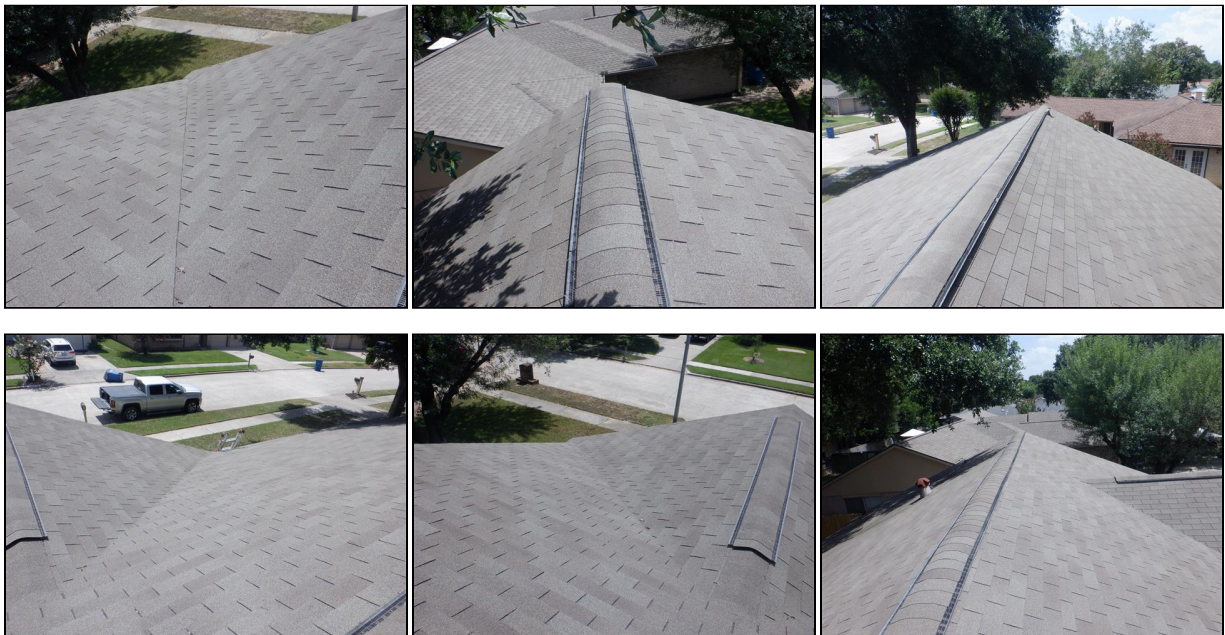
There were several roofing fasteners observed to be improperly sealed or exposed. Left unsealed the fastener

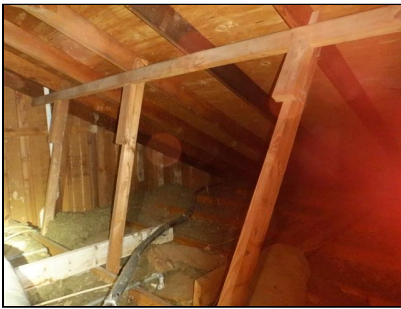
The attic pull down ladder is not insulated completely, nor does it have weather stripping installed at edge of door that meets ceiling framing. Recommend fully insulating the attic stairway to keep the house more energy efficient. On average the insulation R-value for the entire attic area will drop approx. 27% when the attic stairs/hatch is not fully and properly insulated. The reason for this is that, although the attic stairs/hatch account for only 1% of the total attic area, the rate that heat flows through them by conduction (per square foot) is 38 times higher than in the insulated part of the attic.

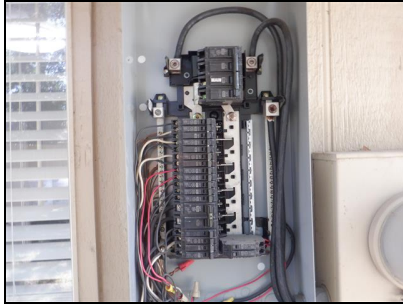
White (neutral) wires are being used as hot wires in the main panel, without the proper identifiers. These should be marked black or red to indicate that they are hot.

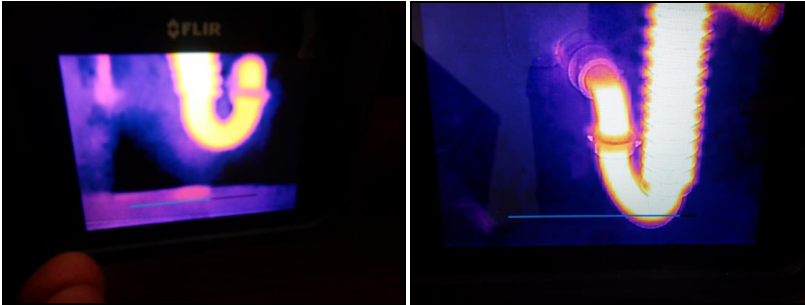
Flex drain lines are not recommended as they tend to accumulate debris, promote clogging and wall of pipe is thinner so can leak easier. Recommend replacement with rigid pipe.

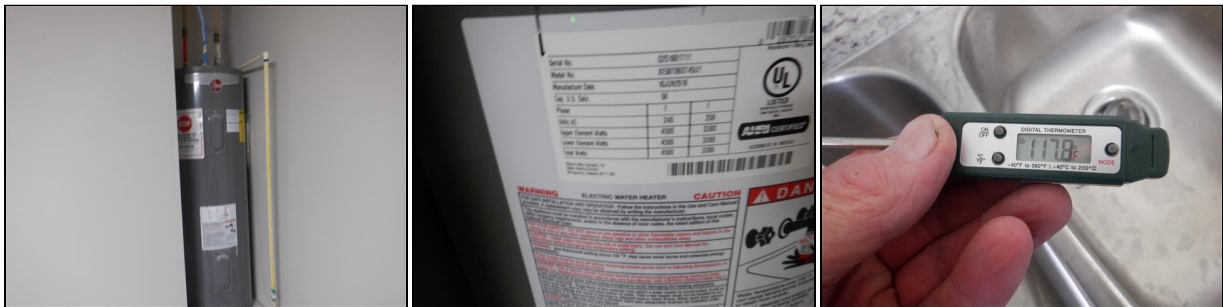
The water heater abuts to an interior wall and there is no emergency leak catch pan installed. Today's standards now require a catch pan that is plumbed to the exterior in locations where tank leaks could cause interior water damage from dripping leaks or condensation.

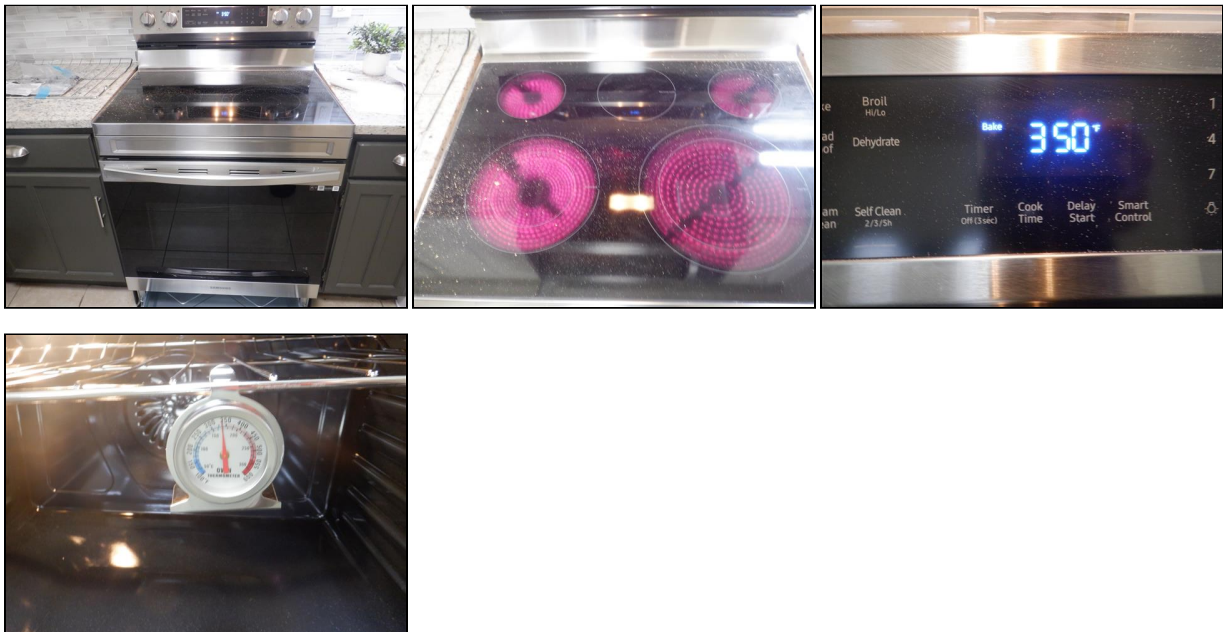
There is no child protection anti-tip device installed. Anti-tip brackets prevent the stove from accidentally tipping over if weight is placed on the oven door
