10210 Crooks Way Ct

Houston, Texas 77065

Client	--
Reference id	a4xPd000002uG7NIAU
Type	Home Inspection and Floor Plan Report - 10210 Crooks Way Ct
Inspected by	ArchiTech Home Inspections
State license	026393
InterNACHI	24043013
Scheduled	October 11, 2025, 4:15 PM
Completed	October 11, 2025, 8:33 PM

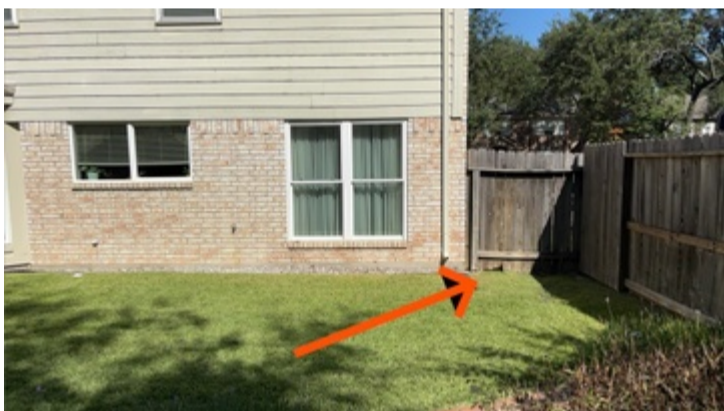
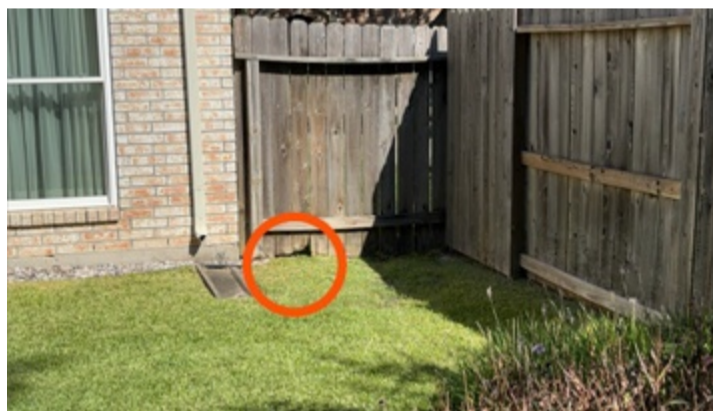
Damaged / Missing Fence Boards

One or more fence boards are missing or damaged. Recommend repairs or replacing by a qualified professional.

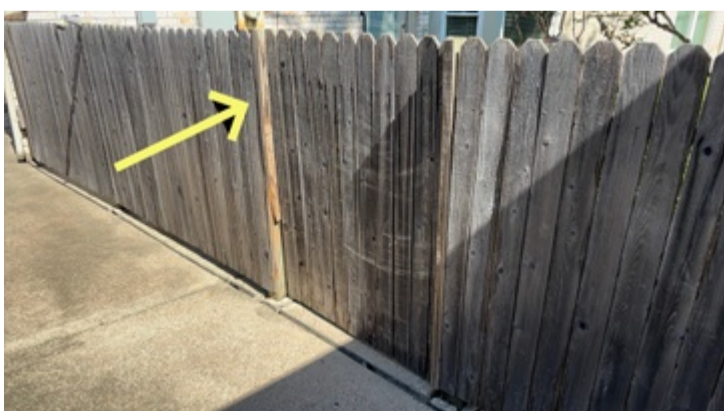
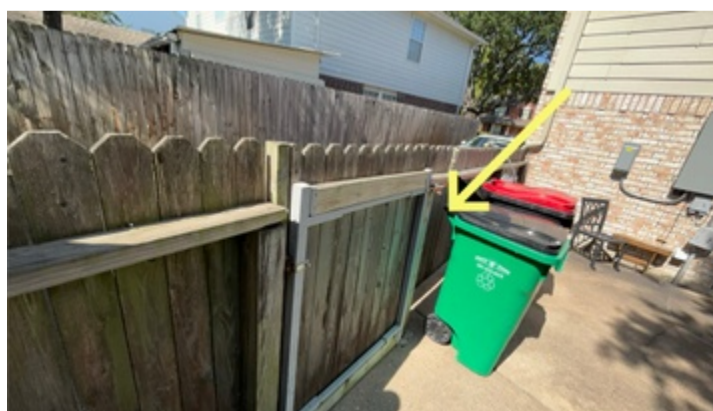
Damaged Gate

The gate is sticking. Recommend further evaluation by a qualified professional.

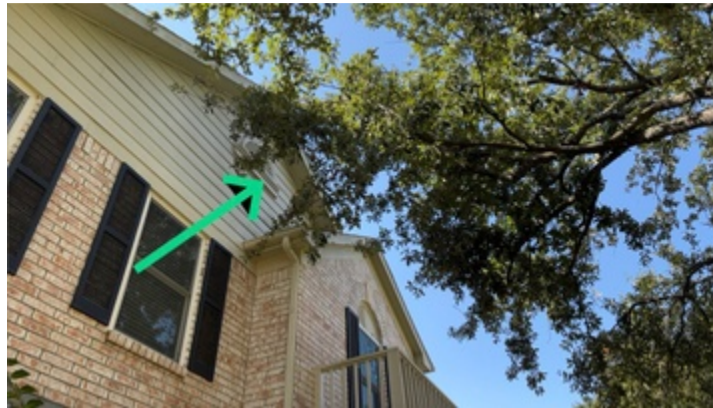
Trim and Monitor Trees

Trees need to be trimmed. Recommend further evaluation by a qualified professional.

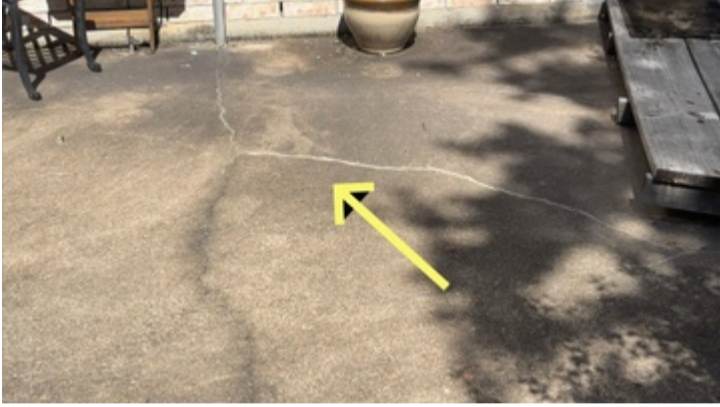
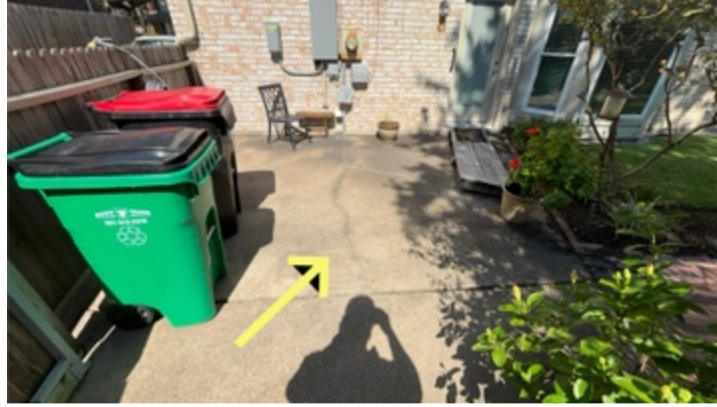
Patio 1 photos / videos

Minor Cracks in Patio / Porch

There are minor cosmetic cracks on the patio / porch. Recommend further evaluation by a qualified professional.

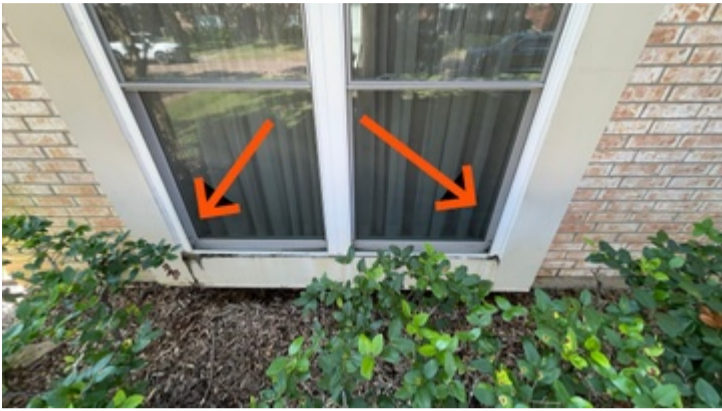
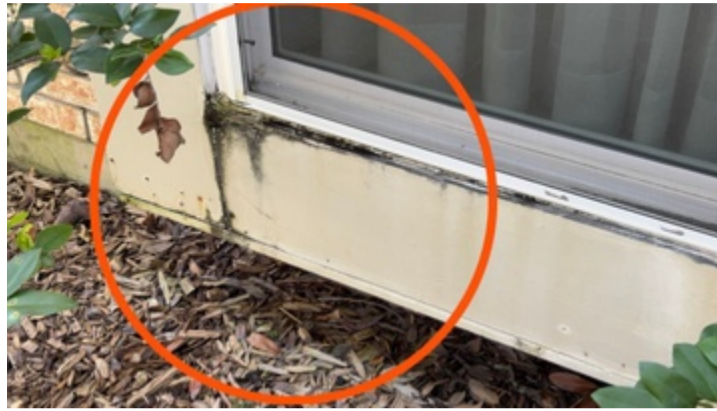
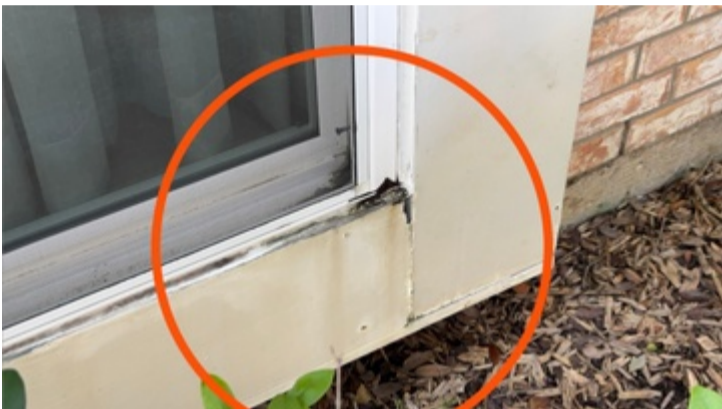
Siding / Trim photos / videos

Deteriorating Exterior

One or more areas of the exterior are rotting. Recommend repairs or replacing by a qualified professional.

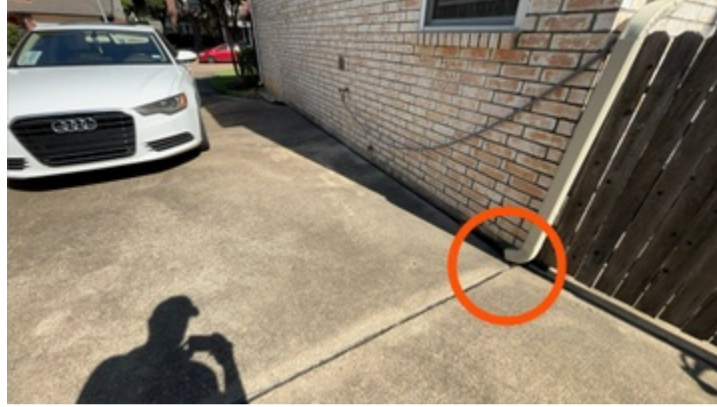
Gutters photos / videos

One or more downspouts / downspout extensions drain too close to the property's foundation. Recommend repairs or replacing by a qualified professional.

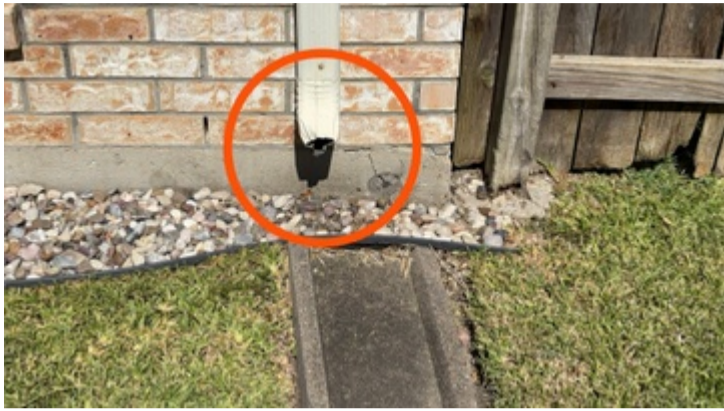
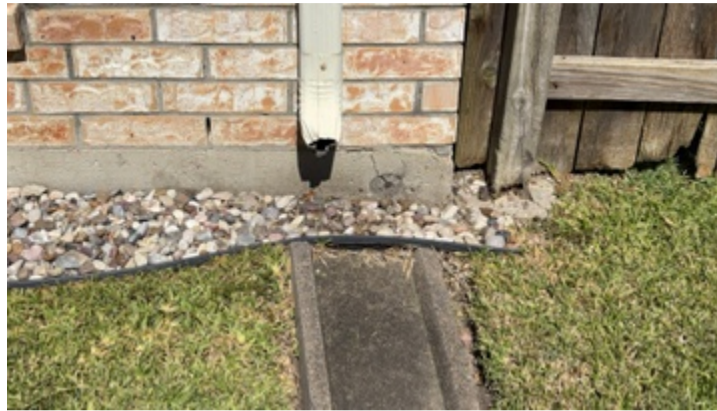
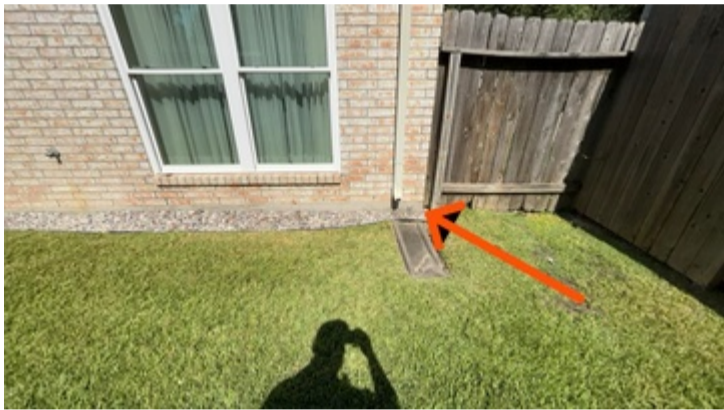
Gutters photos / videos

Damaged Gutter / Downspout

The gutter / downspout is damaged. Recommend further evaluation, and repairs or replacing by a qualified professional.

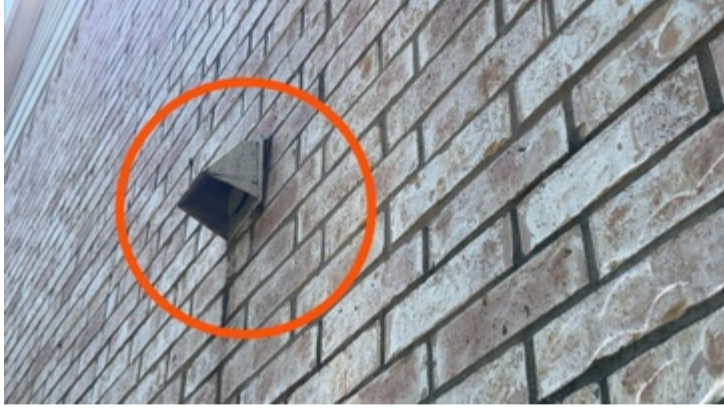
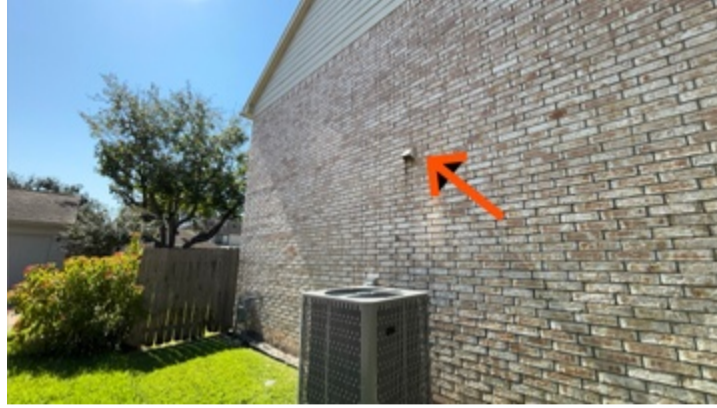
Dryer Exhaust photos / videos

The exterior vent is separating from the property and needs to be sealed. Recommend further evaluation, and repairs or replacing by a qualified professional.

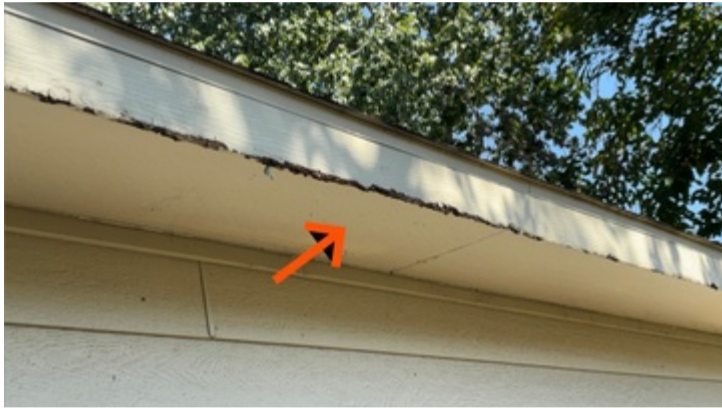
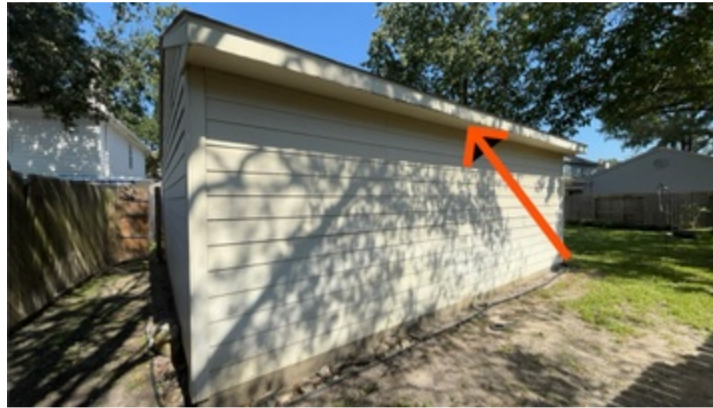
Damaged Fascia

One or more sections of the fascia are damaged. Recommend further evaluation by a qualified professional.

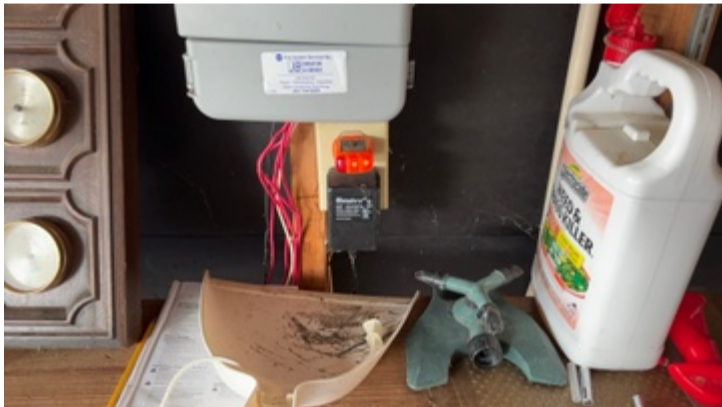
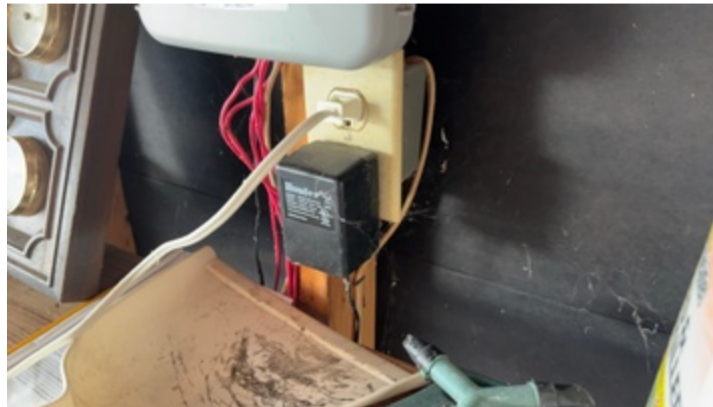
Missing GFCI

There is no GFCI (Ground-Fault Circuit Interrupter) protection. Recommend further evaluation by a qualified professional.

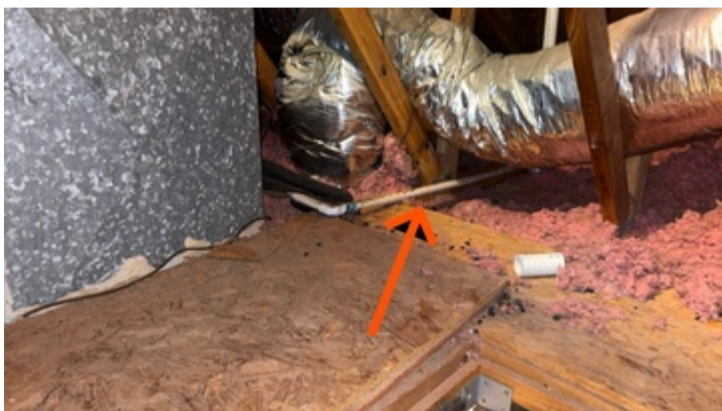
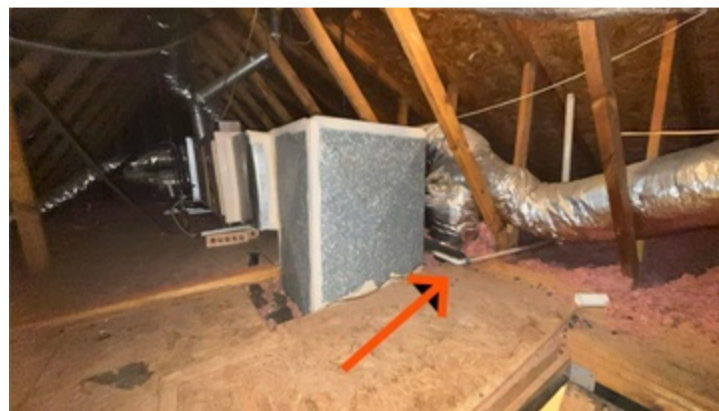
Condensate Line Missing Insulation

The condensate line is not insulated. Recommend further evaluation, and repairs or replacing by a qualified professional.

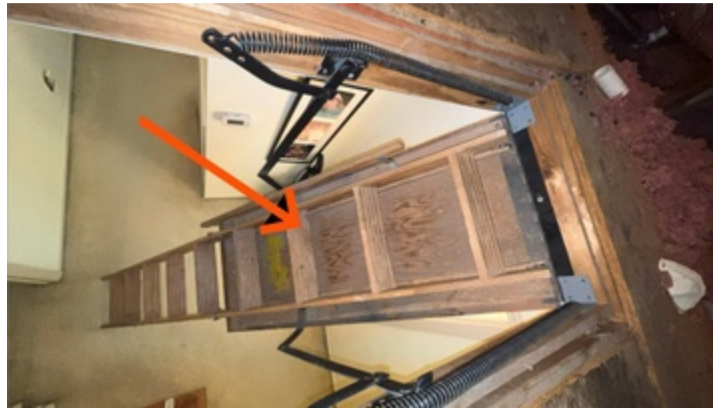
Missing Attic Hatch Insulation

There is no insulation for the attic access hatches. Recommend further evaluation by a qualified professional.

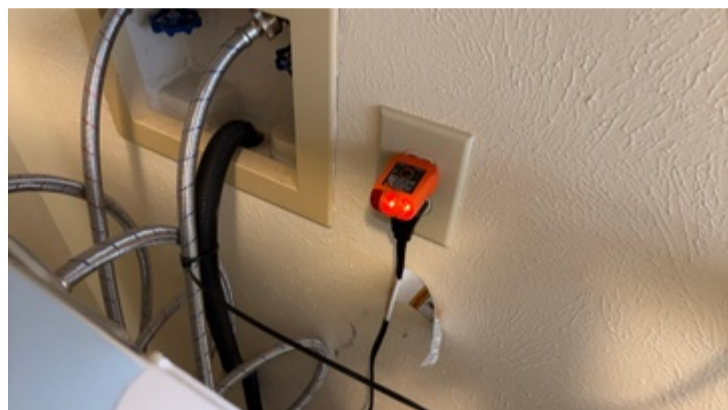
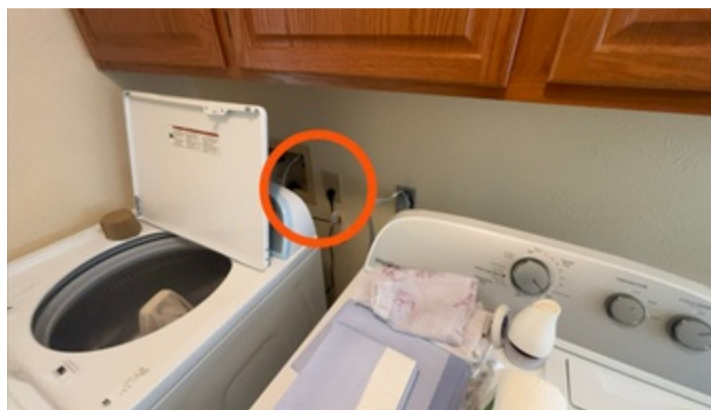
Missing GFCI

There is no GFCI (Ground-Fault Circuit Interrupter) protection. Recommend further evaluation, and repairs or replacing by a qualified professional.

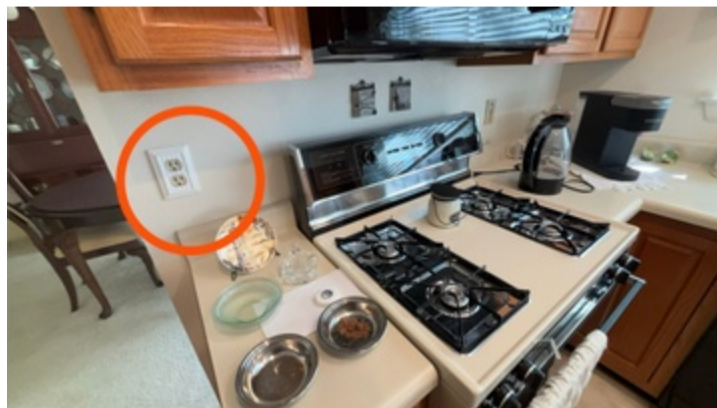
Missing GFCI

There is no GFCI (Ground-Fault Circuit Interrupter) protection. Recommend further evaluation, and repairs or replacing by a qualified professional.

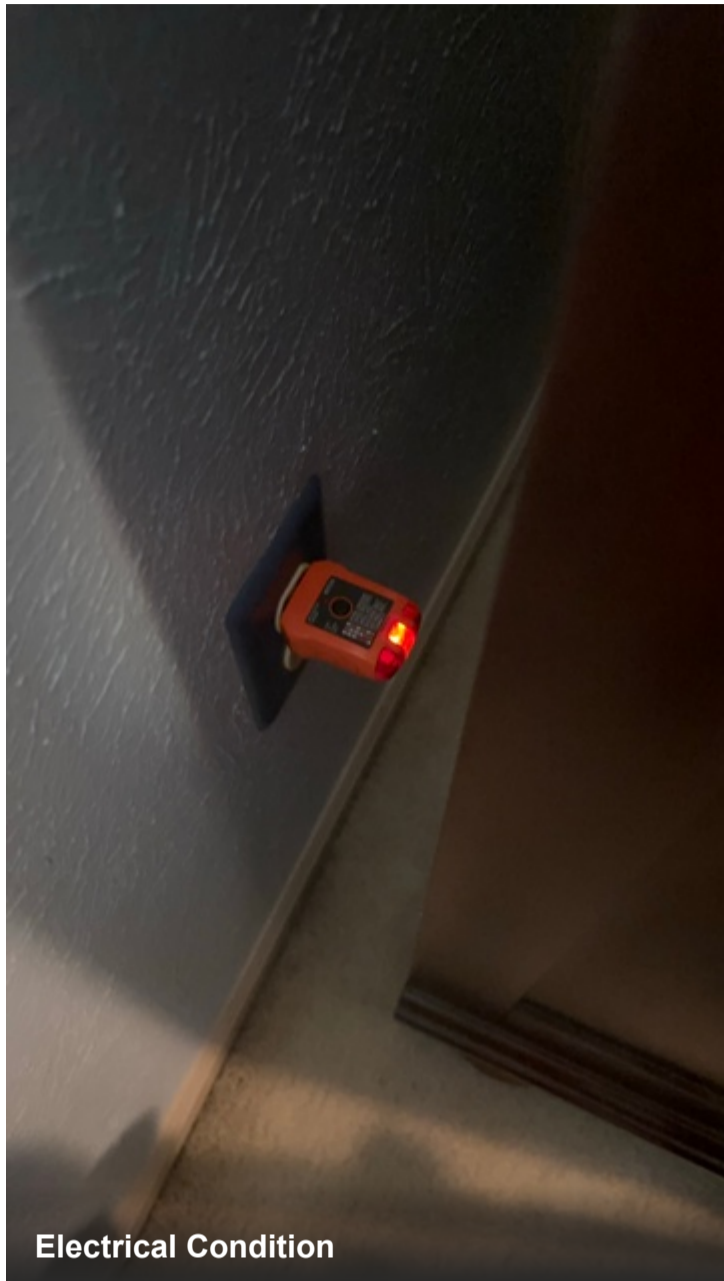
**Safety deficiency**

One or more outlets do not have a connected ground wire. Recommend further evaluation, and repairs or replacing by a qualified professional.

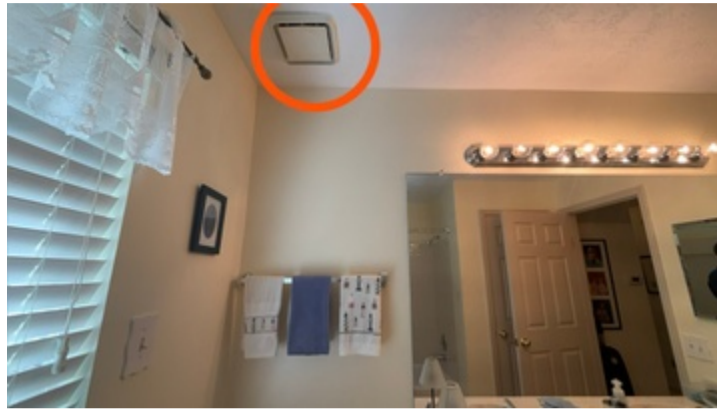
Bathroom 2 photos / videos

The bathroom exhaust fan is inoperable. Recommend further evaluation, and repairs or replacing by a qualified professional.

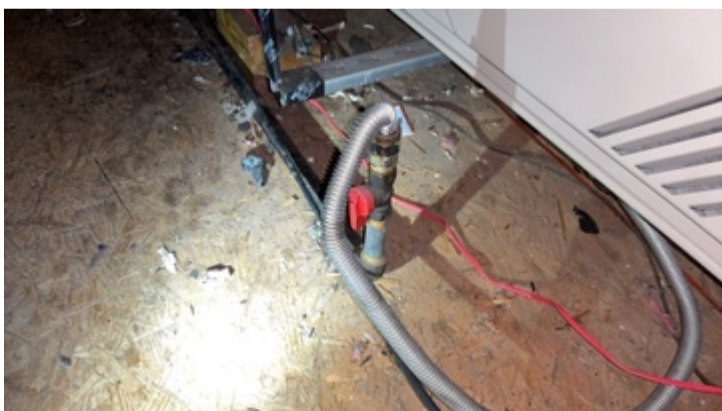
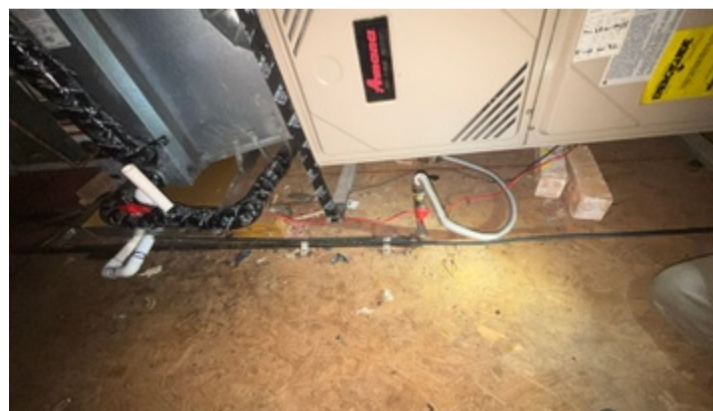
Missing Sediment Trap

There is no sediment trap on the furnace. Recommend further evaluation, and repairs or replacing by a qualified professional.

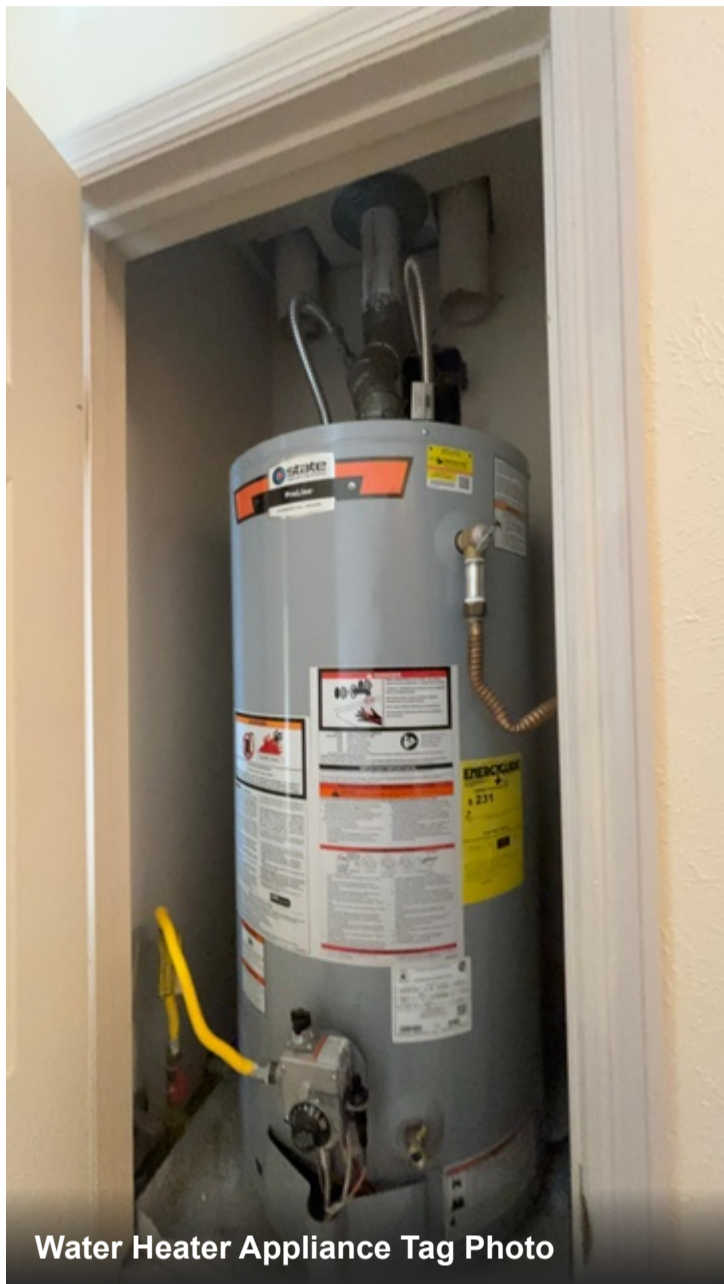
Water Heater Appliance Tag Photo

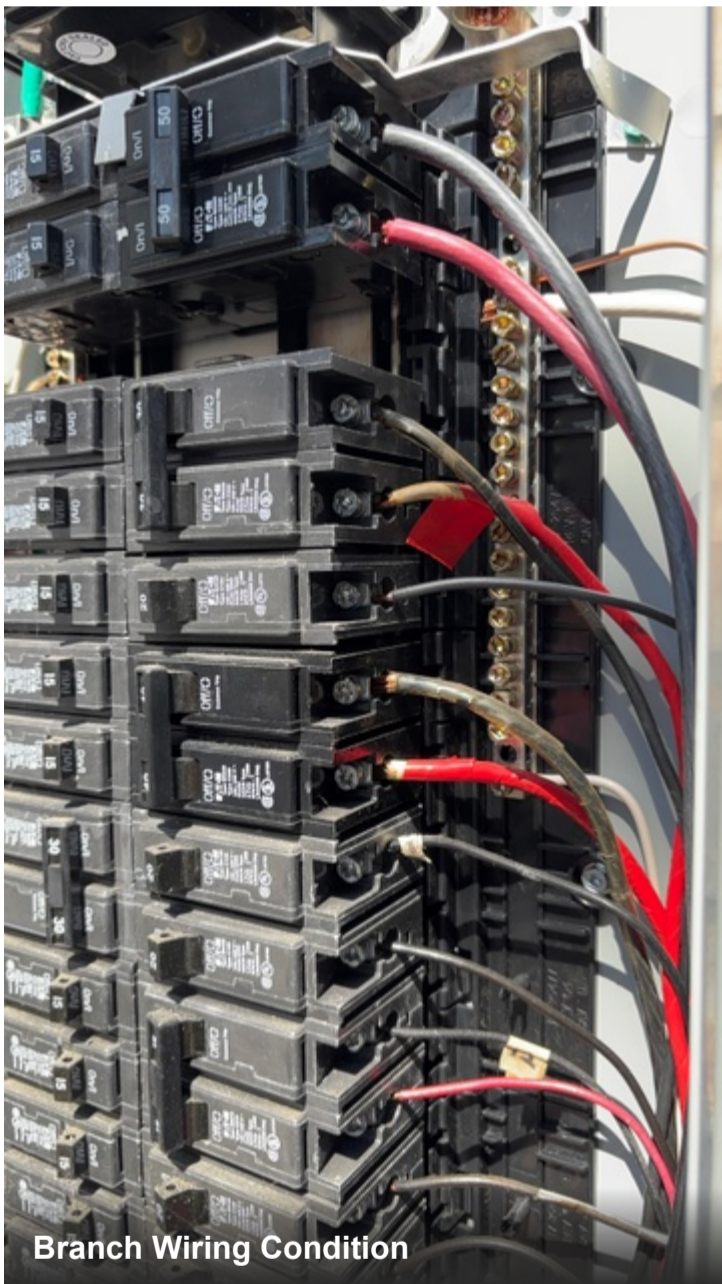
Neutral / Ground Shared Bus Bar

The neutral (white wire) and equipment grounding conductors (bare wire) terminate under the same lug. Recommend further evaluation by a qualified professional.

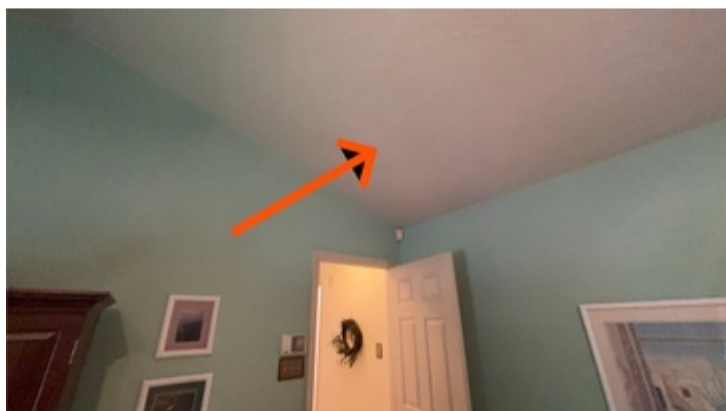
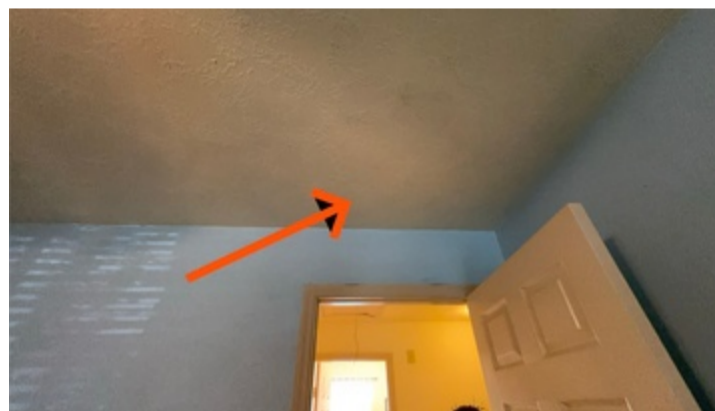
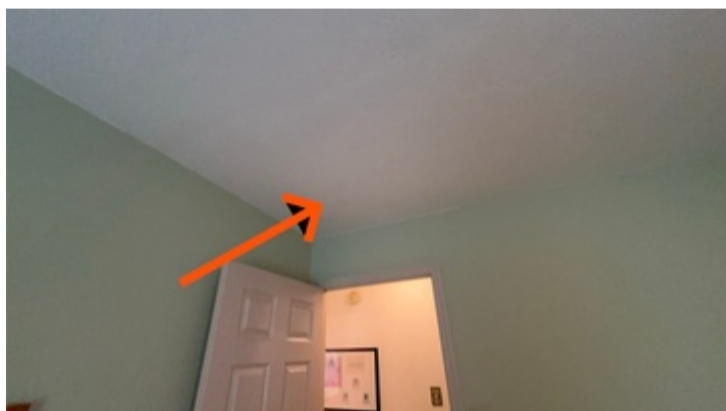
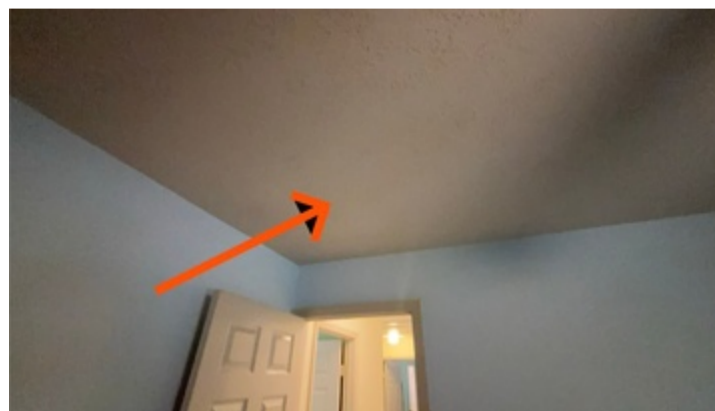
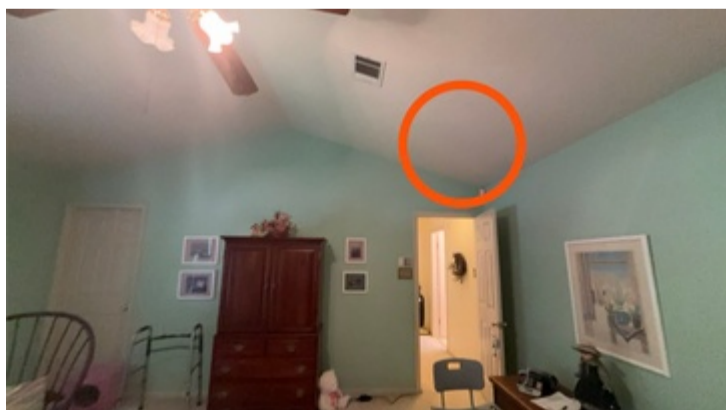
Missing Smoke Detector(s)

The amount of smoke detectors on the property does not meet the residential requirements. Recommend further evaluation by a qualified professional.
