# 14 S Duskwood Pl

## Spring, Texas 77381

| Type | <b>Re Visit Report - 14 S Duskwood Pl</b> |
| Inspected by | <b>Local Property Inspections PLLC</b> |

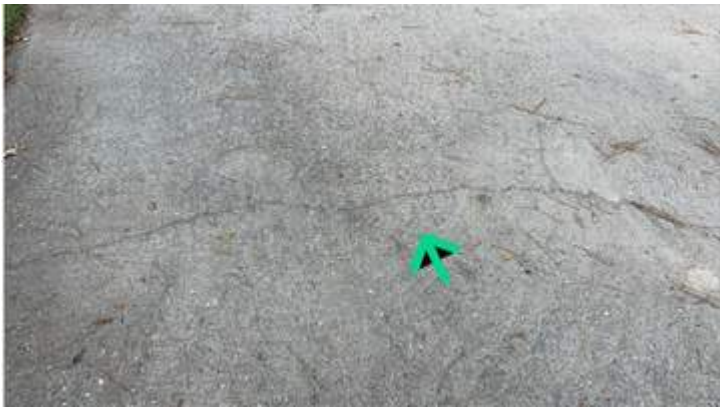
Monitor deficiency

Minor Cracks in the Driveway

The driveway has minor cosmetic cracks. Recommend monitoring this.

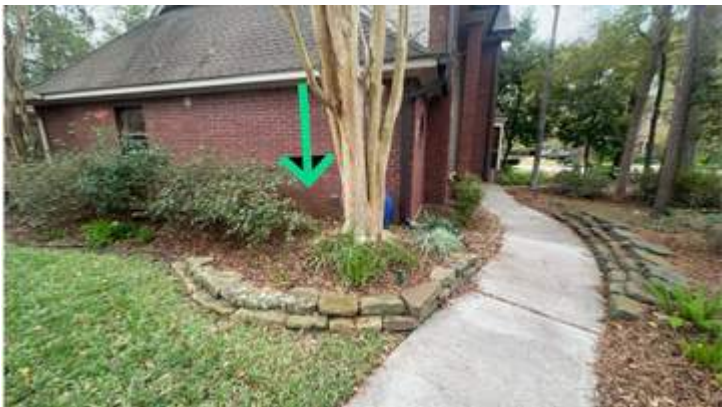
**Left**

**Repair deficiency**

**High Soil Grade**

There are areas of high soil around the foundation.

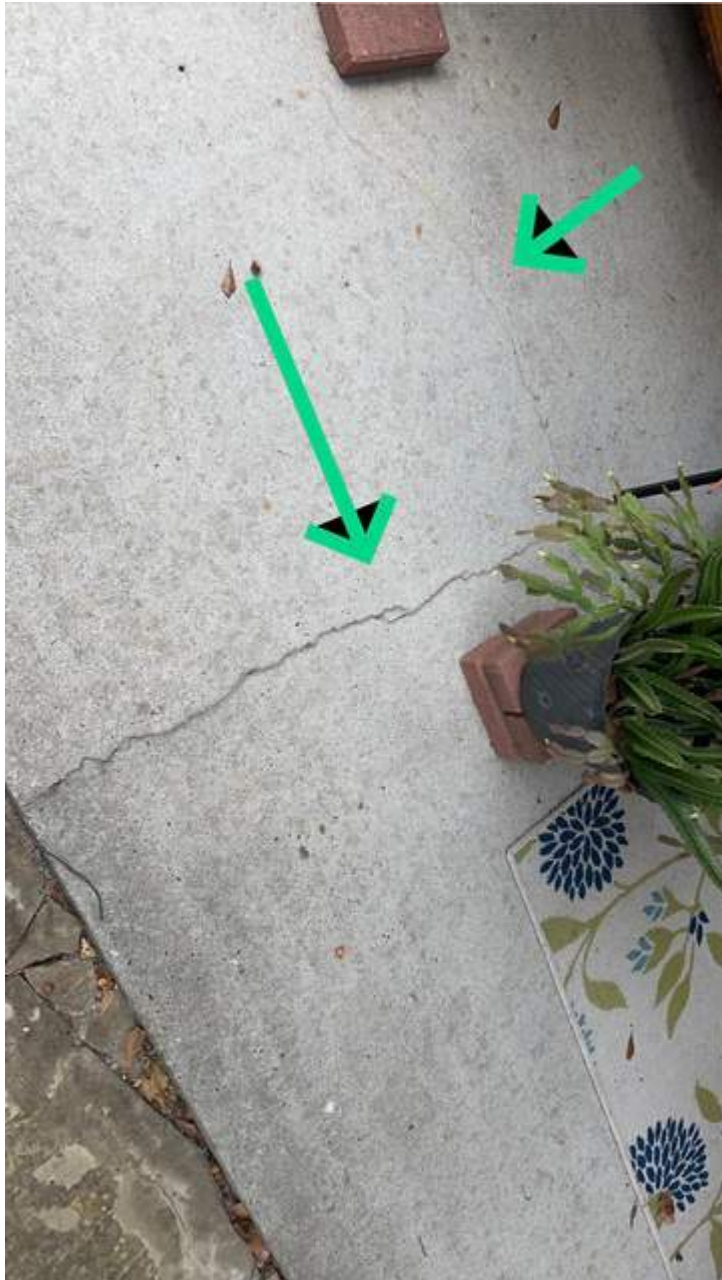
**Back**

**Minor Cracks in Patio / Porch**

There are minor cosmetic cracks on the patio / porch.

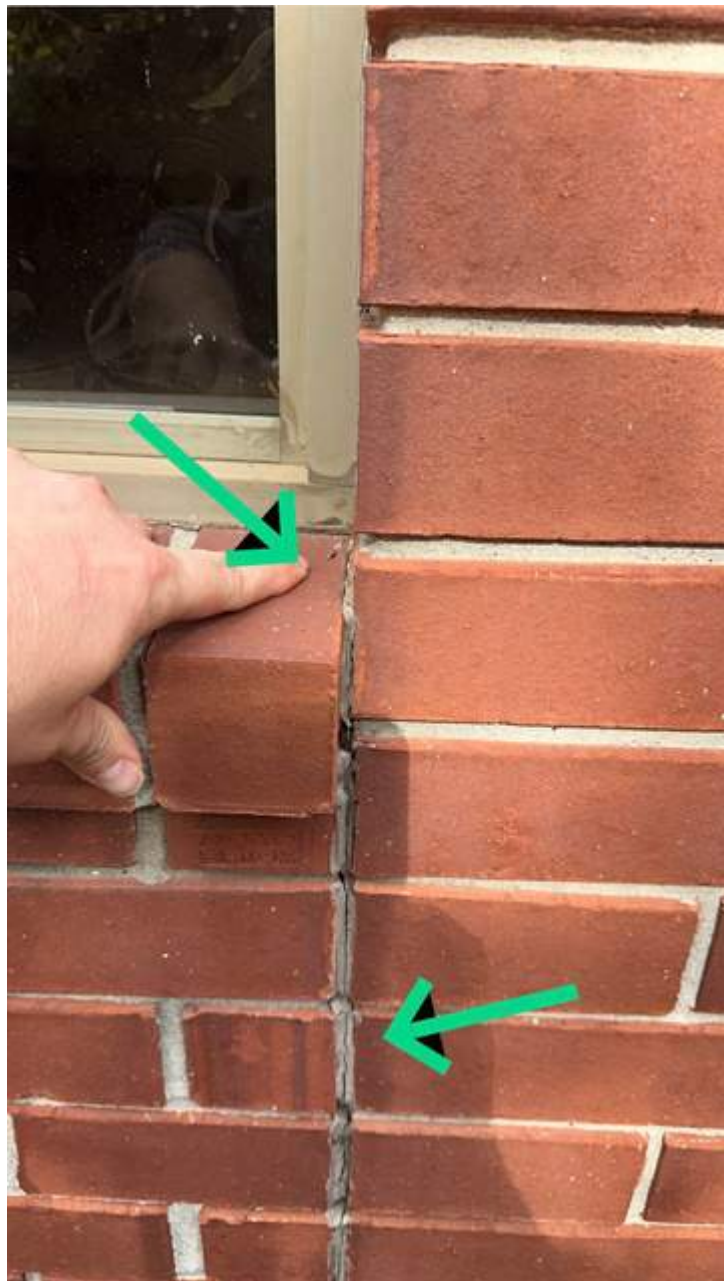
**Right**

## Missing Exterior Caulk

One or more exterior areas need caulking. Recommend repairs or replacing by a qualified professional.

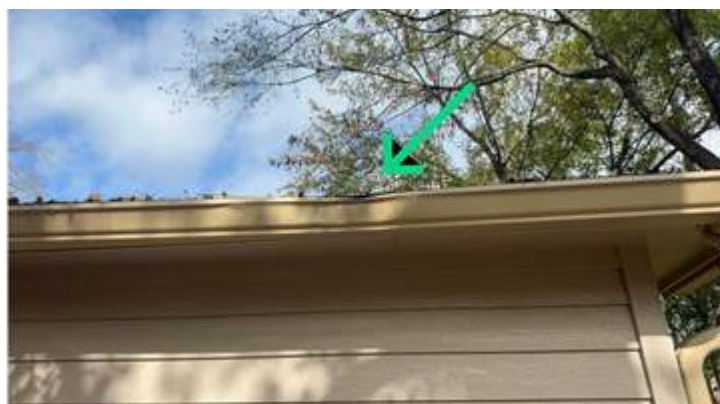
Right

### Damaged Gutters

The gutters are damaged. Recommend repairs or replacing by a qualified professional.

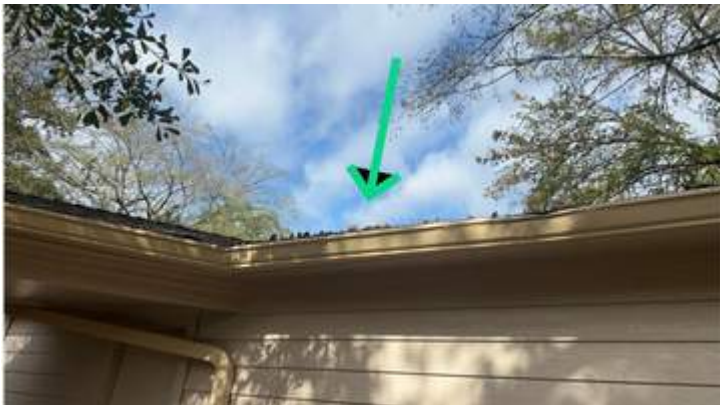
Front, Right, Left, Back

Debris in Gutters

Gutters have accumulated debris throughout. Recommend repairs or replacing by a qualified professional.

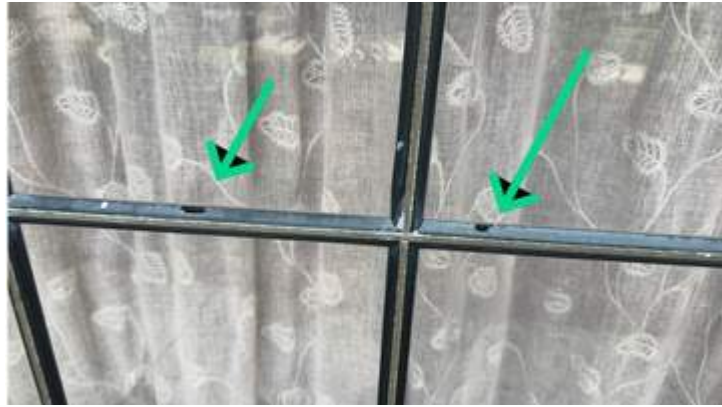
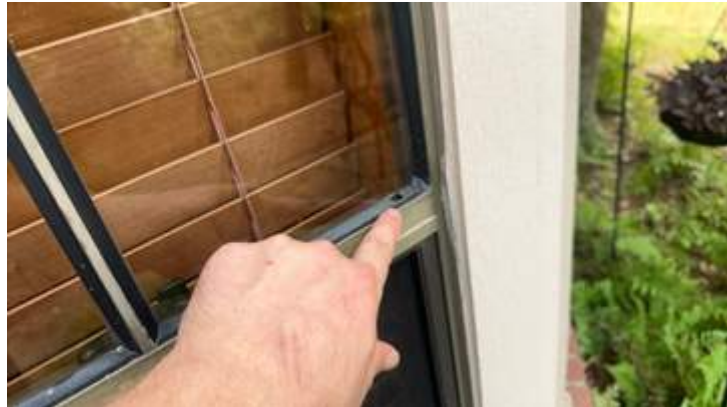
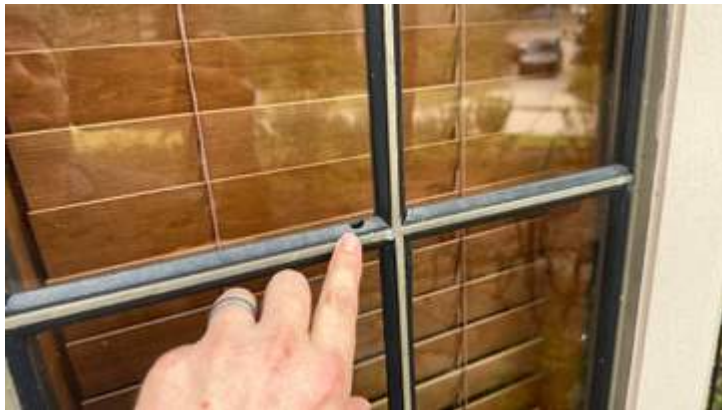
## Deteriorated Window Glazing

The window glazing is deteriorating / damaged. Most windows have damaged glazing strips. Recommend further evaluation by a qualified professional.

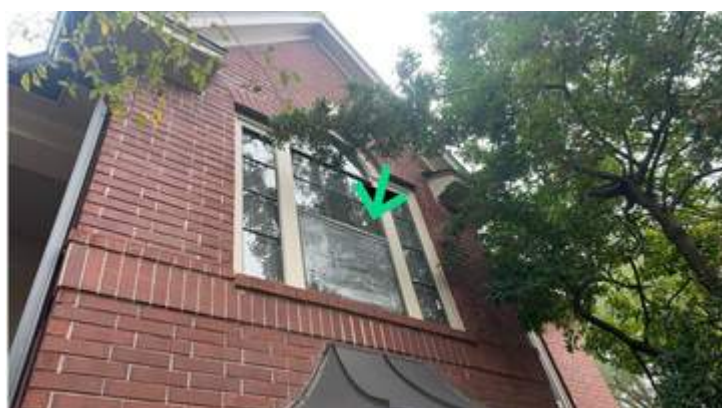
## Front

## Damaged Screen

One or more window screens are damaged.

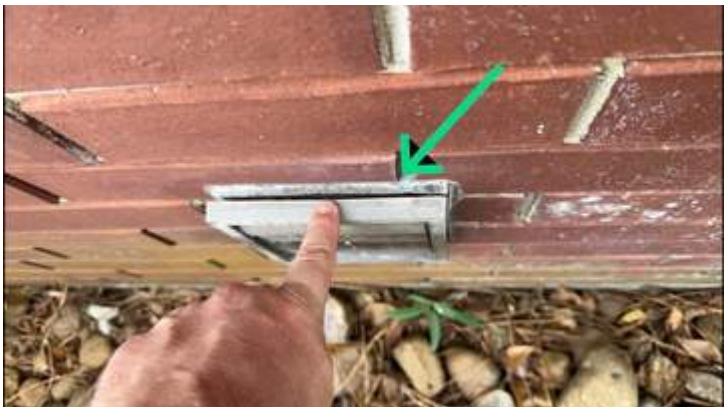
**Left**

The dryer vent line is not sealed properly. Recommend repairs or replacing by a qualified professional.

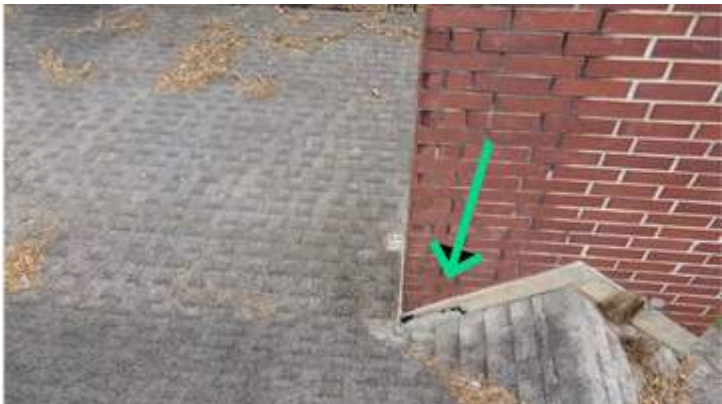
**Roof Granular Loss**

There is granular loss on one or more areas of the roof. Recommend monitoring this, and further evaluation by a qualified professional.

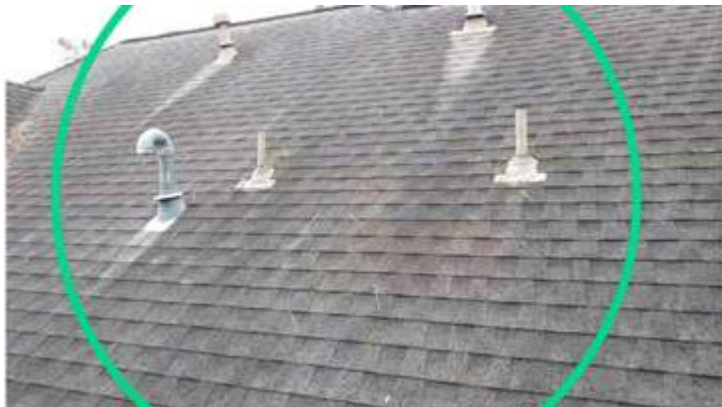
There are leaves, vegetation, or other debris on the roof coverings. Recommend repairs or replacing by a qualified professional.

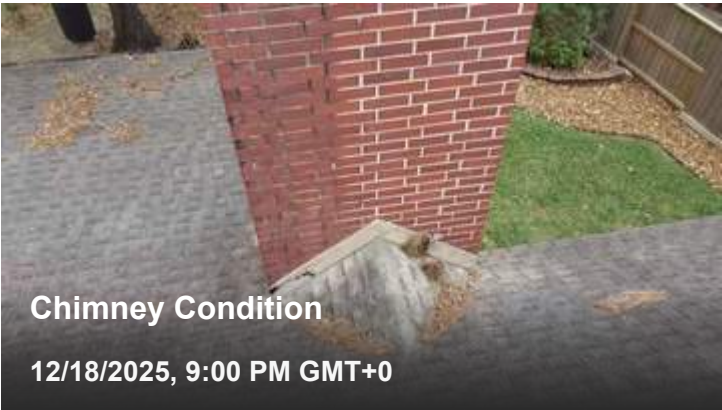
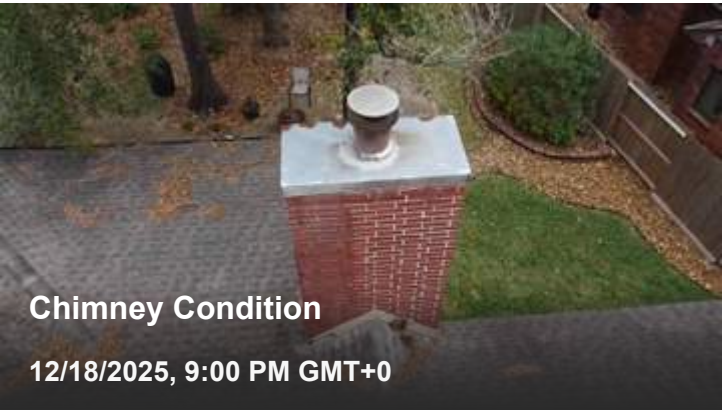
**Rusty Metal Chimney**

The metal chimney shows evidence / signs of rust / rusting. Recommend repairs or replacing by a qualified professional.

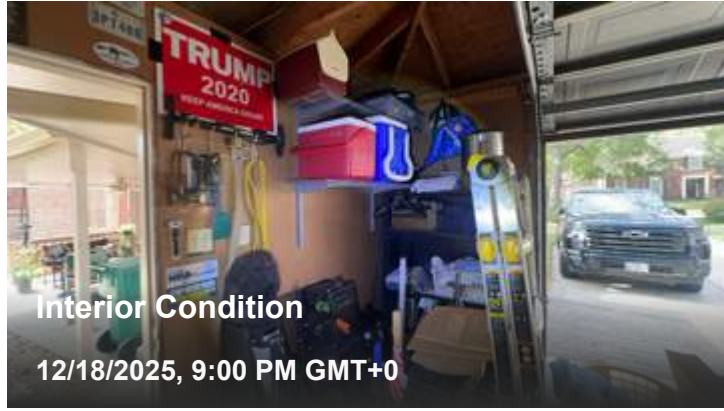
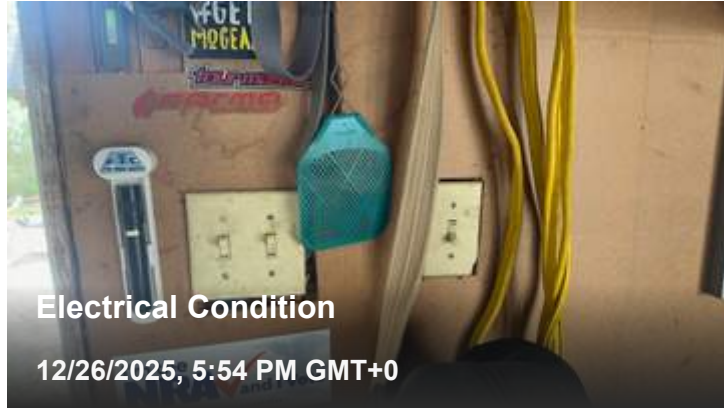
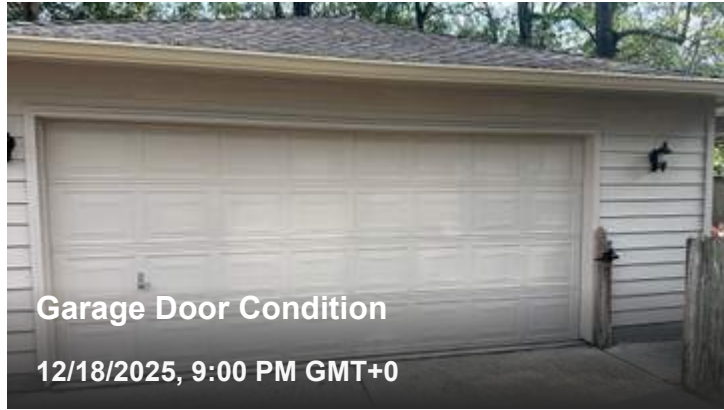
## Poorly Located Garage Door Proximity Sensor

The garage proximity laser is too high off the ground. Recommend repairs or replacing by a qualified professional.

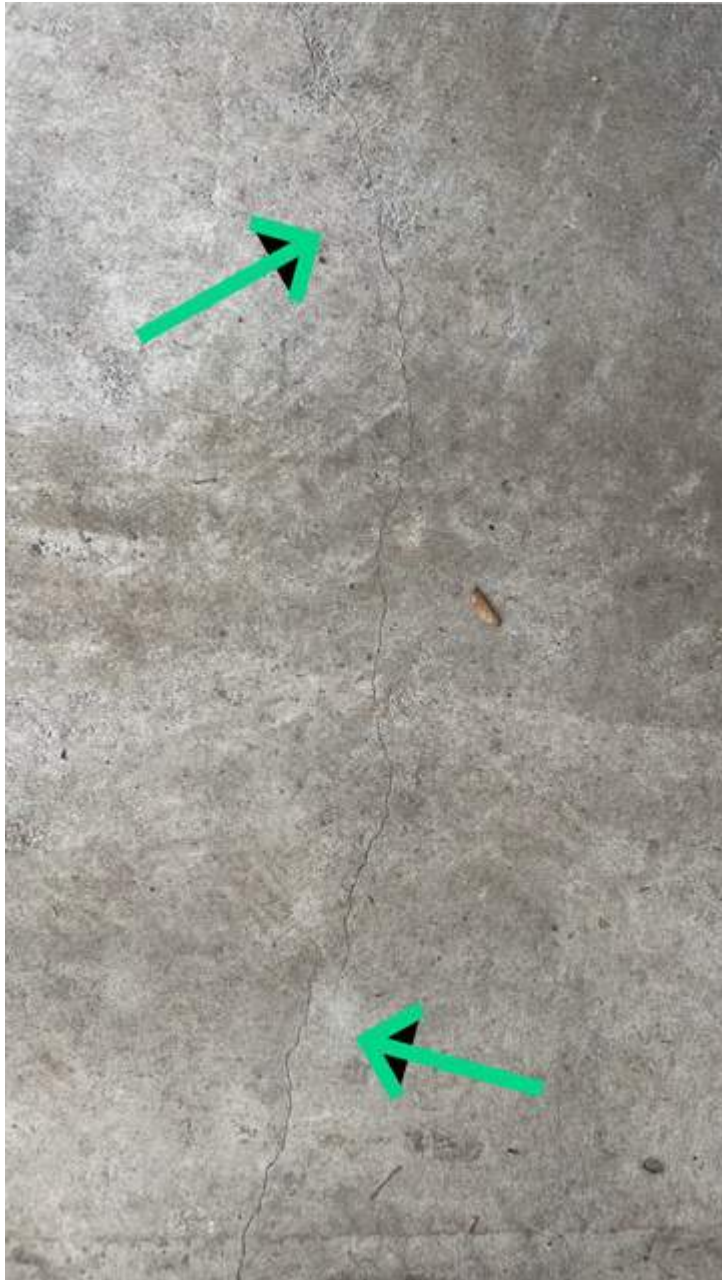
**Garage**

**Minor Cracks in Garage Slab**

There are minor cracks in the garage concrete slab. Recommend monitoring this.

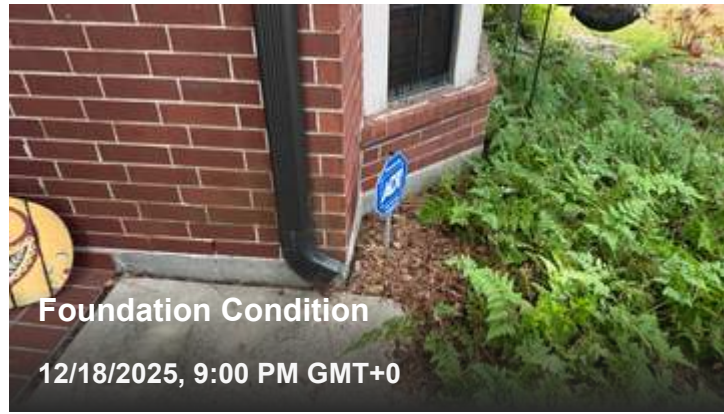
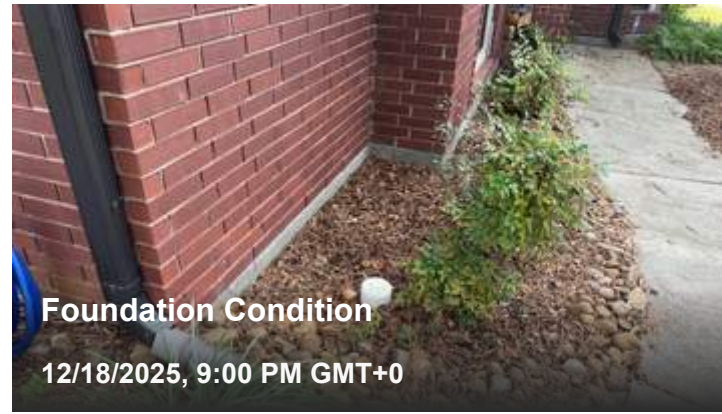
## Minor Corner Cracks

There are minor cracks at the corners of doors / windows / walls. Recommend monitoring this, and further evaluation by a qualified professional.

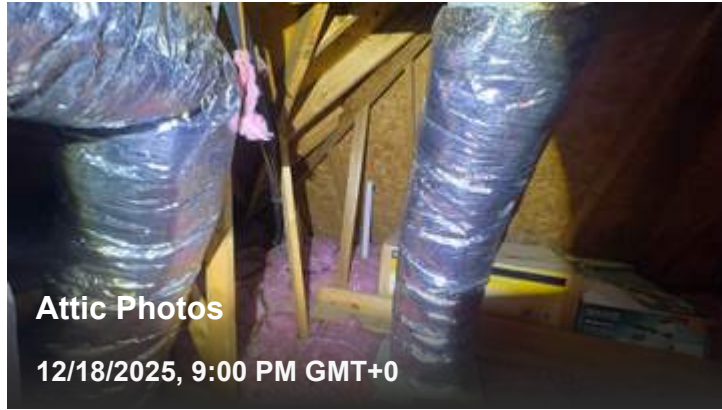
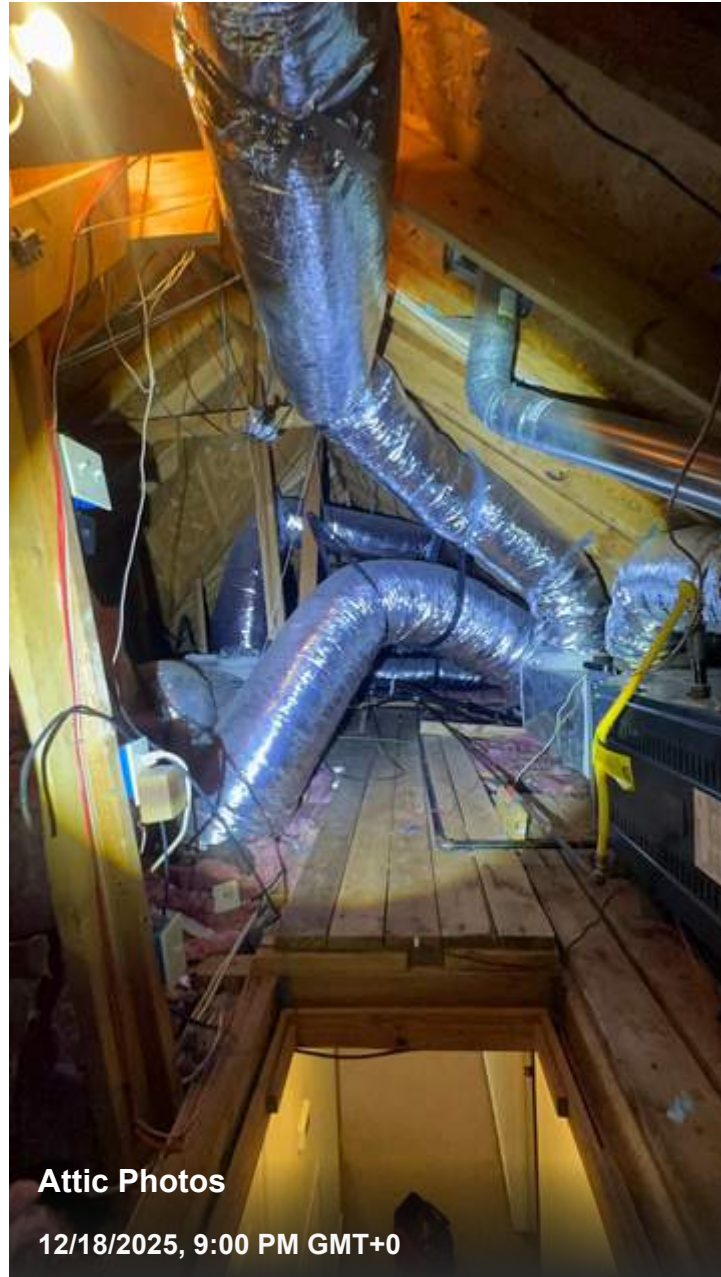
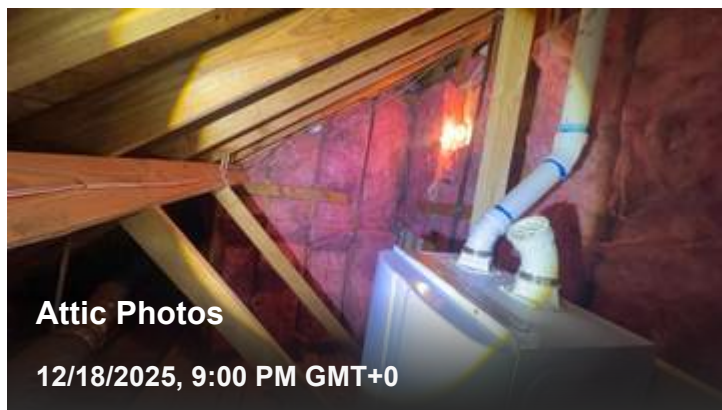
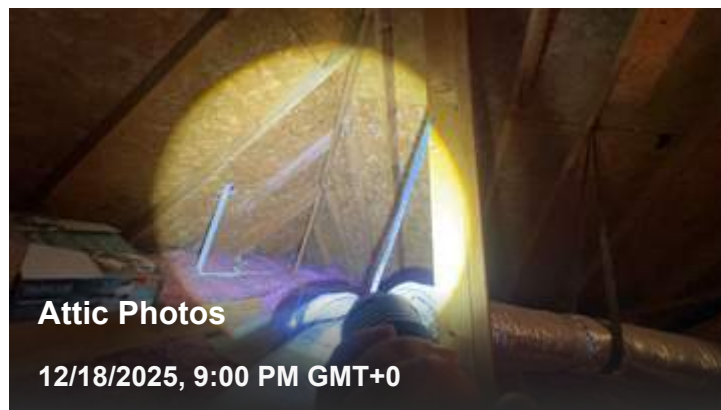
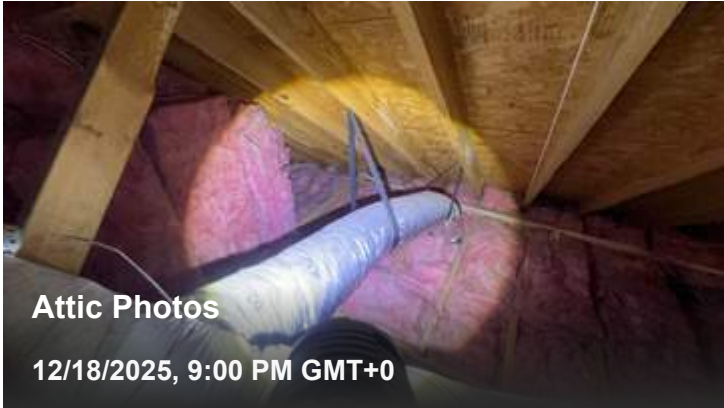
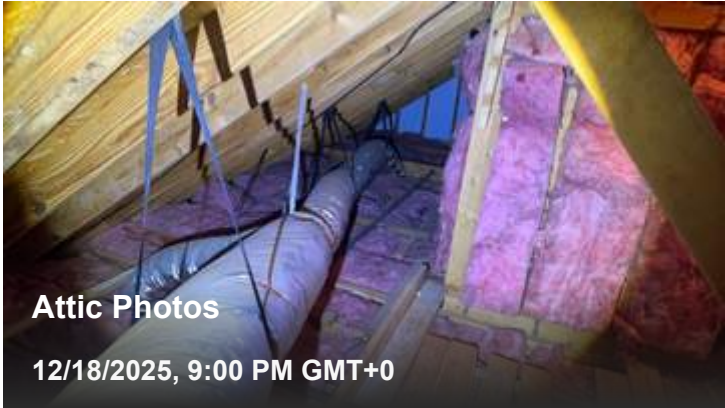
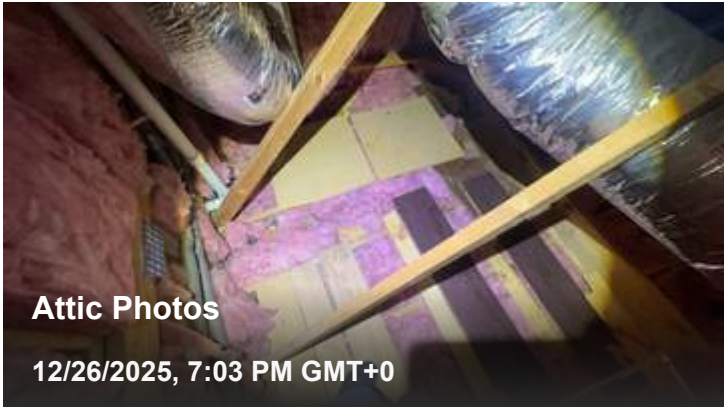
**Mold-Like Substance in Attic**

There is a mold-like substance in the attic. Recommend repairs or replacing by a qualified professional.

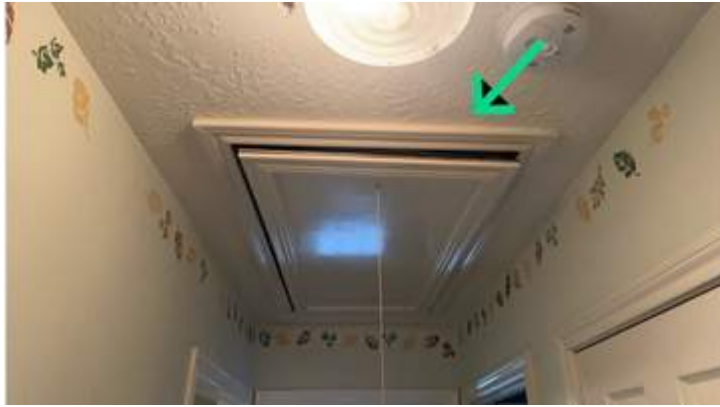
## Leaking Roof

There are indications of a leak from the roof.

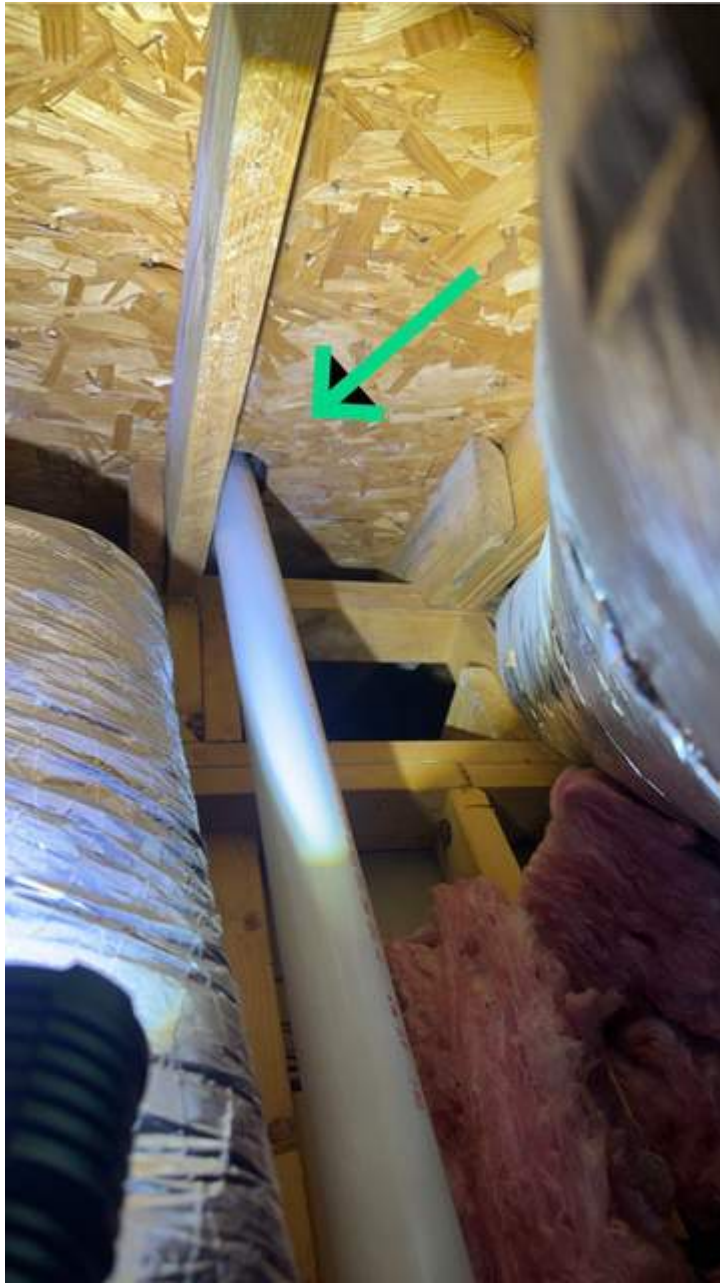
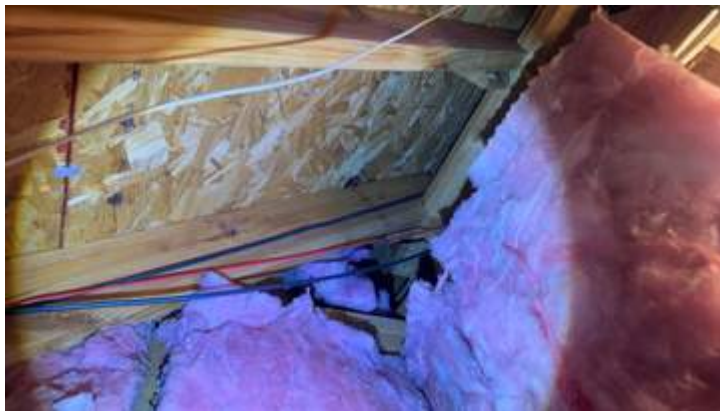
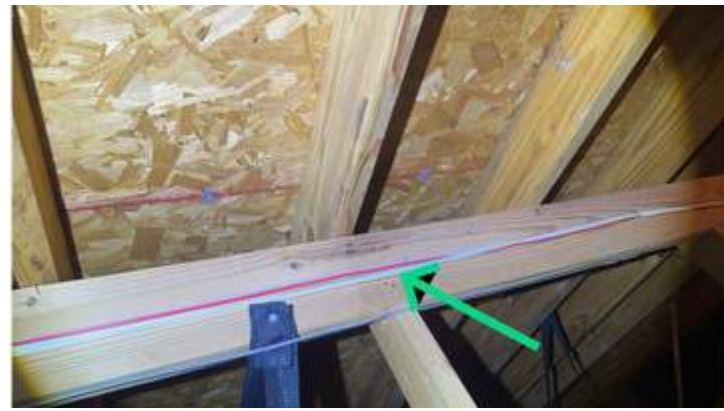
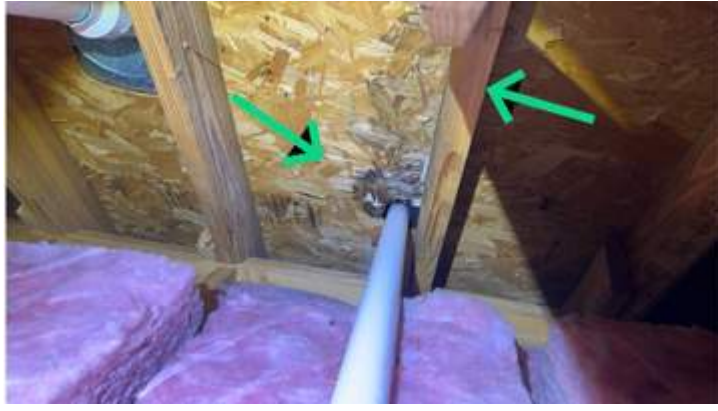
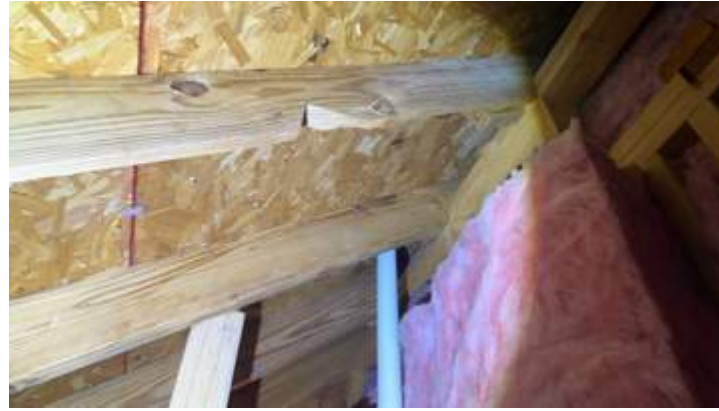
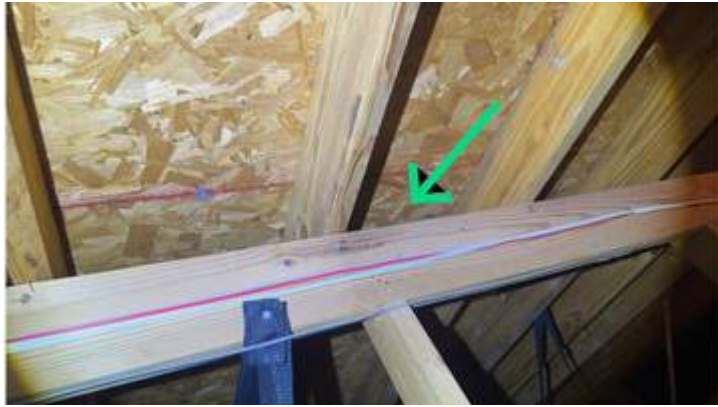
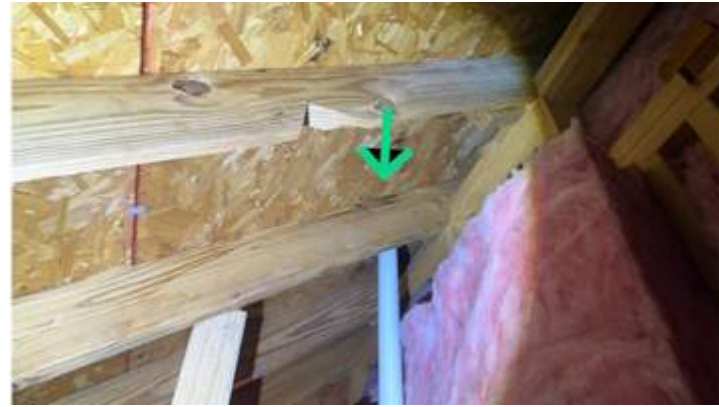
## Missing Attic Hatch Insulation

There is no insulation for the attic access hatches. Recommend repairs or replacing by a qualified professional.

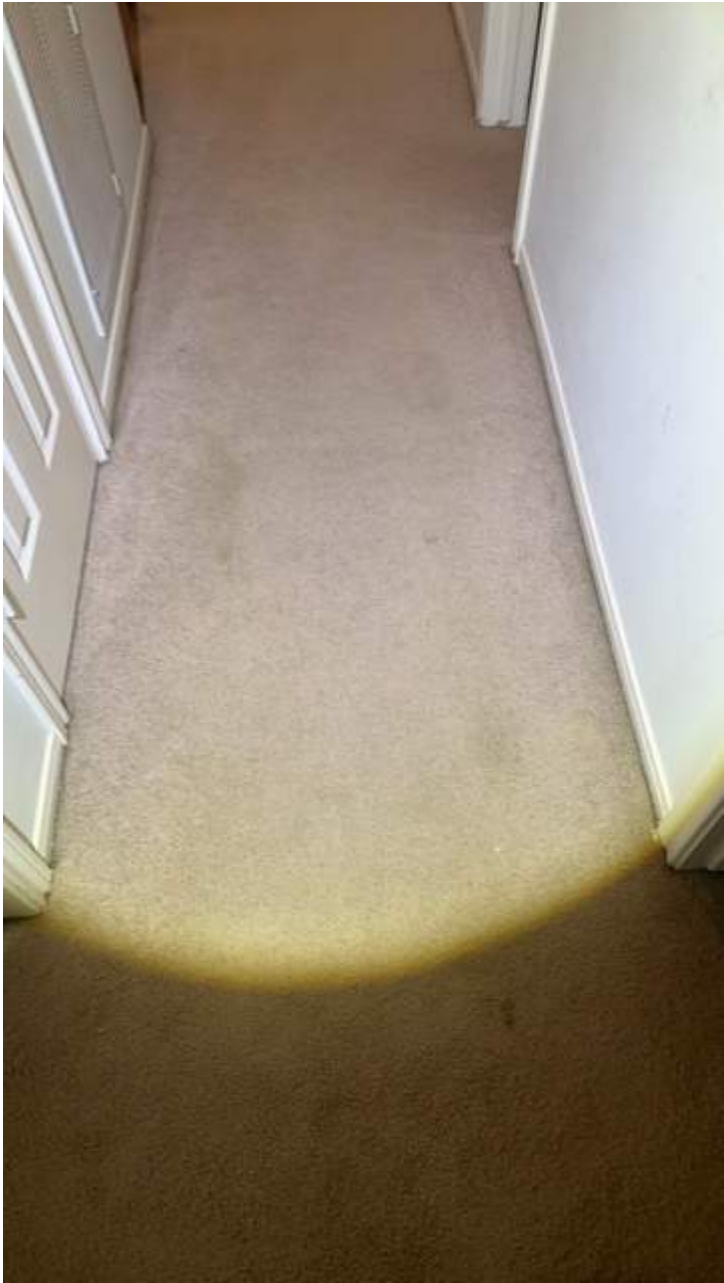
**2nd Floor**

## Stained Carpet

The carpet has areas of staining or discoloration. Recommend repairs or replacing by a qualified professional.

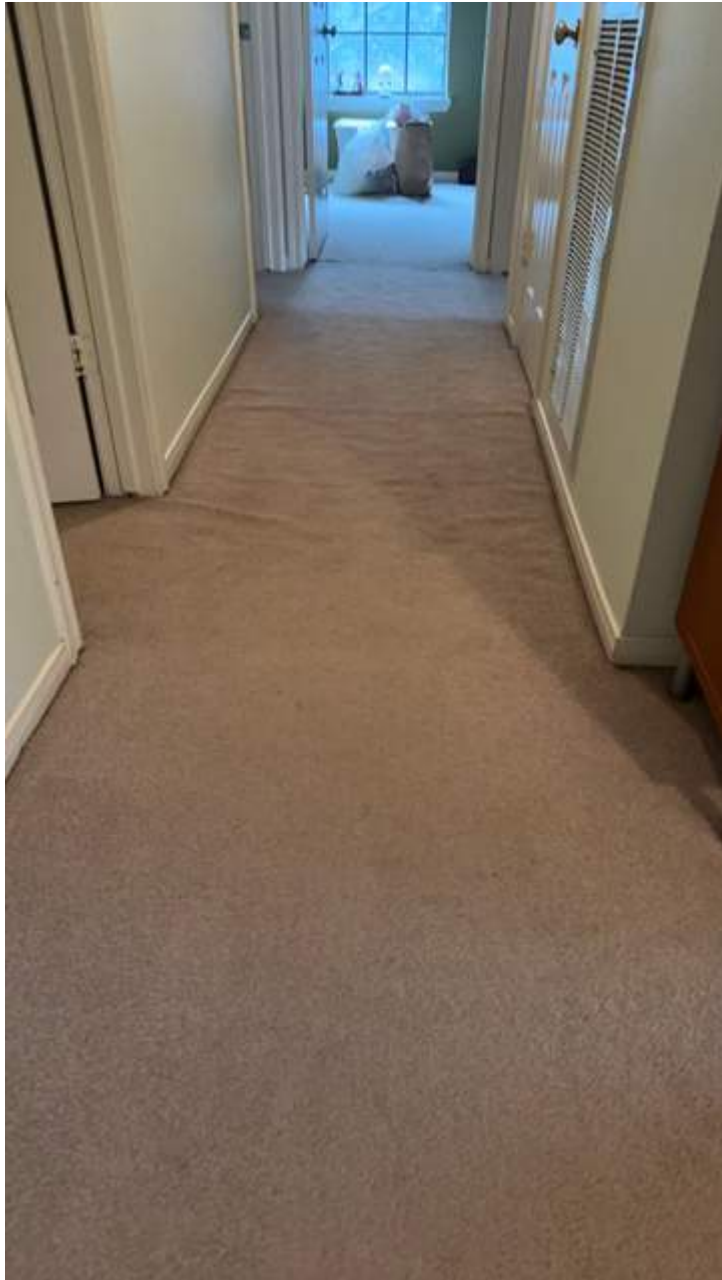
2nd Floor, Common Area

Loose Carpet

The carpet is loose. Recommend repairs or replacing by a qualified professional.

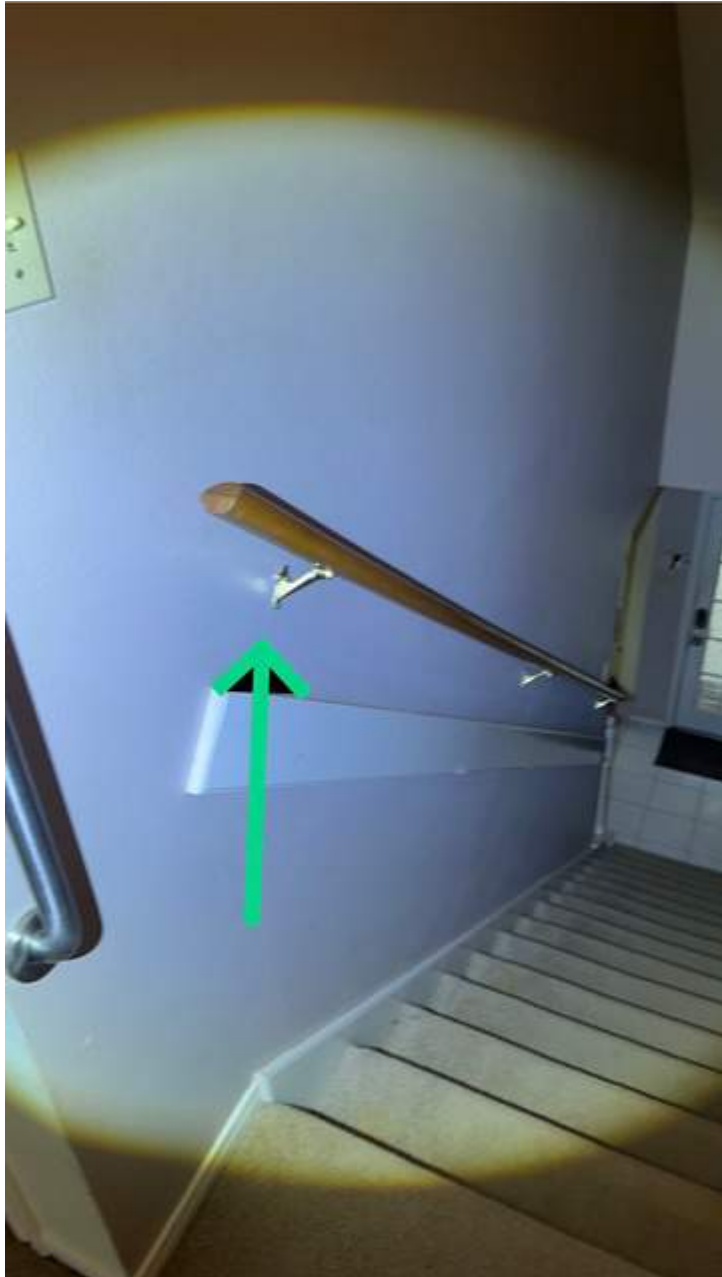
### Loose Handrail

The handrail is loose. Recommend repairs or replacing by a qualified professional.

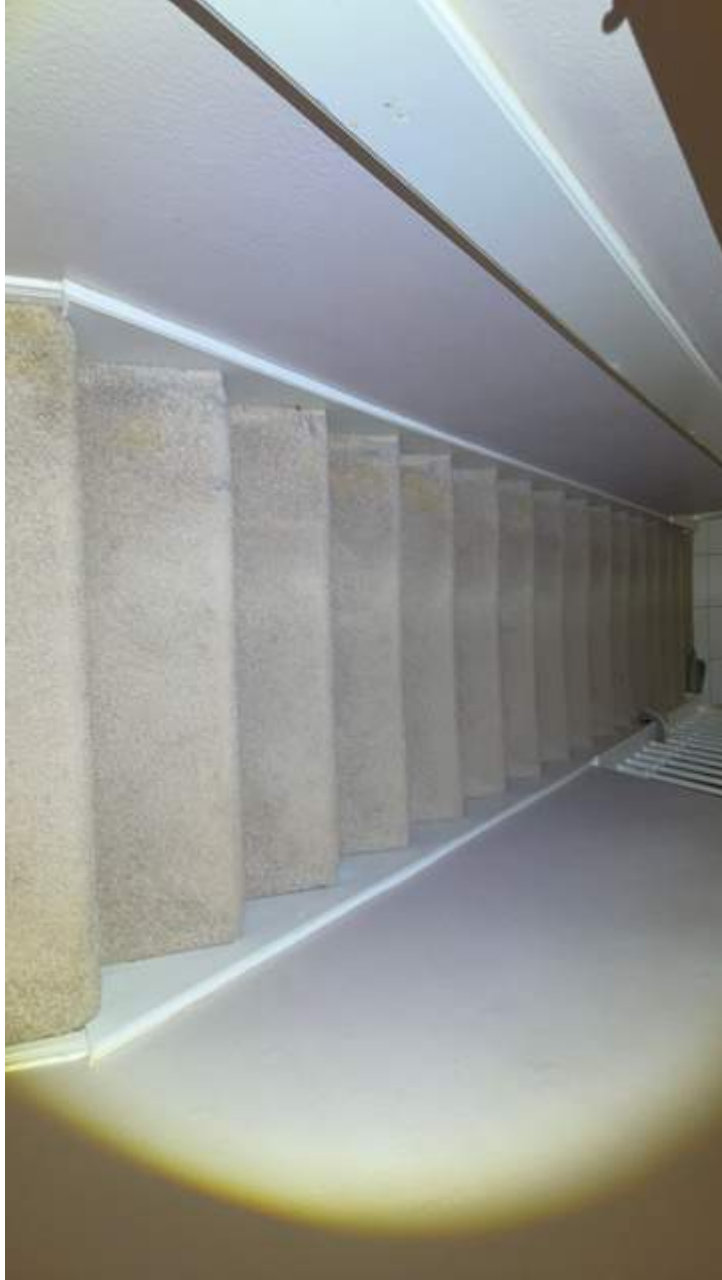
### Stained Carpet

The carpet has areas of staining or discoloration.

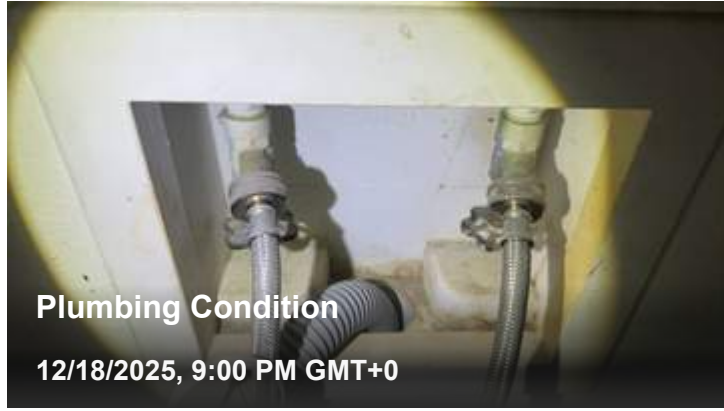
## Deteriorated / Damaged Water Valve

The valve is deteriorated / damaged. Recommend repairs or replacing by a qualified professional.

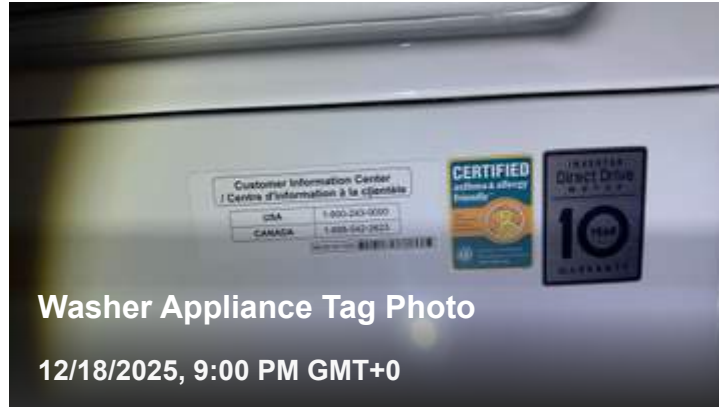
Washer Appliance Tag Photo  
12/18/2025, 9:00 PM GMT+0

The appliance label was not accessible for inspection.

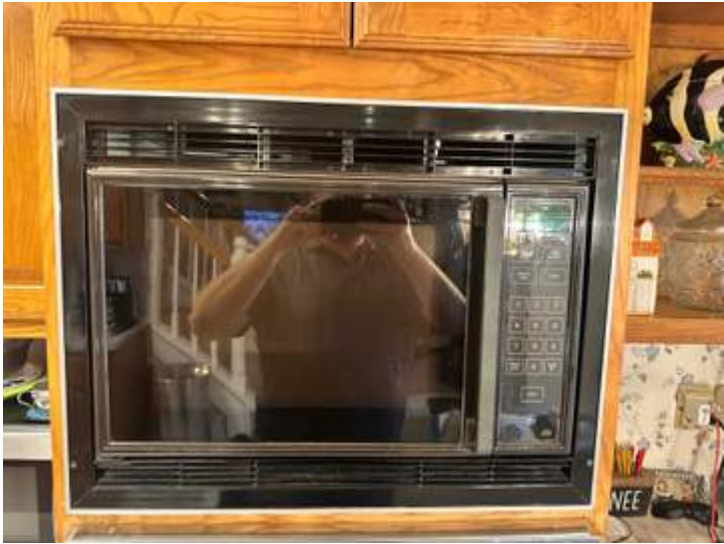
Repair deficiency

Inoperable Microwave

The microwave is inoperable.

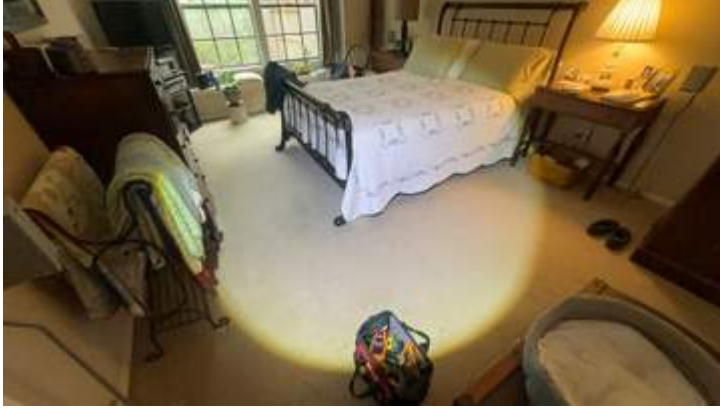
## Repair deficiency

### Missing / Damaged Door Stop(s)

Door stops are missing or damaged for an interior door. Recommend repairs or replacing by a qualified professional.

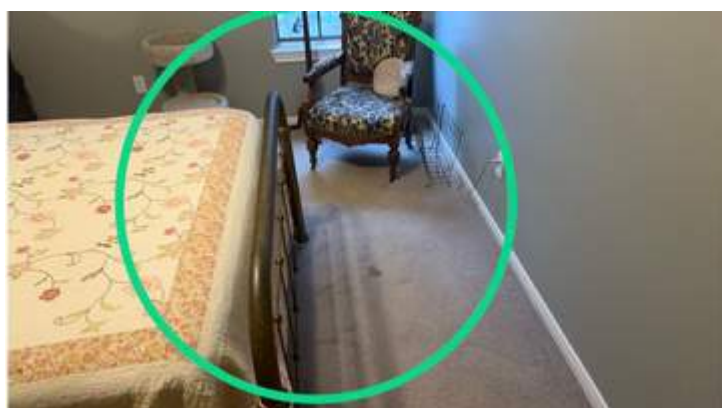
The floors or stairs are squeaking. Recommend further evaluation by a qualified professional.

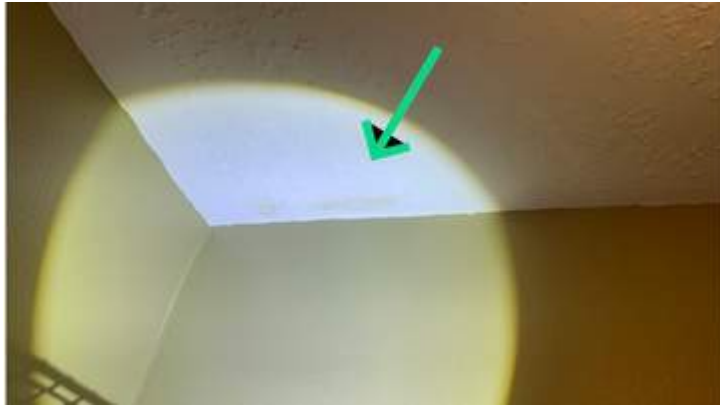
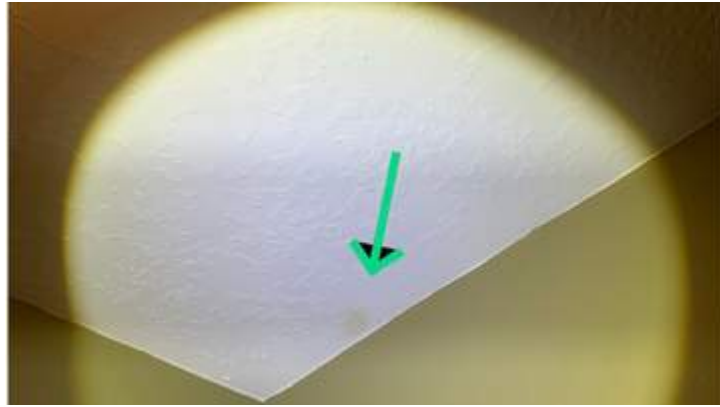
## Water Stained Ceiling

The ceiling has one or more moisture stains. Recommend repairs or replacing by a qualified professional.

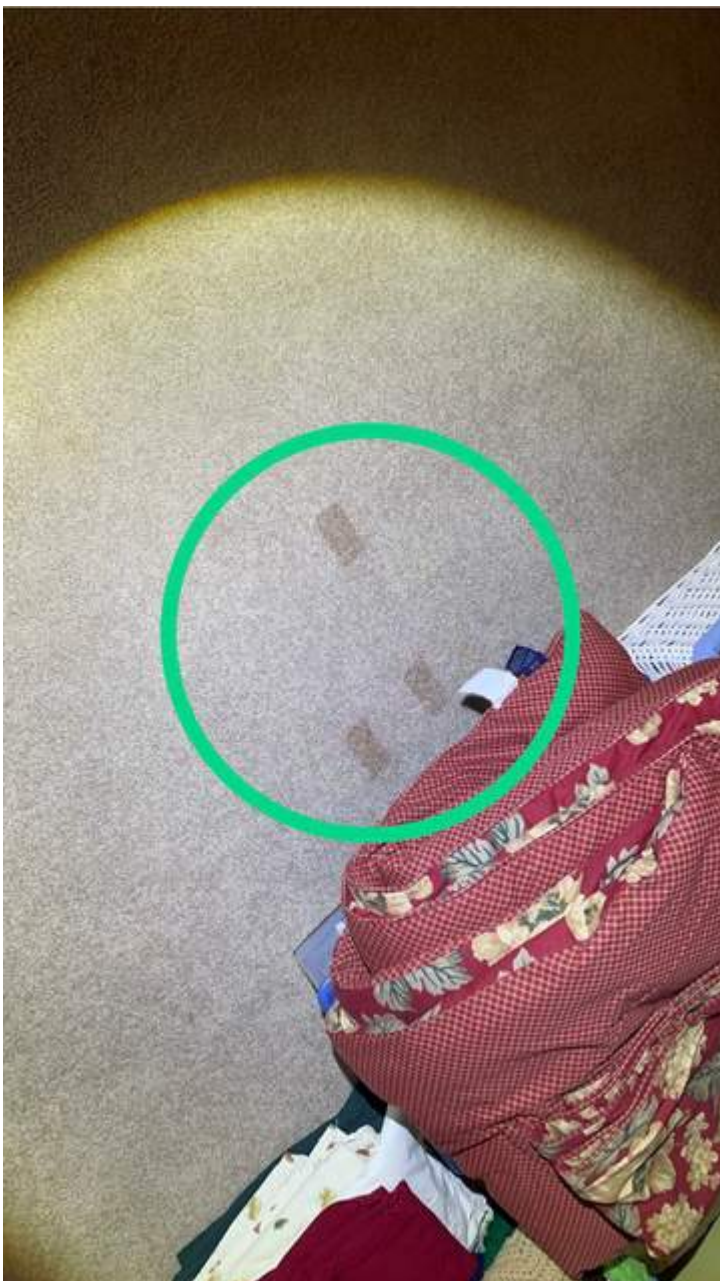
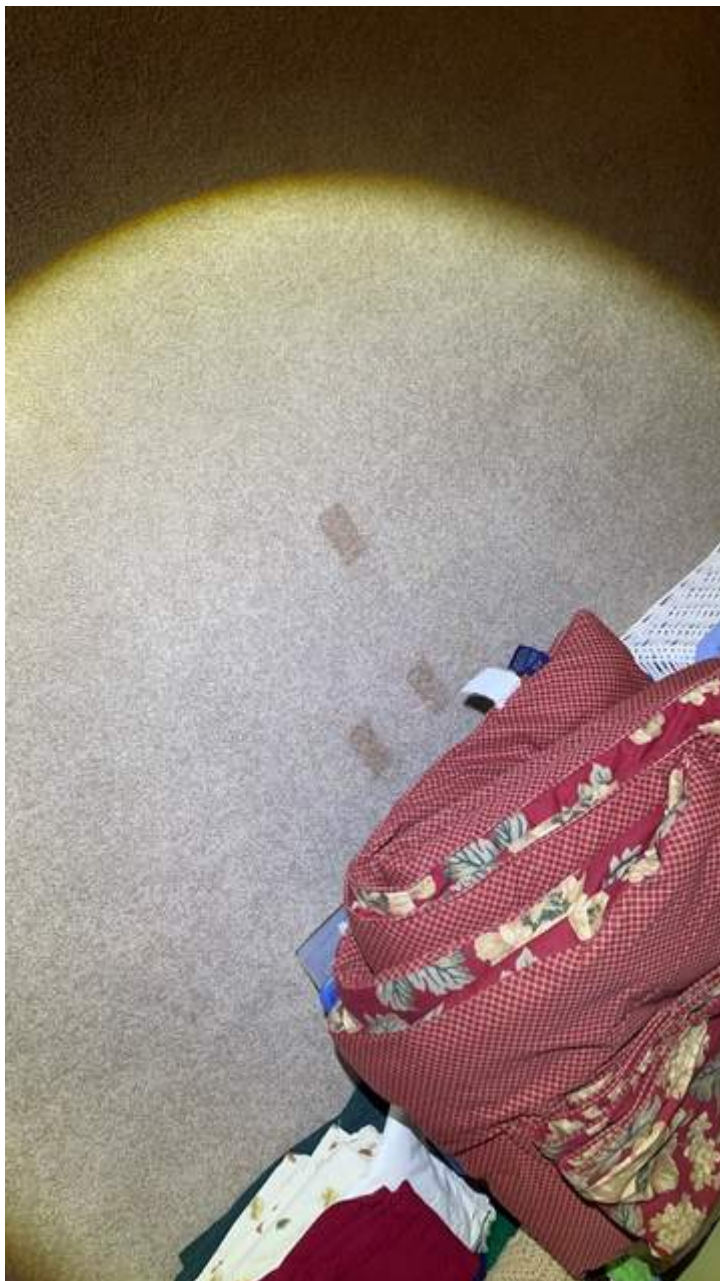
### Stained Carpet

The carpet has areas of staining or discoloration.

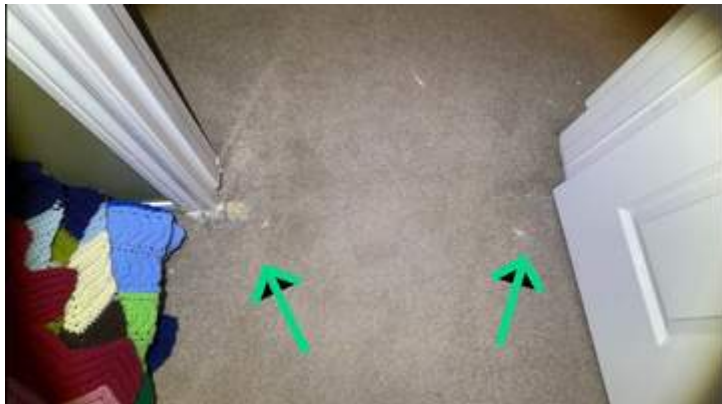
### Damaged or Torn Carpet

The carpet floor is damaged or torn in one or more areas. Recommend repairs or replacing by a qualified professional.

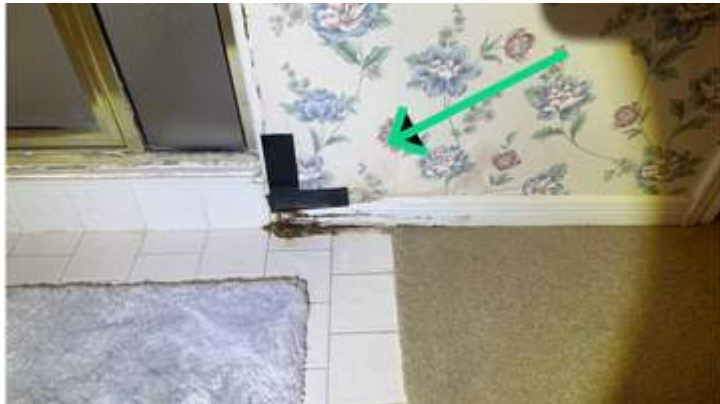
**Repair deficiency**

There are signs of biological growth, mold, or mildew on the property. Recommend repairs or replacing by a qualified professional.
