# 14 S Duskwood Pl

## Spring, Texas 77381

| Type | <b>Re Visit Report - 14 S Duskwood Pl</b> |
| Inspected by | <b>Local Property Inspections PLLC</b> |

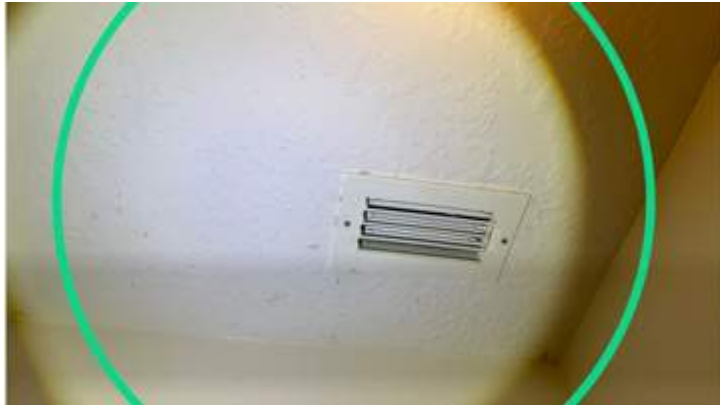
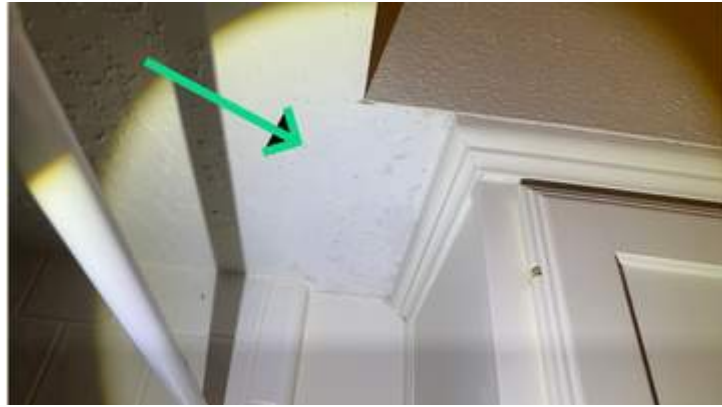
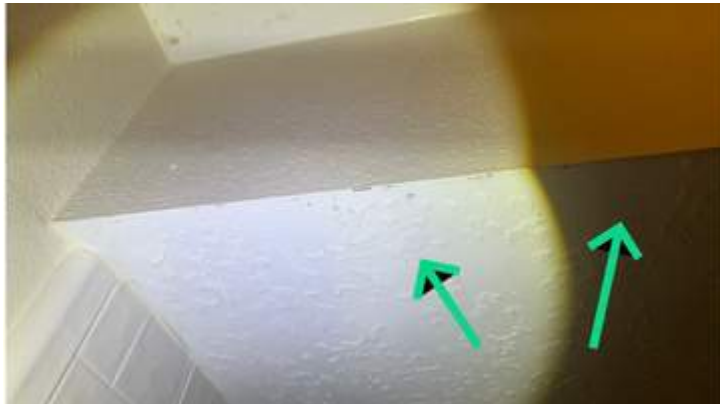
**Repair deficiency**

## Leaking Sink

There are signs of a leak from the sink in the cabinet. Recommend repairs or replacing by a qualified professional.

### Repair deficiency

There are signs of biological growth, mold, or mildew on the ceiling. Recommend repairs or replacing by a qualified professional.

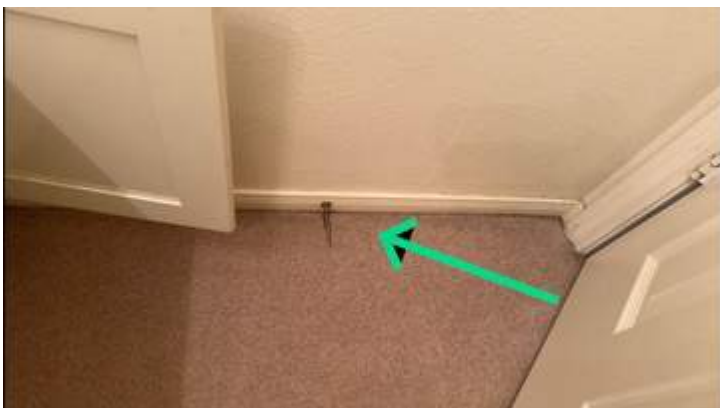
### Repair deficiency

## Missing / Damaged Door Stop(s)

Door stops are missing or damaged for an interior door. Recommend repairs or replacing by a qualified professional.

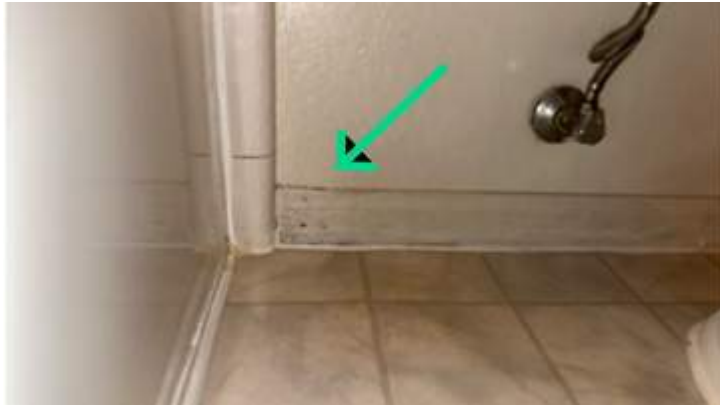
### Repair deficiency

## Signs of Moisture Intrusion to the Trim

There are signs of moisture intrusion at the trim. Recommend repairs or replacing by a qualified professional.

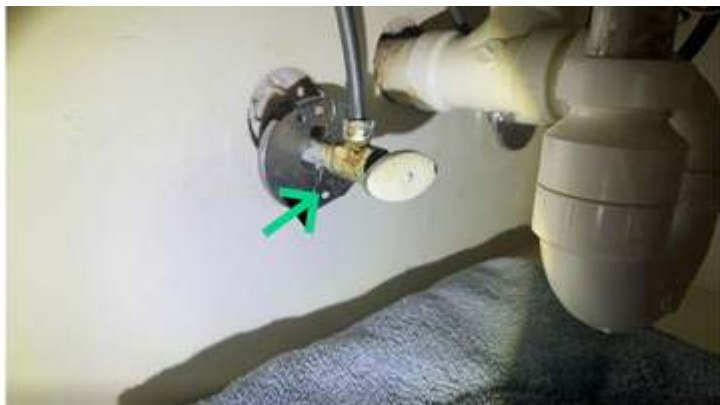
#### Deteriorated / Damaged Water Valve

The valve is deteriorated / damaged. Recommend repairs or replacing by a qualified professional.

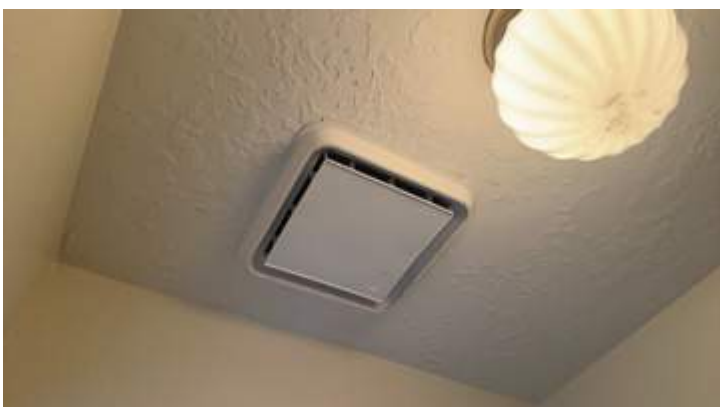
#### Noisy Bathroom Exhaust Fan

The bathroom exhaust is unusually noisy. Recommend repairs or replacing by a qualified professional.

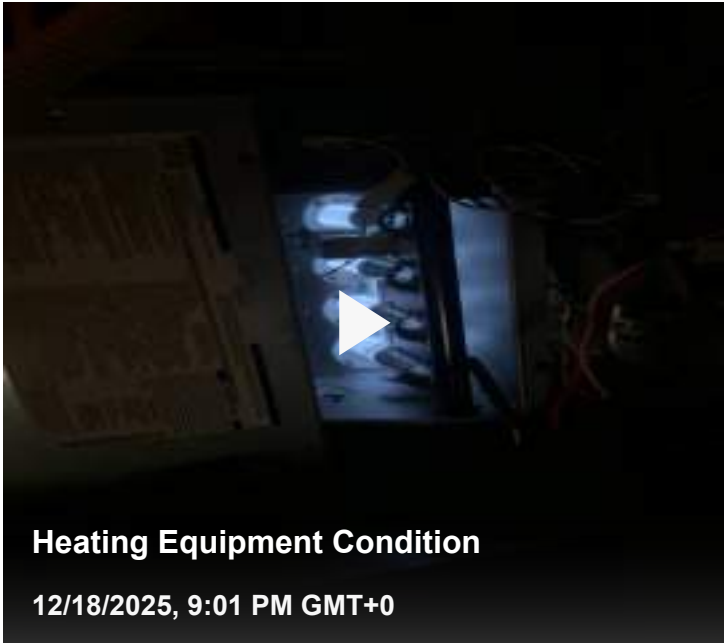
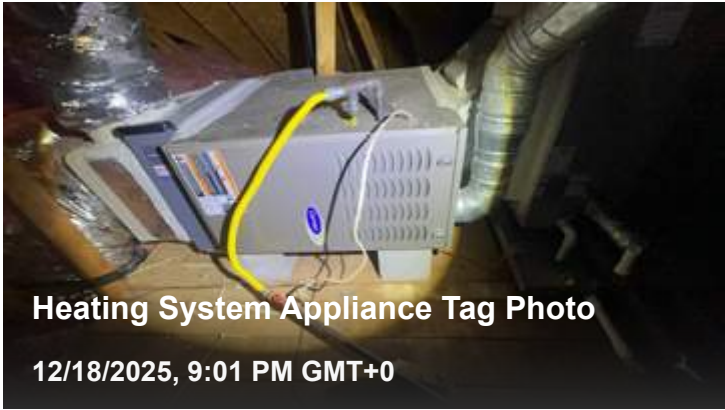
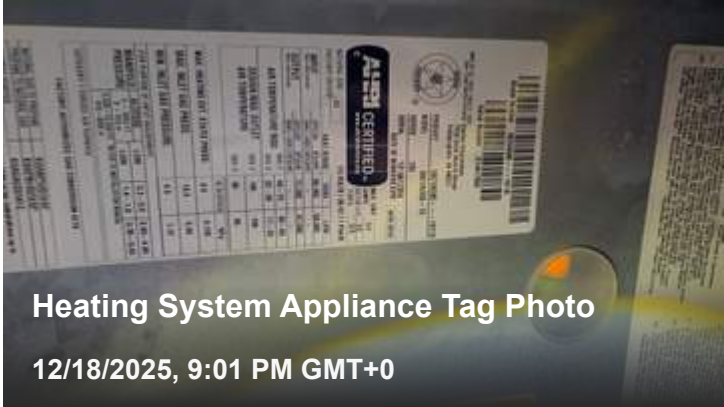
Missing Sediment Trap

There is no sediment trap on the furnace. Recommend repairs or replacing by a qualified professional.

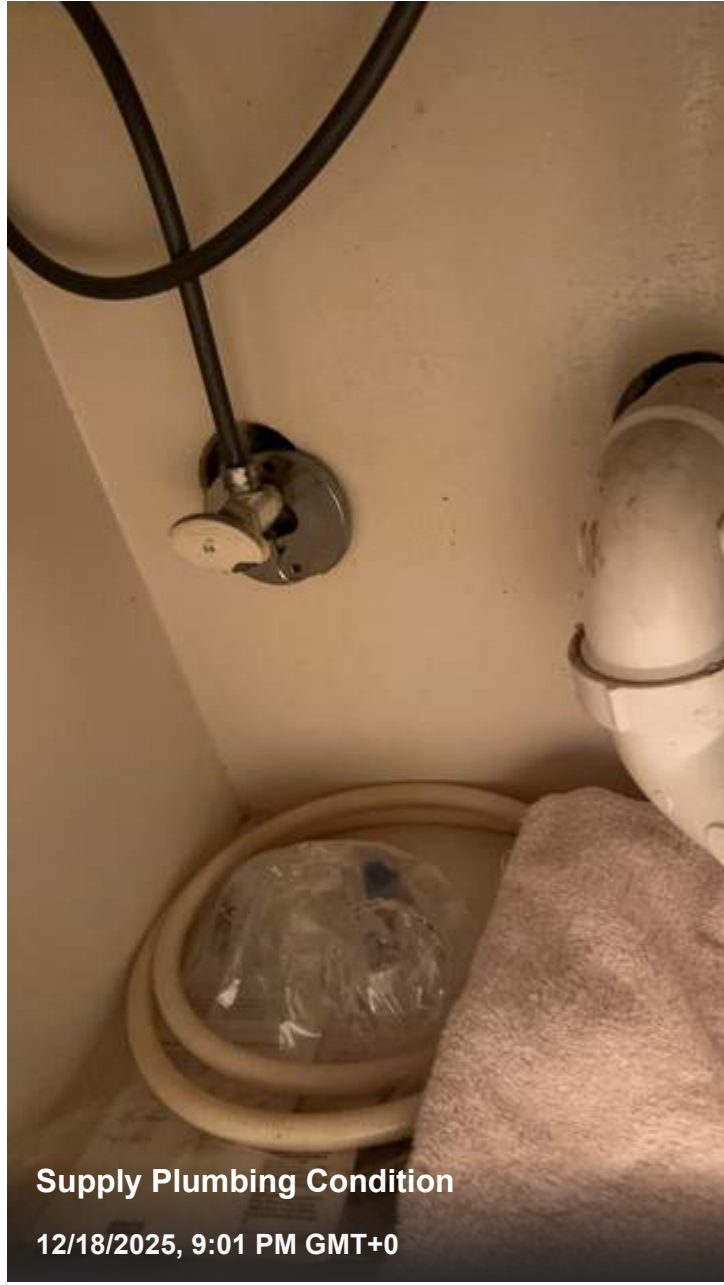
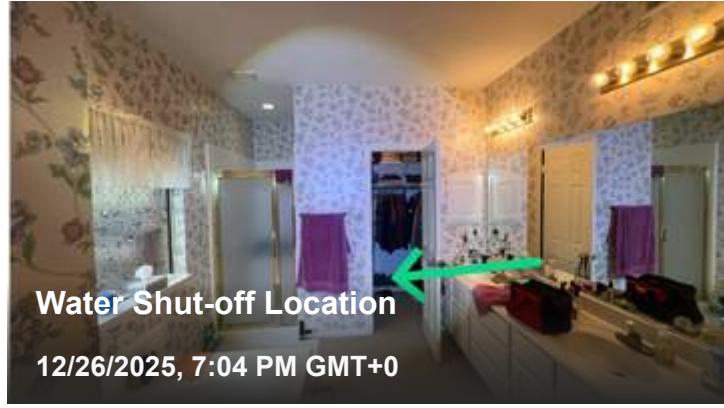
### Uninsulated Water Lines

The water lines are uninsulated. Recommend repairs or replacing by a qualified professional.

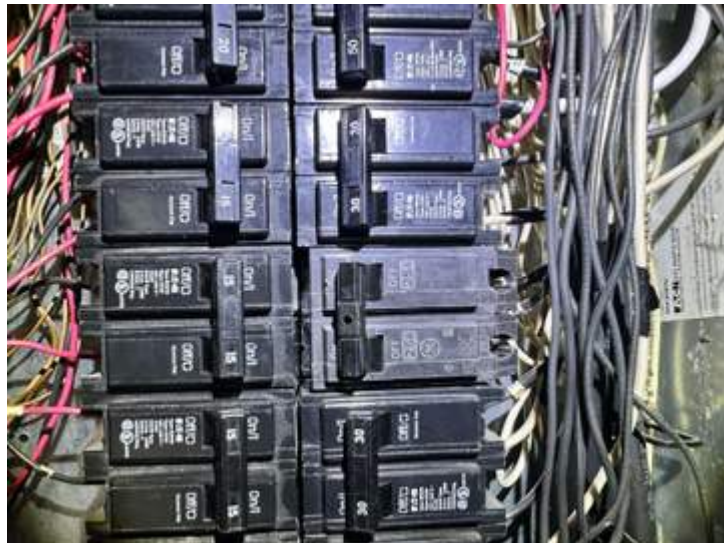
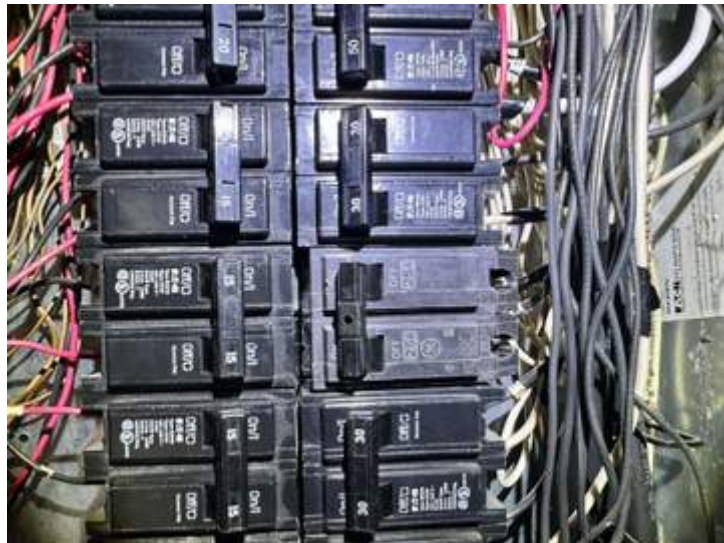
## Circuit Breakers From Different Manufacturers

The panel has circuit breakers that are not manufactured by the company that manufactured the panel. Recommend repairs or replacing by a qualified professional.

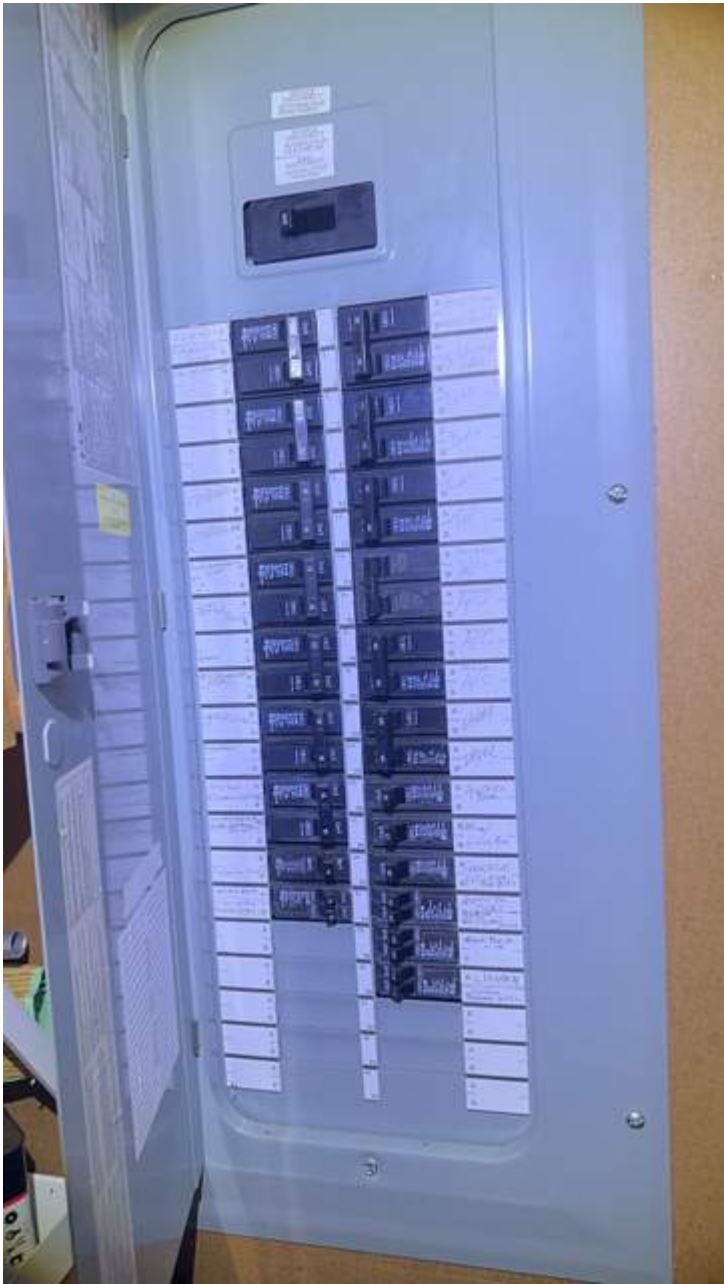
## Missing AFCI Breaker

A required Arc-Fault Circuit Interrupter is missing. Recommend repairs or replacing by a qualified professional.

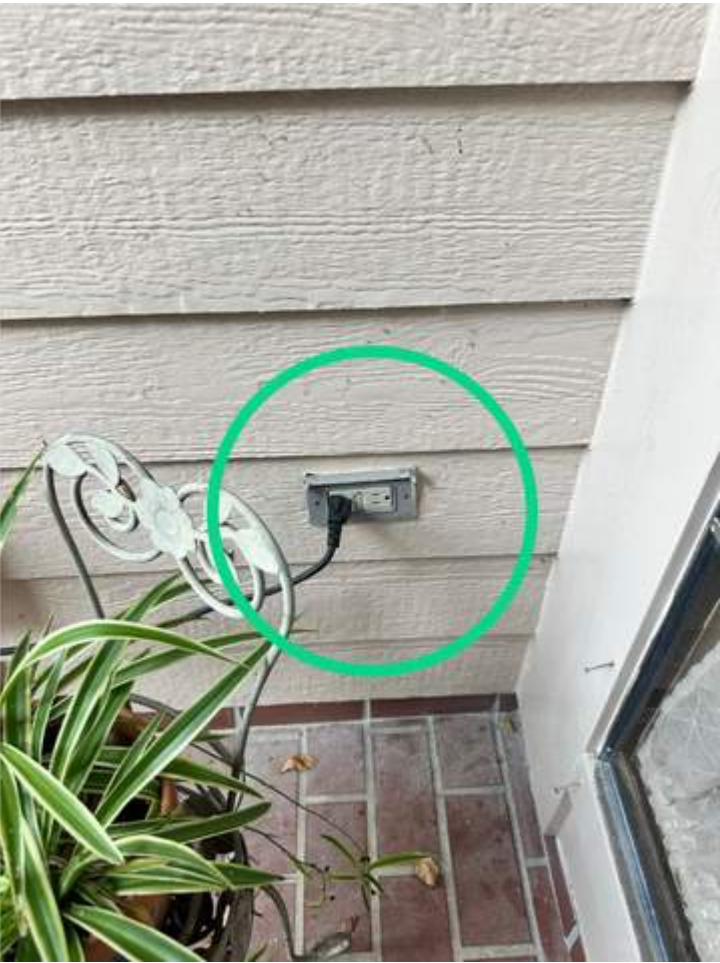
Front

Missing Weather-Resistant Cover

There should be a water-resistant cover installed. Recommend repairs or replacing by a qualified professional.

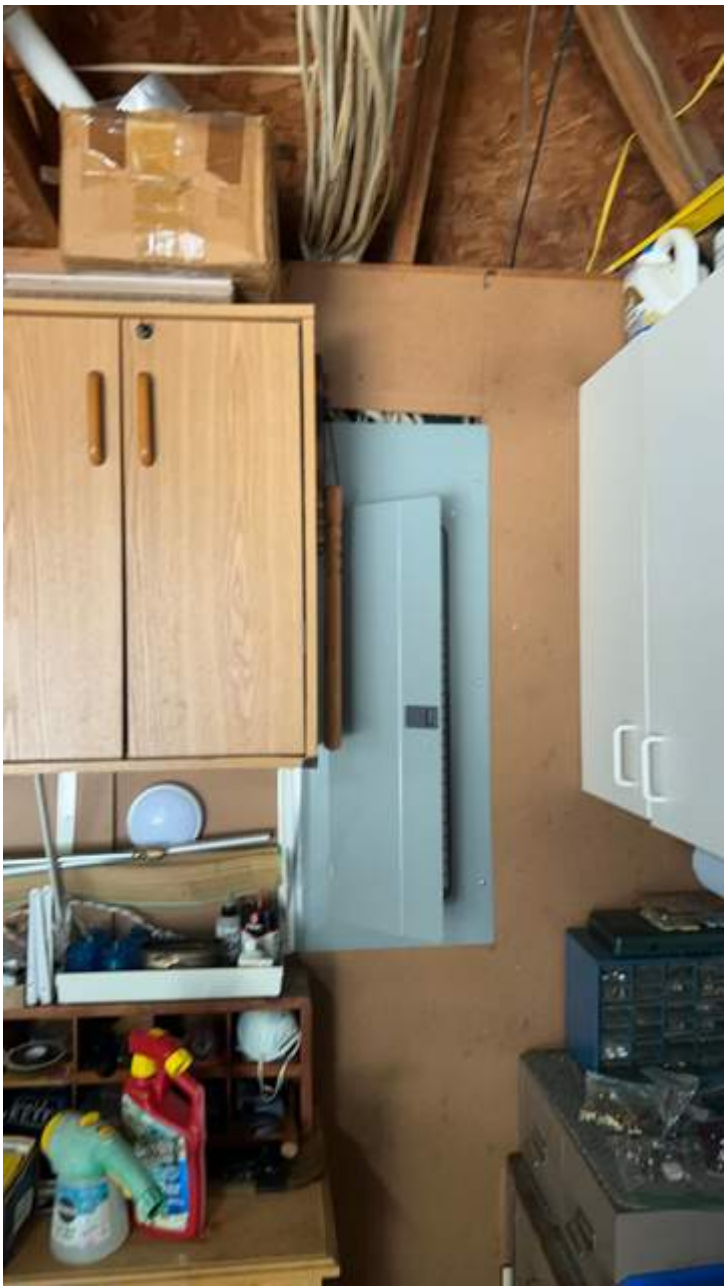
I was unable to inspect all of the electrical wiring. Most of the wiring is hidden from view within walls.

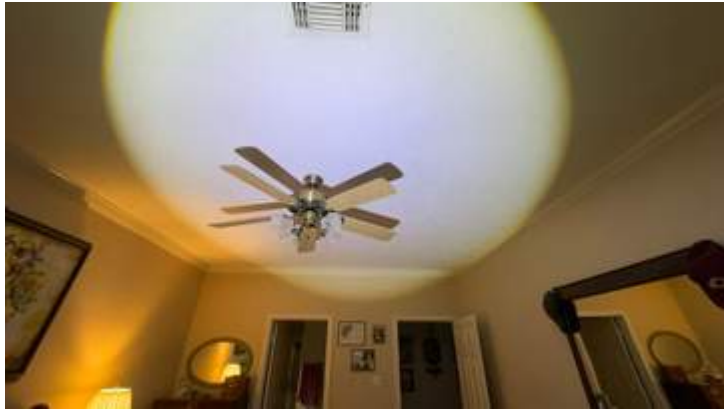
**1st Floor, Master, Bedroom**

#### Missing Smoke Detector(s)

The amount of smoke detectors on the property does not meet the residential requirements. Recommend repairs or replacing by a qualified professional.
