March 18, 2026

PROPERTY INSPECTION REPORT FORM

1620 Elgin St. Unit 9, Houston, TX 77004

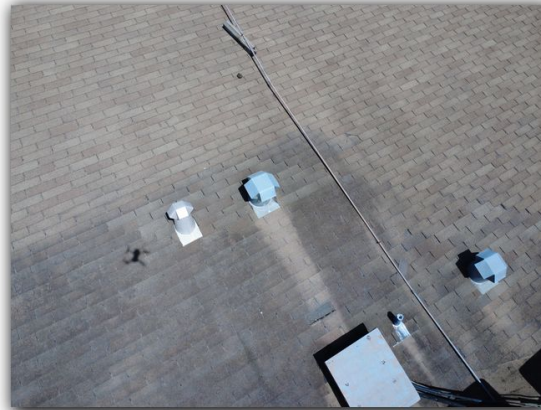
Flashing Details

- It is recommended to paint the flashing to help prevent rust and protect against UV damage. Proper maintenance of flashing can extend its service life and help maintain the roof's overall integrity. Recommend evaluation and painting by a qualified contractor.
- Some metal flashing details were observed to have surface rust. Rust can deteriorate the flashing over time, potentially compromising the roof's watertight integrity. It is recommended to have a professional roofing contractor evaluate the condition and perform necessary maintenance or repairs to prevent further damage.

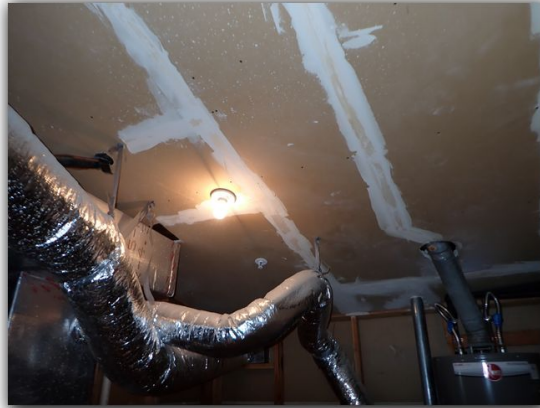
Attic Fireblocking

- There is inadequate fireblock separation between the units. A complete vertical and a four-foot (4-ft.) horizontal fireblock separation of a two-family dwelling are required at the line of dwelling unit separation.

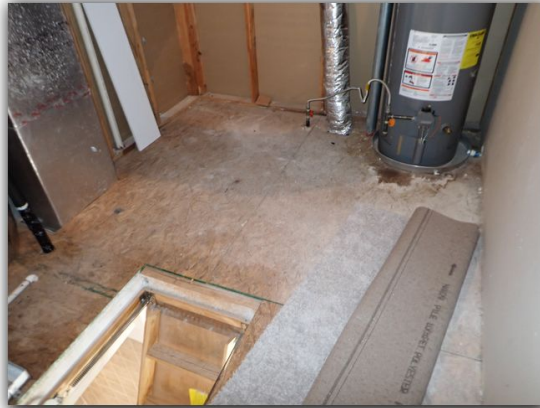
Attic Ladder/Hatch Opening

- The attic ladder does not close completely. The underlying cause should be evaluated and repairs made as necessary to ensure proper operation and safety.
- Surface damage was observed on the face of the attic ladder door.
- Some of the attic ladder nuts and bolts were observed to be loose and/or missing. For safety reasons, it is recommended to secure or replace these fasteners and ensure the attic ladder is properly stabilized.

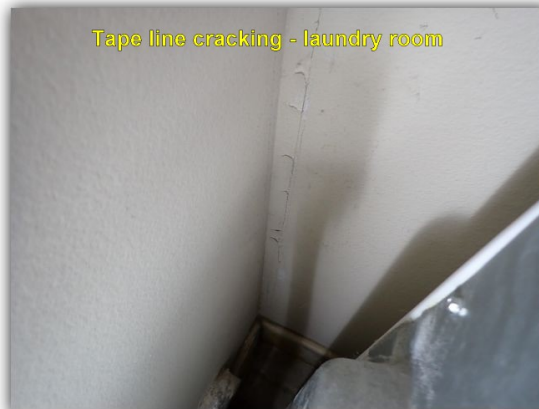
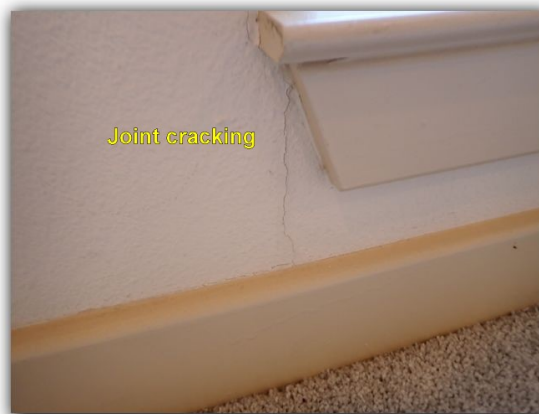
- Joint cracks were observed in the interior walls of several locations throughout the house. These cracks typically indicate normal seasonal expansion and contraction.
- Water staining and/or damage was observed on the baseboards in several locations throughout the house. It is recommended to investigate the cause and address any necessary repairs to prevent further damage.
- Cabinet surface damage was observed in the primary bathroom.
- Stress cracks were observed in the interior walls of the third floor loft area. These cracks may indicate abnormal settling or movement.

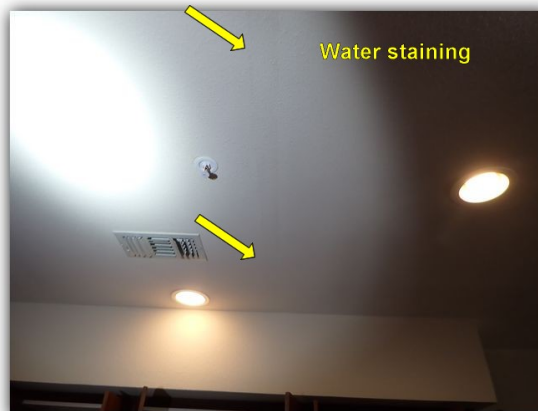
- Water stains were observed on the ceiling(s) in the kitchen, second floor loft area. It is recommended to identify and address the source of moisture (if necessary) to prevent further damage.
- Water stains observed on the ceiling at and/or around the water heater flue area. The sealant at the flue roof level storm collar needs to be further investigated and corrected as necessary.
- Joint cracks were observed in the ceilings of the primary bathroom, second floor loft area. These cracks typically indicate normal seasonal expansion and contraction.

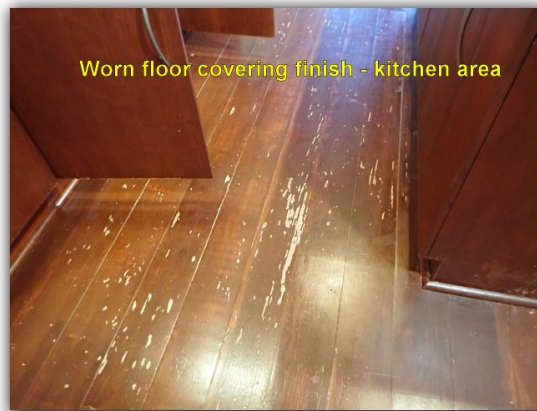
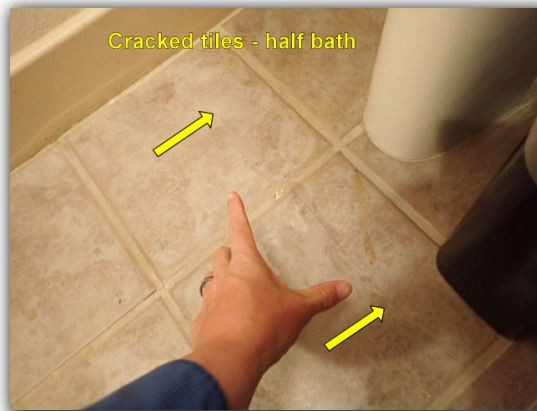
- The floor covering was observed to be damaged in the kitchen.
- The floor tile(s) were observed to be cracked and/or damaged in the laundry room, half bathroom.
- Loose floor tiles were observed in the following area(s): laundry room. This condition may indicate issues with the original installation, such as inadequate adhesive or improper substrate preparation, and can lead to further tile damage or present a tripping hazard. It is recommended to have a qualified flooring contractor assess and properly re-secure or replace the affected tiles to prevent future deterioration.
- The floor tile grout was observed to be damaged and/or missing in the laundry room, primary bathroom.

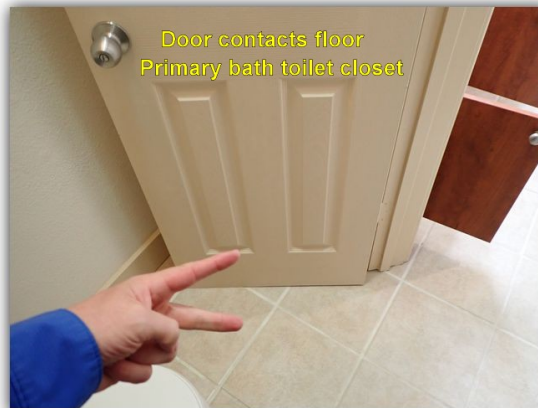
Interior Doors

- The door contacts the floor during operation to the primary bathroom toilet closet. Adjustments are recommended to restore intended operation to the door and prevent floor covering damage.
- The door at the following location(s): front entry closet, is not latching properly. This may be due to misalignment, worn hardware, and/or damage to the latch mechanism, which can affect functionality.

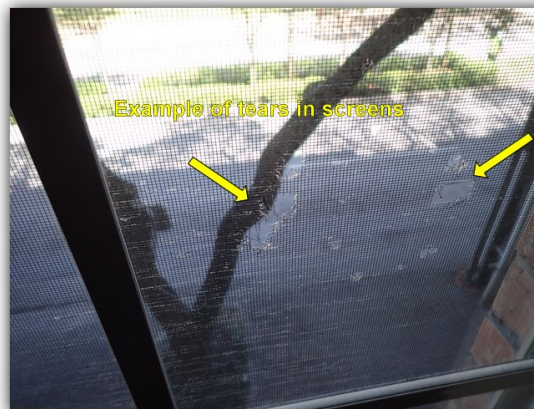
Window Screens

- One or more of the window screens were observed to be damaged.

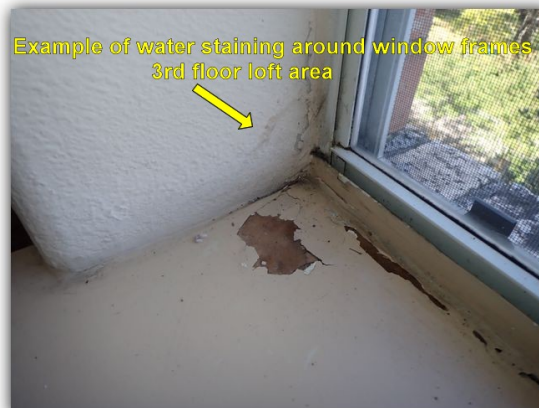
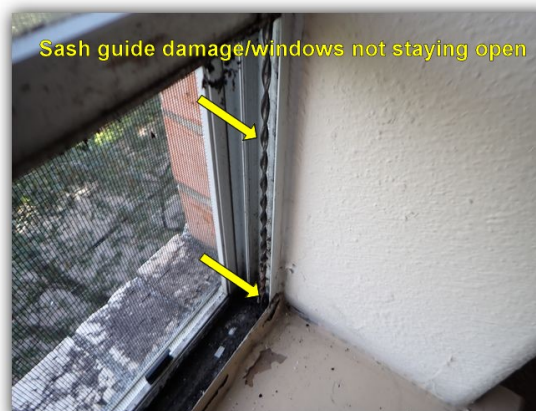
- Water stains were observed at and/or around the window(s) in the following area(s): North side windows. This may indicate past or ongoing moisture intrusion. The source of the staining should be investigated by a qualified professional, and appropriate repairs made to prevent further damage and ensure the area remains dry.

- The window guide is damaged in the following area(s): primary bedroom, third floor loft area, causing the window to not stay in the open position. This condition affects window functionality. It is recommended to have a qualified professional repair or replace the damaged guide to restore proper operation.

- The window sill(s) finish in the following area(s): several locations throughout the house, show signs of deterioration and/or damage. This may be due to moisture intrusion, age, or general wear and tear.

- One or more windows in the following area(s): third floor loft area, are stiff and difficult to operate. This may be due to issues such as swelling, damaged hardware, or lack of maintenance. It is recommended to have the windows inspected and serviced by a qualified professional to restore smooth and safe operation.

- The weather-stripping is damaged and/or missing at one or more windows. This condition can lead to air/water intrusion and reduced energy efficiency. It is recommended to repair or replace the weather-stripping to improve sealing and overall window performance.

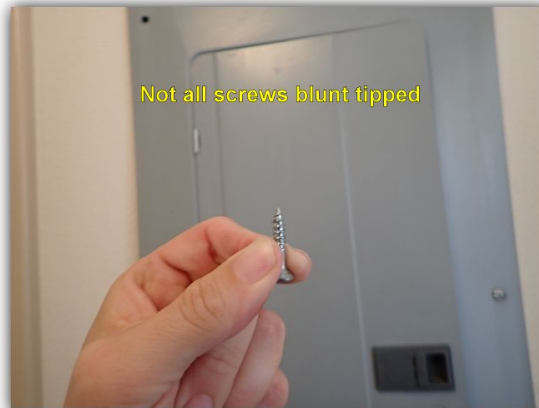
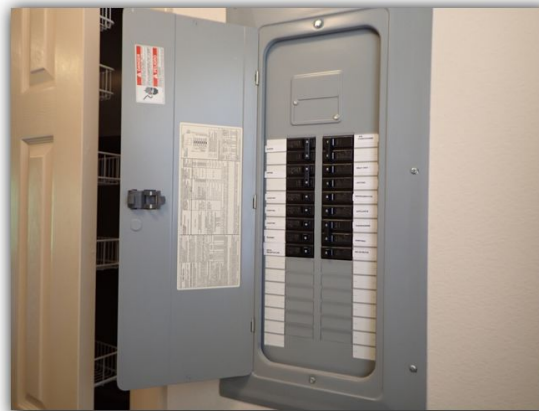
- The electrical cabinet cover plate (dead front) should be secured using blunt-tip screws rather than pointed tip screws to enhance safety and prevent potential damage.
- In the sub-panel electrical cabinet, the ground and neutral wires are not properly separated. According to current National Electrical Code (NEC) standards, neutral conductors in a sub-panel should be isolated on a separate bus bar, while ground conductors should be bonded to the panel cabinet. Although the sub-panel may appear functional, this configuration does not meet current code requirements and should be evaluated and corrected by a licensed electrician.

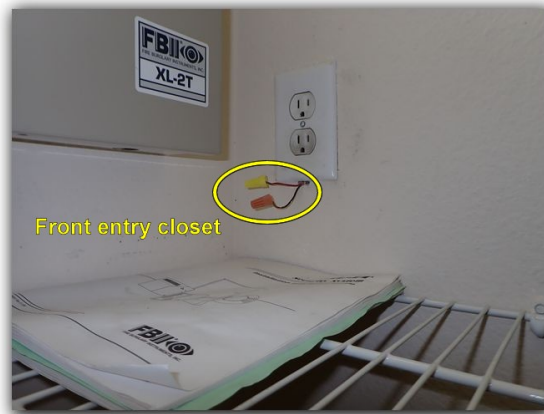
Distribution Wiring

- Exposed wires were observed in the front entry closet. For safety, all open end wires should be properly enclosed within approved junction boxes.

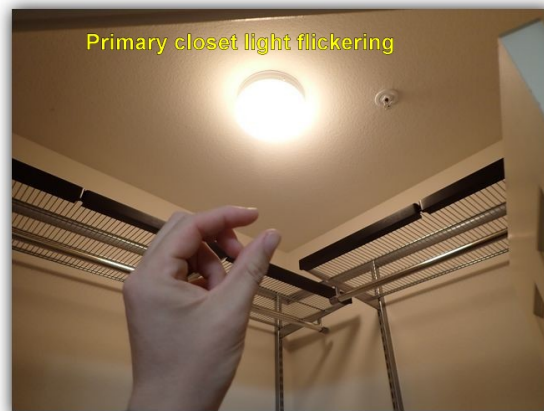
Fixtures

- One or more light fixtures in the primary bedroom closet are not functioning properly. Recommend evaluation and repair or replacement as necessary by a qualified technician.
- The ceiling fan in the living room, third floor loft area is not properly balanced and wobbles when operated. Recommend adjustment or servicing to ensure safe and smooth operation.

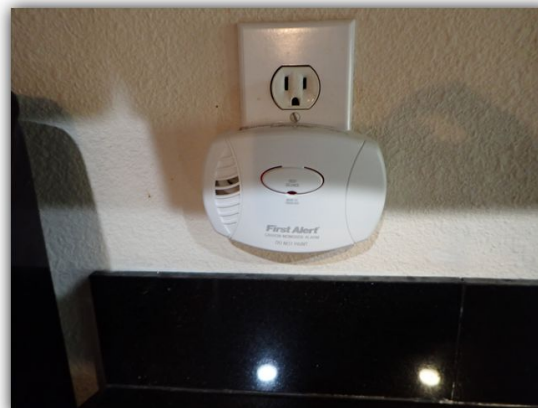
Smoke & Carbon Monoxide Alarms

- I was unable to locate a carbon monoxide alarm in the immediate vicinity of all the bedrooms.
- The smoke alarms present at the time of inspection are older. Most manufacturers recommend replacing smoke alarms every 10 years for safety. It is recommended to replace these alarms to ensure protection.
- One or more smoke alarms are loose at their mounting in the second to third floor stairway. Recommend securing them properly to ensure reliable operation.

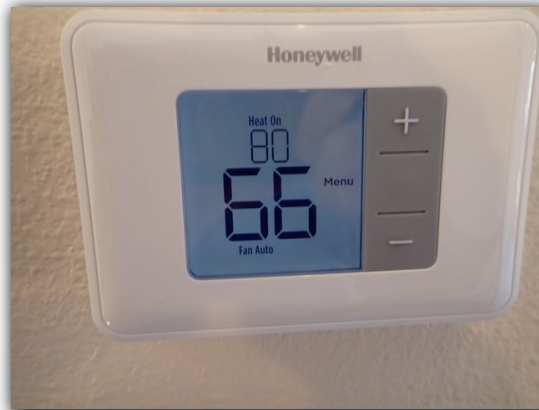
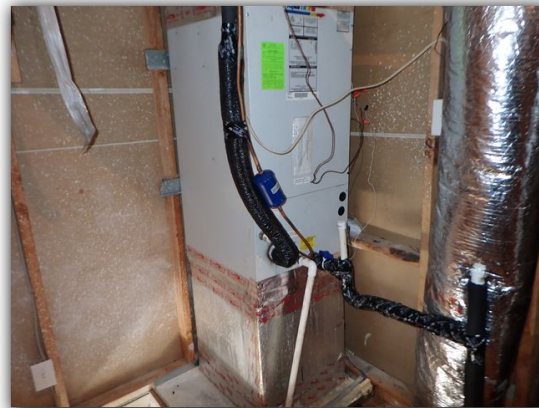
- The heating equipment was found to be inoperative at the time of the inspection. The system did not respond to normal operating controls.
- The air filter is dirty and should be replaced to ensure optimal system performance and air quality.
- A service disconnect was not located or observed at or near the heating unit. Recommend further evaluation and installation of an appropriate disconnect by a qualified electrician or HVAC technician.

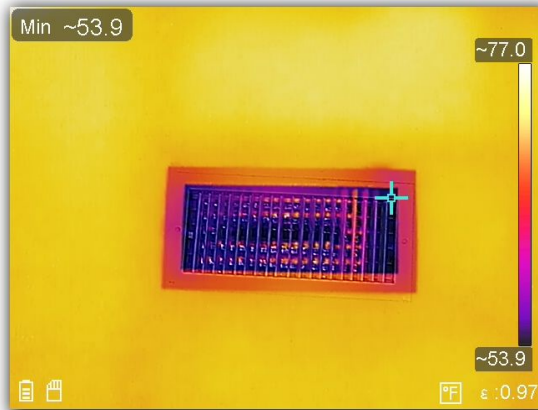
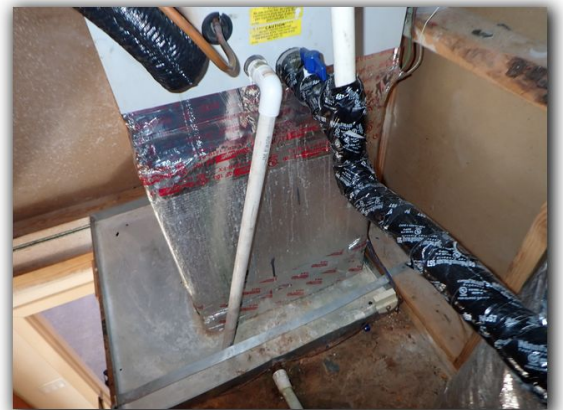
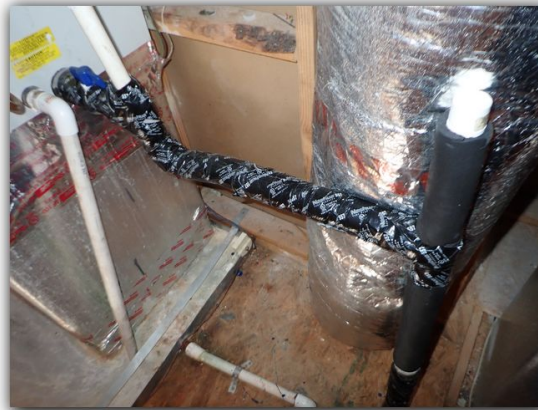
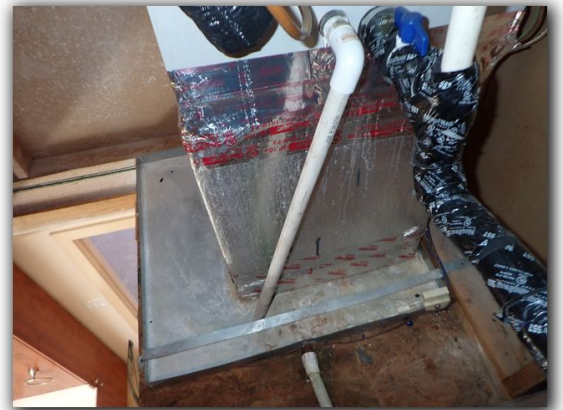
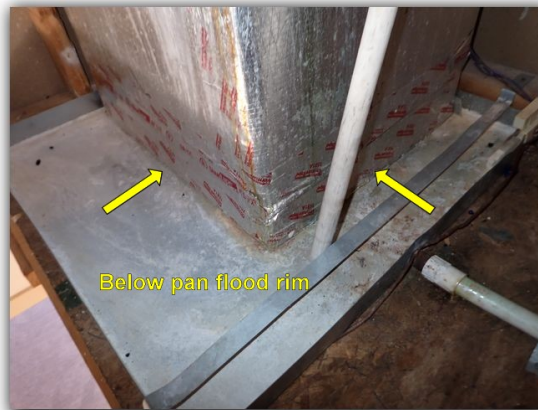
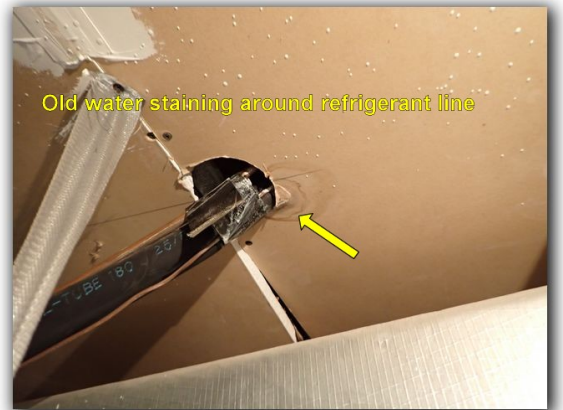
- The air filter is dirty and should be replaced to ensure optimal system performance and air quality.
- The air return is in a difficult location to access. A ladder will be needed to change the air filter.
- The equipment is sitting inside the secondary condensate drain pan below the flood rim. This installation does not meet current mechanical standards. The equipment should be elevated on a water-resistant support above the pan's flood rim.

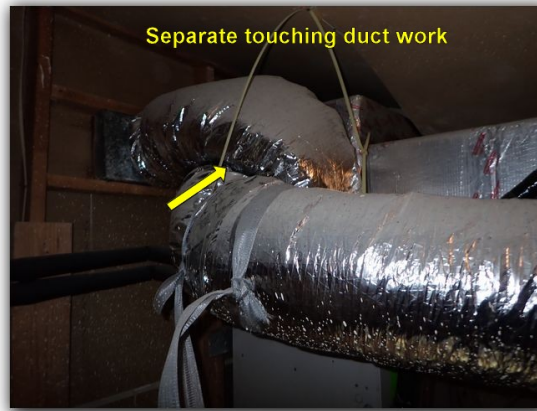
- The duct work in the attic area is not properly separated to help prevent condensation from developing. It is recommended to separate the duct work with a minimum intervals of 1.5-inches.

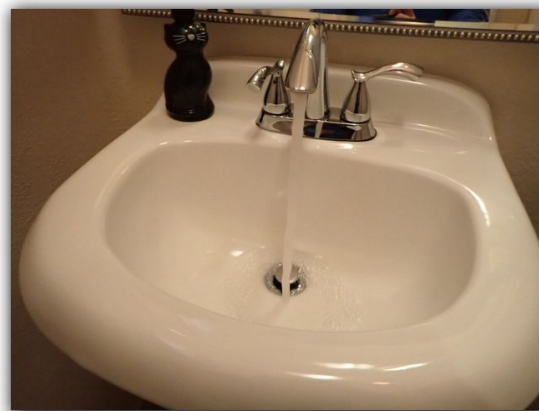
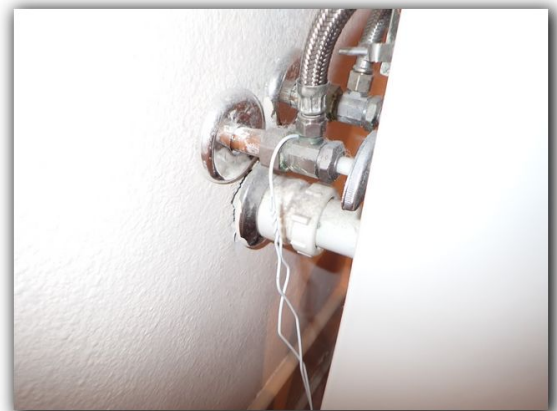
Lavatory / Sink

- The sink stopper does not function properly.

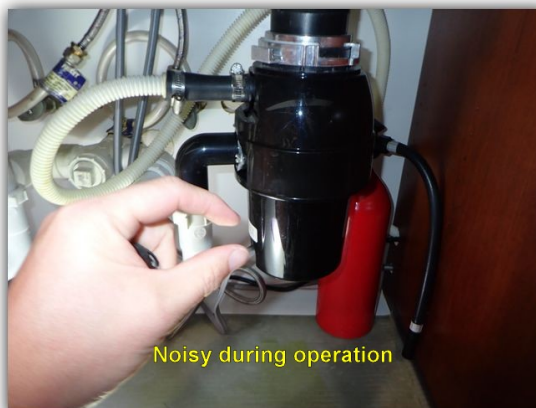
B. Food Waste Disposers

- The food waste disposer was observed to be noisy during operation. This could indicate internal wear, loose components, or debris. Further evaluation and servicing or replacement is recommended to prevent potential failure.
- The spliced wires at the food waste disposer should be properly enclosed in a junction box or appropriate electrical enclosure. This is necessary for safety and to prevent electrical shock or short circuits.

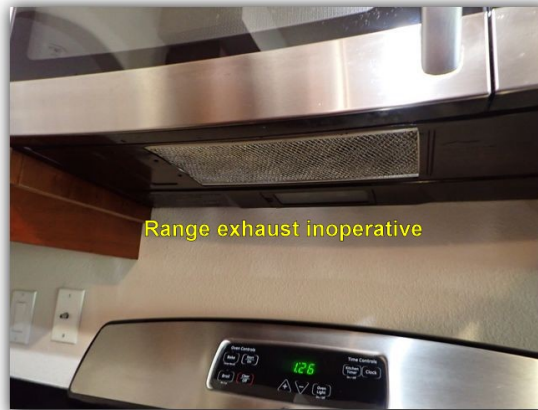
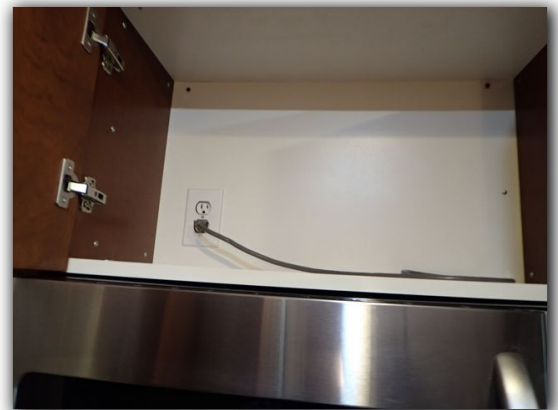
- The range exhaust vent fan was inoperative at the time of inspection. This condition should be further evaluated and corrected as necessary.

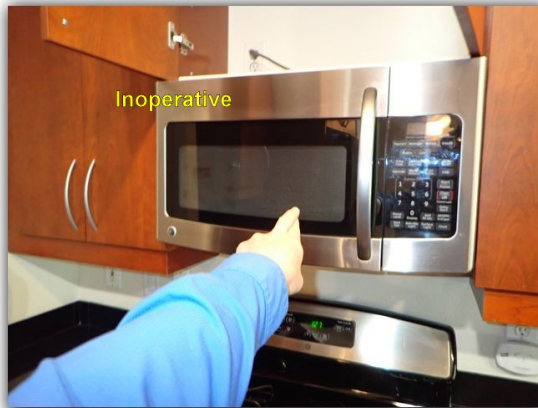
E. Microwave Ovens

- The microwave oven was inoperative at the time of inspection and did not respond to normal user controls. The unit should be further evaluated and repaired or replaced as needed to restore proper function.

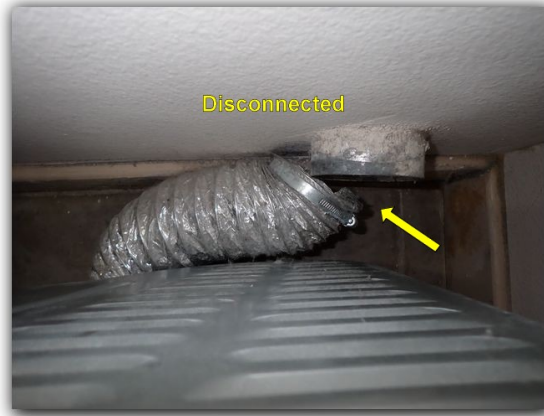
- The dryer exhaust duct was separated from the wall mount at the time of inspection. Reset is needed prior to dryer use.
