# PROPERTY INSPECTION REPORT FORM

Debra Hosein <i>Name of Client</i>	08/09/2025 <i>Date of Inspection</i>
3206 Watercliff Court , Spring, TX 77388 <i>Address of Inspected Property</i>	
Kevin Akins <i>Name of Inspector</i>	22211 <i>TREC License #</i>
<i>Name of Sponsor (if applicable)</i>	<i>TREC License #</i>

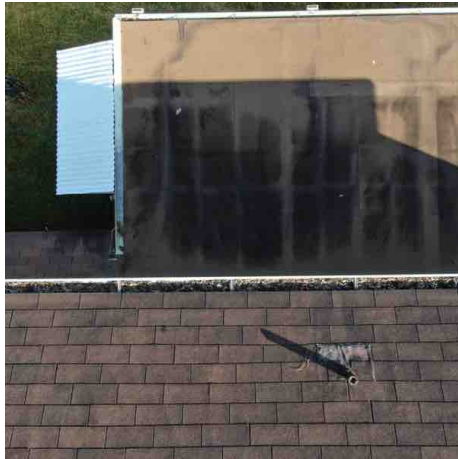
- Normal industry standards indicate water can pond in yards during rainstorms, but if the water does not dissipate within 48 hours after the rain stops from either soil absorption, or natural drainage runoff then a ponding issue exists.
- **Gutters have debris from nearby trees. Cleaning gutters will ensure storm water is processed to the ground and away from the structure as efficiently as possible.**

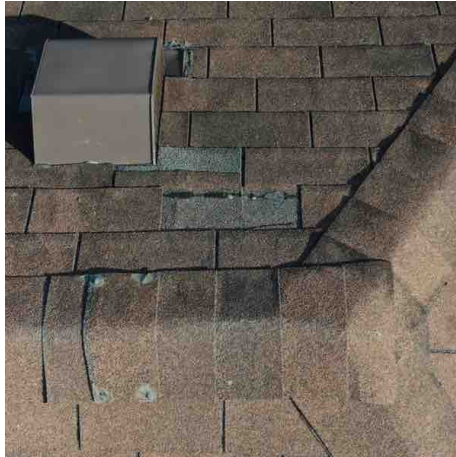
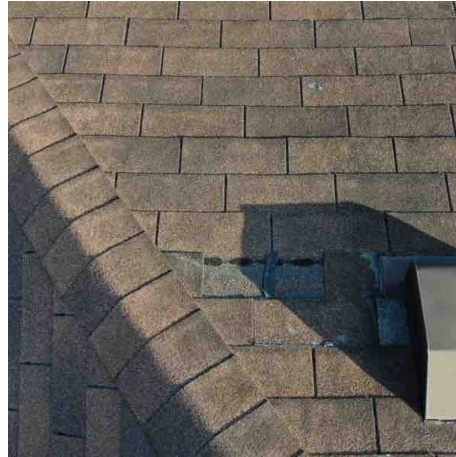
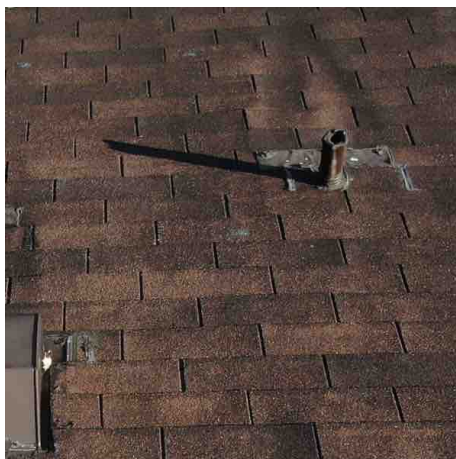
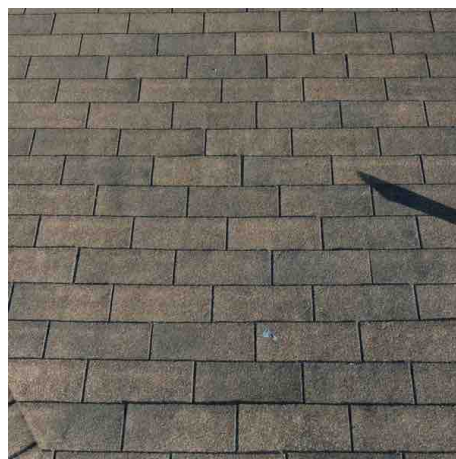
- Damage, missing and deteriorated shingles observed at the roof covering (see photos below). A qualified roofing contractor should perform all repairs and a complete roof punch.

- **Damage, missing and deteriorated shingles observed at the roof covering (see photos below). A qualified roofing contractor should perform all repairs and a complete roof punch.**

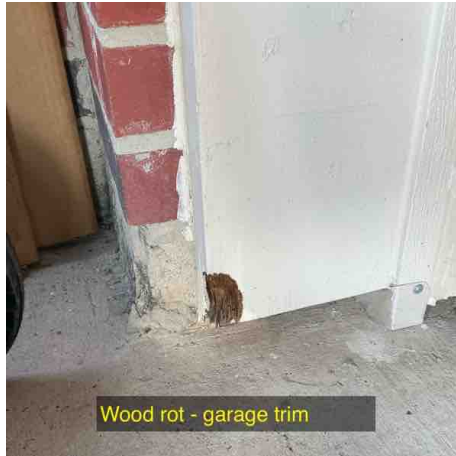
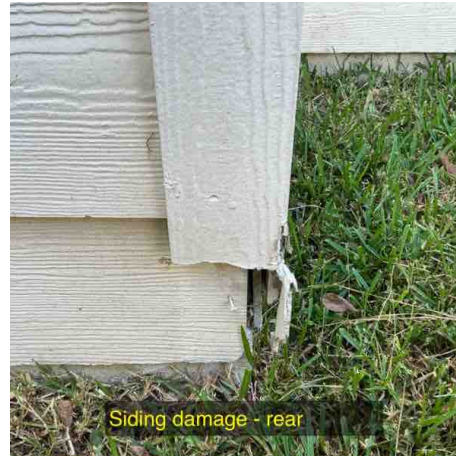
- Observe general painting needs, damage siding, wood rot, gaps and caulking touch-ups around the structure (see a representative number of photos below). Recommend corrective actions by a painting and general contractor as needed.

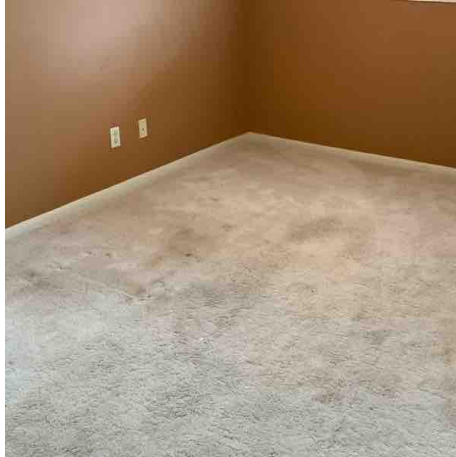
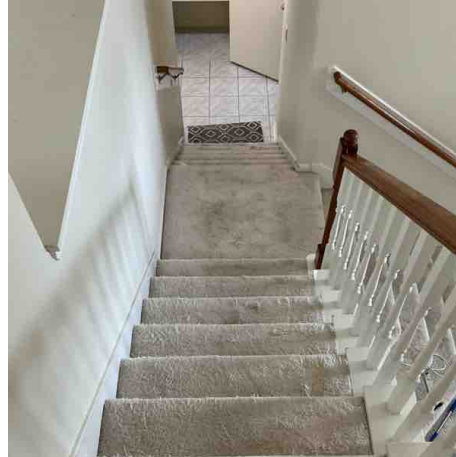
- **Stains observed at the carpeting. If the desire is to keep carpeting it should be professionally cleaned.**

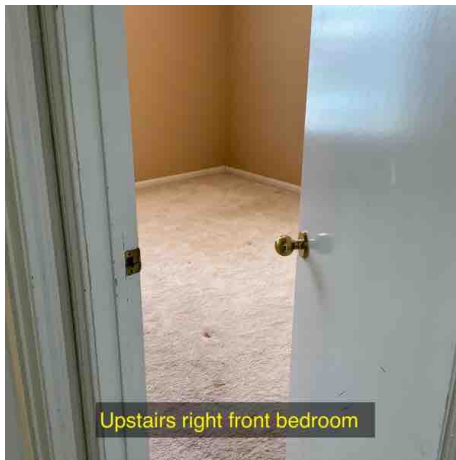
- **Drifting doors identified, which could be a nuisance to home occupants. Recommend adjustments by a qualified trim contractor.**

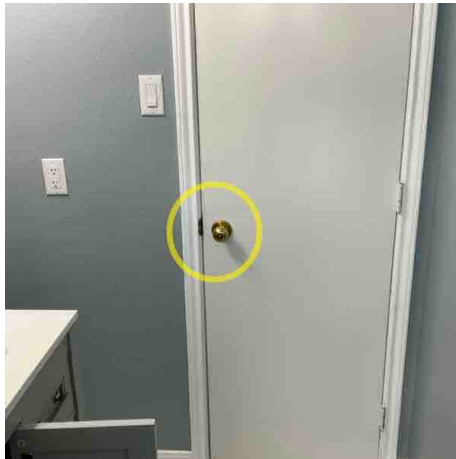
- **Door hardware does not latch properly. Recommend adjusting the strike plate to promote proper closure. (Upstairs Hall Bathroom)**

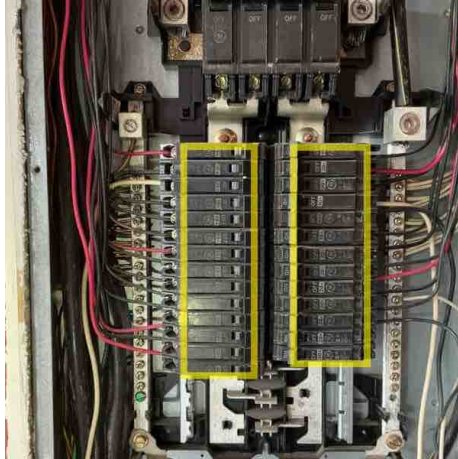
- Main distribution panel does not meet current standards which require arc-fault circuit interrupting breakers. In regards to safety, buyers should have a licensed Electrician install AFCI's in all required locations (ie. bedrooms, living areas, hallways and closets).

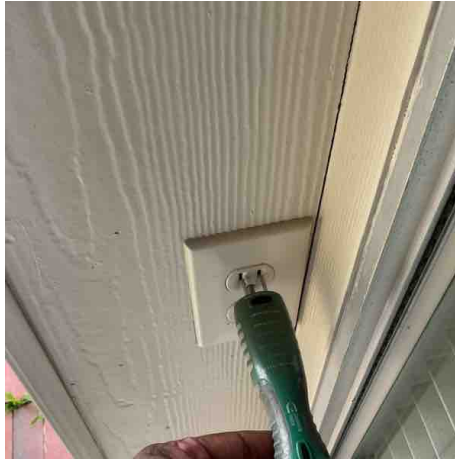
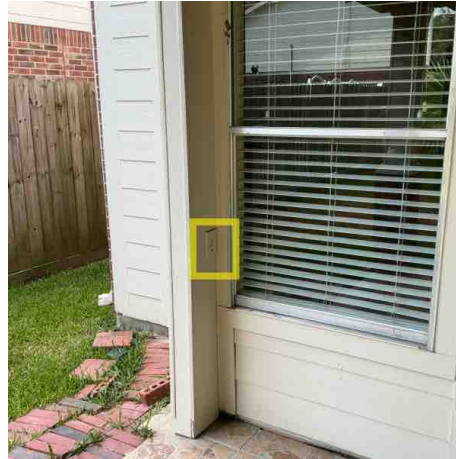
- Rear patio exterior switch plates and outlets are exposed to moisture. Recommend adding a dome style protective cover as a correction.
- Rear patio outlet would not accept a tester. This could be the result of something blocking the grounding port. Corrections should be made by a licensed Electrician.

- **Rear patio outlet would not accept a tester. This could be the result of something blocking the grounding port. Corrections should be made by a licensed Electrician.**

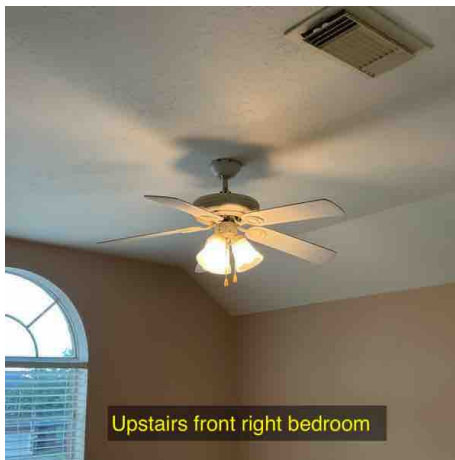
- **Ceiling fan wobbles (typical of fan blades that are not balanced properly). Recommend corrective action by a ceiling fan contractor.**

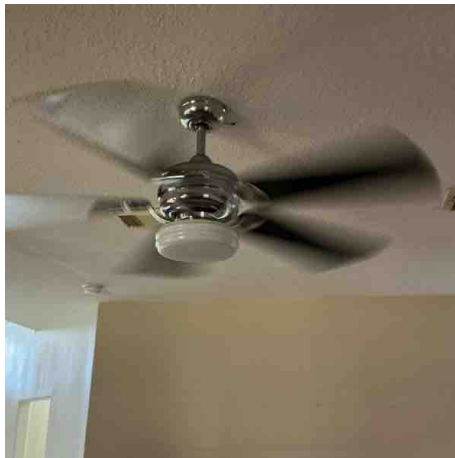
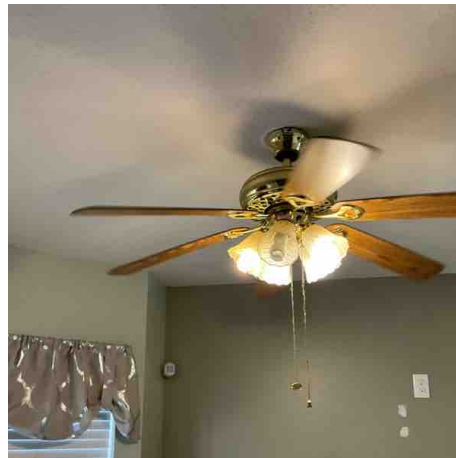
- **Some light bulbs were not functioning during the inspection. Light bulbs should be replaced, and fixture operation verified to ensure an underlying electrical issue does not exist.**

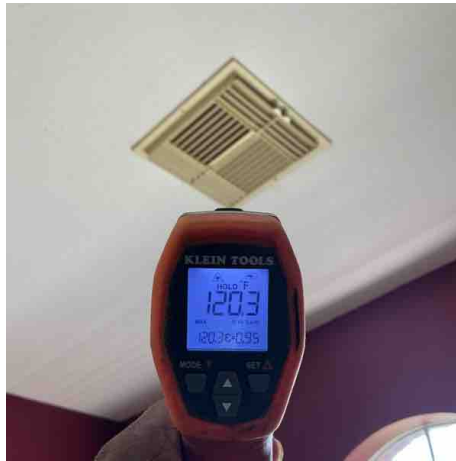
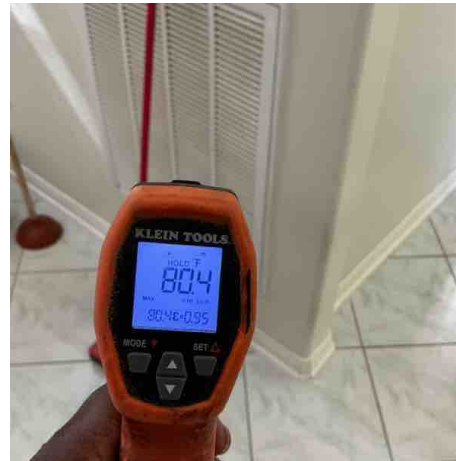
- The downstairs system was operated and tested. The general standard for room air differential should be 30-60 degrees. Supply air temperature is 120 degrees, return air temperature is 80 degrees. (40 degrees differential).

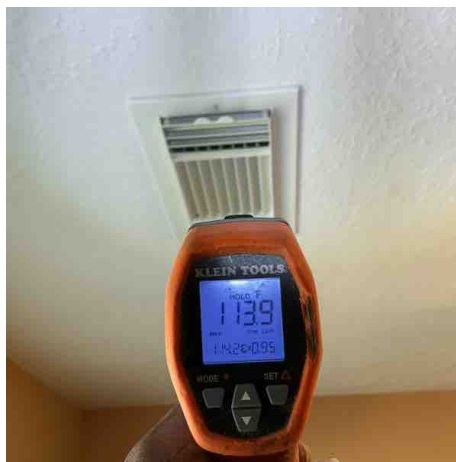
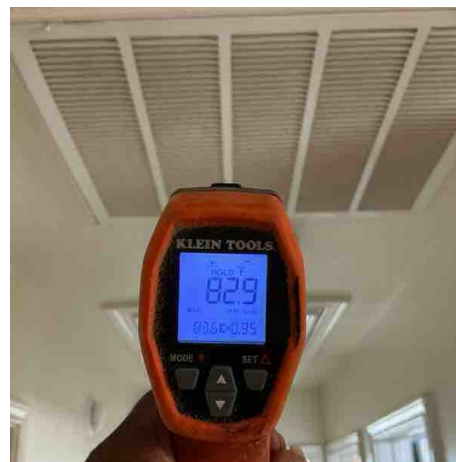
- The upstairs system was operated and tested. The general standard for room air differential should be 30-60 degrees. Supply air temperature is 113 degrees, return air temperature is 82 degrees. (31 degrees differential).

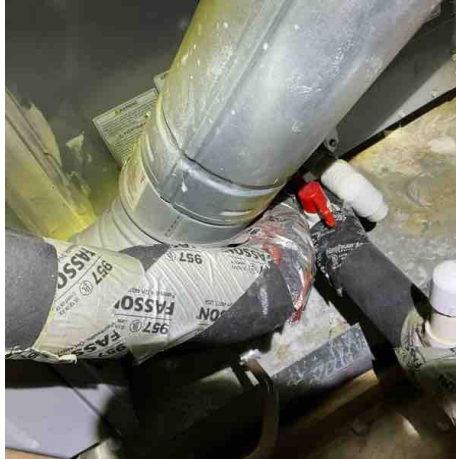
- Flue pipe has inadequate clearance from the suction line insulation in attic. A minimum of 1" clearance is required around the vent pipe. Recommend a qualified mechanical contractor for corrections where needed.

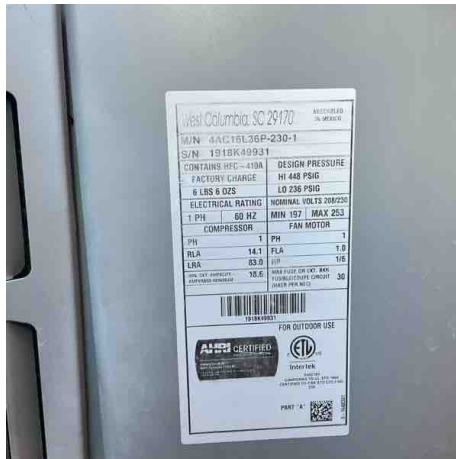
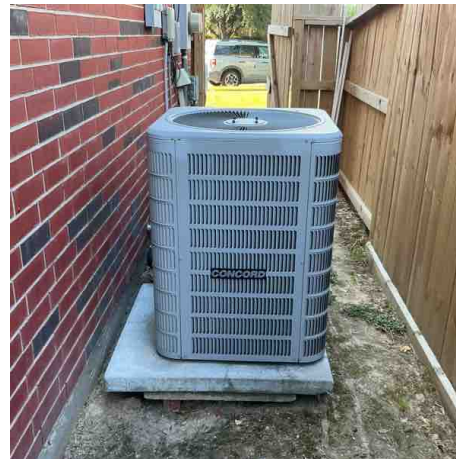
• The downstairs system was operated and tested. The general standard for room air differential should be 15 - 22 degrees. Supply air temperature is 67 degrees, return air temperature is 77 degrees. (10 degrees differential). At the time of the inspection the system appears to be in need of service.

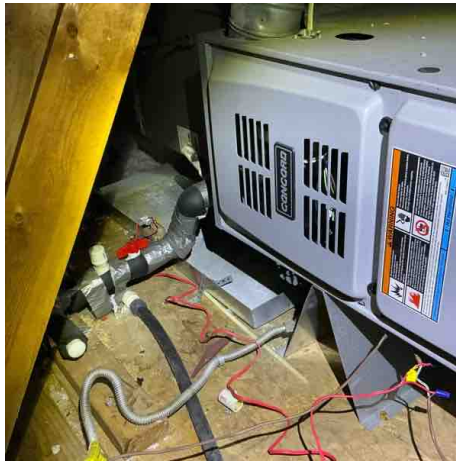
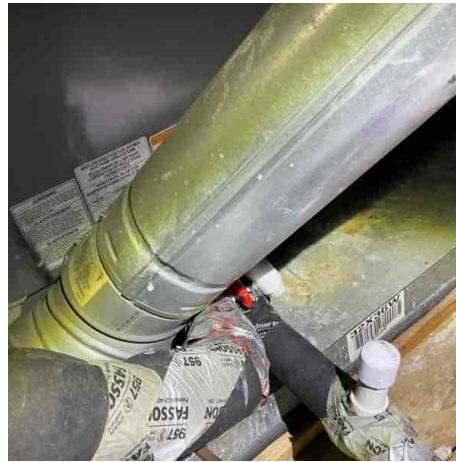
- No rust or moisture noted in the evaporator coil pan. No deficiencies noted.

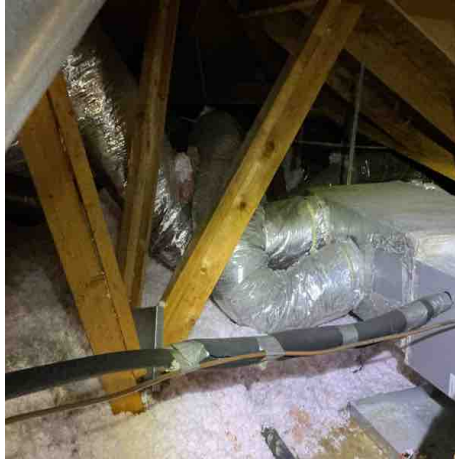
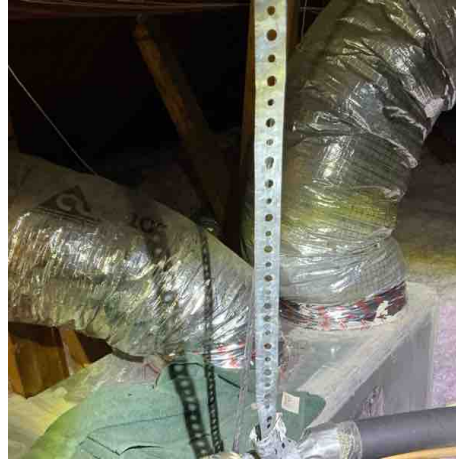
- All visible ductwork in the attic appears to be in good condition, connected and functioning properly at the time of the inspection.

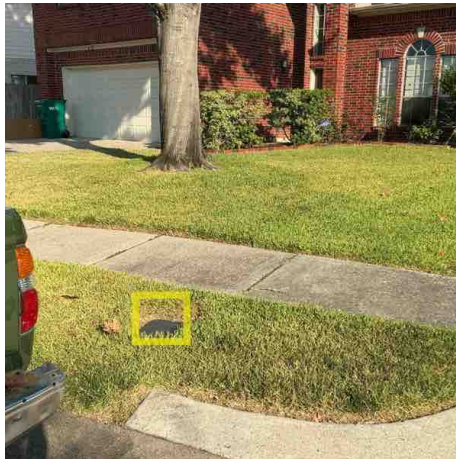
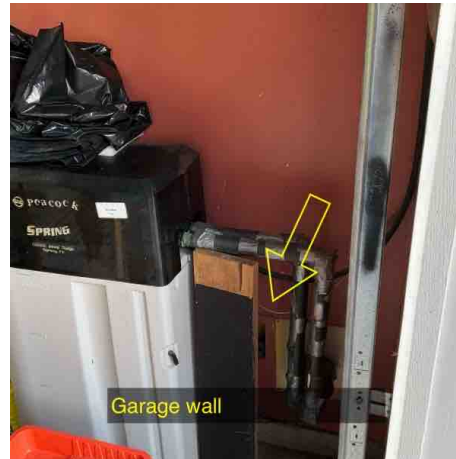
- Location of the water meter and shut off valve. No deficiencies noted.

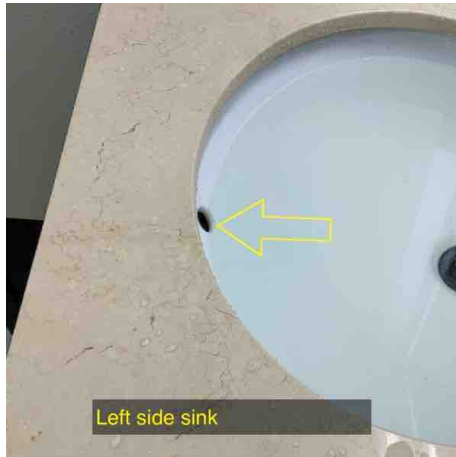
- The overflow drain is not functioning as intended. Corrections should be made by a licensed Plumber.

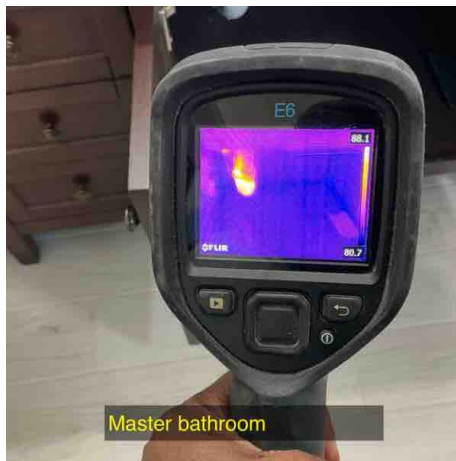
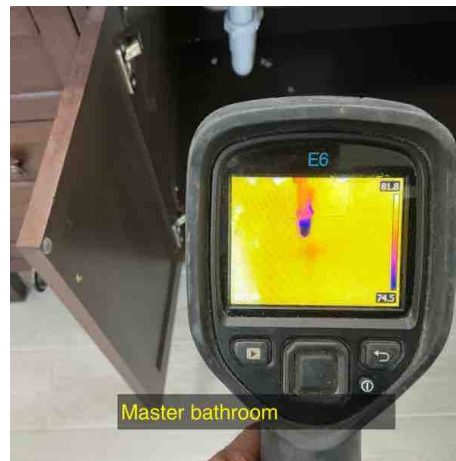
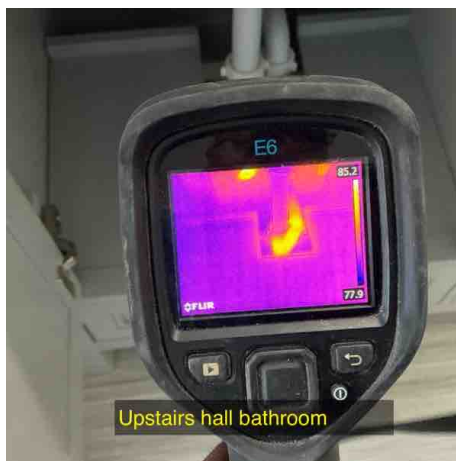
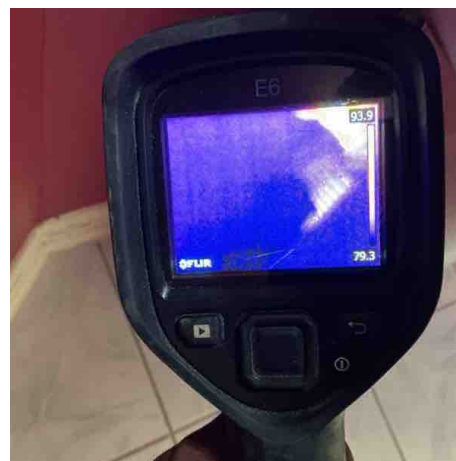
- All bathroom drain lines were evaluated and tested for leaks with the water supply in use. No leaks detected.

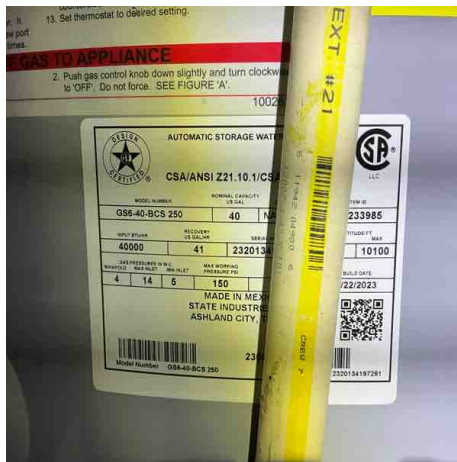
- 40 gallon unit manufactured in 2023.

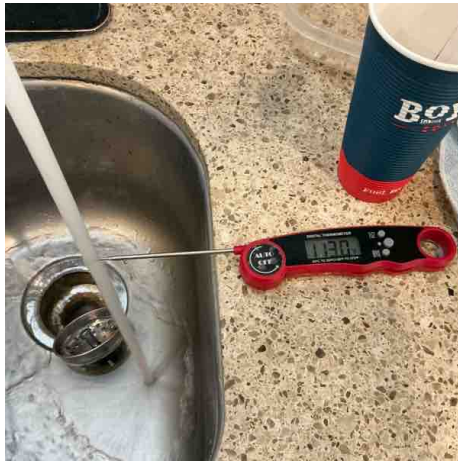
- Hot water temperature at the time of the inspection.

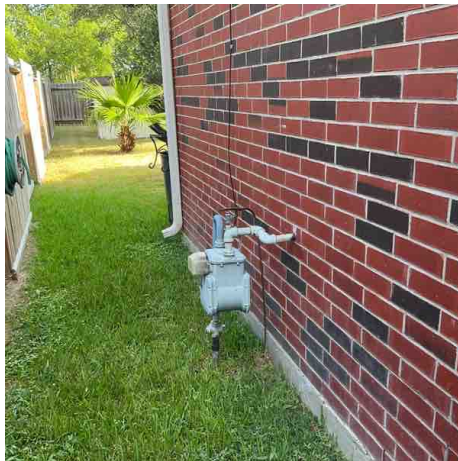
- Gas meter located on the Left side. No deficiencies noted.

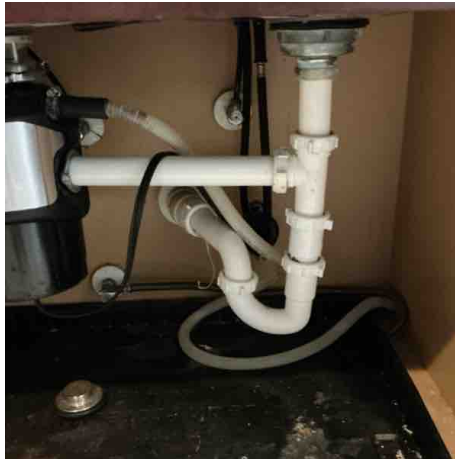
- Drain line for the dishwasher is not "high looped". A licensed Plumber should establish a "high loop" to prevent back-siphoning (which is required when an air gap is not in use).

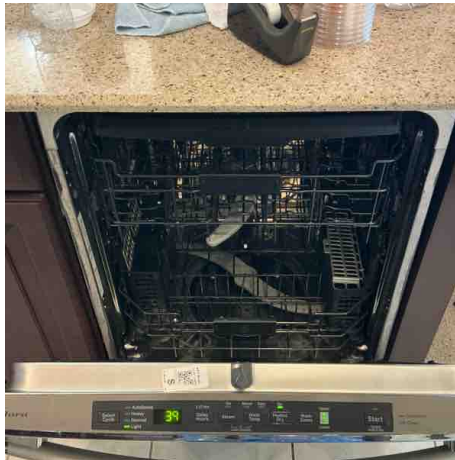
- Dishwasher was operated and run through a complete cycle. Functionality and operation appear to be normal with no leaks detected.

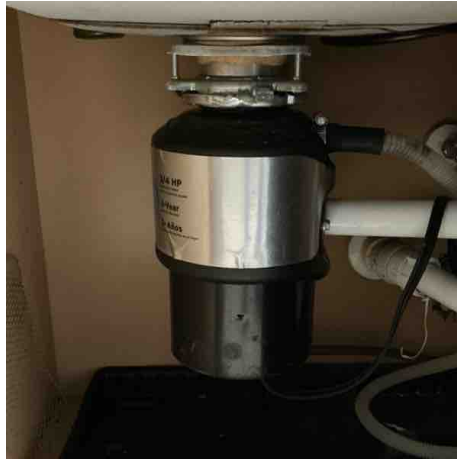
- Waste disposer is secure and operated.

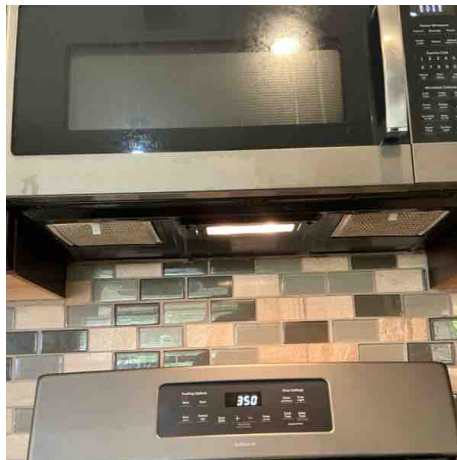
- Range hood and lights functioned at time of inspection. No deficiencies noted.

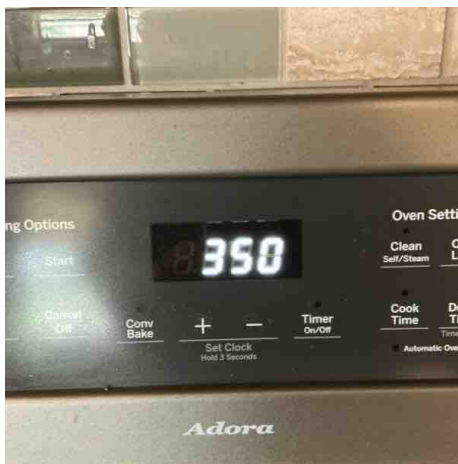
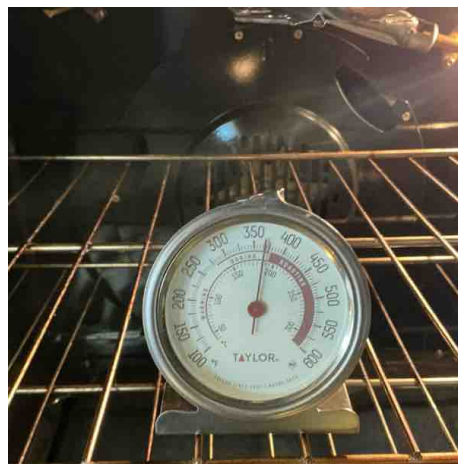
- Oven was tested at a temperature setting of 350 degrees. The oven measured 370 degrees; which is considered within normal operation parameters (+ / - 25 degrees).

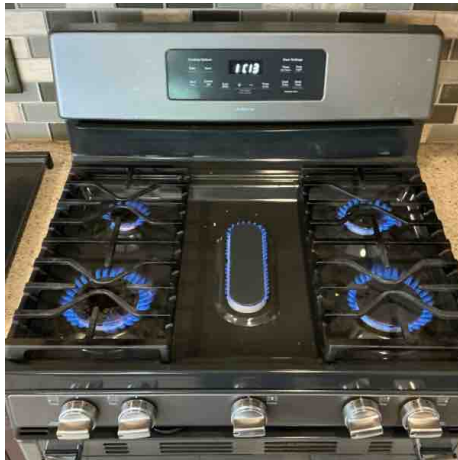
- Cook top in operation - no deficiencies noted.

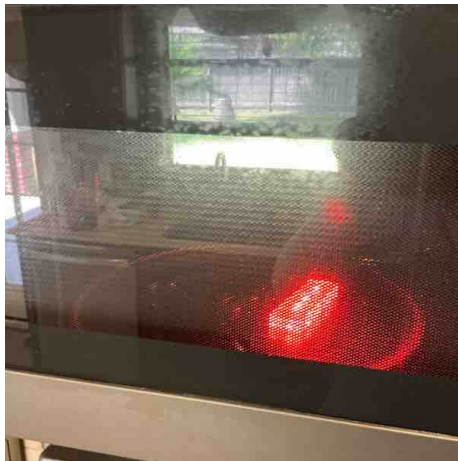
- Microwave tested with a heat detector - no deficiencies noted.

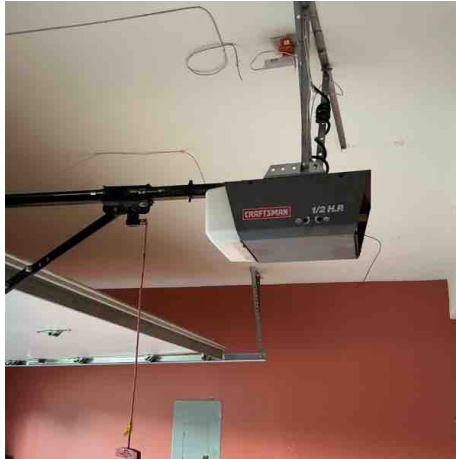
- Garage door operated as intended. No deficiencies noted.

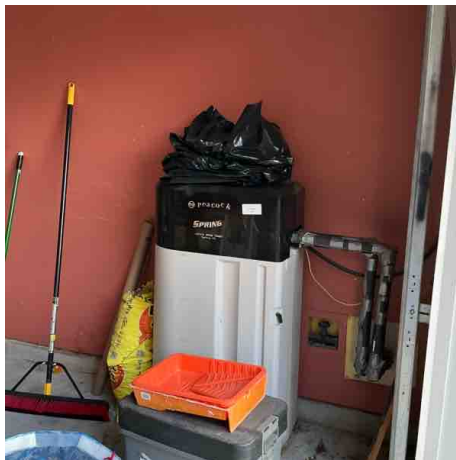
- This home has a water purification system which is outside the scope of a standard home inspection. Recommend consulting with the sellers regarding history.
