PROPERTY INSPECTION REPORT

Concerning: 16734 Pebbleglen Dr, Houston TX 77095

By: Brett Finch - TREC #22635

05/25/2021 2:00 pm

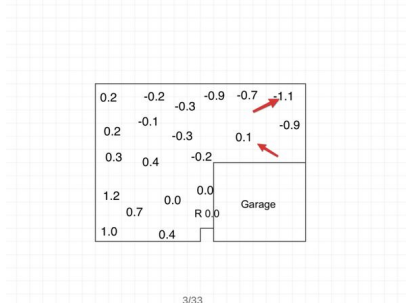
Foundation Performance: Further Evaluation is Recommended:

Structural movement and/or settling noted. See the report for more information regarding these signs. Suggest that an expert in this field be consulted for further evaluation of the structure and to provide suggestions as to what, if any, corrective actions should be taken.

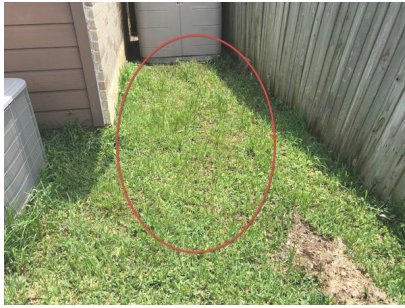
Soil erosion was observed at various locations around the home, likely being contributed to the lack of gutters. This condition can lead to grading issues and standing water. Recommend further evaluation and correction as needed to prevent further erosion and ensure proper drainage conditions.

Recommendation: Contact a qualified landscaping contractor

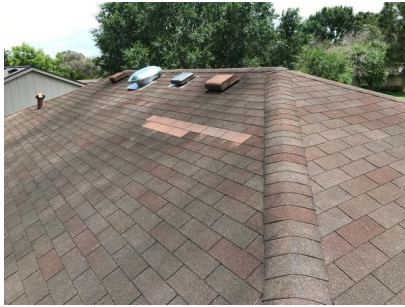
Signs of Previous Repair:

Note: Signs of previous repairs observed on the roof covering at the time of inspection. Recommend consulting with the seller to determine any previous issues and scope of previous repairs. No signs of active water intrusion were observed, recommend continued monitoring of these areas.

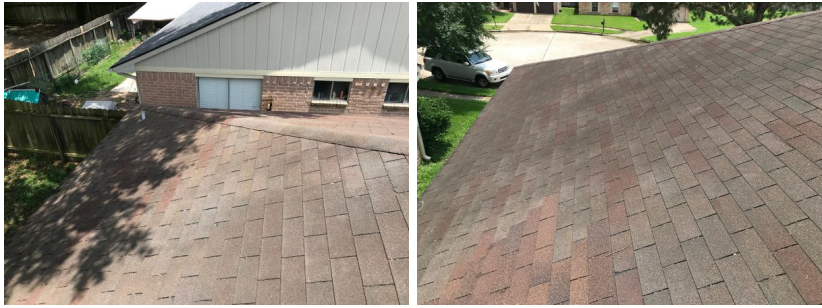
Decking Under Satellite Dish:

The inspector was unable to verify the condition of roof decking material under the mounted satellite dish(es). It is recommended that these dishes be secured to walls or other similar locations, and not secured through the roof covering. Recommend continued monitoring or considering removal/relocation.

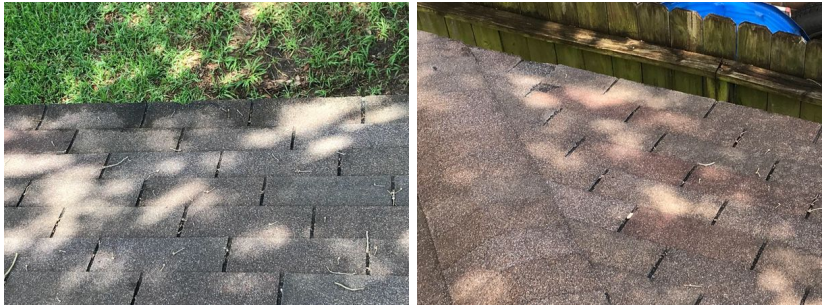
5: Drip Edge: Drip Edge Damaged

Locations were observed where the drip edge flashing was damaged and/or displaced. Recommend further evaluation and correction as needed to avoid potential moisture intrusion issues.

Recommendation: Contact a qualified roofing professional.

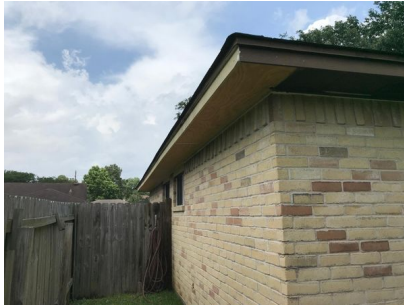
Previous Repairs Noted:

The inspector noted evidence of previous or recent repairs to the walls at observed locations. More information may be contained within this report. Recommend you consult with the seller regarding any previous repairs or issues at these locations.

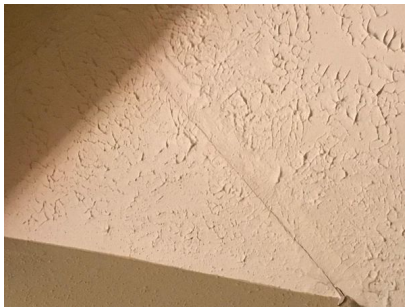
Previous Repairs:

Previous repairs were noted. Recommend obtaining all repair documents or further evaluation of repairs.

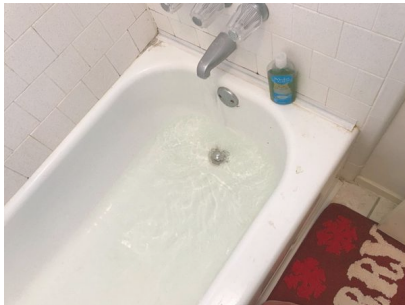
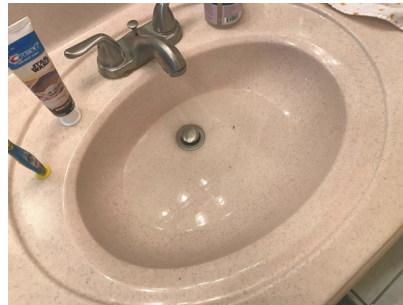
Poor/slow drainage was observed at time of inspection. Recommend a qualified plumber evaluate and repair.

Recommendation: Contact a qualified plumbing contractor.

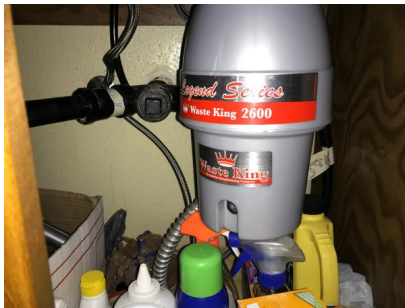
Food waste disposal was performing as intended at the time of the inspection.:

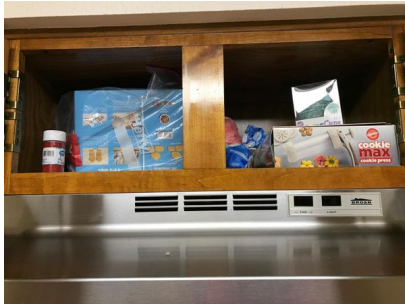
Exhaust systems were performing as intended at the time of the inspection.:

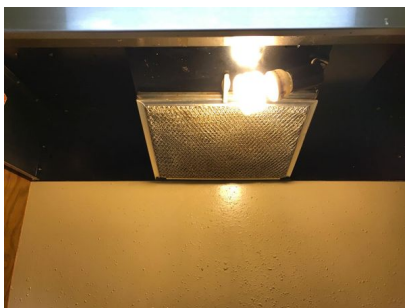
Range hood light was performing as intended at the time of the inspection.:

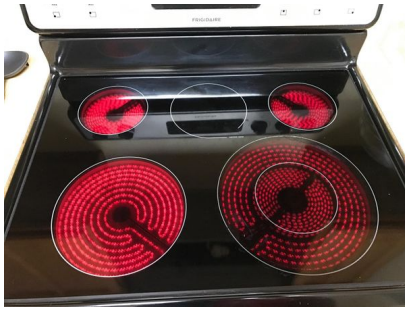
Cooktop was performing as intended at the time of the inspection.:

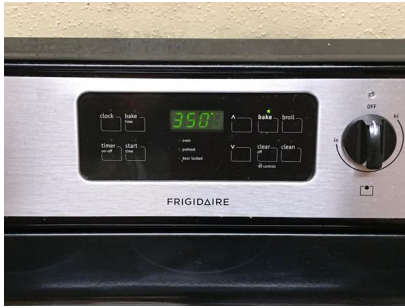
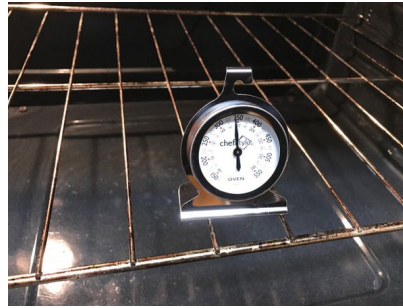
Ovens were performing as intended at the time of the inspection.:

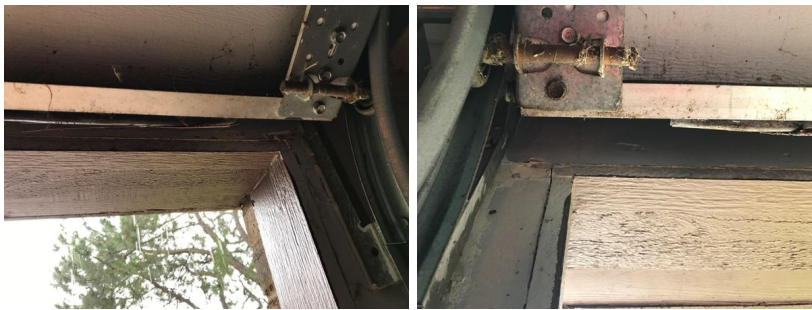
3: Missing weatherstripping

The garage door was observed to be missing weatherstripping. The weatherstripping along the trim prevents water intrusion and helps keep out unwanted pest. Recommend further evaluation and repair as needed

Recommendation: Contact a qualified professional.
