Confidential Inspection Report

LOCATED AT:
8507 Clarkman Ridge Ln
Cypress, TX 77433

INSPECTED ON:
Tuesday, November 25, 2025

Inspector, Justin Vincent
Texas Prime Inspections

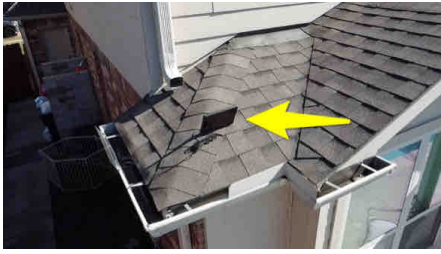
EVAL 3: There was a satellite attached to the roof surface with fasteners that are often times driven through the roof surface. This may require future maintenance or repair.

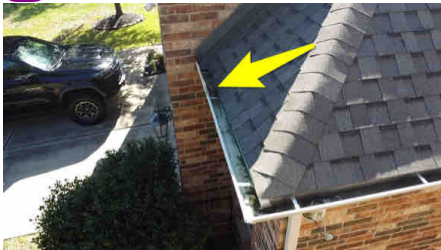
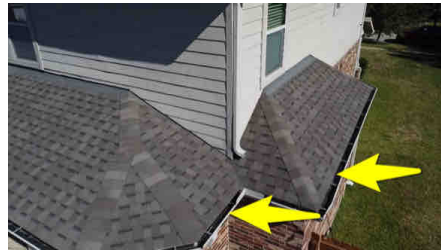
EVAL 4: It appeared that water will stand in some of the rain gutters. Adjustments are needed.

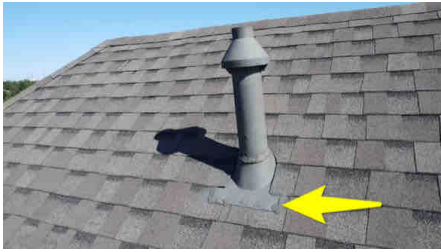
MNT 7: There were limited gaps at the shingles by the vent flashing parts and/or covers that need to be sealed and repaired as a preventative measure.

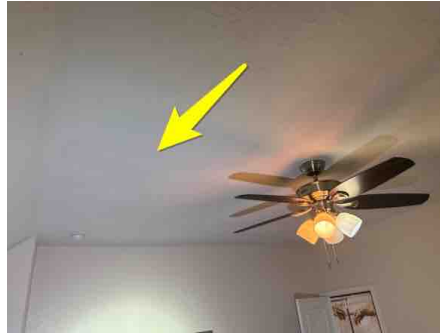
Media room

EVAL 18: The ceilings had limited instances of water stains or damages. The sellers may be able to describe what had caused them. The areas pictured were not actively wet during the inspection. Further evaluation is recommended. (The staining around some of the vent registers could be related to gaps at the ducts.)

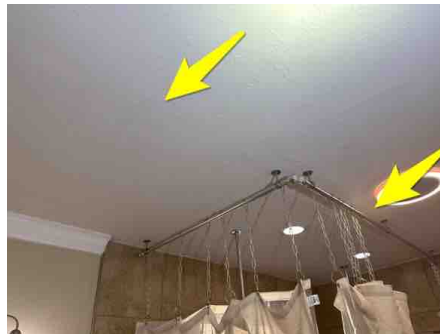
Kitchen

EVAL 19: The ceilings had what appeared to be signs of past repairs. The sellers may be able to describe what had occurred at these areas.

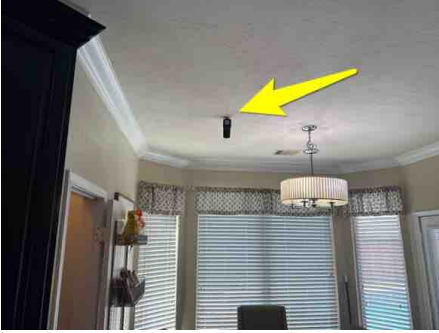
Moisture detected

REC 20: Limited moisture was detected at the dining area ceiling. We were unable to determine the source. We recommend this be further evaluated by a qualified contractor and repaired as necessary.

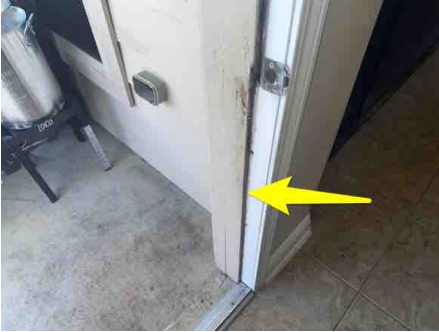
Back door

MNT 24: The exterior door weather stripping parts and sweeps had some gaps or damages that could be repaired.

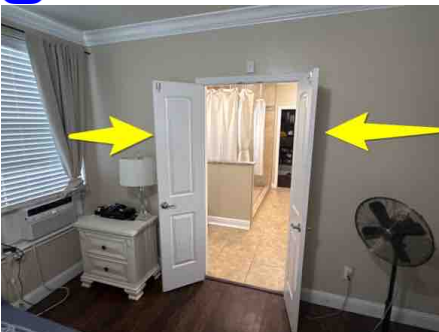
Primary bathroom

MNT 27: Some of the doors did not catch properly. The latch parts need to be adjusted or replaced.

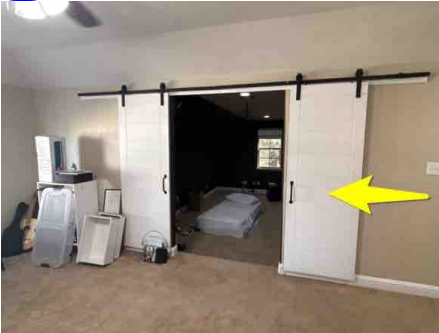
MNT 29: The media room sliding doors did not operate properly when tested and could be repaired.

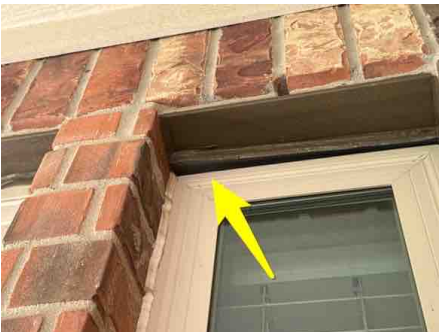
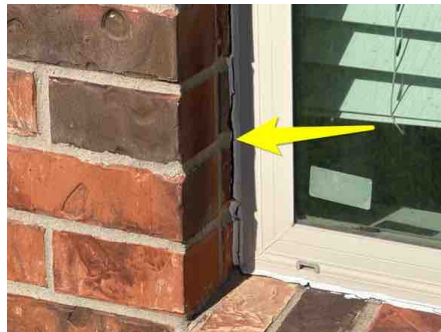
MNT 30: There were gaps around the windows and window trim. This is a common maintenance item. All gaps should be touched up and repaired.

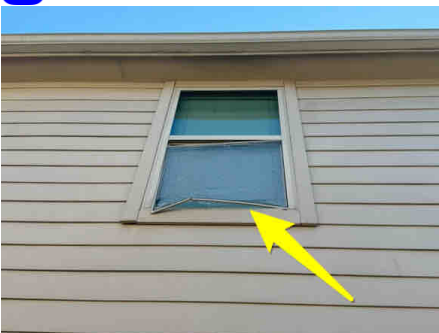
MNT 31: Some of the window screens were damaged and could be replaced.

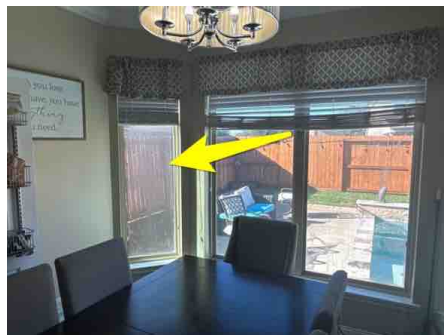
Dining area

EVAL 32: Some of the windows had surface discoloration. It appeared that the low-e or low emissivity coating that is a surface tint or coating to block some of the light entry had begun to age or the windows had failed seals. The discolored window panes could be replaced.

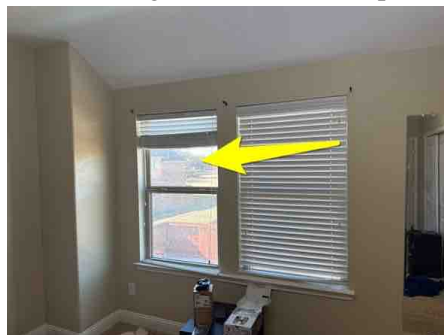
Middle rear guest bedroom

REC 33: Some window panes were cracked or damaged and could be replaced.

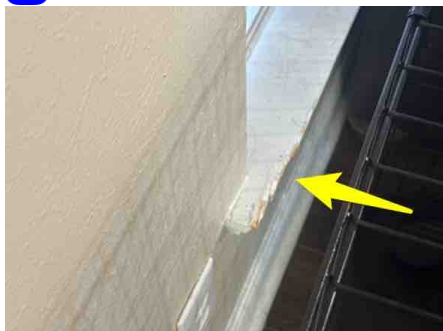
MNT 34: The windowsills had some marks, gaps, and irregularities. They need to be sanded, caulked and repainted.

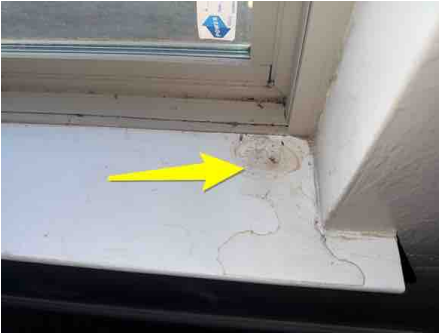
Gameroom

EVAL 35: The wall areas and windowsills adjacent to some of the windows had signs that condensation had been present or that rainwater had entered which is a common condition found at most homes. Further evaluation is recommended.

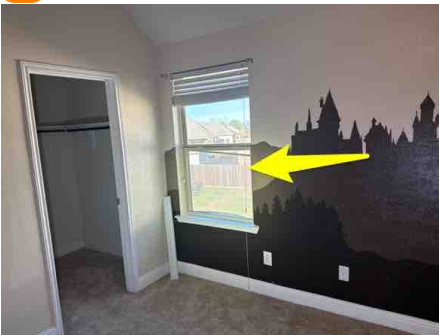
Back right guest bedroom

REC 36: Some windows did not operate properly when tested. Further evaluation and repair is recommended.

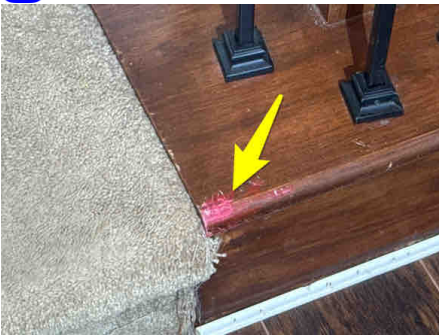
MNT 37: The stairway trim and railings had limited marks, damages, and/or gaps. Repairs are recommended.

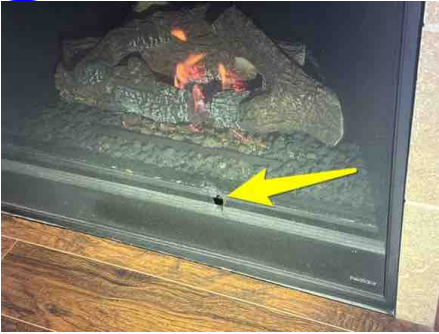
MNT 38: The fireplace screen was damaged and could be replaced.

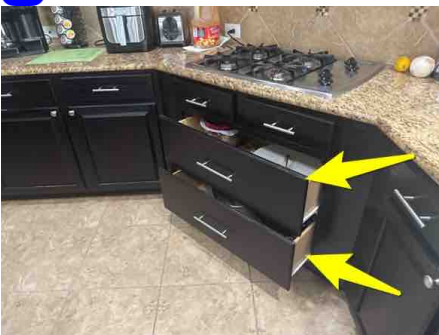
MNT 40: Some cabinet drawers were stiff or did not operate properly and could be repaired.

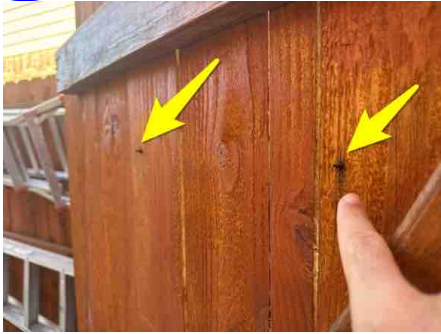
Right gate

MNT 41: There were some sharp fasteners at the fences that need to be flattened or removed.

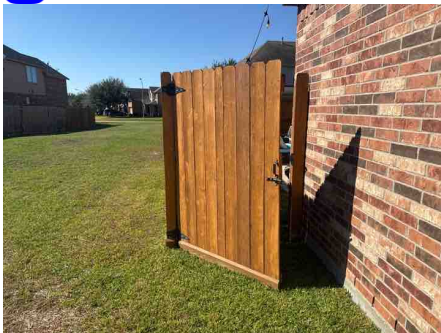
MNT 43: The left gate rubbed at the ground surfaces. Adjustments could be made.

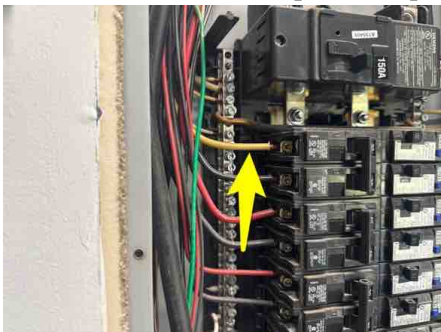
MNT 44: White wires were connected to some of the breakers and disconnects. This is a common condition found and does not impact the functionality, but is considered a deficiency per TREC standards. The white wires should be marked with electrical tape or sharpie to indicate they are carrying a positive current.

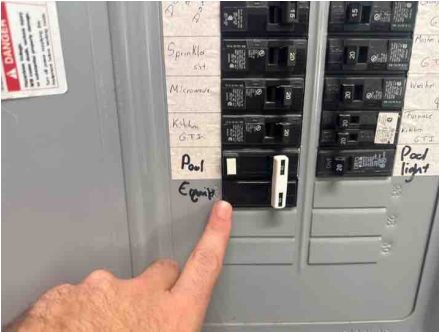
REC 45: The breaker for the pool was observed to pop or spark when tested. The pool equipment did not appear to be receiving power as a result. We recommend this be further evaluated by a licensed electrician, and repaired or replaced as needed

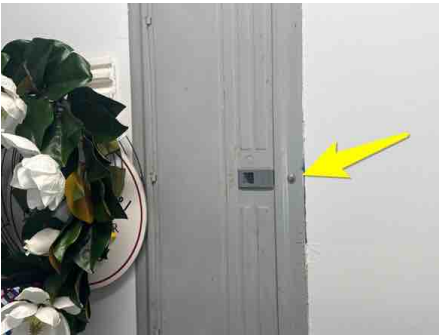
MNT 46: The breaker panel face plate middle fastener holes were stripped. The fasteners here could not be properly tightened as a result. Repairs could be made.

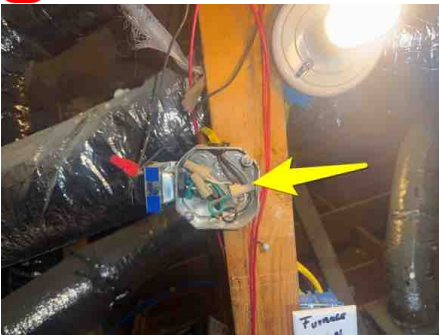
Attic

SAFE 47: There were uncovered junction boxes. We recommend they be covered to protect the wiring connections.

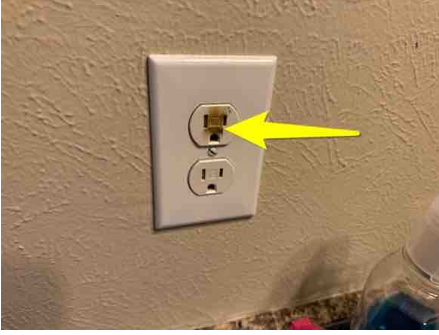
Upstairs back right bathroom

51: Some of the receptacle surfaces had discoloration consistent with scorching, however, there were no signs of over-heating or damages at the wiring when the covers were removed. Further evaluation is recommended.

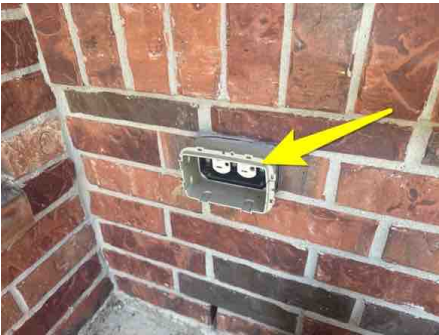
52: Some of the exterior electrical receptacle cover parts were missing and need to be replaced as a safety precaution.

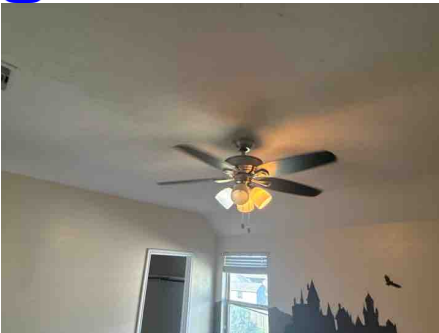
Back right guest bedroom

53: Some of the ceiling fans made some noises and could be repaired or replaced.

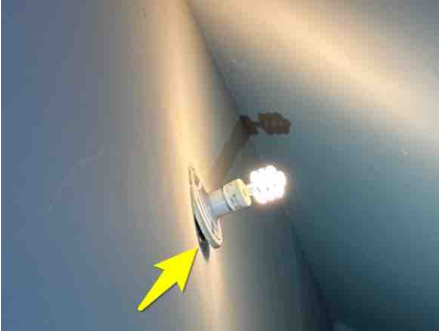
Media room, left attic space/closet

MNT 54: Some light fixtures were loose or had gaps, and could be repaired.

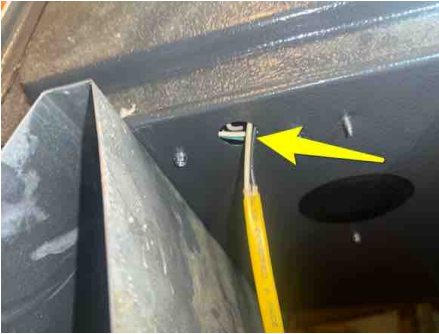
SAFE 55: The electrical wire that passed through the furnace did not have a bushing or a grommet present to protect it and the wiring insulation was stripped before the wiring passed through the equipment. Repairs are recommended.

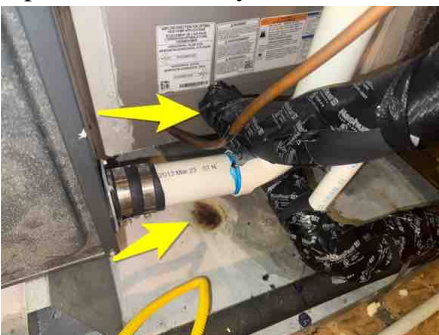
Limited water in pan

REC 56: There were minor gaps at the air-conditioner unit refrigerant line insulation and/or equipment surfaces that should be repaired, to prevent energy loss and to prevent condensation from dripping from it. Some moisture was present in the drain pan which was most likely related. We recommend the equipment be further evaluated and repaired as necessary.

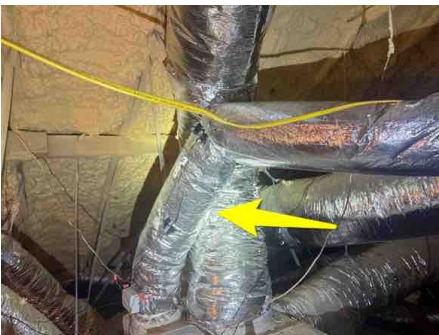
MNT 58: Some of the ducts were in contact with each other, which could lead to condensation formation. It is recommended that the ducts be separated. Repairs can be performed by adding attic insulation between the ducts where they are in contact with each other.

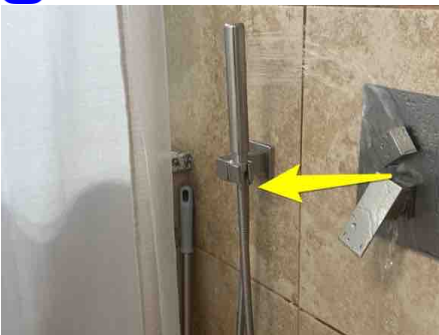
Primary shower, left hand sprayer

MNT 59: Some of the shower head or hand sprayers had minor leaks when tested and could be repaired.

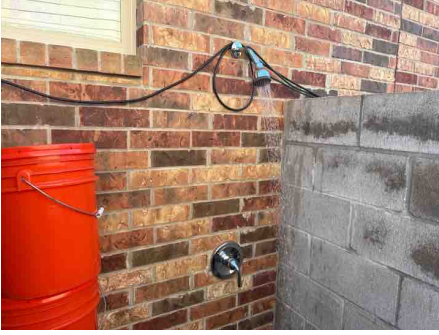
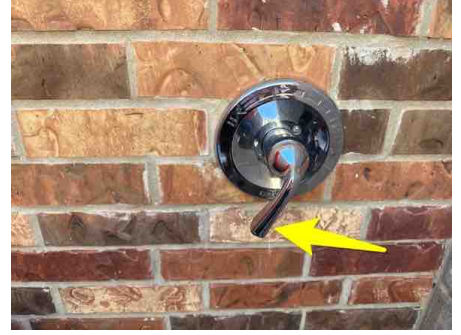
EVAL 60: The outdoor shower operated when tested, however, the handle had a regularities as it could only be turned a quarter of the way. This could be repaired on a needed basis.

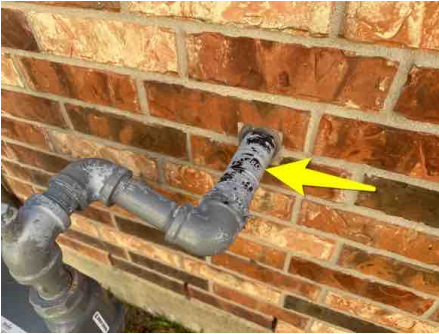
EVAL 61: Bonding between the gas supply lines and the breaker panel was not found at the gas line where it enters the home, where it is normally installed, which should be installed if it is not present.

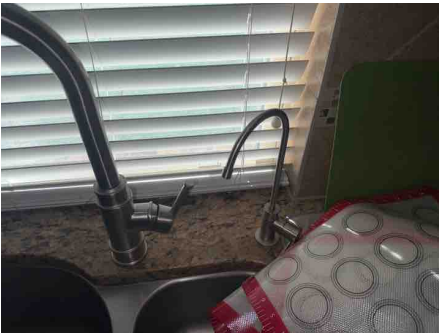
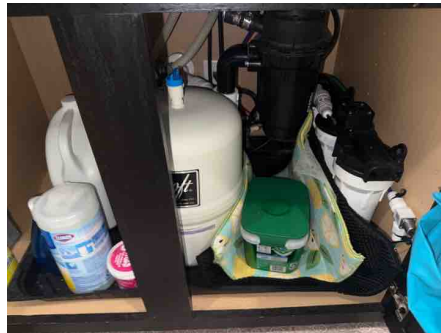
EVAL 62: A water filter system was present that did not supply water at the time of the inspection. It will need to be repaired, set up for use, and serviced on a periodic basis.

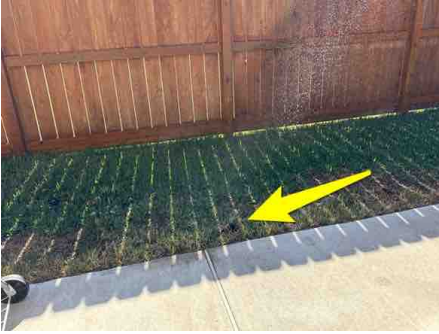
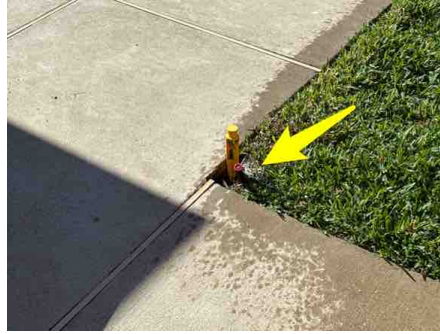
Zone 4

MNT 70: Some of the sprinkler heads were leaning and could be adjusted.

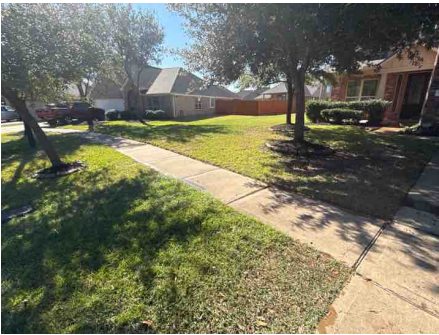
Zone 2

REC 71: Some of the sprinkler zones or heads did not operate properly or had low pressure when tested. Further evaluation and repairs are recommended.

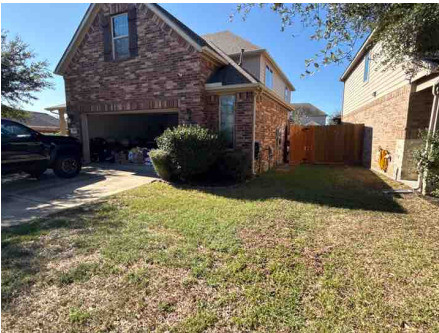
EVAL 72: The front right yard area did not appear to have sprinkler heads, or the zone where did not respond when tested. Further evaluation is recommended.
