# 4650 Axis Trl

## Conroe, Texas 77303

| Type | <b>Home Inspection, Floor Plan and Pool Inspection Report - 4650 Axis Trl</b> |
| Inspected by | <b>Rio Bravo - Inspectify Pro - Houston</b> |

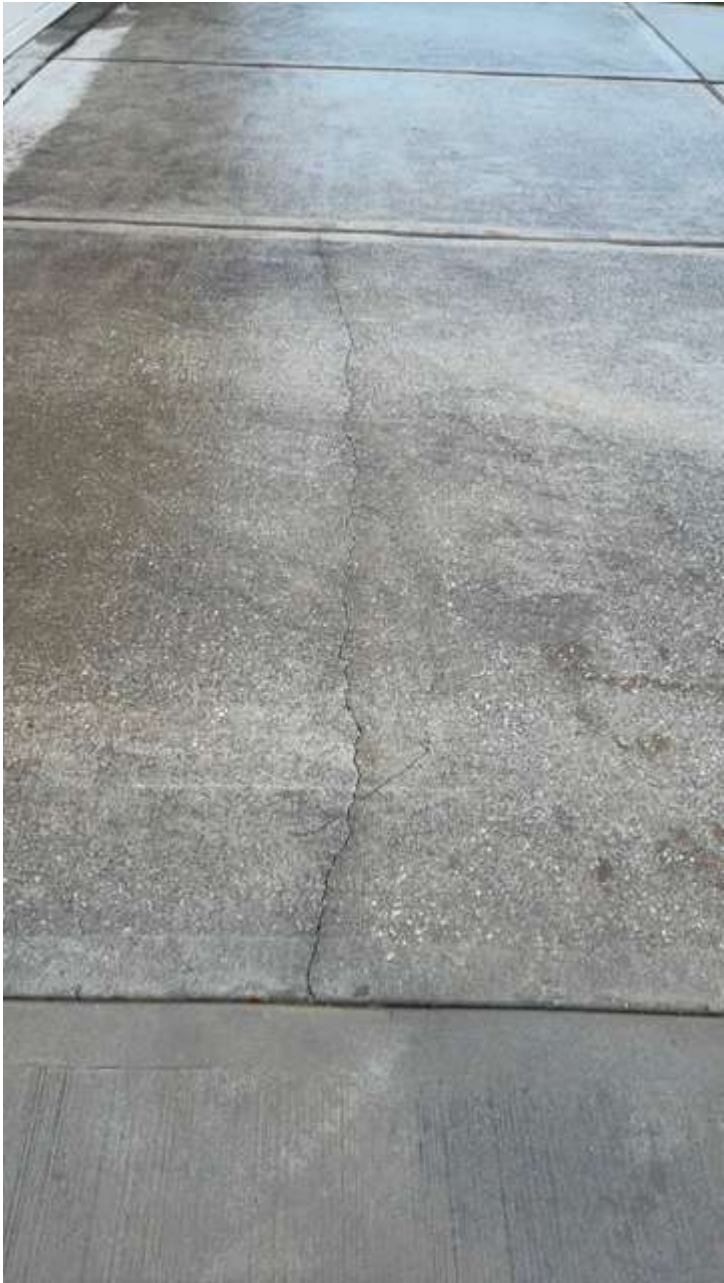
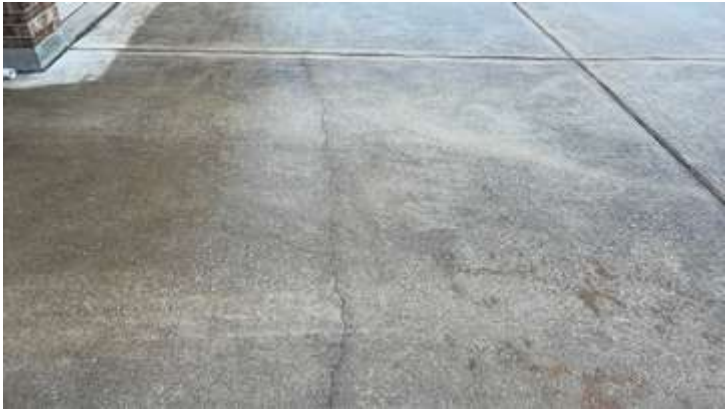
Northeast

Minor Cracks in the Driveway

The driveway has minor cosmetic cracks. Recommend repairs or replacing by a qualified professional.

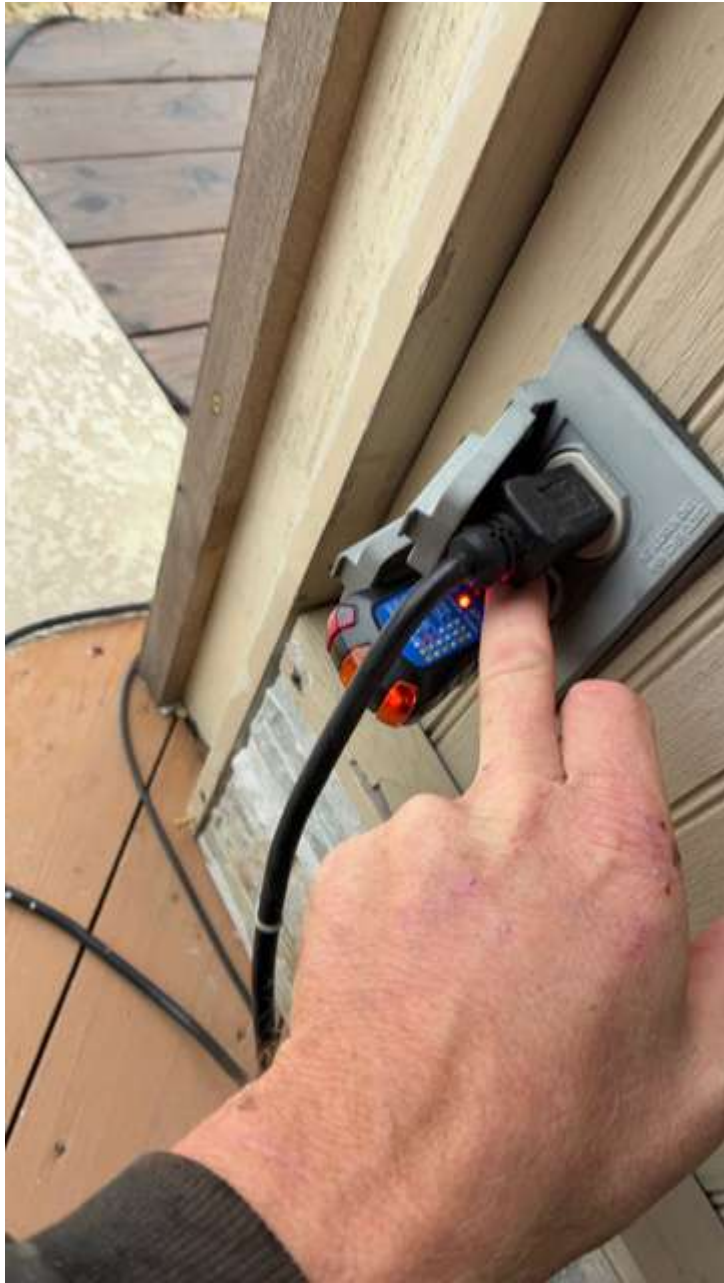
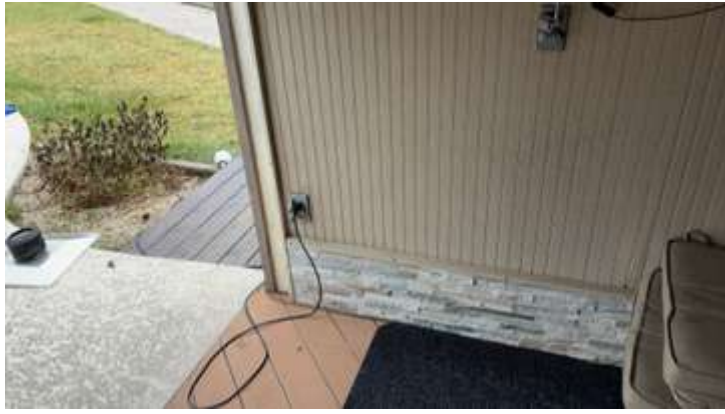
## Missing GFCI

There is no GFCI (Ground-Fault Circuit Interrupter) protection.

**All outlets and unconditioned pool house area**

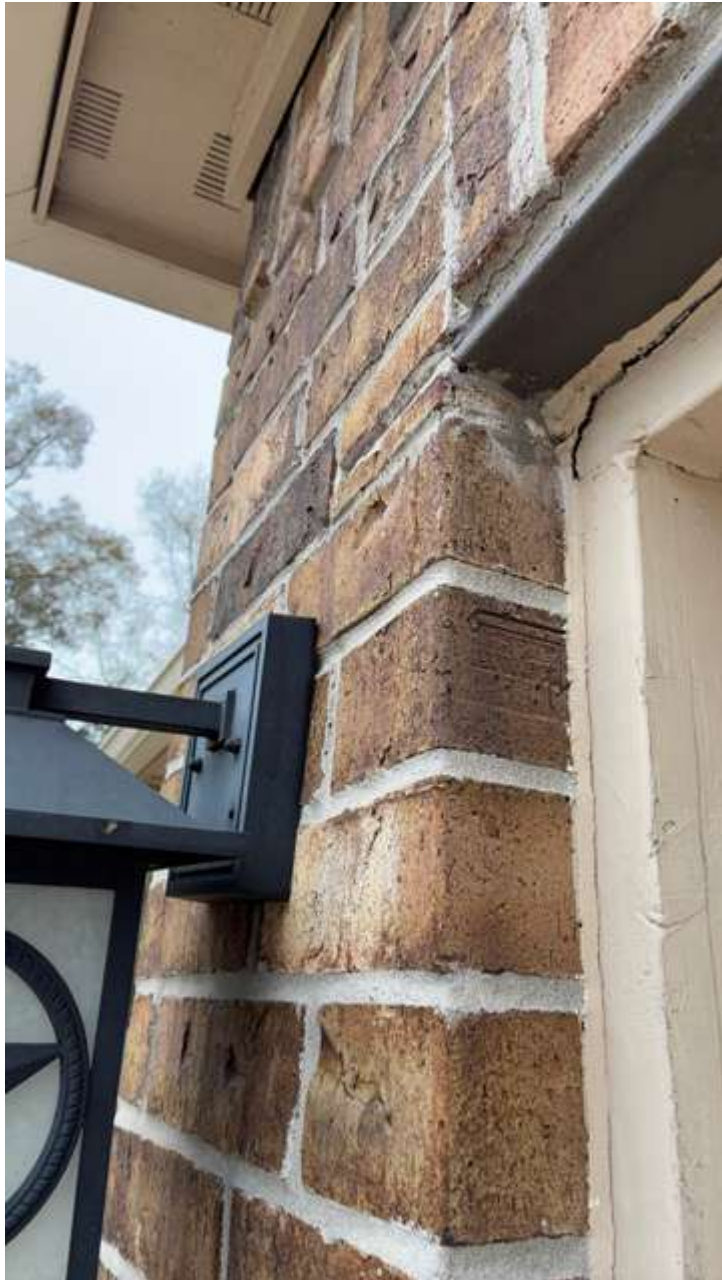
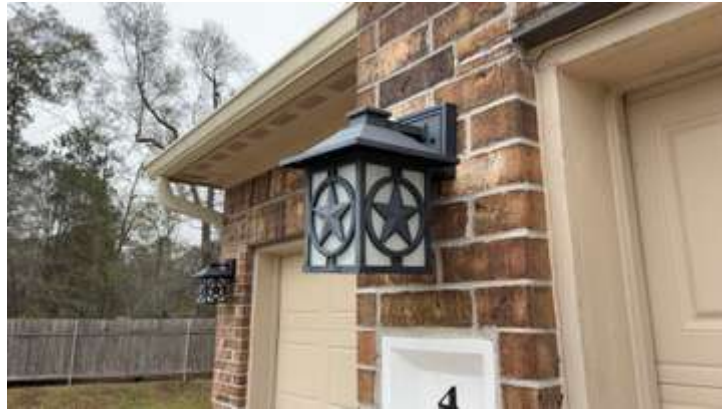
**Northeast**

## Missing Exterior Caulk

**Majority of exterior light fixtures**

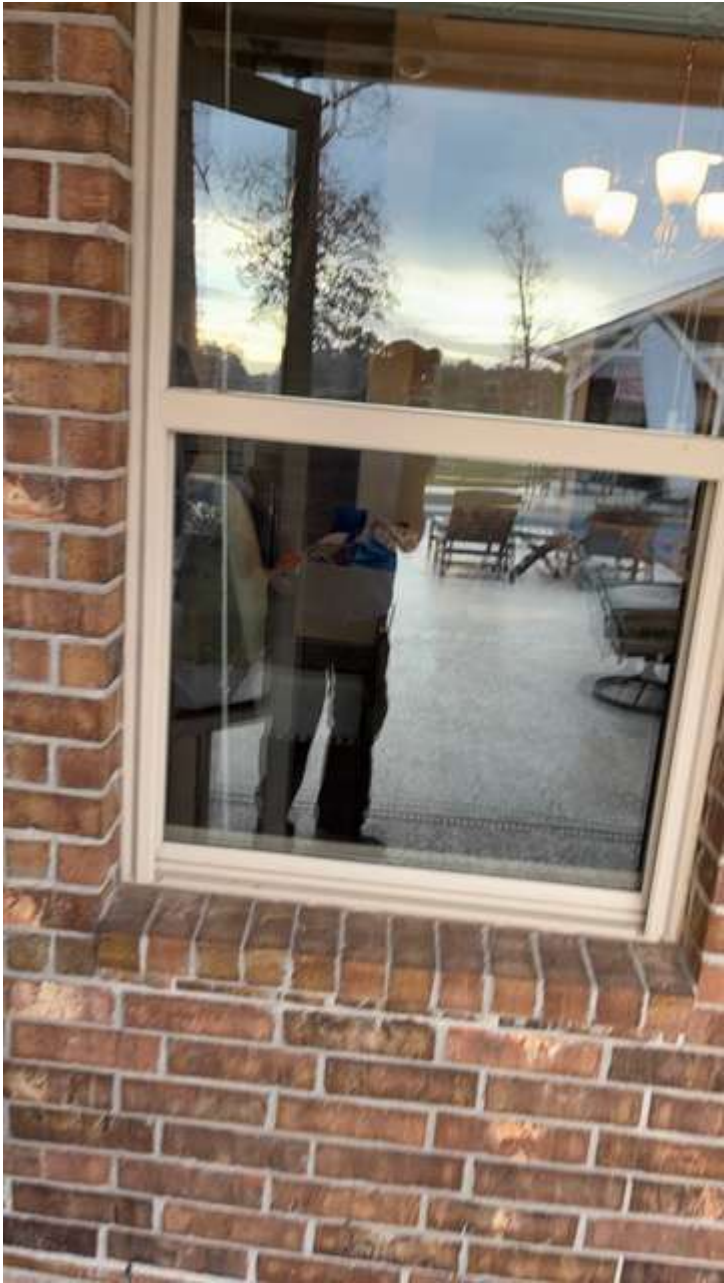
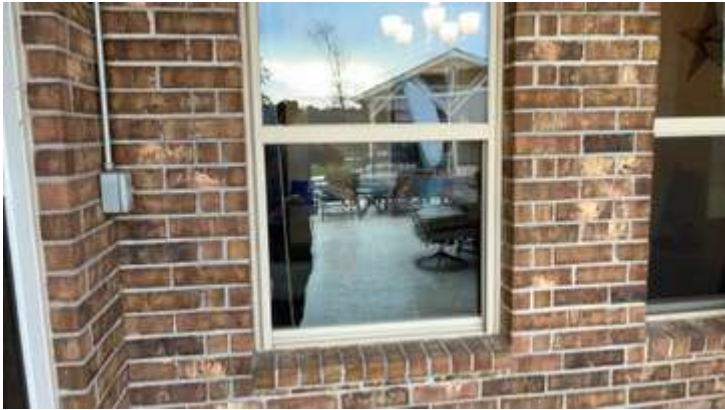
**West**

## Missing Window Screen

One or more windows are missing a screen. Recommend repairs or replacing by a qualified professional.

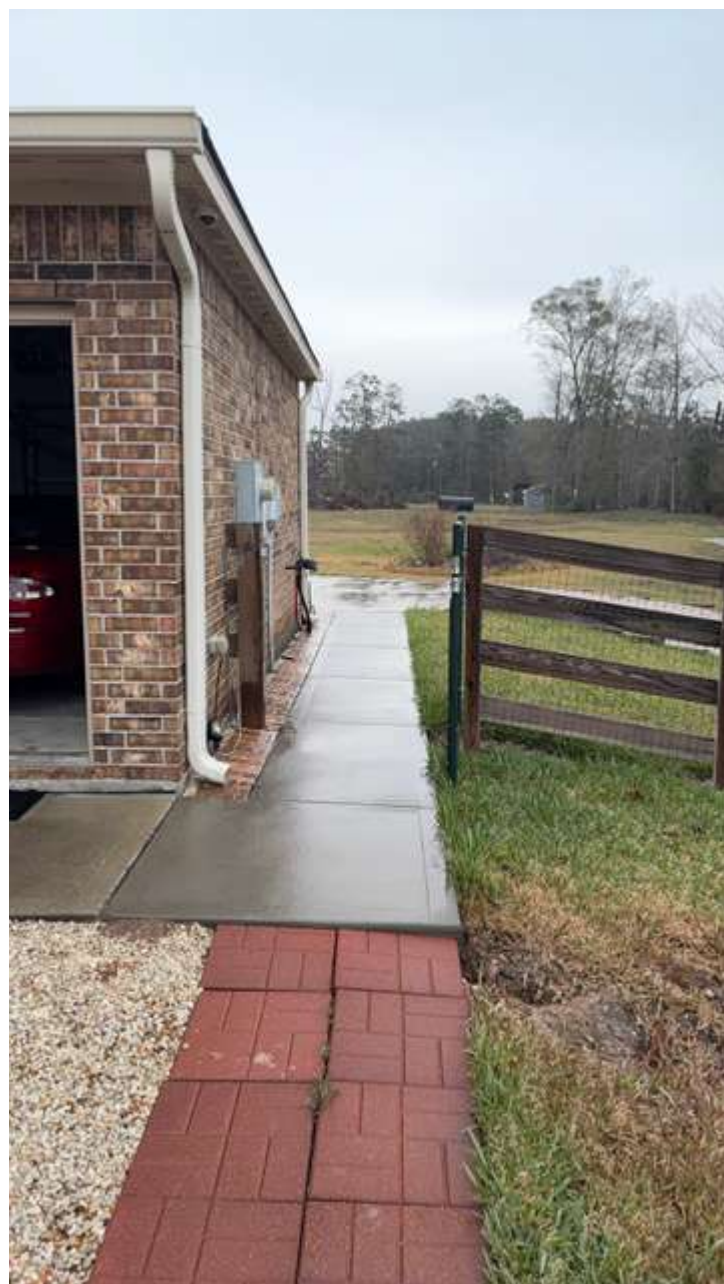
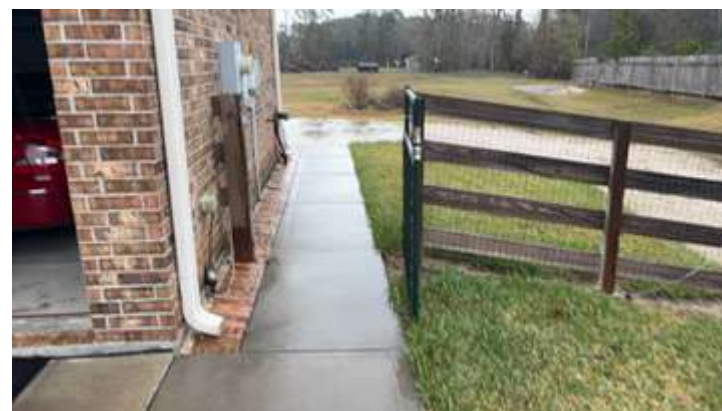
## Inadequate Pool Gate

The pool gates should be self-closing for safety.

**Both gates. Latch height was also less than 54 inches.**

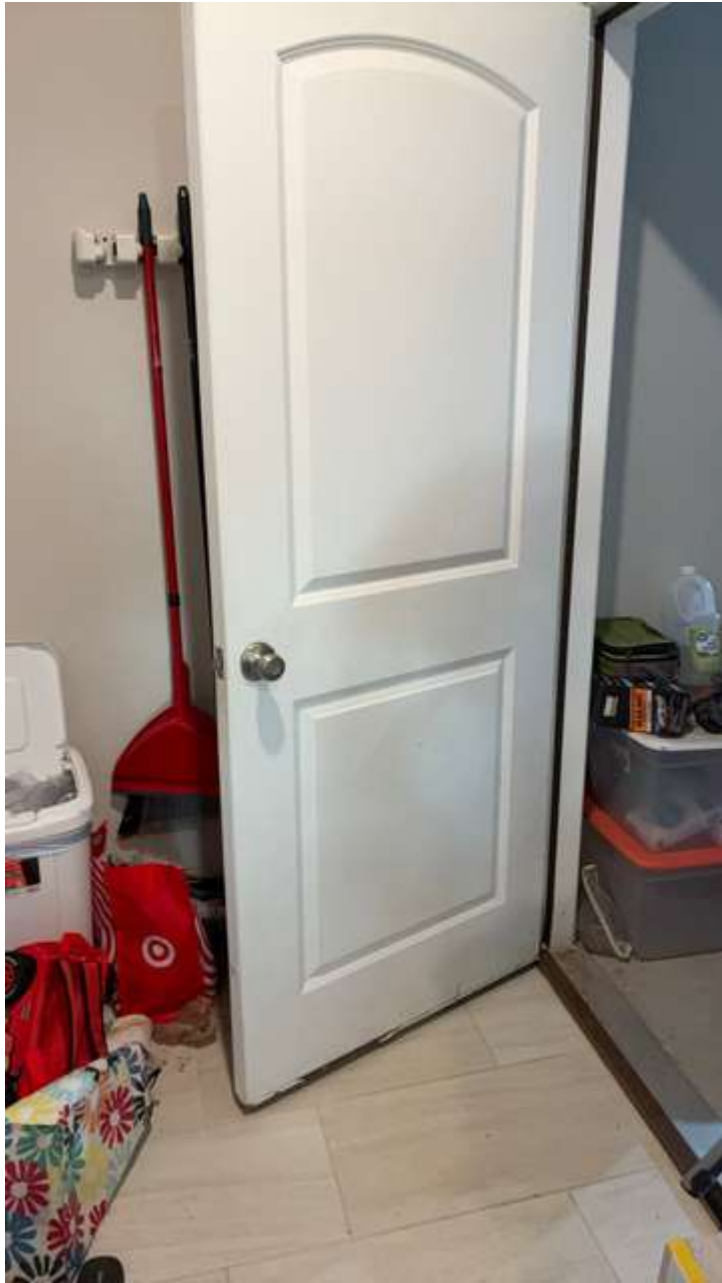
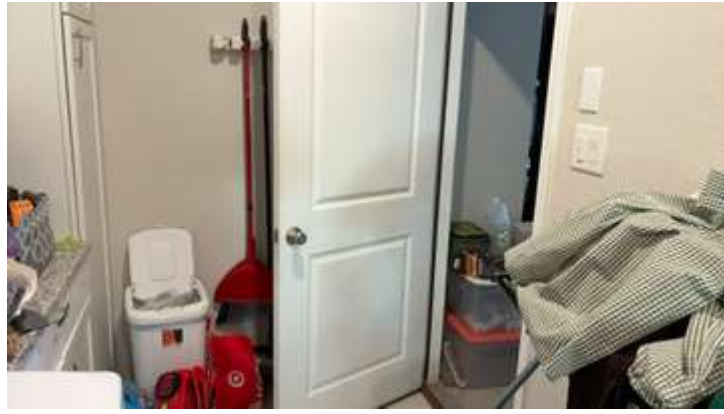
## Missing / Inoperable Self-Closing Door Hinges

The self-closing door hinges are missing / inoperable. Recommend further evaluation by a qualified professional.

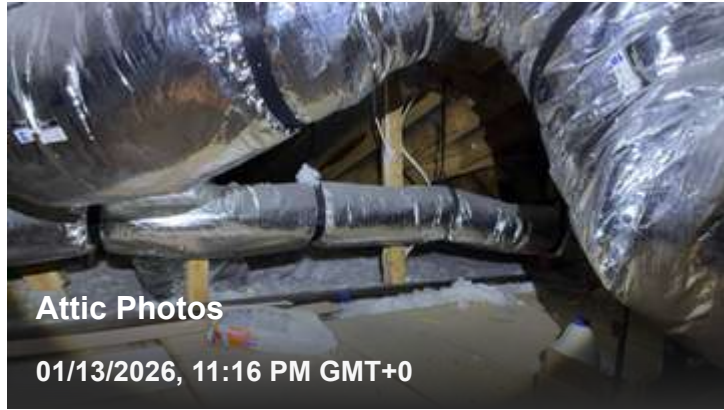
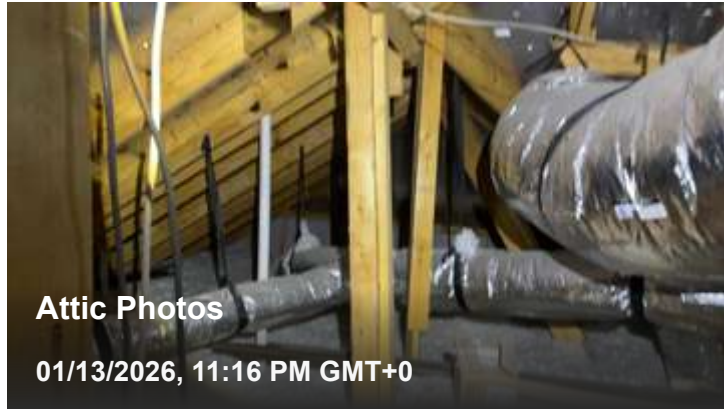
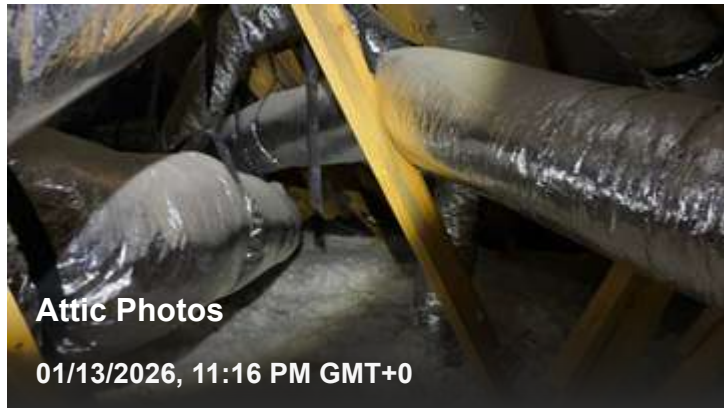
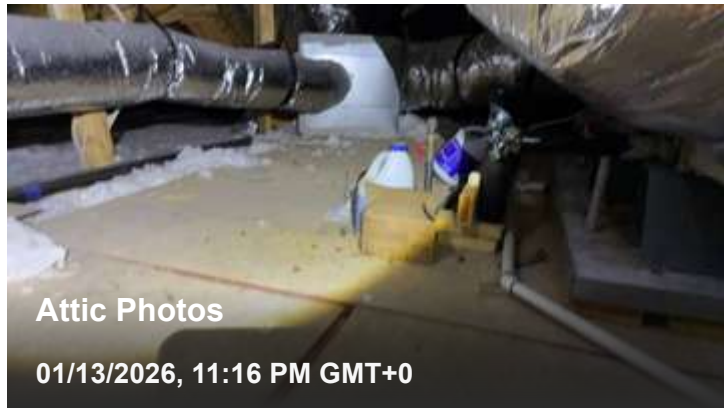
## Attic photos / videos

Attic Condition

**Fair (Some Repairs)**

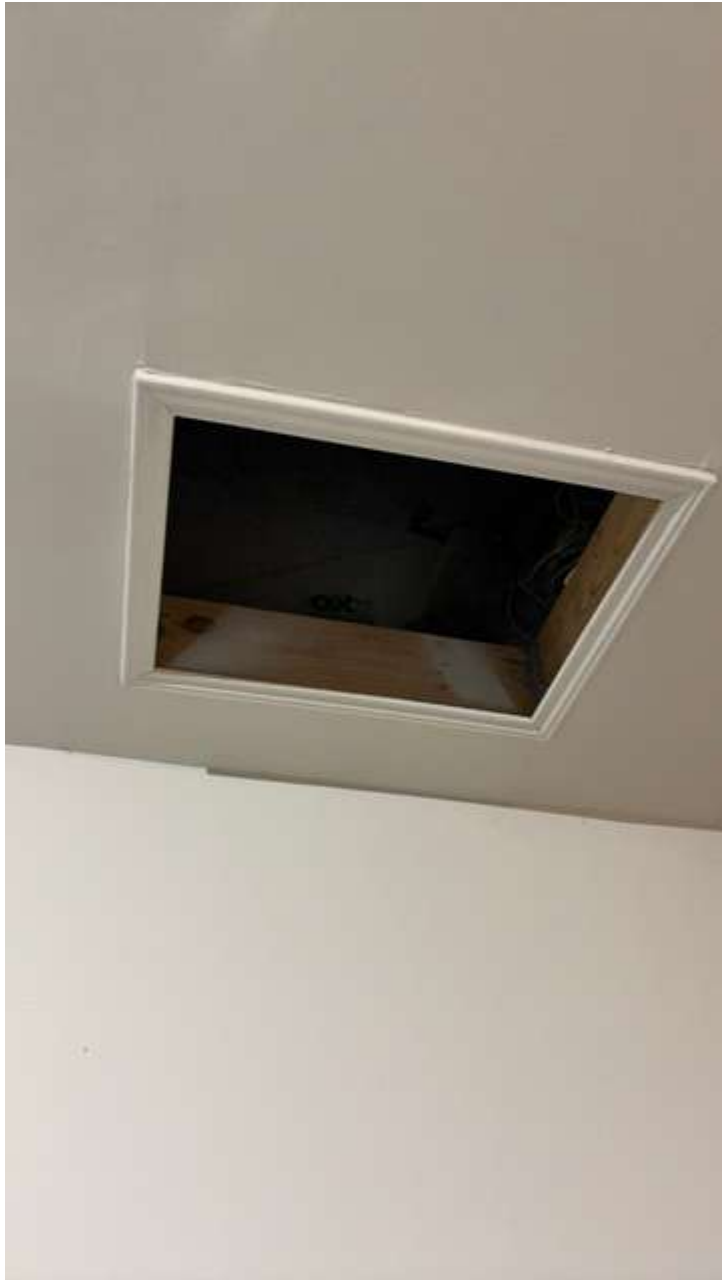
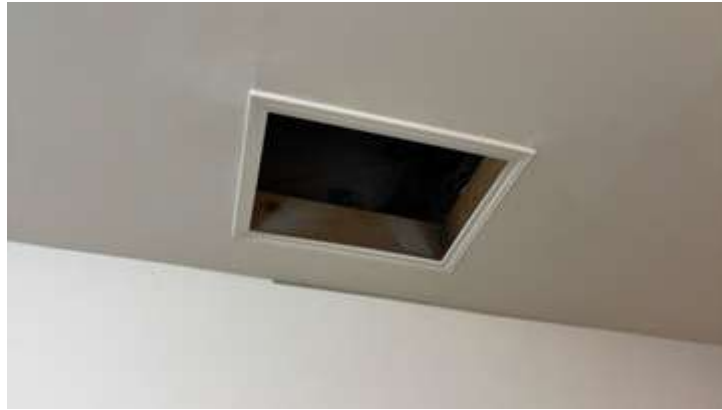
## Missing scuttle hole cover in garage

Scuttle hole cover was missing in the garage Recommend repairs or replacing by a qualified professional.

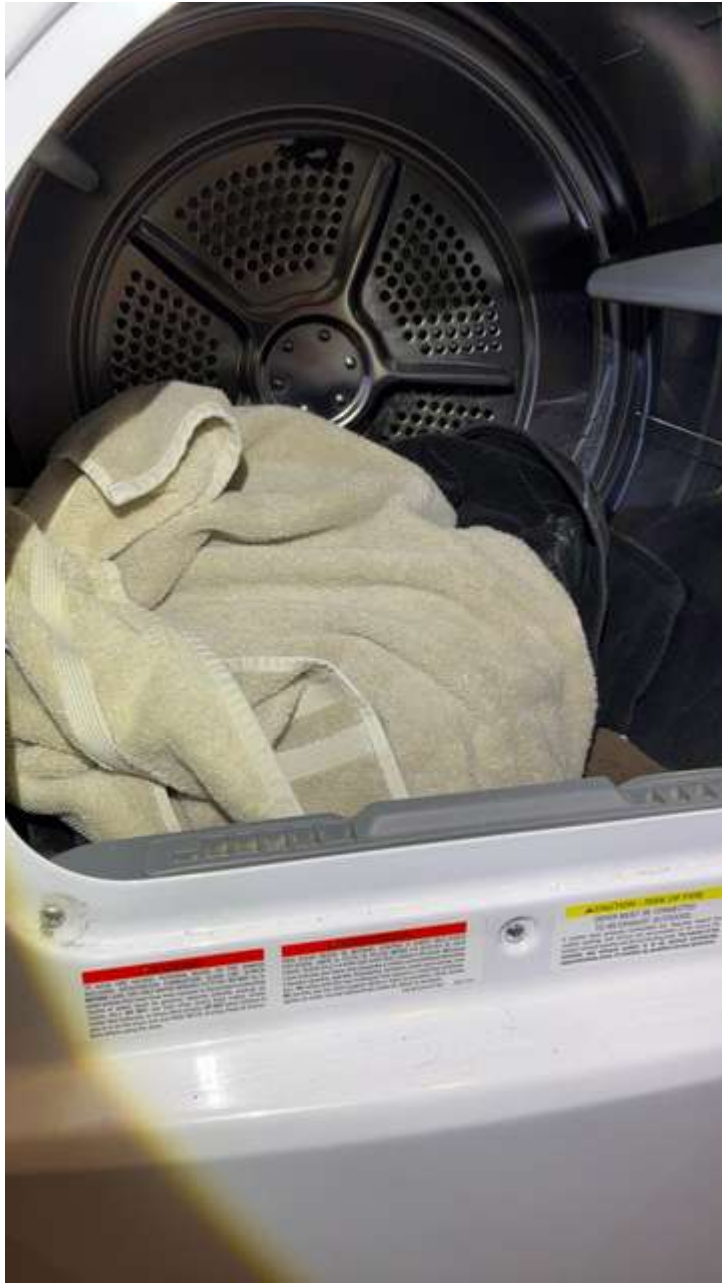
**Dryer Condition: Other**

This inspector does not operate dryers with Personal items in dryer

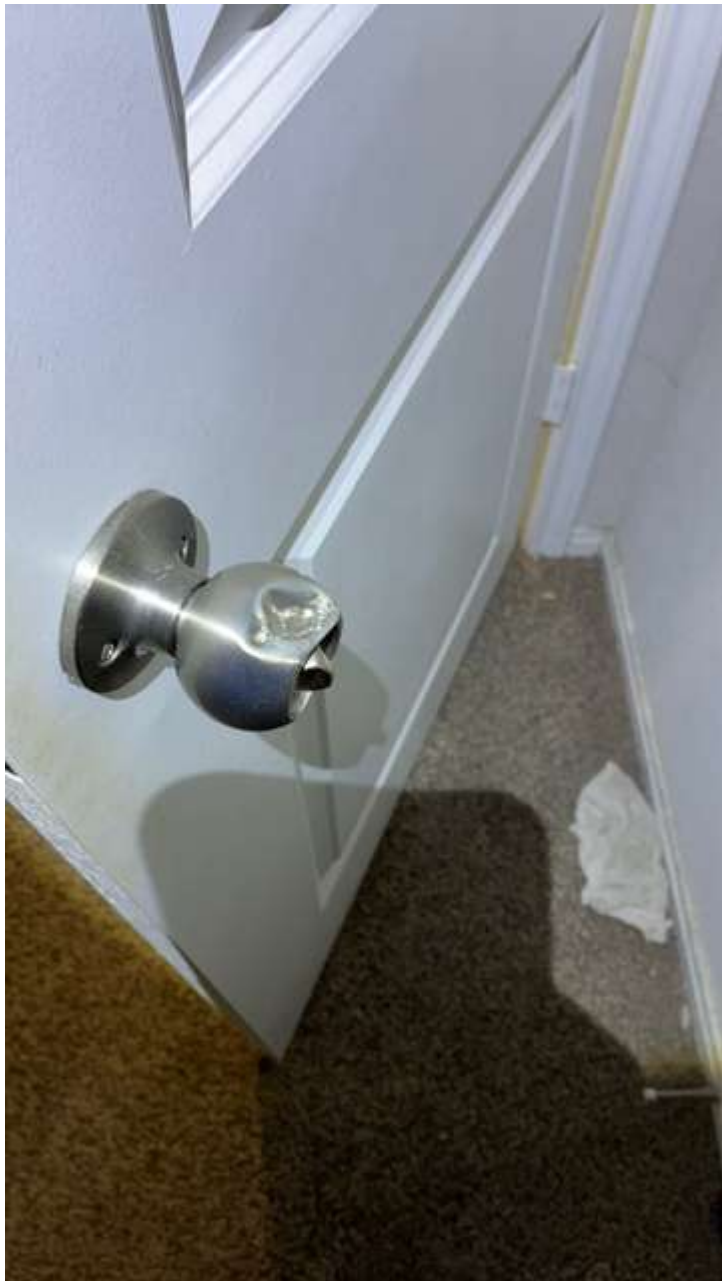
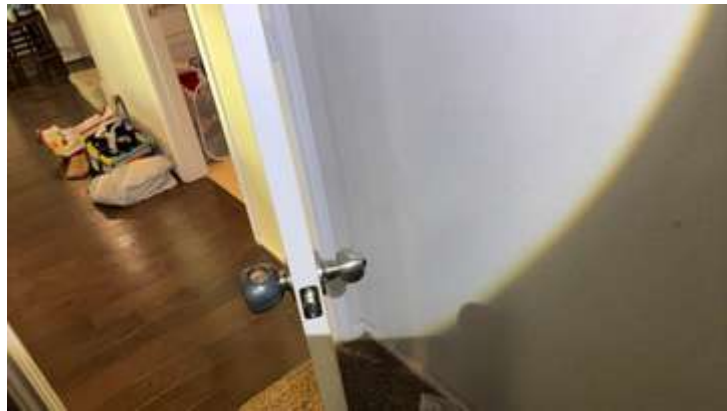
| System | Subsystem | Issues identified |
|---|---|---|
| Common Areas | Common Room | <u>Odor Source: Not Present</u> |
| | | <u>Doors / Casing / Door Stops Condition: Not Present</u> |

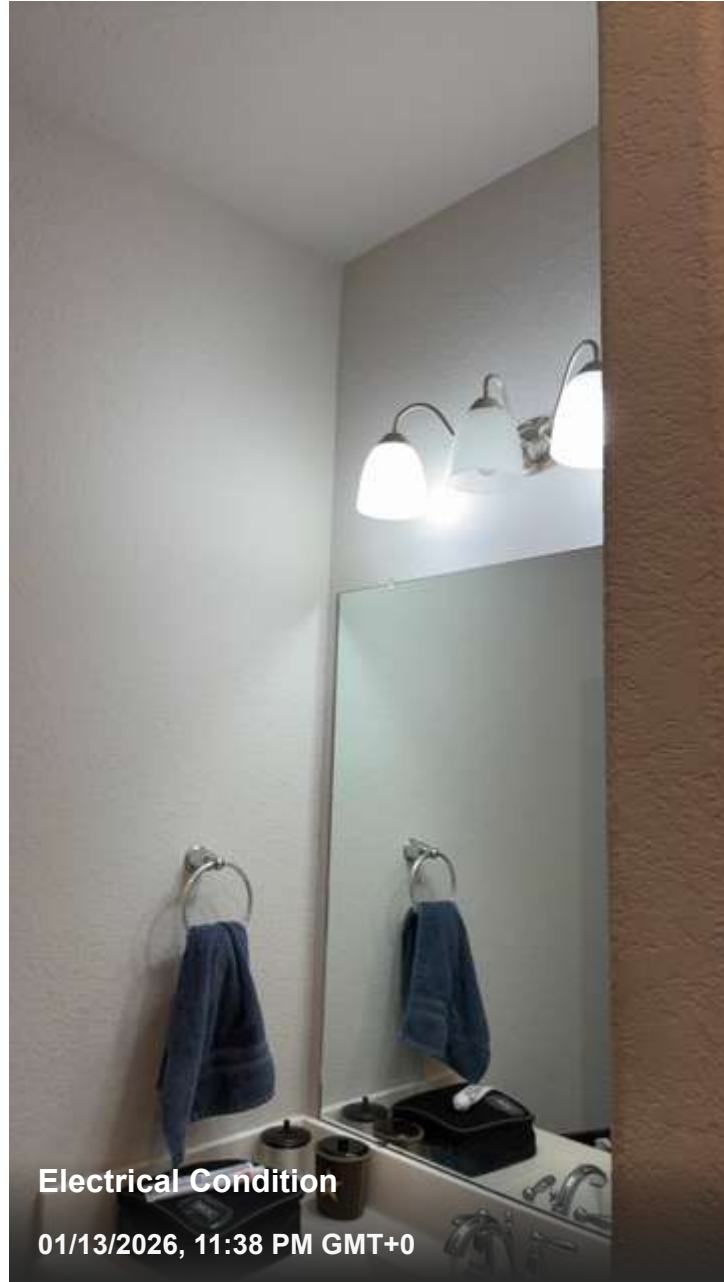
**Electrical Condition**

**Fair (Some Repairs)**

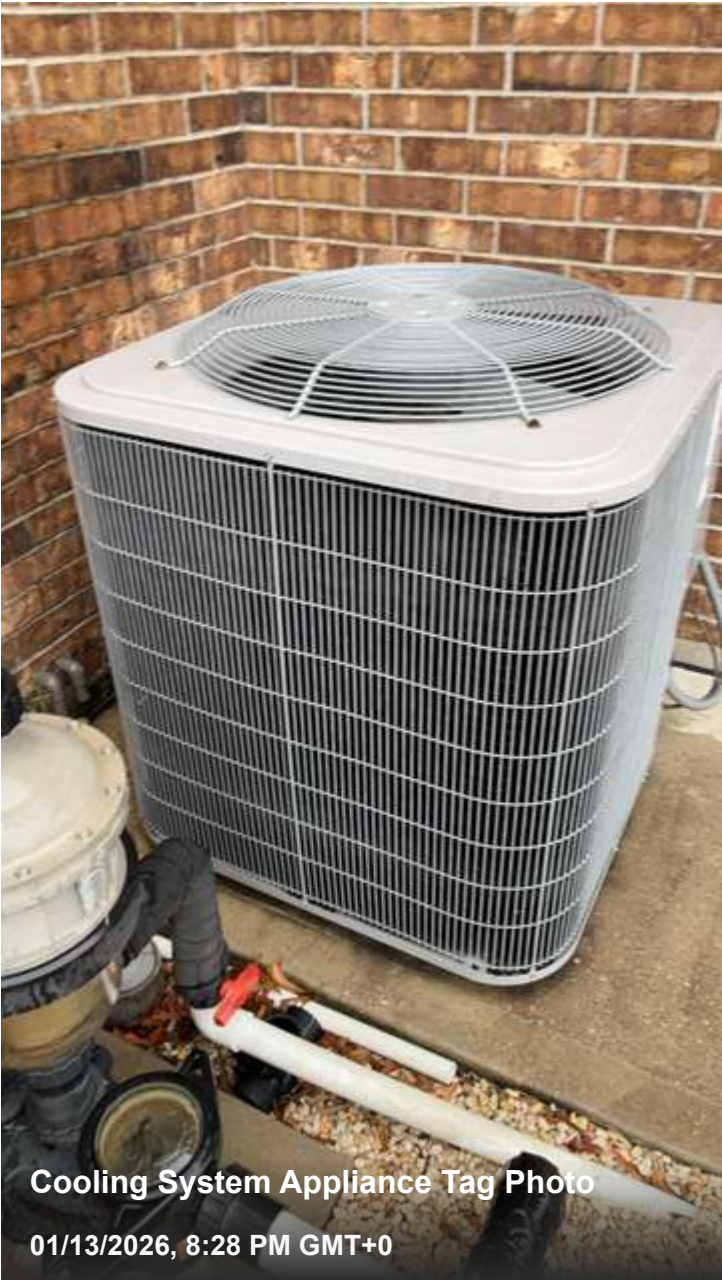
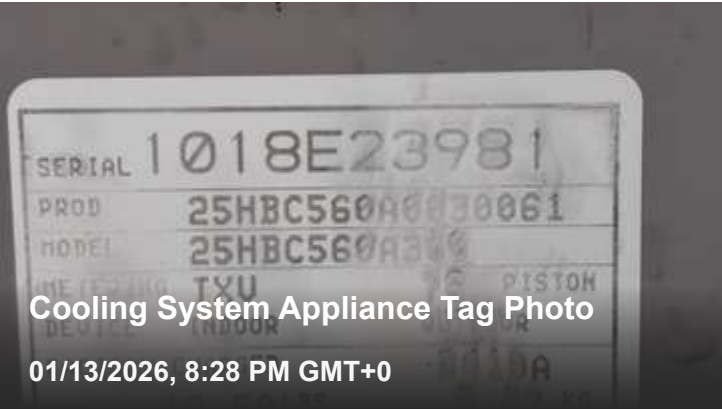
Cooling photos / videos

Because the outside temperature was too cool to operate the air conditioner without the possibility of damaging the system, I did not operate the cooling system.

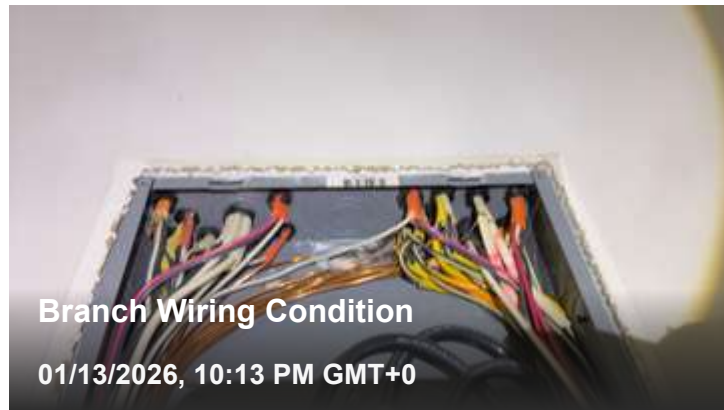
### Repair deficiency

## Missing Cover Plate

One or more switches / outlets / receptacles are missing a cover plate. Recommend repairs or replacing by a qualified professional.

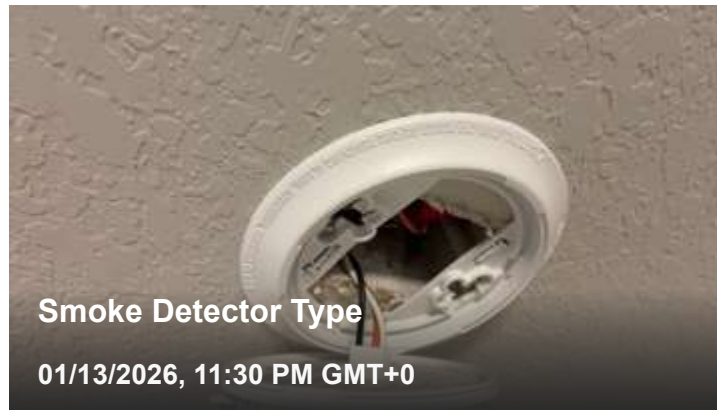
### Safety deficiency

#### Missing Smoke Detector(s)

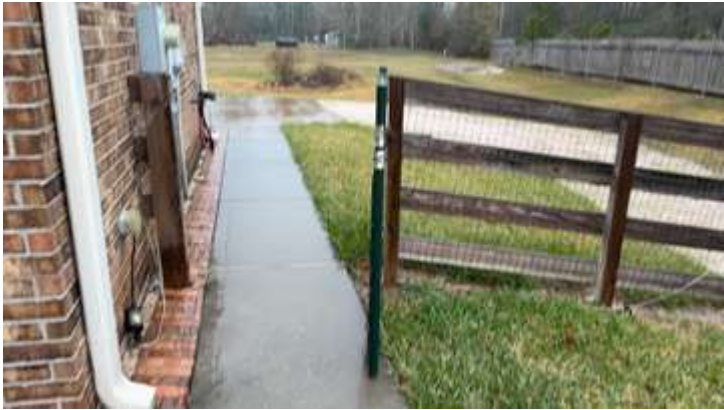
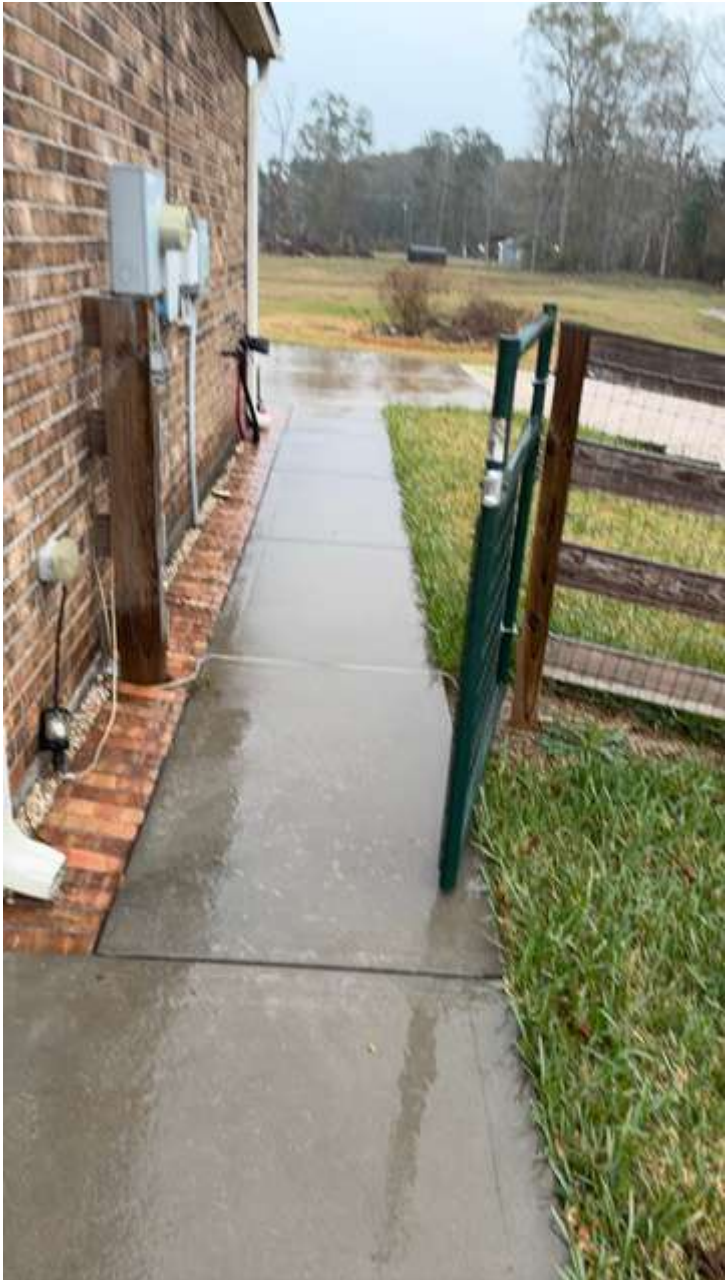
**South, North**

## Missing / Inoperable Self-Closing Door Hinges

The self-closing door hinges are missing / inoperable. Recommend repairs or replacing by a qualified professional.

Both gates

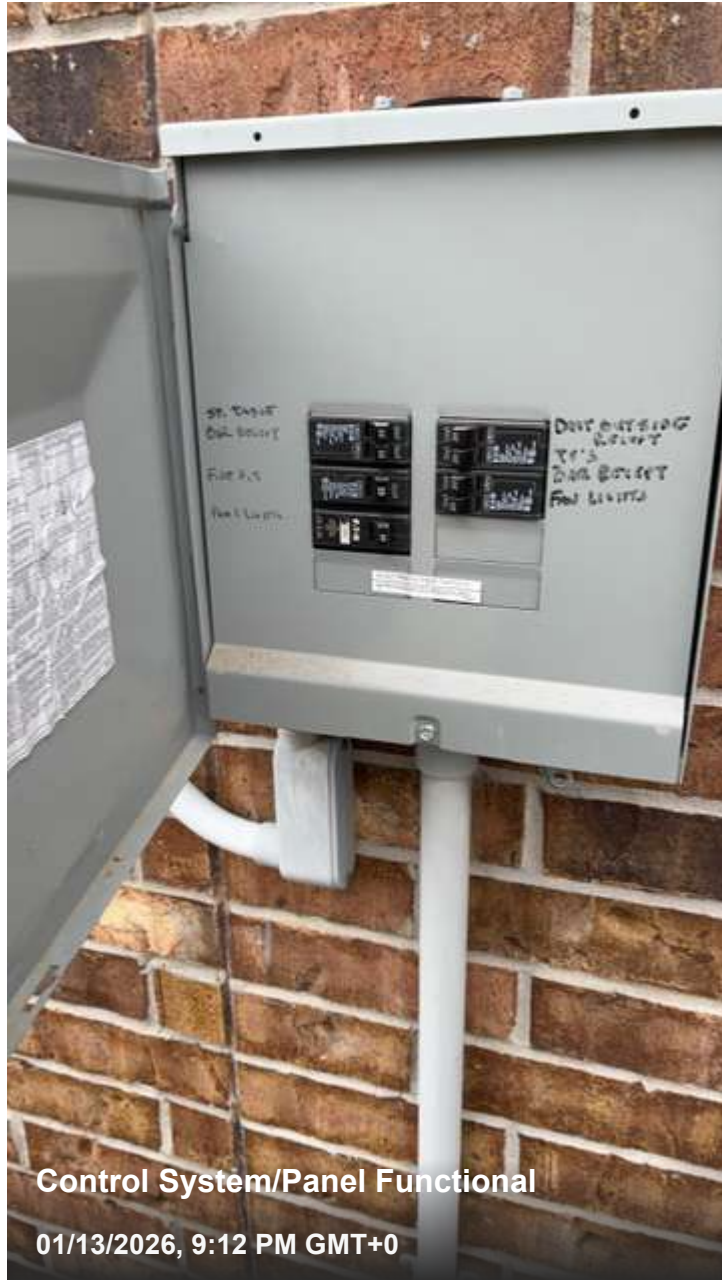
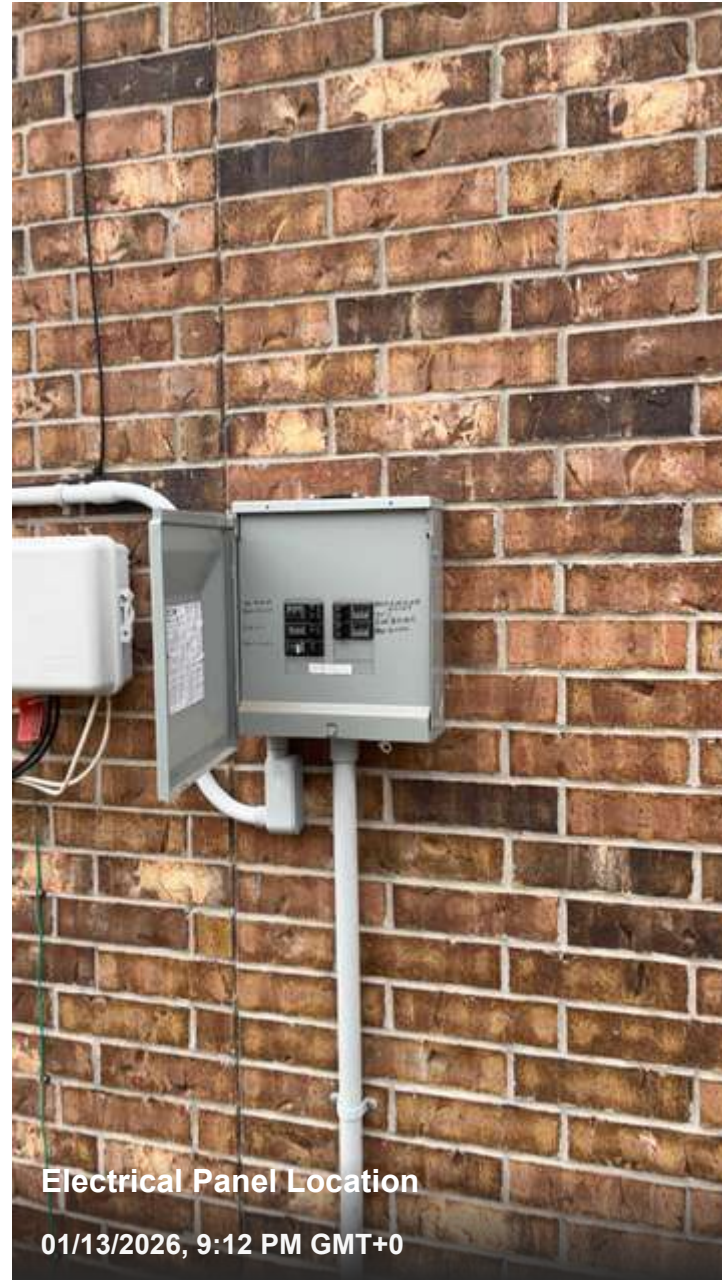
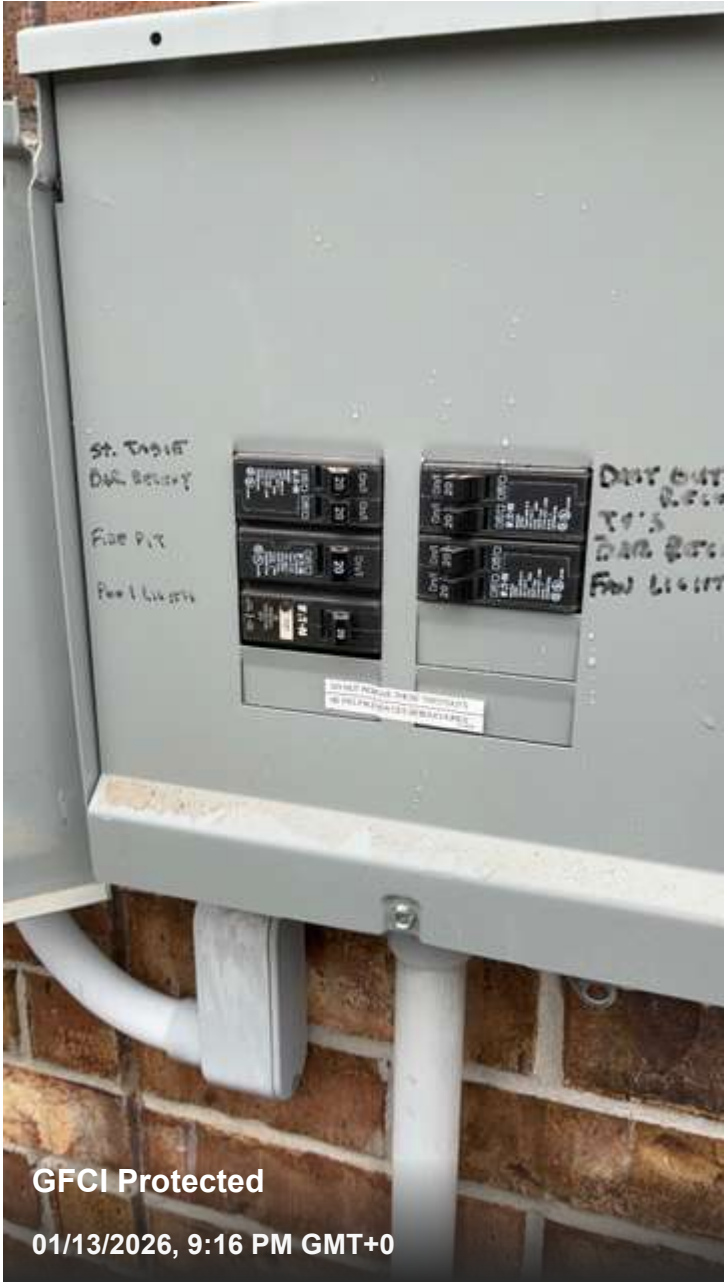
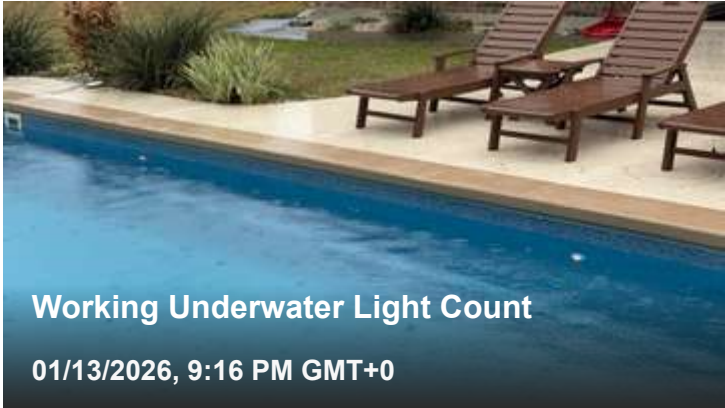
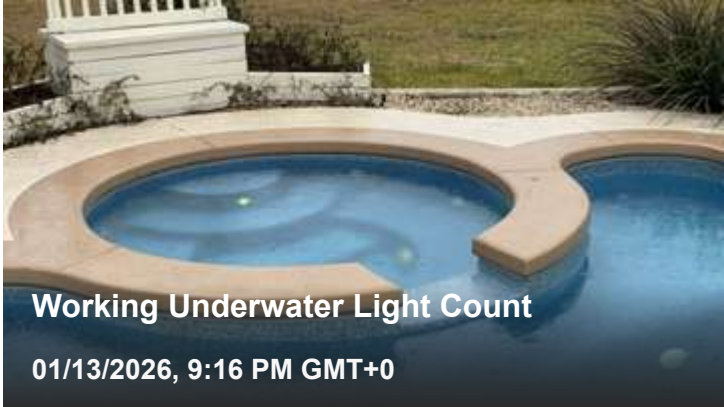
**Gfci breaker for pool lights would not trip**
