Job Estimate

Date: March 3, 2026  
To: Linda Mullins  
RE: 2314 Hudly St B Houston, Tx 77019

# Lone Star Stucco, LLC

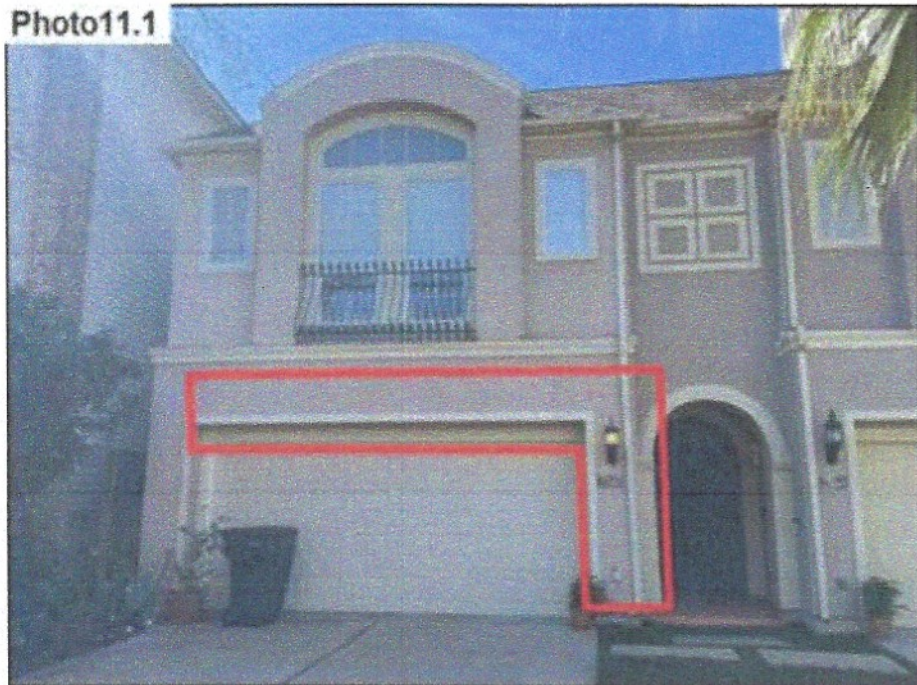
Photo11.1

Grid Location	Item Description	Moisture Readings	Substrate Condition	Observations
Red Boxes	Damage			Confirmed substrate and potential frame damage is noted at the bottom of the wall. The inspector recommends having a qualified waterproofing contractor further assess the extent of damage, repair as needed and install a proper relief in an effort to prevent moisture intrusion. Please refer to photos #11.2, #11.3, #11.4, #11.5 and #11.6 for more detail.

Remove damaged stucco and sheeting on page 11,16,21,23,24,25,27,33

Repair the framing members, replace the sheeting and insulation (if present), and install new Tyvek.

Install the missing drainage openings on page 11,21,23,24 (Drain Relief)

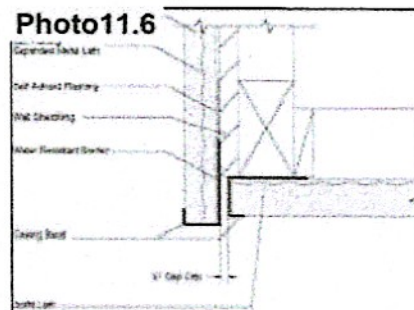
Photo11.6

Proper Relief Detail

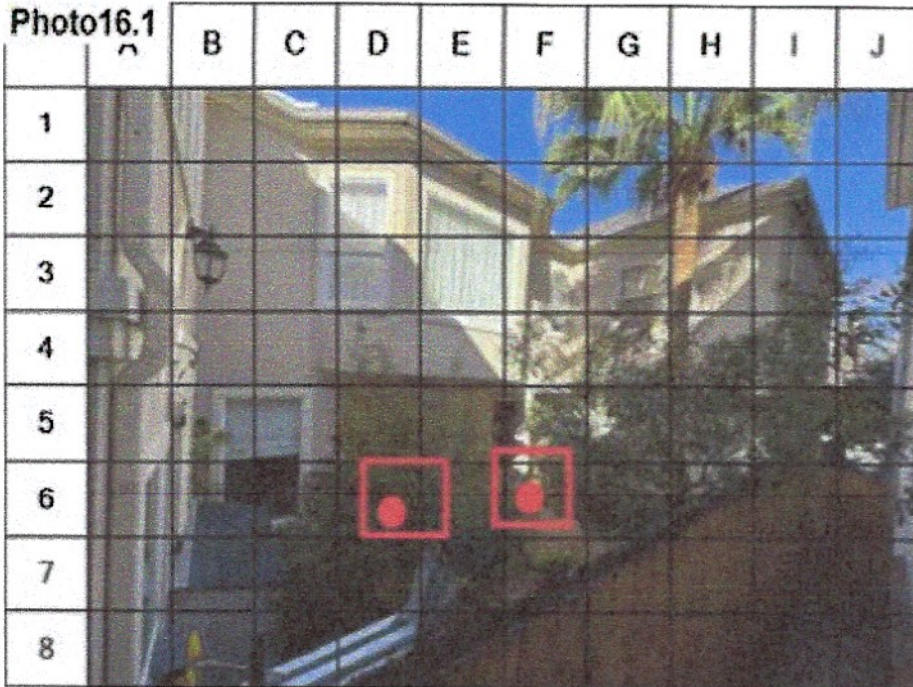
Grid Location	Item Description	Moisture Readings	Substrate Condition	Observations
Red Boxes	Damage			Confirmed substrate and potential frame damage is noted in the column. The inspector recommends having a qualified waterproofing contractor further assess the extent of damage, repair and modify as needed in an effort to prevent moisture intrusion. Please refer to photos #16.2, #16.3, #16.4, #16.5 and #16.6 for more detail.
D6	Columns		None	A moisture probe was taken at column. No substrate was noted at this time, modify as needed.
F6	Columns		None	A moisture probe was taken at column. No substrate was noted at this time, modify as needed.

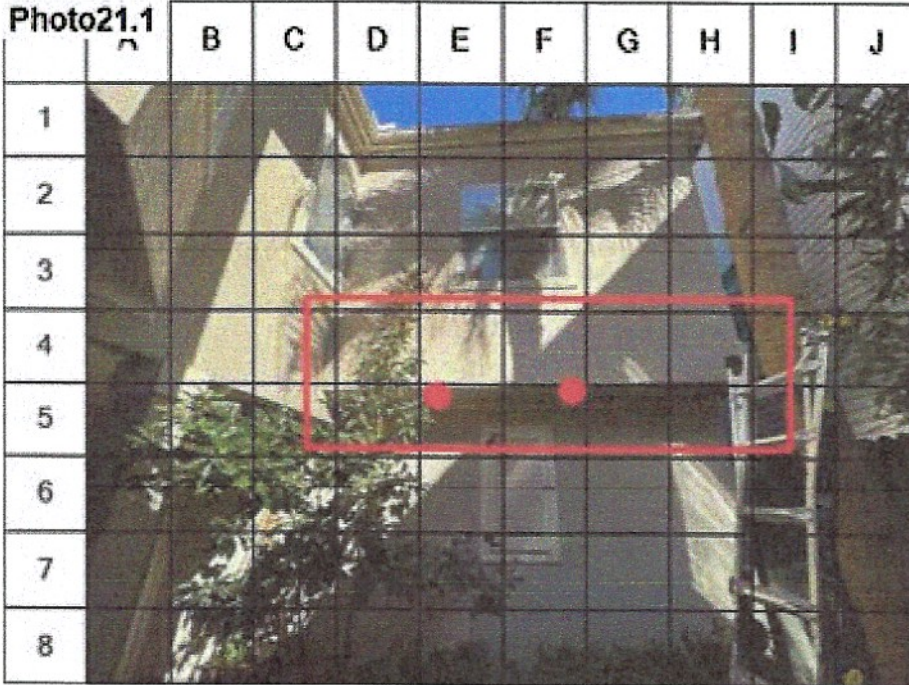
Grid Location	Item Description	Moisture Readings	Substrate Condition	Observations
Red Box	Damage			Confirmed substrate and potential beam damage is noted at the bottom of the wall. The inspector recommends having a qualified waterproofing contractor further assess the extent of damage, repair as needed and install a proper relief in an effort to prevent moisture intrusion. Please refer to photos #21.2, #21.3, #21.4 and #21.5 for more detail.
E5	Bottom Wall		None	A moisture probe was taken at bottom wall. No substrate was noted at this time, modify as needed.
F5	Bottom Wall		None	A moisture probe was taken at bottom wall. No substrate was noted at this time, modify as needed.

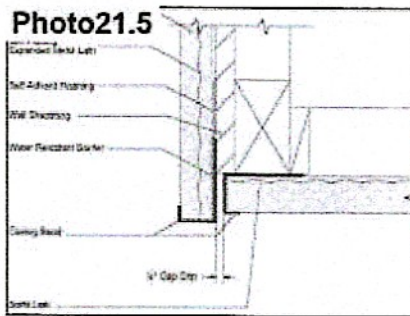
Photo21.5  
Proper Relief Detail

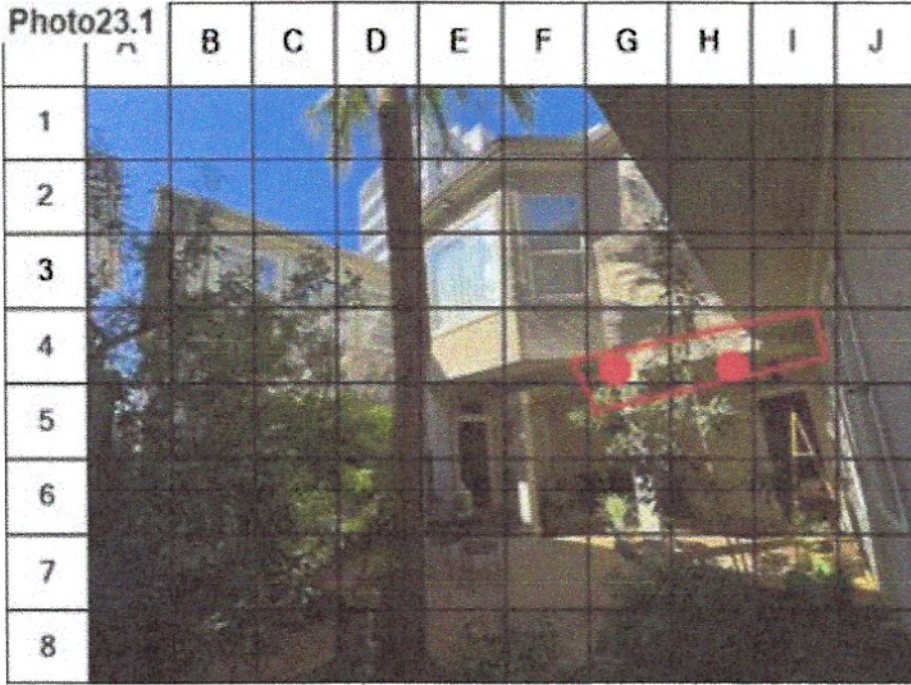
Grid Location	Item Description	Moisture Readings	Substrate Condition	Observations
Red Box	Damage			Confirmed substrate and potential frame damage is noted at the bottom of the wall. The inspector recommends having a qualified waterproofing contractor further assess the extent of damage, repair as needed and install a proper relief in an effort to prevent moisture intrusion. Please refer to photos #23.2, #23.3, #23.4, #23.5 and #23.6 for more detail.
G4	Bottom Wall		None	A moisture probe was taken at bottom wall. No substrate was noted at this time, modify as needed.
H4	Bottom Wall		None	A moisture probe was taken at bottom wall. No substrate was noted at this time, modify as needed.

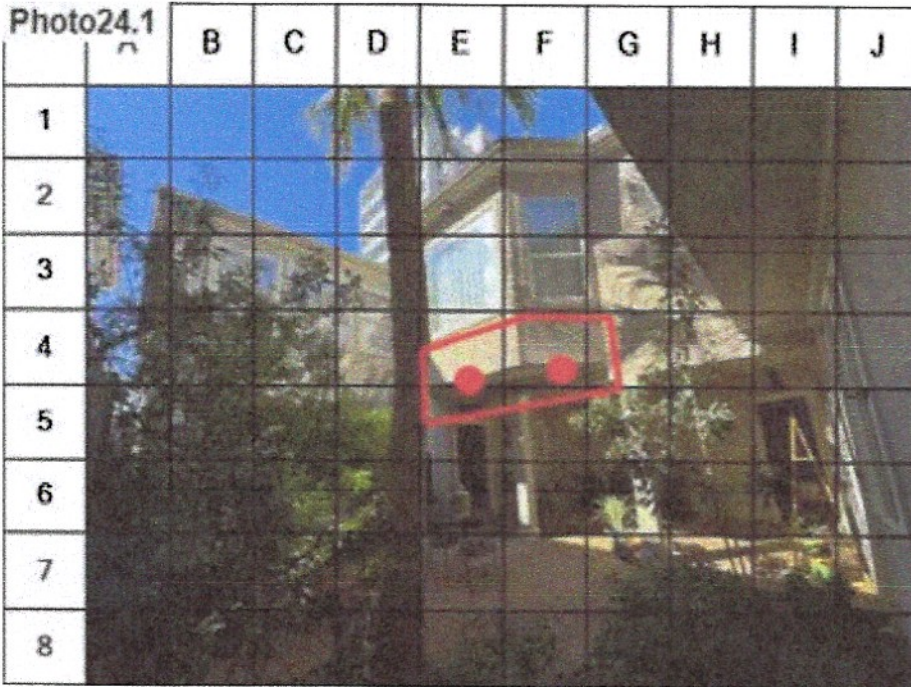
Grid Location	Item Description	Moisture Readings	Substrate Condition	Observations
Red Box	Damage			Confirmed substrate and potential frame damage is noted at the bottom of the wall. The inspector recommends having a qualified waterproofing contractor further assess the extent of damage, repair as needed and install a proper relief in an effort to prevent moisture intrusion. Please refer to photos #24.2, #24.3, #24.4, #24.5 and #24.6 for more detail.
F4	Bottom Wall		None	A moisture probe was taken at bottom wall. No substrate was noted at this time, modify as needed.
E4	Bottom Wall		None	A moisture probe was taken at bottom wall. No substrate was noted at this time, modify as needed.

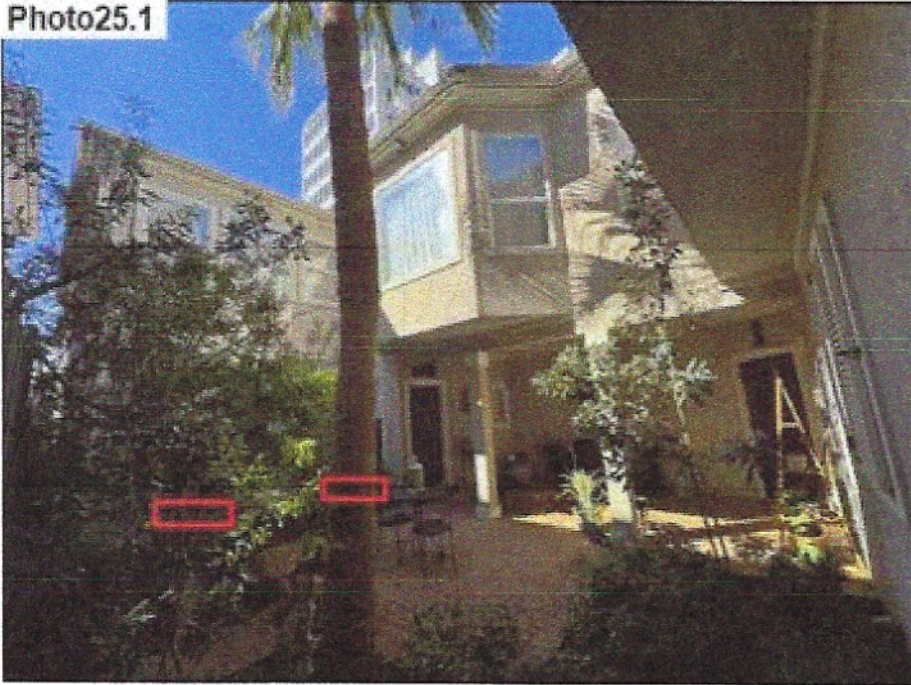
Photo25.1

Grid Location	Item Description	Moisture Readings	Substrate Condition	Observations
Red Box	Wood Rot			The bottom of the wall in this area has wood rot. The inspector suggests to have a qualified contractor further assess and repair this area as needed in an effort to prevent moisture intrusion. All wood rot was not necessarily identified in this report. Please refer to photos #25.2, #25.3 and #25.4 for more detail.

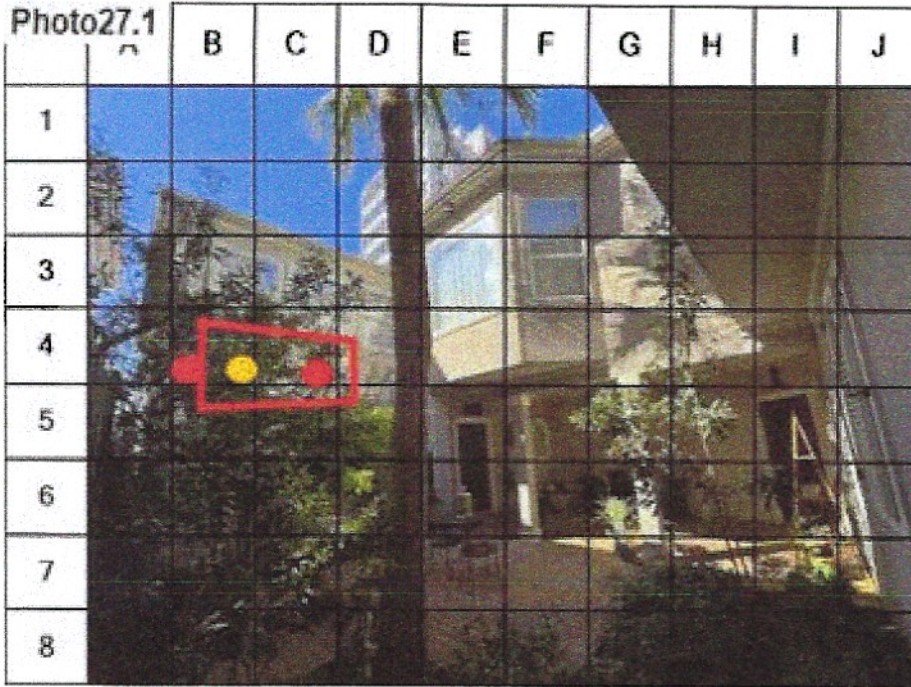
Grid Location	Item Description	Moisture Readings	Substrate Condition	Observations
Red Box	Damage			Confirmed substrate and potential window header damage noted at this location. The inspector suggests to have a qualified waterproofing contractor further assess the extent of damage, modify this area and install a relief in an effort to prevent moisture intrusion. Please refer to photos #27.2, #27.3, #27.4 and #27.5 for more detail.
B4 (Red)	Window Header		None	A moisture probe was taken at the window header. No substrate was noted at this time, modify as needed.
B4 (Orange)	Window Header		None	A moisture probe was taken at the window header. No substrate was noted at this time, modify as needed.
C4	Window Header	20%	Firm	A moisture probe was taken at window header. An elevated moisture reading was noted with a firm substrate.

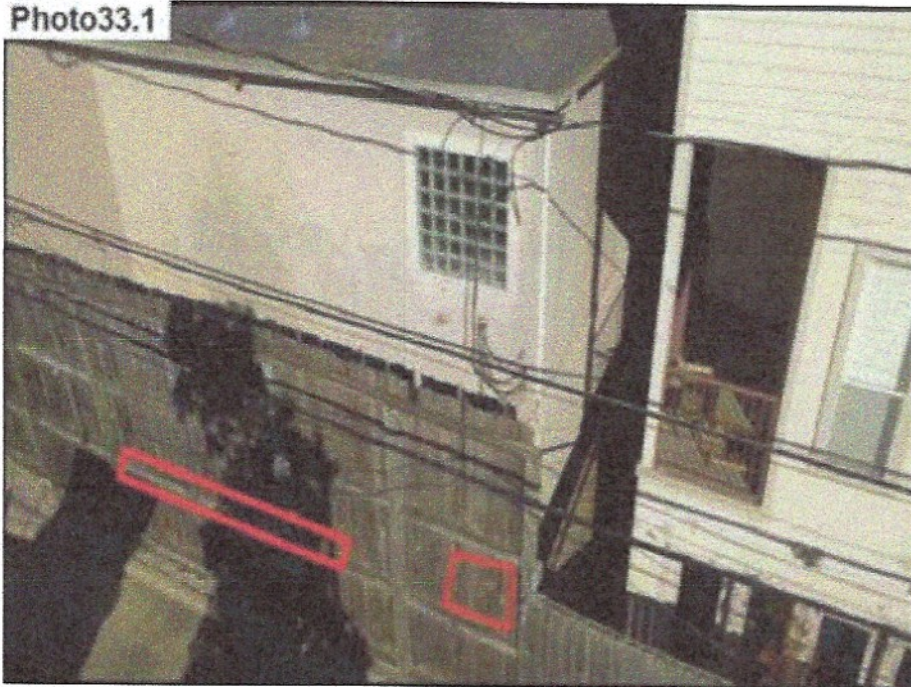
Photo33.1

Grid Location	Item Description	Moisture Readings	Substrate Condition	Observations
Red Box	Damage			Confirmed substrate and potential frame damage is noted at the bottom of the wall. The inspector recommends having a qualified waterproofing contractor further assess the extent of damage, repair as needed and install a proper relief in an effort to prevent moisture intrusion. Please refer to photos #33.2, #33.3, #33.4, #33.5 and #33.6 for more detail.
