ESTIMATE

FOR: Blake Hillegeist
2314 Huldy St Houston, TX 77019

Lone Star Stucco, LLC

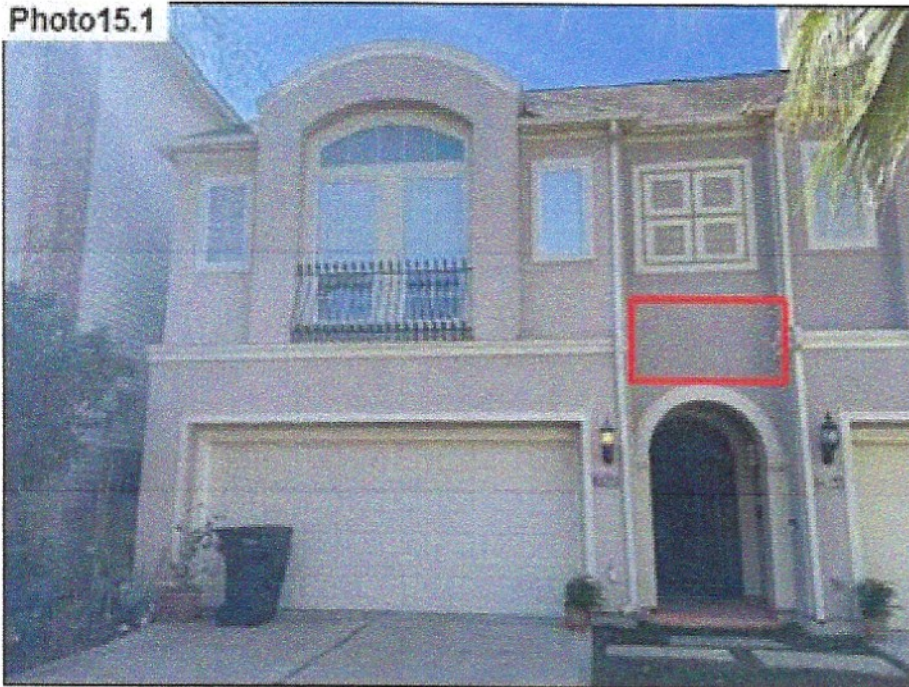
Photo15.1

Grid Location	Item Description	Moisture Readings	Substrate Condition	Observations
Red Box	Cracks			Cracks are noted at this location. The inspector suggests to have a qualified waterproofing contractor paint for aesthetic concerns only. All cracking was not necessarily identified in this report. Please refer to photos #15.2, #15.3, #15.4 and #15.5 for more detail.

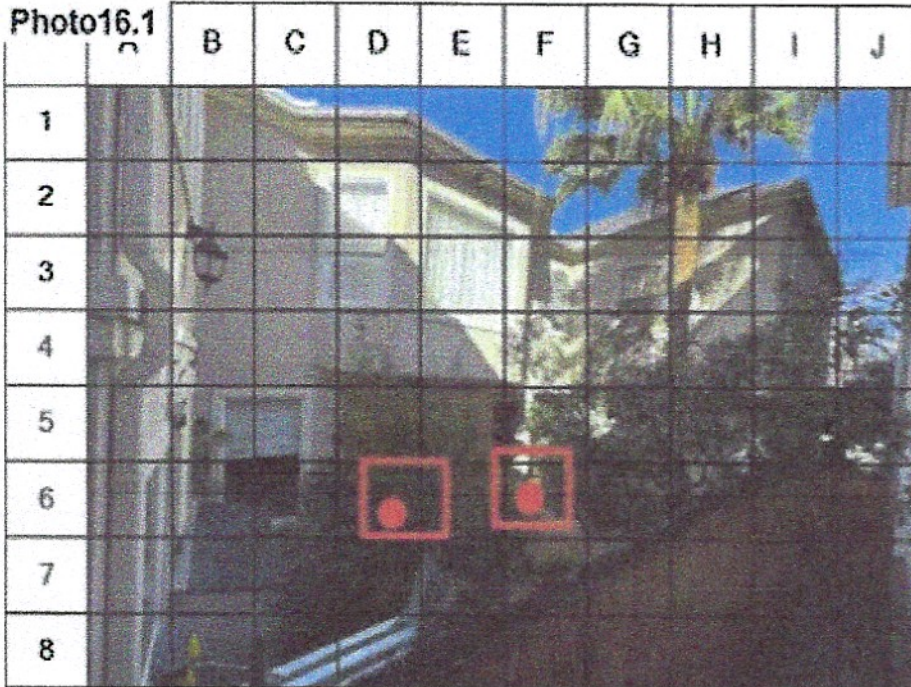
Grid Location	Item Description	Moisture Readings	Substrate Condition	Observations
Red Boxes	Damage			Confirmed substrate and potential frame damage is noted in the column. The inspector recommends having a qualified waterproofing contractor further assess the extent of damage, repair and modify as needed in an effort to prevent moisture intrusion. Please refer to photos #16.2, #16.3, #16.4, #16.5 and #16.6 for more detail.
D6	Columns		None	A moisture probe was taken at column. No substrate was noted at this time, modify as needed.
F6	Columns		None	A moisture probe was taken at column. No substrate was noted at this time, modify as needed.

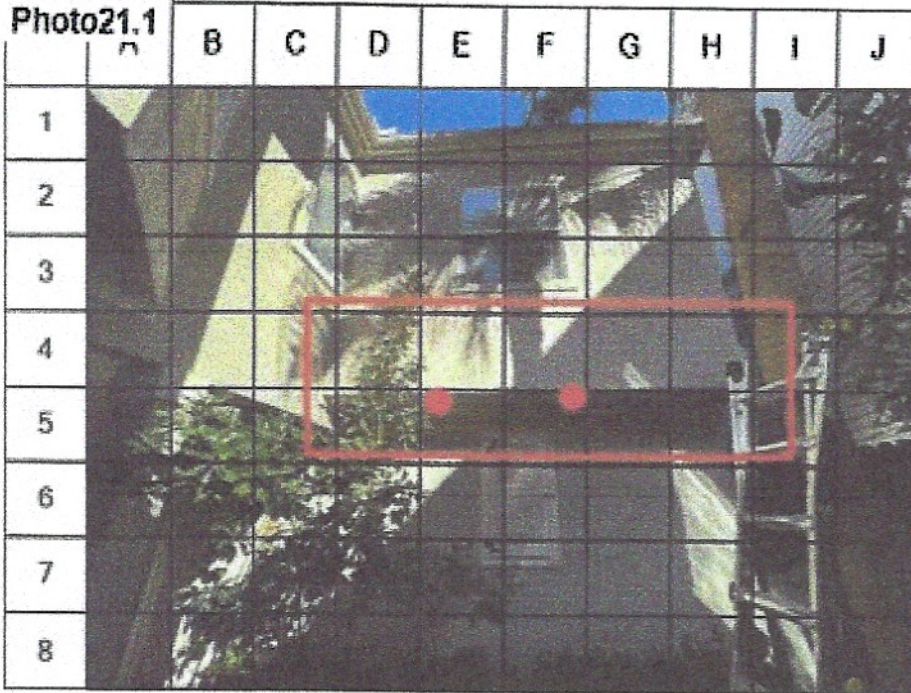
Grid Location	Item Description	Moisture Readings	Substrate Condition	Observations
Red Box	Damage			Confirmed substrate and potential beam damage is noted at the bottom of the wall. The inspector recommends having a qualified waterproofing contractor further assess the extent of damage, repair as needed and install a proper relief in an effort to prevent moisture intrusion. Please refer to photos #21.2, #21.3, #21.4 and #21.5 for more detail.
E5	Bottom Wall		None	A moisture probe was taken at bottom wall. No substrate was noted at this time, modify as needed.
F5	Bottom Wall		None	A moisture probe was taken at bottom wall. No substrate was noted at this time, modify as needed.

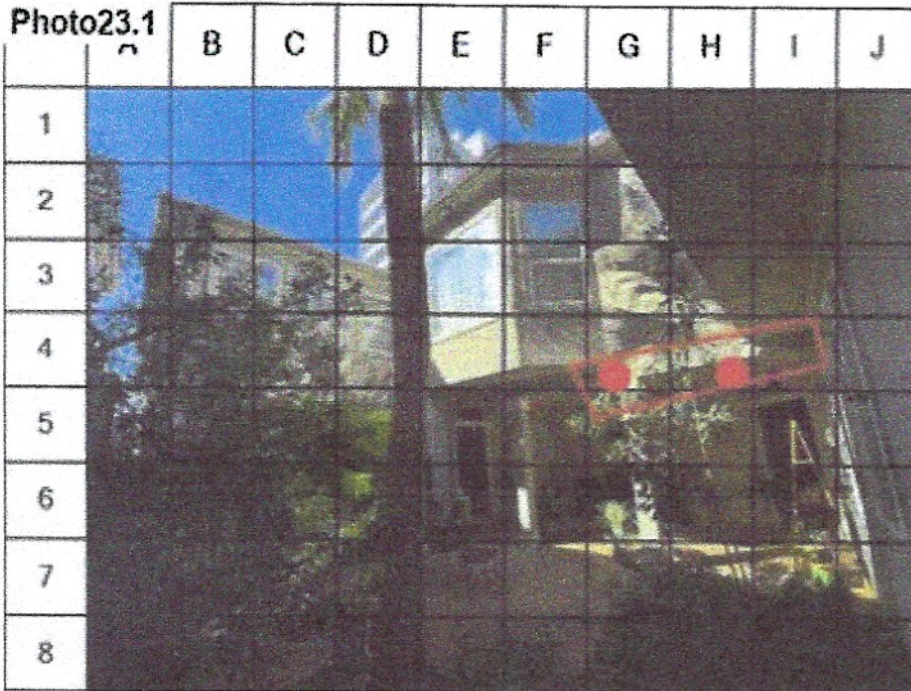
Grid Location	Item Description	Moisture Readings	Substrate Condition	Observations
Red Box	Damage			Confirmed substrate and potential frame damage is noted at the bottom of the wall. The inspector recommends having a qualified waterproofing contractor further assess the extent of damage, repair as needed and install a proper relief in an effort to prevent moisture intrusion. Please refer to photos #23.2, #23.3, #23.4, #23.5 and #23.6 for more detail.
G4	Bottom Wall		None	A moisture probe was taken at bottom wall. No substrate was noted at this time, modify as needed.
H4	Bottom Wall		None	A moisture probe was taken at bottom wall. No substrate was noted at this time, modify as needed.

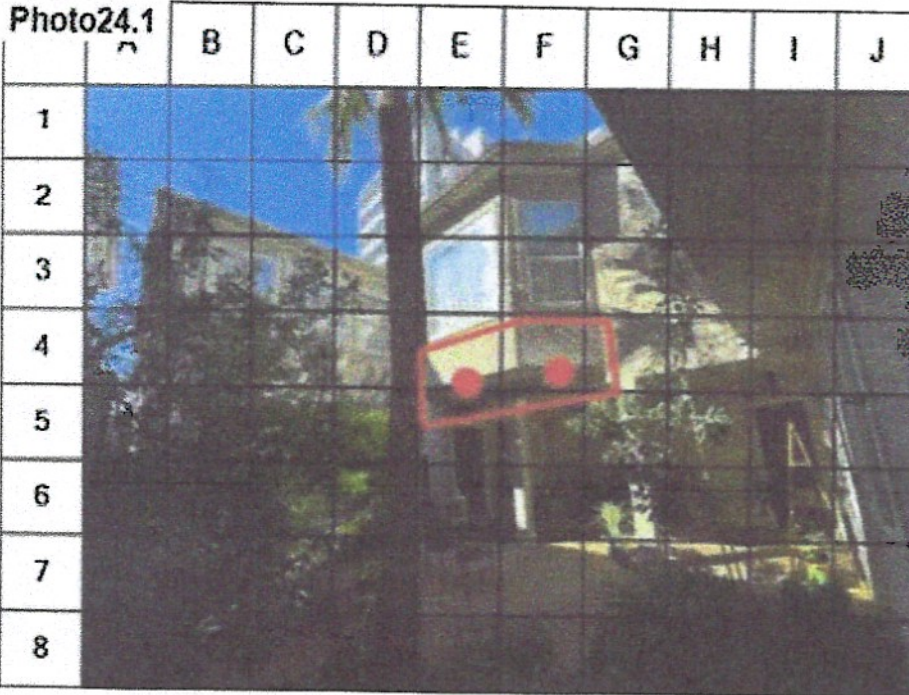
Grid Location	Item Description	Moisture Readings	Substrate Condition	Observations
Red Box	Damage			Confirmed substrate and potential frame damage is noted at the bottom of the wall. The inspector recommends having a qualified waterproofing contractor further assess the extent of damage, repair as needed and install a proper relief in an effort to prevent moisture intrusion. Please refer to photos #24.2, #24.3, #24.4, #24.5 and #24.6 for more detail.
F4	Bottom Wall		None	A moisture probe was taken at bottom wall. No substrate was noted at this time, modify as needed.
E4	Bottom Wall		None	A moisture probe was taken at bottom wall. No substrate was noted at this time, modify as needed.

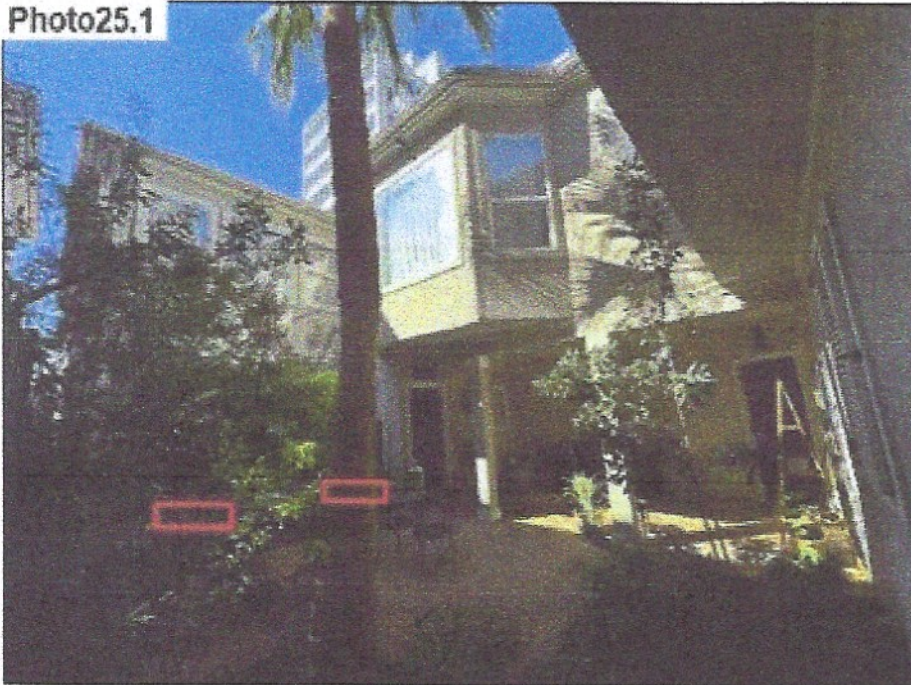
Photo25.1

Grid Location	Item Description	Moisture Readings	Substrate Condition	Observations
Red Box	Wood Rot			The bottom of the wall in this area has wood rot. The inspector suggests to have a qualified contractor further assess and repair this area as needed in an effort to prevent moisture intrusion. All wood rot was not necessarily identified in this report. Please refer to photos #25.2, #25.3 and #25.4 for more detail.

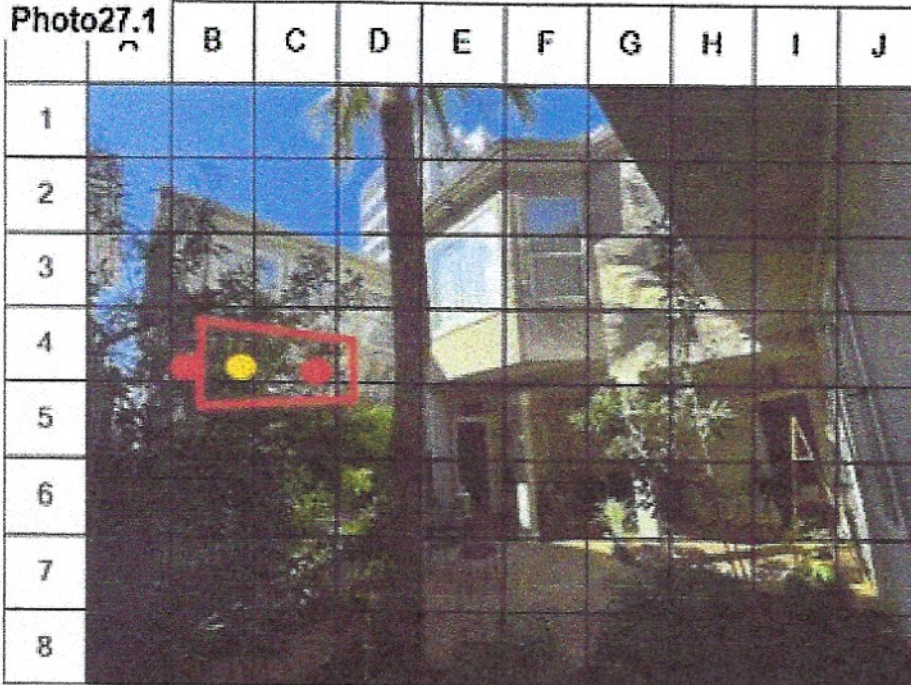
Substrate Damage / Assess & Repair

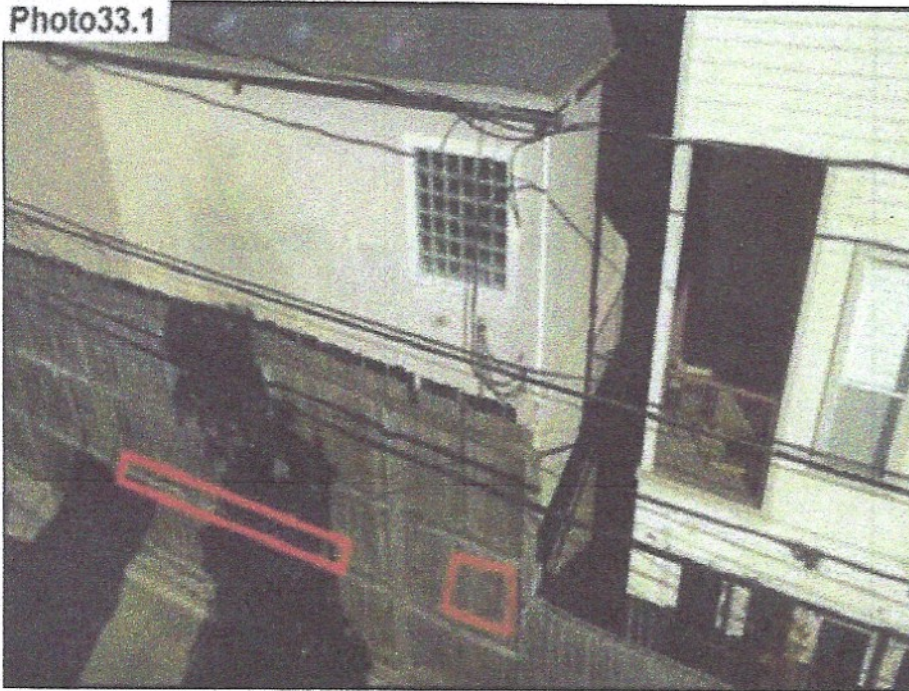
Photo33.1

Grid Location	Item Description	Moisture Readings	Substrate Condition	Observations
Red Box	Damage			Confirmed substrate and potential frame damage is noted at the bottom of the wall. The Inspector recommends having a qualified waterproofing contractor further assess the extent of damage, repair as needed and install a proper relief in an effort to prevent moisture intrusion. Please refer to photos #33.2, #33.3, #33.4, #33.5 and #33.6 for more detail.
