Lone Star Stucco, LLC

Moisture Assessment Report

2314 Hudly St B

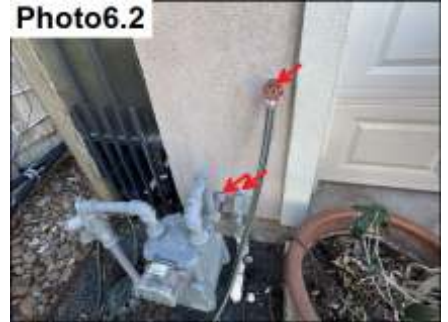
Photo6.2

Penetration Sealants / Seal

Grid Location	Item Description	Moisture Readings	Substrate Condition	Observations
Red Arrows	Penetrations			The penetration sealants are aged in this location. The inspector suggests to have a qualified waterproofing contractor seal this area with a low modulus sealant in an effort to prevent moisture intrusion. These types of sealants are of high quality and compatible with stucco and other termination points. Please refer to photos #6.2, #6.3, #6.4, #6.5 and #6.6 for more detail.

- The penetration sealants are aged in this location. The inspector suggests to have a qualified waterproofing contractor seal this area with a low modulus sealant in an effort to prevent moisture intrusion. These types of sealants are of high quality and compatible with stucco and other termination points. Please refer to photos #6.2, #6.3, #6.4, #6.5 and #6.6 for more detail.

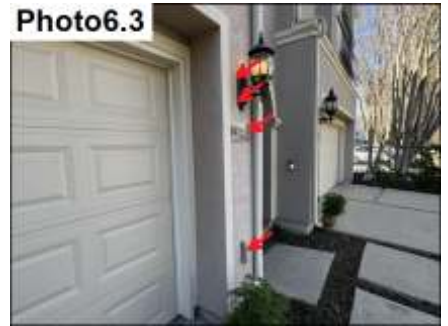
Photo6.3

Penetration Sealants / Seal

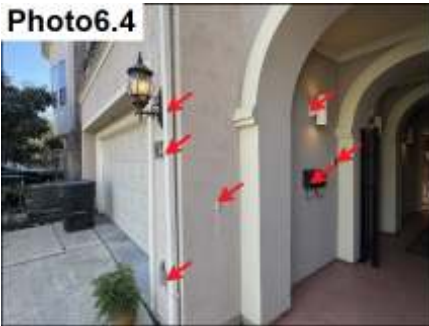
Photo6.4

Penetration Sealants / Seal

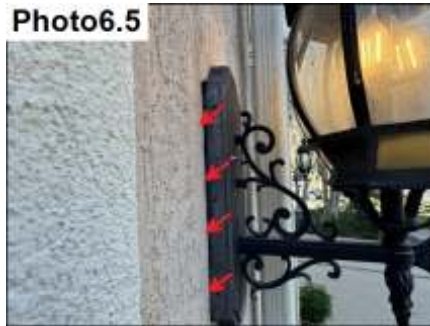
Photo6.5

Penetration Sealants / Seal

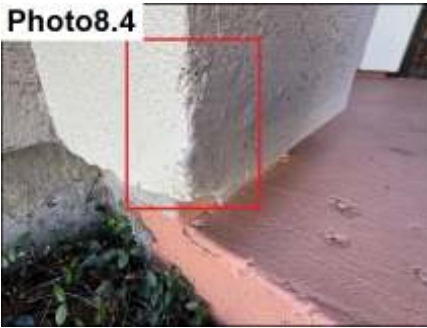
Photo8.4

- Impact damage noted on foam accent with exposed mesh at these locations. The inspector suggests to have a qualified waterproofing contractor further assess the extent of damage and repair as needed in an effort to prevent moisture intrusion. All impact damage was not necessarily identified in this report. Please refer to photos #8.2, #8.3, #8.4 and #8.5 for more detail.

Impact Damage / Repair

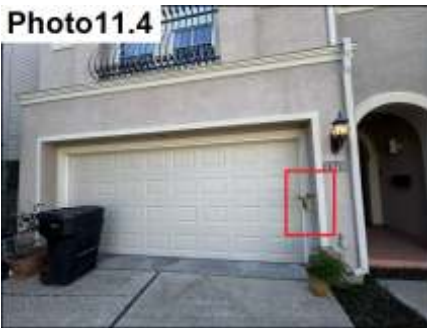
Photo11.4

- Confirmed substrate and potential frame damage is noted at the bottom of the wall. The inspector recommends having a qualified waterproofing contractor further assess the extent of damage, repair as needed and install a proper relief in an effort to prevent moisture intrusion. Please refer to photos #11.2, #11.3, #11.4, #11.5 and #11.6 for more detail.

Substrate Damage / Assess, Repair and Install Proper Relief

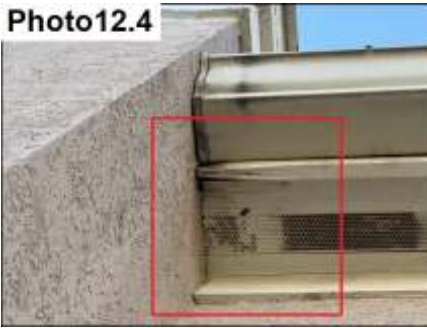
Photo12.4

Wood Rot on Fascia / Repair

Grid Location	Item Description	Moisture Readings	Substrate Condition	Observations
Red Box	Wood Rot			The fascia at this area has wood rot. The inspector suggests to have a qualified contractor further assess and repair this area as needed in an effort to prevent moisture intrusion. All wood rot was not necessarily identified in this report. Please refer to photos #12.2, #12.3 and #12.4 for more detail.

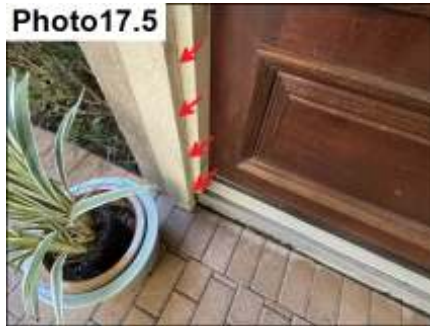
Photo17.6

Grid Location	Item Description	Moisture Readings	Substrate Condition	Observations
Red Arrows	Doors			The door trim and miter sealants are separated or aged at this location. The inspector suggests to have a qualified waterproofing contractor seal this area with a low modulus sealant in an effort to prevent moisture intrusion. These types of sealants are of high quality and compatible with stucco and other termination points. Please refer to photos #17.2, #17.3, #17.4, #17.5 and #17.6 for more detail.

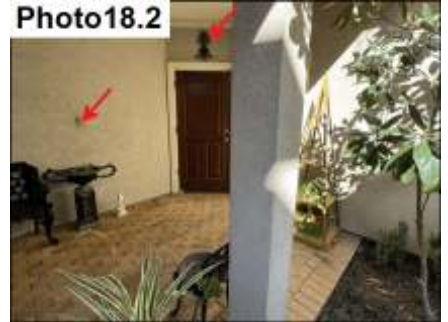
Photo18.3

Penetration Sealants / Seal

Grid Location	Item Description	Moisture Readings	Substrate Condition	Observations
Red Arrows	Penetrations			The penetration sealants are aged in this location. The inspector suggests to have a qualified waterproofing contractor seal this area with a low modulus sealant in an effort to prevent moisture intrusion. These types of sealants are of high quality and compatible with stucco and other termination points. Please refer to photos #18.2, #18.3, #18.4, #18.5 and #18.6 for more detail.

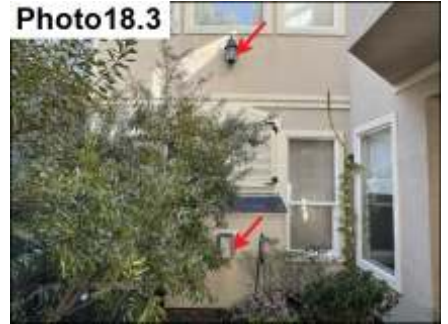
Photo18.4

Penetration Sealants / Seal

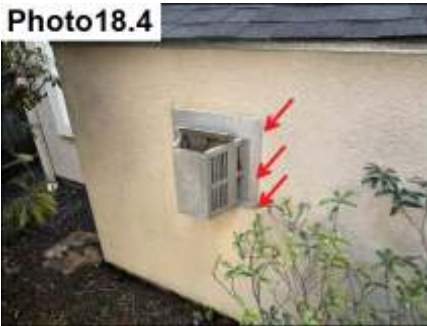
Photo18.5

Penetration Sealants / Seal

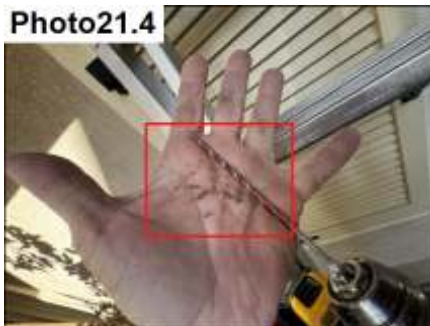
Photo21.4
Substrate Damage / Assess, Repair and Install Proper Relief

Grid Location	Item Description	Moisture Readings	Substrate Condition	Observations
Red Box	Damage			Confirmed substrate and potential beam damage is noted at the bottom of the wall. The inspector recommends having a qualified waterproofing contractor further assess the extent of damage, repair as needed and install a proper relief in an effort to prevent moisture intrusion. Please refer to photos #21.2, #21.3, #21.4 and #21.5 for more detail.
E5	Bottom Wall		None	A moisture probe was taken at bottom wall. No substrate was noted at this time, modify as needed.
F5	Bottom Wall		None	A moisture probe was taken at bottom wall. No substrate was noted at this time, modify as needed.

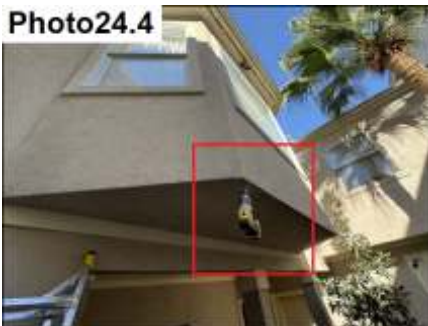
Photo24.4
Substrate Damage / Assess, Repair and Install Proper Relief

Grid Location	Item Description	Moisture Readings	Substrate Condition	Observations
Red Box	Damage			Confirmed substrate and potential frame damage is noted at the bottom of the wall. The inspector recommends having a qualified waterproofing contractor further assess the extent of damage, repair as needed and install a proper relief in an effort to prevent moisture intrusion. Please refer to photos #24.2, #24.3, #24.4, #24.5 and #24.6 for more detail.
F4	Bottom Wall		None	A moisture probe was taken at bottom wall. No substrate was noted at this time, modify as needed.
E4	Bottom Wall		None	A moisture probe was taken at bottom wall. No substrate was noted at this time, modify as needed.

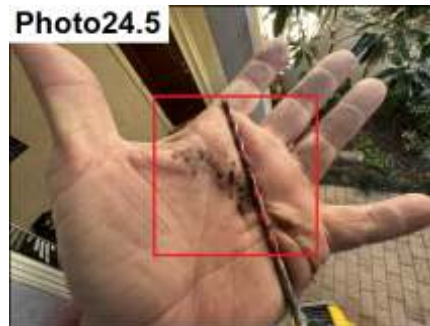
Photo24.5
Substrate Damage / Assess, Repair and Install Proper Relief

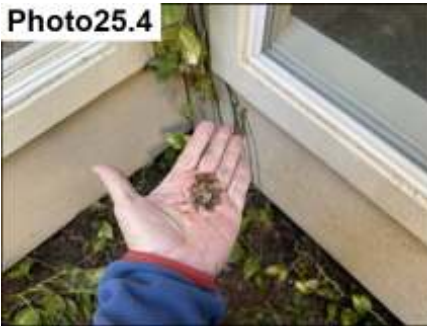
Photo25.4

Wood Rot at Bottom Wall/ Repair

Grid Location	Item Description	Moisture Readings	Substrate Condition	Observations
Red Box	Wood Rot			The bottom of the wall in this area has wood rot. The inspector suggests to have a qualified contractor further assess and repair this area as needed in an effort to prevent moisture intrusion. All wood rot was not necessarily identified in this report. Please refer to photos #25.2, #25.3 and #25.4 for more detail.

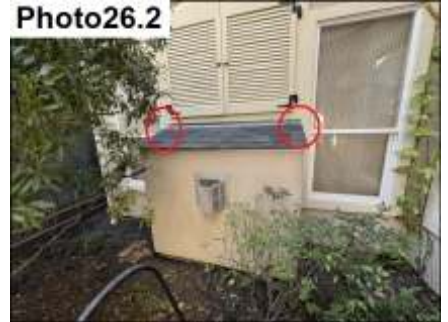
Photo26.3

Roof Diverter Flashing Sealants / Seal

Grid Location	Item Description	Moisture Readings	Substrate Condition	Observations
Red Circle	Flashing			The roof diverter flashing sealants are aged at this location. The inspector suggests to have a qualified waterproofing contractor further assess and seal this area with a low modulus sealant in an effort to prevent moisture intrusion. These types of sealants are of high quality and compatible with stucco and other termination points. Please refer to photos #26.2, #26.3, #26.4, #26.5 and #26.6 for more detail.

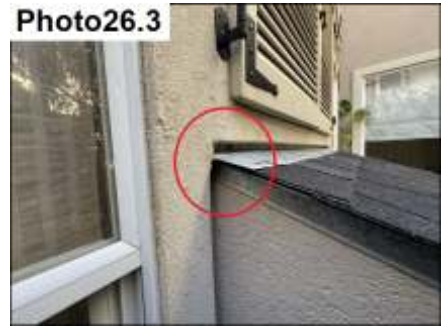
Photo26.4

Roof Diverter Flashing Sealants / Seal

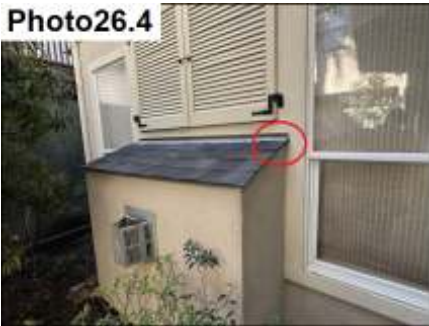
Photo26.5

Roof Diverter Flashing Sealants / Seal

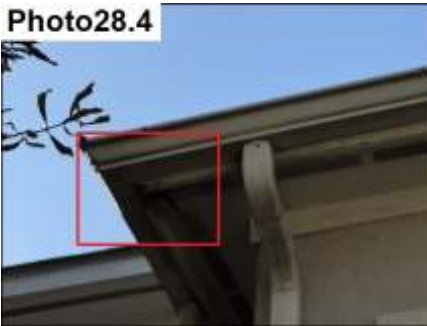
Photo28.4

Wood Rot on Fascia / Repair

Grid Location	Item Description	Moisture Readings	Substrate Condition	Observations
Red Box	Wood Rot			The fascia at this area has wood rot. The inspector suggests to have a qualified contractor further assess and repair this area as needed in an effort to prevent moisture intrusion. All wood rot was not necessarily identified in this report. Please refer to photos #28.2, #28.3, #28.4, #28.5 and #28.6 for more detail.

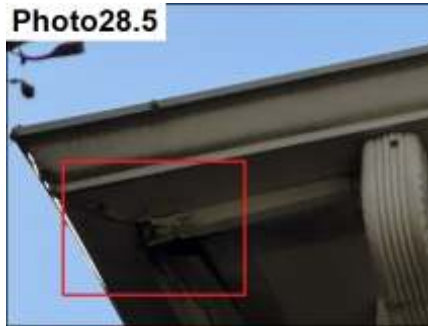
Photo28.5

Wood Rot on Fascia / Repair

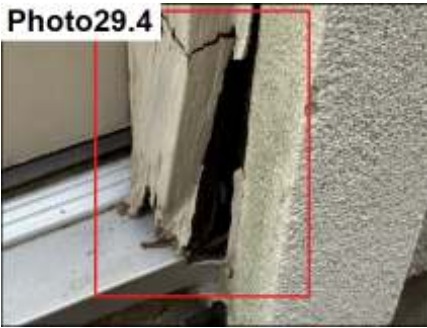
Photo29.4

Wood Rot on Door Trim / Repair

Grid Location	Item Description	Moisture Readings	Substrate Condition	Observations
Red Box	Wood Rot			The door trim at this area has wood rot. The inspector suggests to have a qualified contractor further assess and repair this area as needed in an effort to prevent moisture intrusion. All wood rot was not necessarily identified in this report. Please refer to photos #29.2, #29.3, #29.4 and #29.5 for more detail.

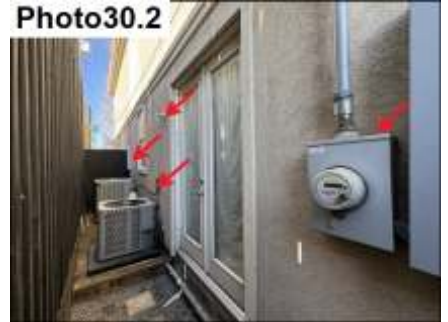
Photo30.3

Penetration Sealants / Seal

Grid Location	Item Description	Moisture Readings	Substrate Condition	Observations
Red Arrows	Penetrations			The penetration sealants are aged in this location. The inspector suggests to have a qualified waterproofing contractor seal this area with a low modulus sealant in an effort to prevent moisture intrusion. These types of sealants are of high quality and compatible with stucco and other termination points. Please refer to photos #30.2, #30.3, #30.4, #30.5 and #30.6 for more detail.

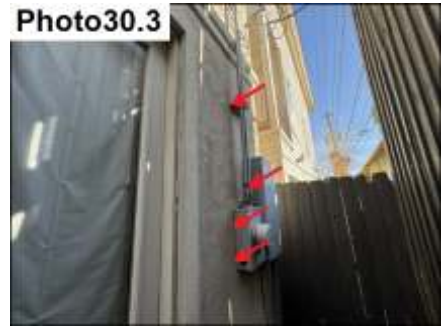
Photo30.4

Penetration Sealants / Seal

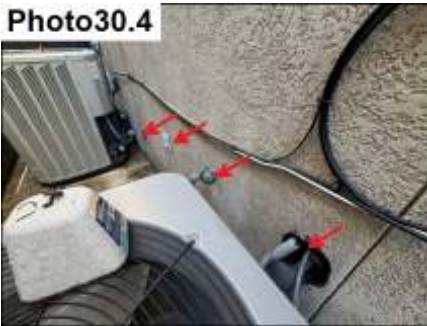
Photo30.5

Penetration Sealants / Seal
