HEDDERMAN SERVICES

MECHANICAL INSPECTION

1119 Del Norte St
Houston, TX 77018

PROPERTY INSPECTION REPORT FORM

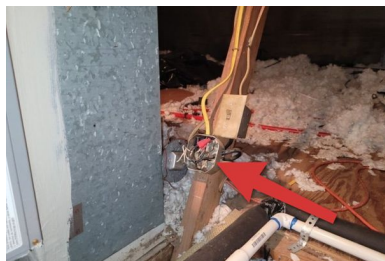
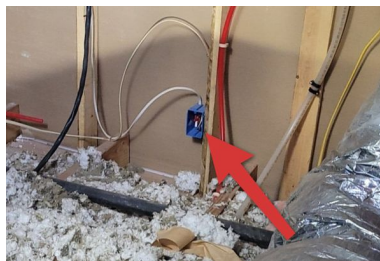
8: Unprotected wire splice

In Attic Above Kitchen Area

Wiring that was spliced and not enclosed in a junction box was observed.

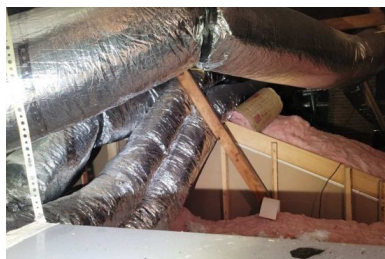
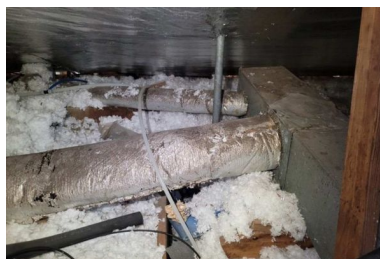
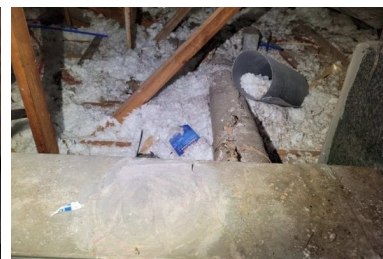
The air ducts in the attic consisted of some newer flex ducts and some older rigid ducts. Due to the age of the rigid air ducts, further investigation is recommended with the homeowner and/or a service company to determine if the ductwork has been cleaned recently. If the air ducts have not been cleaned, it is recommended that the interior of the ducts be checked by a service company.

We observed that some of the air ducts in the attic were in contact with each other, which can cause condensation to form on the outside of the ductwork. It is recommended that the ducts that are touching be separated. Typically, this is done by inserting a piece of fiberglass batt insulation or duct board between the ducts.

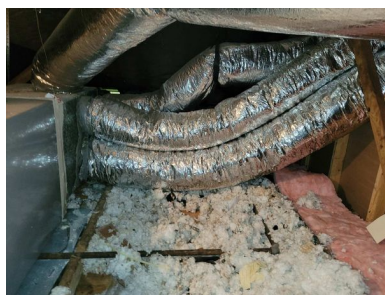
2: Return Air - Not sealed

The chase was not sealed properly and was drawing unconditioned air from the floor and/or wall cavities into the system. Have the chase sealed against air leaks.

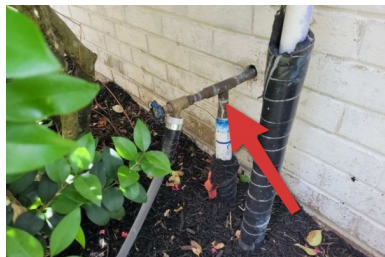
2: Vacuum Breaker - Missing

The atmospheric vacuum breaker devices were missing at one or more of the hose bibbs, and it is recommended that they be installed to prevent cross connections, which can allow contaminated water to enter the potable water supply.

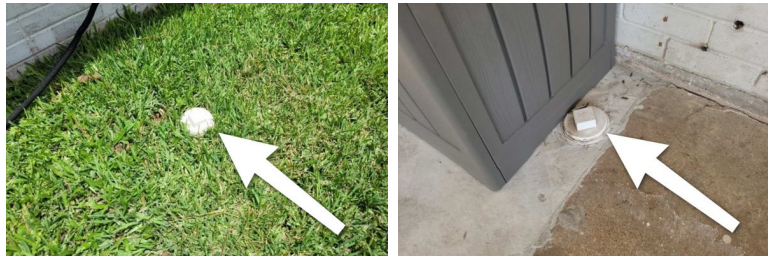
Sewer Piping - Evidence of repairs observed: PVC clean out present, PVC drain(s) extended through wall and rerouted, Concrete patched inline with sewer system -

Evidences of sewer line repairs and/or replacement were observed. It is noted that we could not determine the extent of the repairs to the sewer system or if any of the original cast iron piping is still active. Further investigation is recommended with the owner and/or a service company to determine the extent of the repairs and to determine if any further repairs are needed. A sewer inspection with a plumber to verify the extent of the repairs and the condition of the sewer piping and the repairs is recommended. The plumber should also determine if the washing machine drain riser is adequately sized to accommodate a modern washing machine.

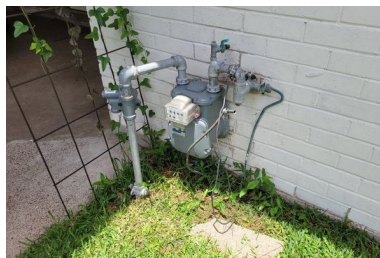
1: Sediment Trap - Missing

Sediment traps were not installed at the gas supply lines for one or more of the gas fired equipment. A sediment trap is intended to catch sediment/moisture/debris in a gas supply line before it can enter into the gas equipment.

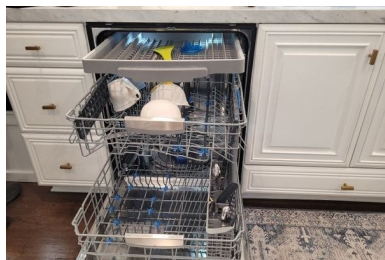
1: No Anti-Siphon

The drain line under the sink was not equipped with an anti-siphon device, nor was it looped up so that the top of the loop is at least six inches above the entrance of the drain line into the disposal. It is recommended at least that the drain line be looped to prevent the water from the garbage disposal from siphoning back into the dishwasher, or an anti-siphon device installed.

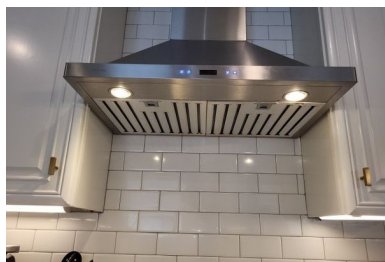
1: Vent Pipe - not secured to roof jack

The end of the vent pipe in the attic was not secured into the roof jack and was discharging air into the attic. The vent pipe needs to be repositioned into the roof jack to discharge to the outside.

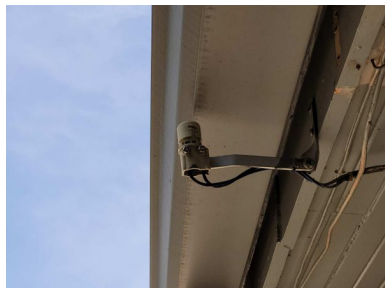
Zone 1

1: Adjust sprinkler head spray
