STRUCTURAL INSPECTION

1119 Del Norte St
Houston, TX 77018

MAY 25, 2022

REF: CONDITION OF PROPERTY SURVEY

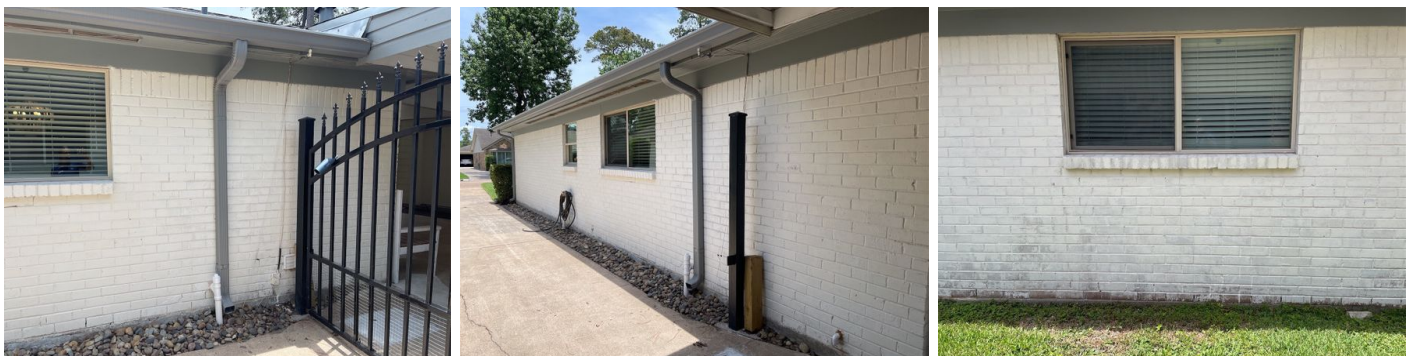
Veneer - Painted

It is pointed out that the veneer was painted, and some cracks and patches in the veneer may not be visible.

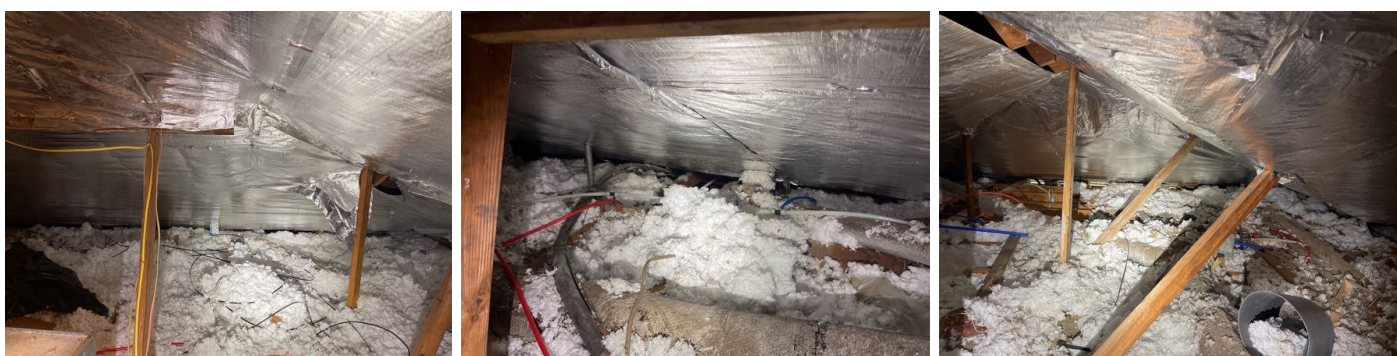
Ridge Beam: Undersized but functional

The ridge beam was undersized for the miter cut on the ends of the rafters. Although the rafters were not braced against the ridge beam for the full length of the miter cut, the consequences of this condition were minimal at this time, and, in our opinion, repairs are not required. Both the ridge beam and rafters are performing their intended function at the time of the inspection, and have been since the house was built. If you are concerned about the condition, it is recommended that consideration be given to a make up piece of lumber being installed along the bottom edge of the ridge beam so that the rafters are bearing against the ridge for the full length of the miter cut on the rafters.

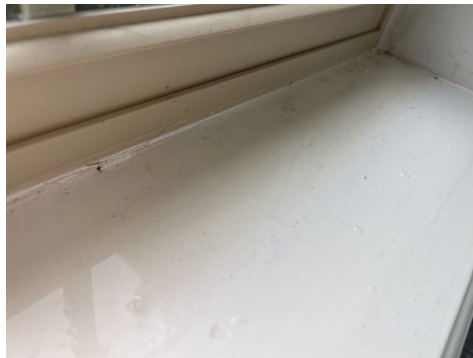
Pooling water.

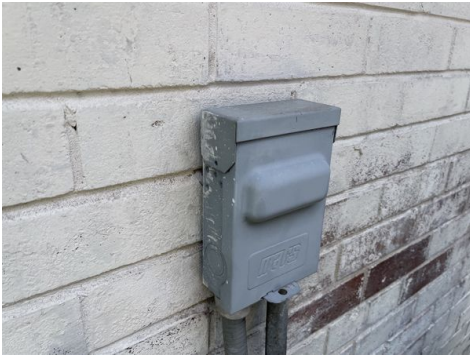
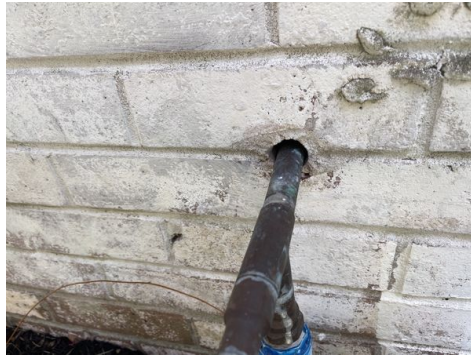
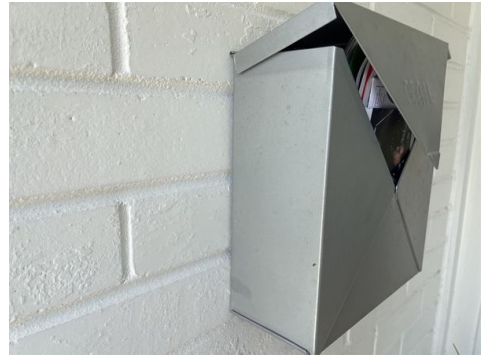
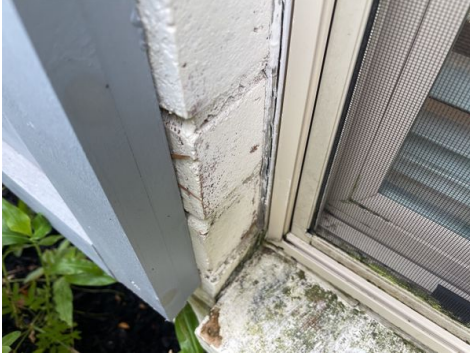
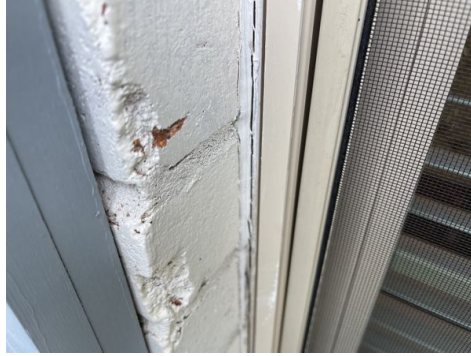
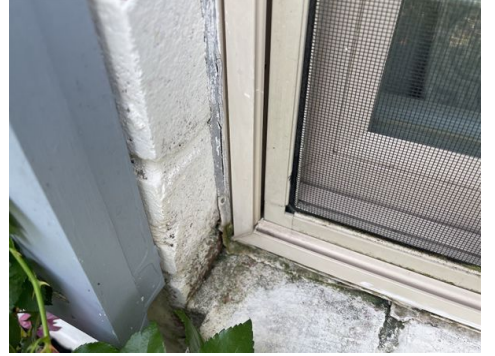
Sealants deteriorated/missing, Hose Bibb, Light Fixtures, Electrical Wiring, Electrical Box, Electric outlet, Window sealants

A substantial vulnerability to water penetration was observed at penetrations/openings through the exterior building envelope, and it is recommended that all penetrations/openings be sealed against water penetration. Typical examples on a structure may include light fixtures, air conditioning refrigerant lines, water piping, gas piping, vent caps, windows, doors, expansion joints, etc. Below is a representative sample of locations and/or photographs showing some, but not necessarily all, locations where there is a vulnerability to water penetration. Have a contractor provide a cost estimate to seal all vulnerable areas on the exterior building envelope against water penetration and/or open up any clogged weepholes in the veneer.

Obtain Cost Estimate

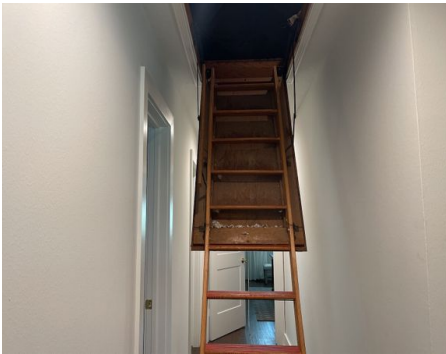
Ladder: Original ladder - Not rated

The access ladder into the attic appeared to be the original installation ladder, and the ladder was not labeled to indicate the rated capacity of the ladder. The ladder does not meet current code requirements for ladders into attics. Consideration should be given to replacing the ladder with a ladder that meets current code requirements.

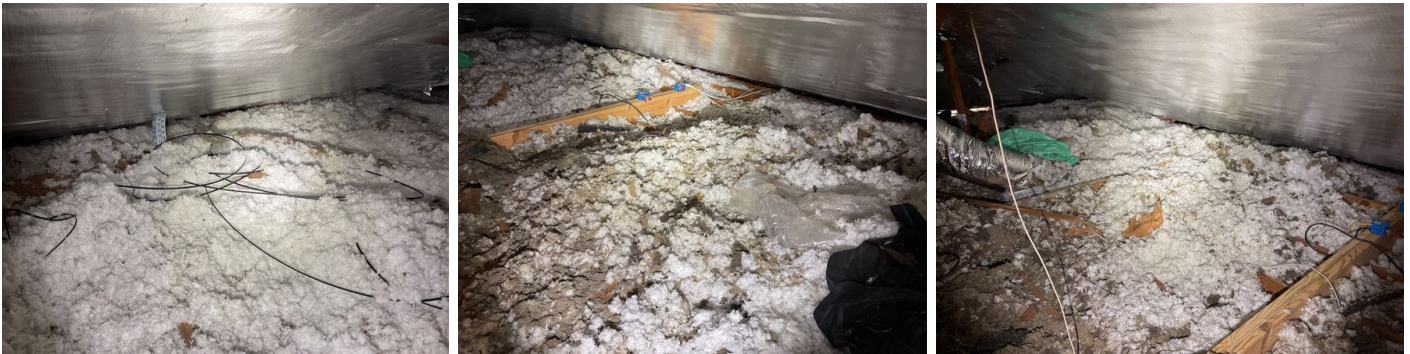
Insulation: 10"-12" Blown-in

The insulation in the attic was average for the age of the house. The blown-in insulation appeared to be approximately 10-12" thick, which would be approximately an R30 energy rating. It is pointed out that the insulation requirements according to the latest standard for new houses in this area is an R38 energy rating.

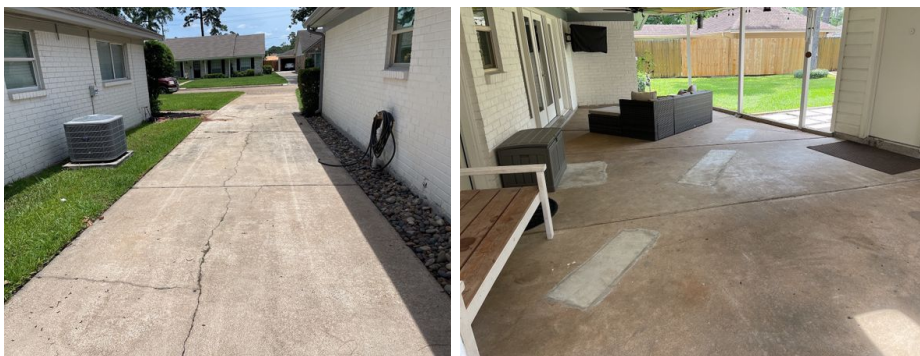
Driveway, Patio

The flatwork concrete listed above was in generally good condition at the time of the inspection with no significant repairs needed. Note that there may be some small cracks in the concrete, but in the opinion of the inspector, the concrete is still functional.

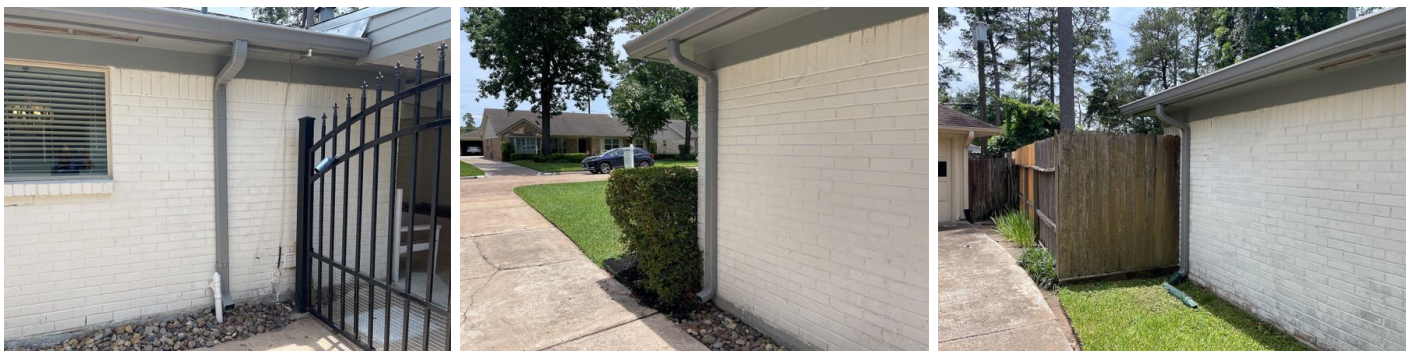
Gutters and Downspouts: Gutters and Downspouts - OK with some repairs needed

The gutters and downspouts were generally OK with some repairs needed as noted below.

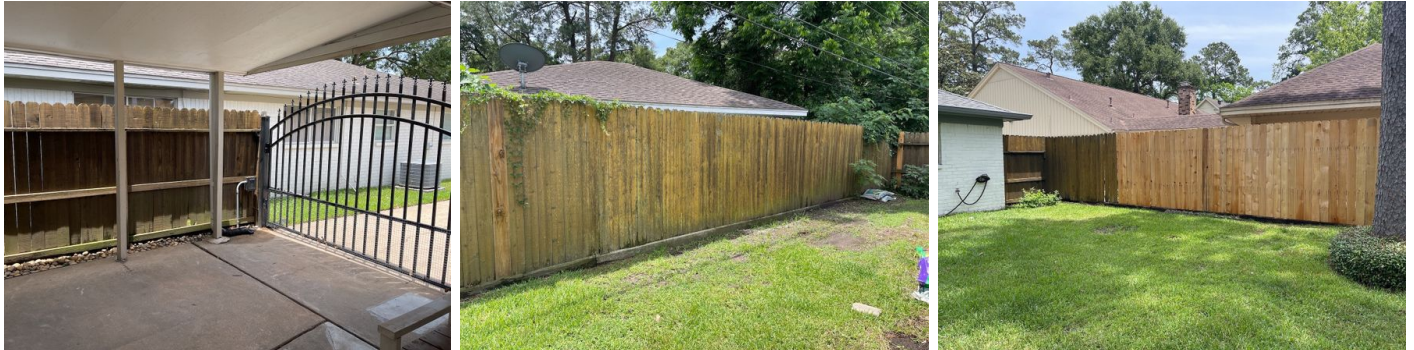
Gates and Fences: Gates and Fences - Some Repairs

The gates and fences were in generally good condition at the time of the inspection with some repairs observed to be needed as shown below under Recommendations/Repairs.
