## **Moisture Assessment Report**

2006 N. Memorial Way  
Houston, TX 77007  
02/02/2026

## Project Information

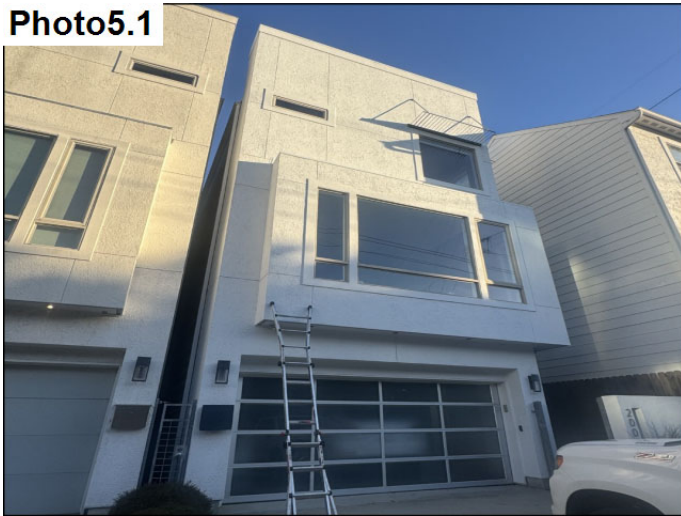
Elevation #1

Grid Location	Item Description	Moisture Readings	Substrate Condition	Observations-Photo #6.1	Chapter Reference
				Always maintain sealants at all windows, doors, flashing terminations and penetrations.	Ch 3.1,3.2
D4	Below Metal Cap Termination	11%	Firm	Moisture reading was made below metal cap termination.	
D5	Outside Corner	18%	Firm	Moisture reading was made at outside corner.	
C6	Outside Corner	15%	Firm		
E5	Window Lower Left	18%	Firm	Moisture reading was made at window lower left.	
F5	Below Windows	21%	Firm	Slightly elevated moisture reading was made below windows.	
H5	Below Windows	25%	Firm	Elevated moisture reading was made below windows.

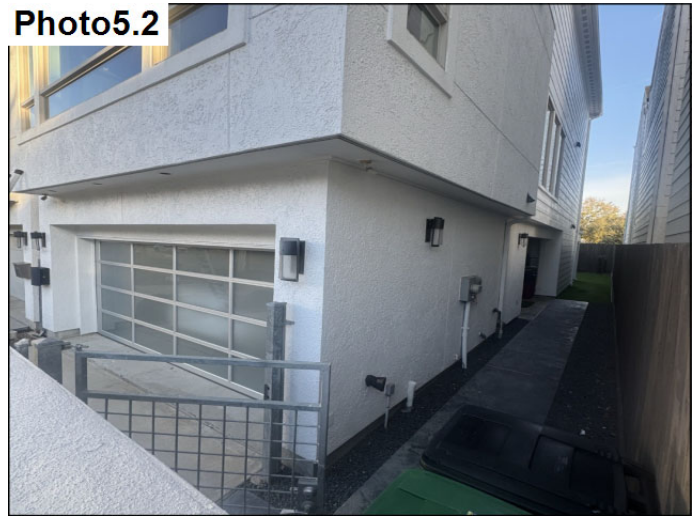
Elevation #2

Grid Location	Item Description	Moisture Readings	Substrate Condition	Observations-Photo #7.1	Chapter Reference
				Always maintain sealants at all windows, doors, flashing terminations and penetrations.	Ch 3.1.3.2
G5	Below Penetrations	14%	Firm	Moisture reading was made below penetrations.

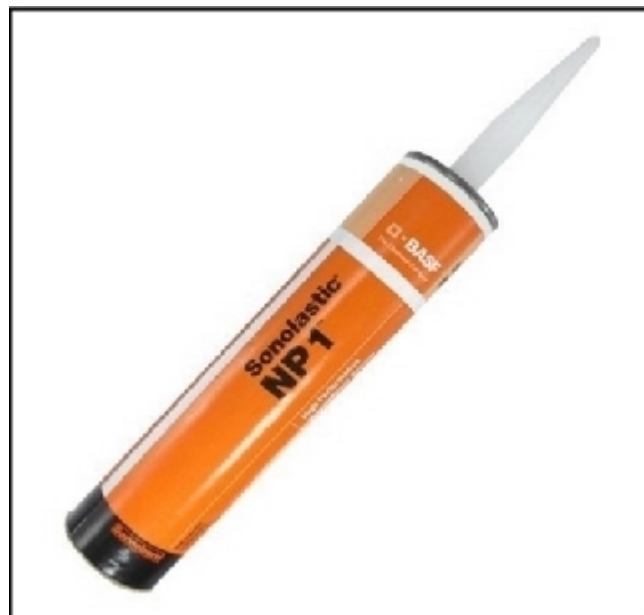
**Photo10.1**

Sealant separation noted at windows in stucco and siding. Reseal all windows.
