Home Inspection - TREC

Inspection Completed for: Graebel Companies - CO
(770) 325-4790
16346 Airport Circle
Aurora, CO 80011
APROA649919

Transferee / Property Information: Mingzhe Yu
3923 Birch Vale Ln
Sugar Land, TX 77479

PROPERTY INSPECTION REPORT FORM

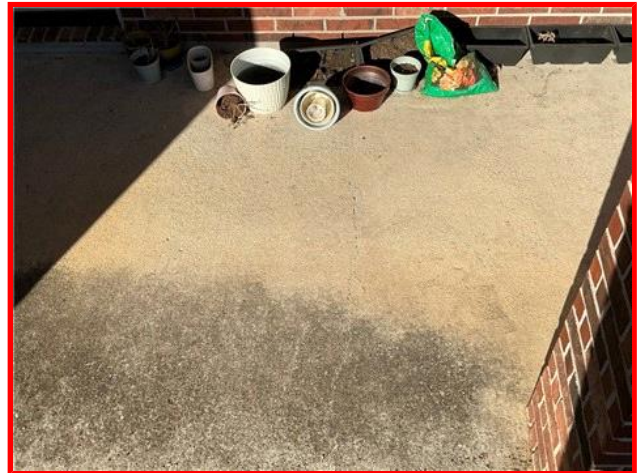
| Section | Remarks |
|---|---|
| Structural Systems | <p>Foundations Problem: The foundation has cracked corners on the right back, back right patio, and the front left. A crack was observed in the back patio concrete. The foundation has spalling on the left side. A framing member in the walk-in attic is broken. Corrective Action: Further evaluation is recommended. Contact a structural engineer to evaluate the foundation / structure. Pay special attention to the items listed above, in the walls section, and in the exterior surfaces section.</p> <p>Grading and Drainage Problem: The gutter downspout on the front by the garage discharges incorrectly. Corrective Action: Contractor to reroute the downspout away from the home.</p> <p>Roof Covering Materials #1 Problem: The rear right and chimney boots are lifted. Flashing at the left is damaged. Drip edge flashing is damaged at the left. Kickout flashing is missing at the front. Granular loss was observed throughout the roof. The roof was not walked due to height and design. Corrective Action: Further evaluation is recommended. Contact a roofer to evaluate the condition of the roof system. Pay special attention to the items listed above.</p> <p>Roof Structure and Attic Problem: The main attic ladder has loose hardware. The chimney in the attic is not properly sealed. Corrective Action: Contractor to secure the hardware and seal the chimney.</p> <p>Walls (Interior and Exterior) Problem: Cracks were observed in the corner of the walls in the Jack and Jill bathroom, upstairs bathroom, downstairs bedroom, and downstairs bathroom. The baseboard is separating in the upstairs hallway, game room and the primary bedroom. Seam tape failure was noted in the game room, downstairs bathroom, and the primary bedroom. A crack was noted where the wall and ceiling meet in the upstairs game room. A crack was noted in the garage wall. A crack was noted in the ceiling in the upstairs bathroom. Corrective Action: See Foundation comments above.</p> <p>Ceilings and Floors Problem: Grout is missing around the tiles in the downstairs bathroom. Corrective Action: Contractor to re-grout the tiles.</p> <p>Doors (Interior and Exterior) Problem: The doorstop is missing in the upstairs front bedroom. Corrective Action: Contractor to replace the doorstop.</p> <p>Windows Problem: Failed thermal seal window(s) (fogged glass) were observed at the small upper windows in the primary bedroom, the window over the front door, dining room, upstairs back bedroom, back left upstairs bedroom, Jack and Jill bathroom, upstairs front bedroom, and game room. Cracks / separations were observed in the window framing on the upstairs front bedroom window and the primary bedroom window. Corrective Action: Window contractor to assess all windows to confirm and replace all failed thermal seal windows and repair / replace the window framing as needed. Cost to be determined at the time of repairs.</p> |

Crack in Patio

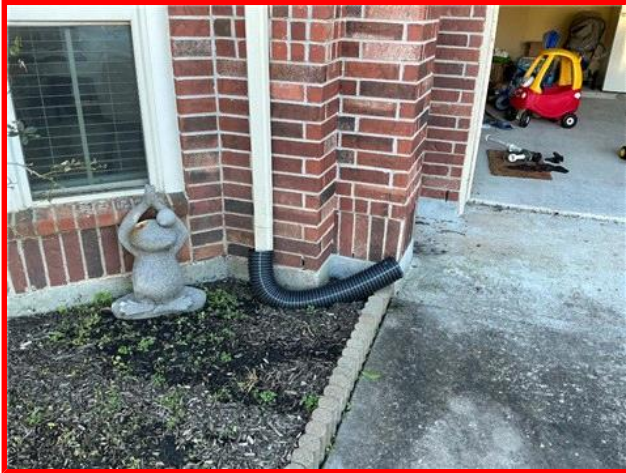
Improper Downspout Discharge

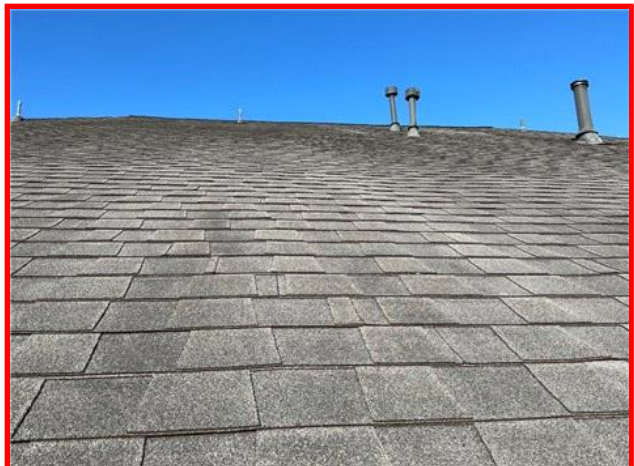
Roof - Granular Loss

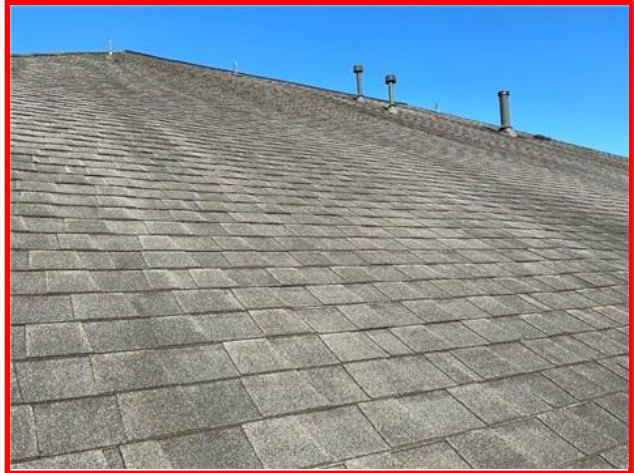
Roof - Granular Loss

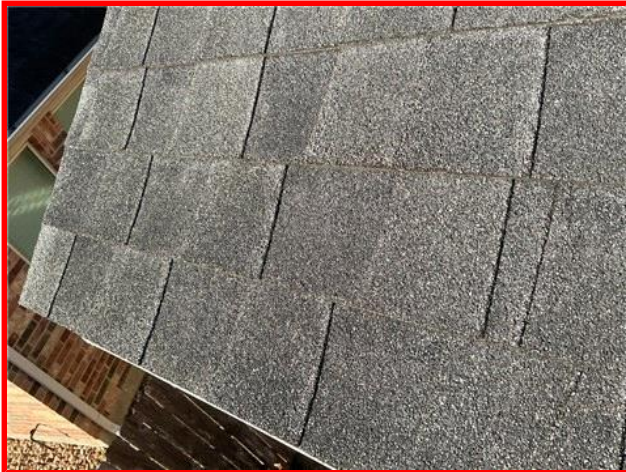
Roof - Granular Loss

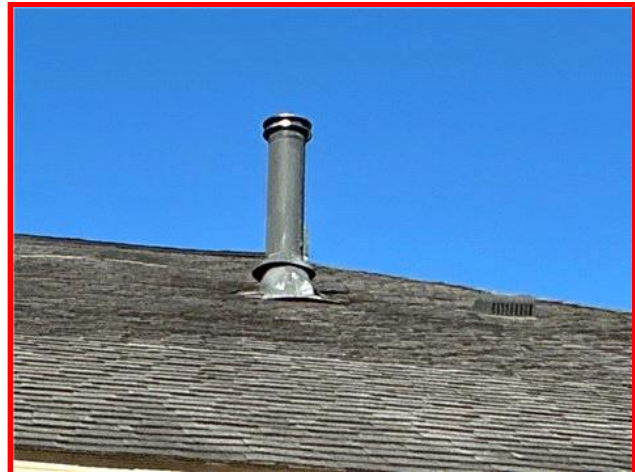
Lifted Chimney Boot

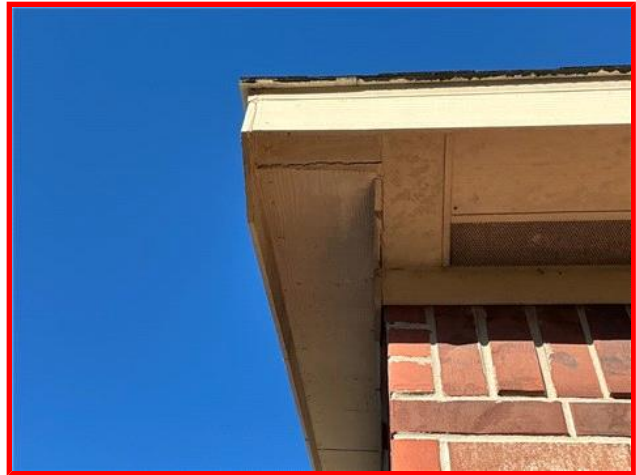
Soffit Separation at Left

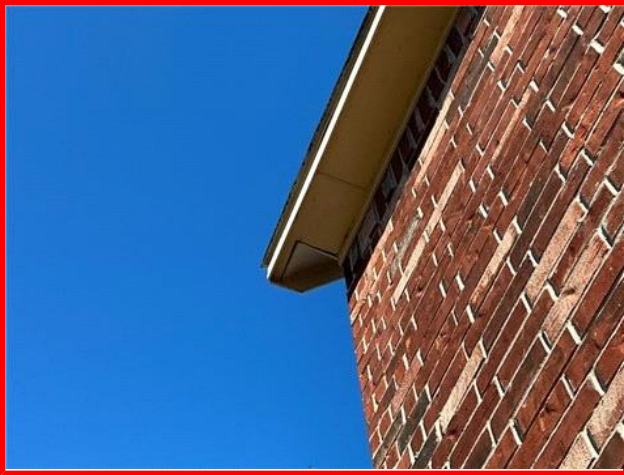
Soffit Separation at Right

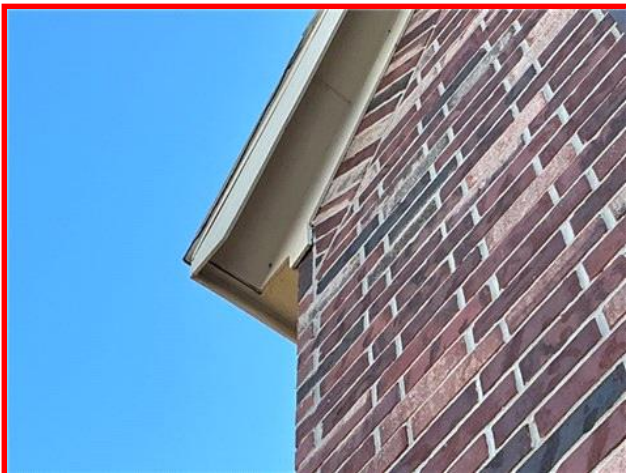
Soffit & Frieze Board Separation

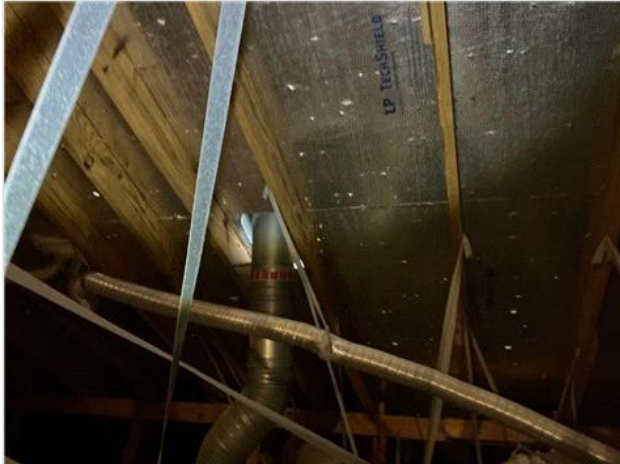
Chimney Not Sealed Properly

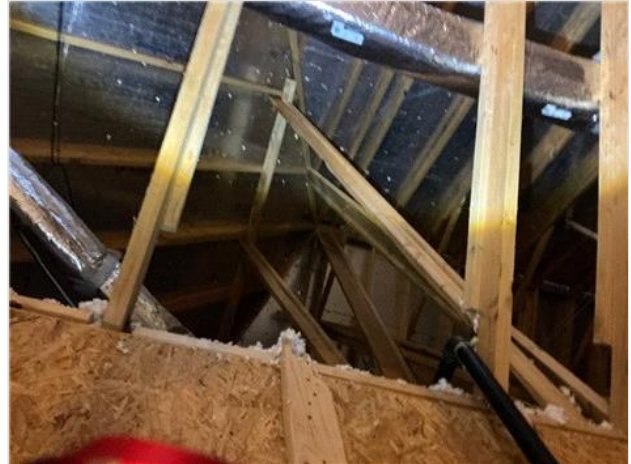
Broken Framing Member in Attic

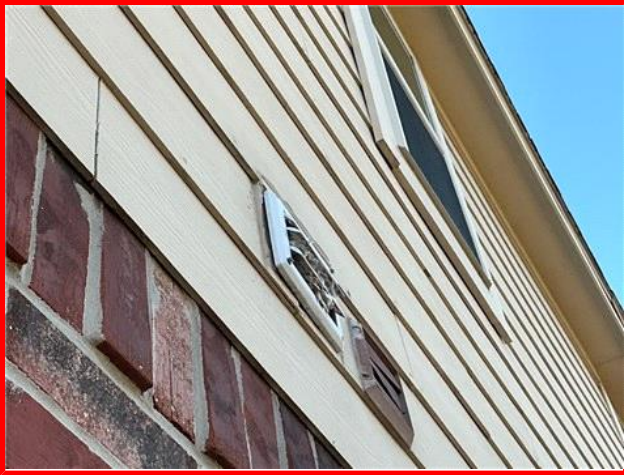
| Section | Remarks |
|---|---|
| Structural Systems | <p>Other Problem: The vent covers are damaged on the left side. There is a vent on the left side that is not sealed and has debris in it. Corrective Action: Contractor to repair / replace and clean the vents / covers.</p> <p>Exterior Surfaces Problem: The freeze board is separating on the front. The soffit is separating on the left side and the front. The fascia board is separating on the right and left sides. A crack was observed in the mortar at the left. The expansion joints on the right and left sides are missing the mortar. Siding separation was noted on the right and the left sides. The trim is separating around the window on the right side. There is a crack in the brick on the right side. Damaged brick was observed by the garage. There is a trim board separation on the left side. A gap was observed in the trim around the garage. Voids were observed in the mortar at the rear. The front left lintel over the window is rusting and separating. The mortar is separating and missing around the front window. The brick by the garage has the lintel coming through it. The trim around the garage is deteriorating and separating. The lintel over the garage is rusted. Corrective Action: See Foundation comments above.</p> |

Vent Not Sealed

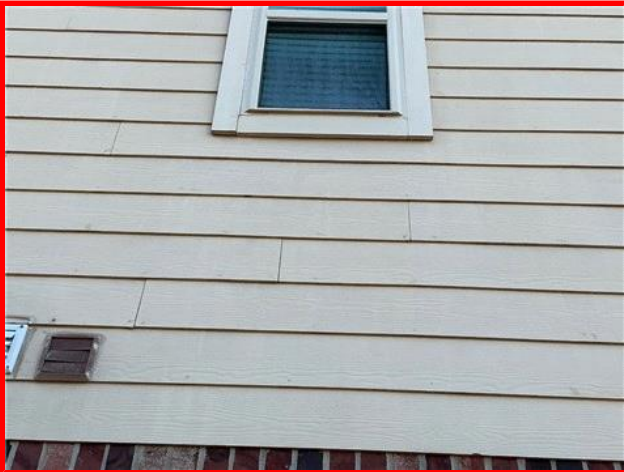
Siding Separation at Left

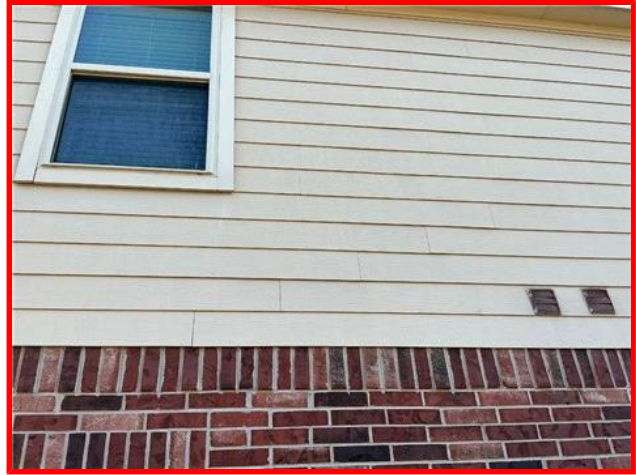
Siding Separation at Left

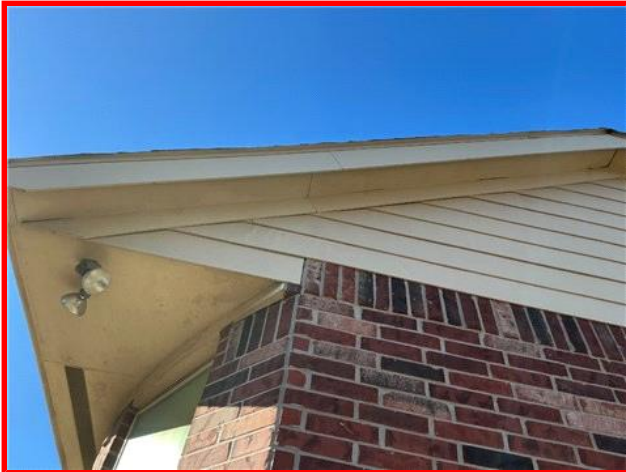
Fascia Separation at Left

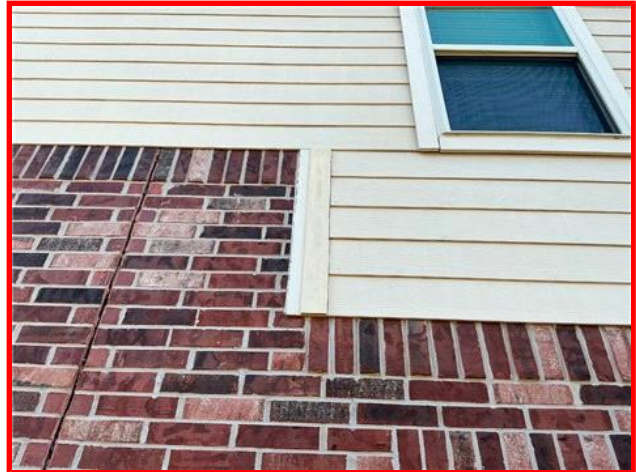
Trim Separation at Left

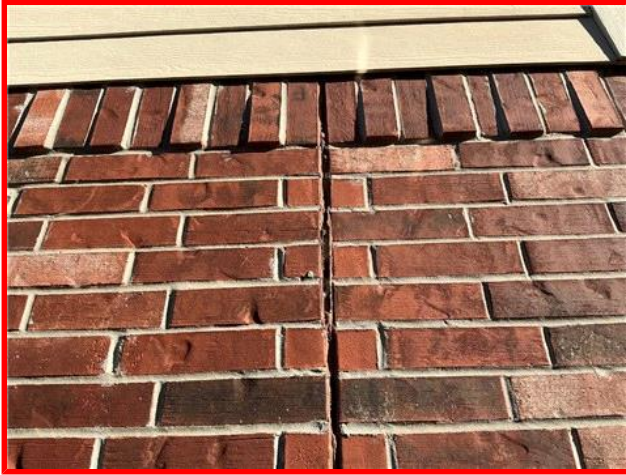
Missing Mortar at Right Expansion Joint

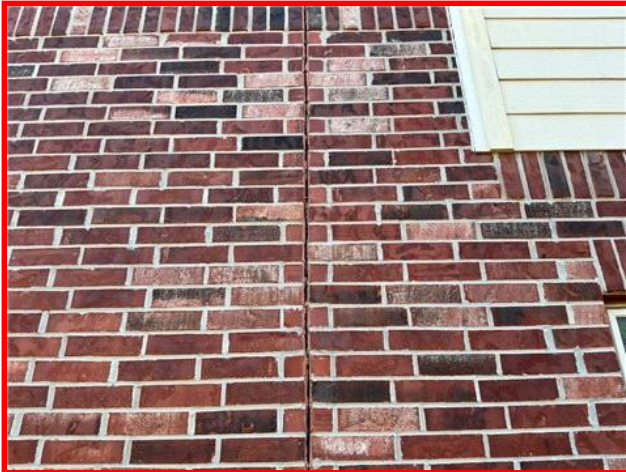
Missing Mortar at Right Expansion Joint

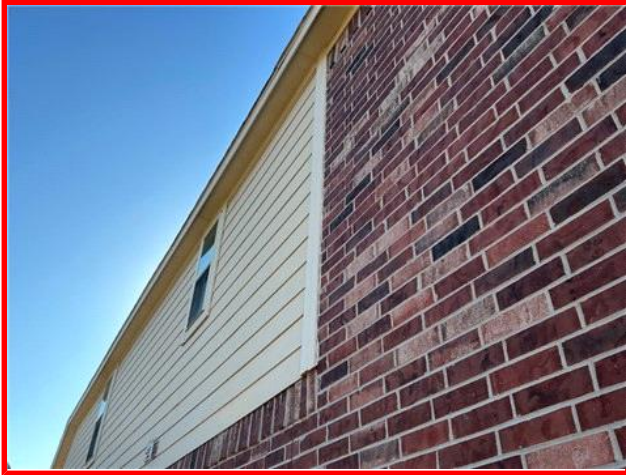
Trim Separation at Left

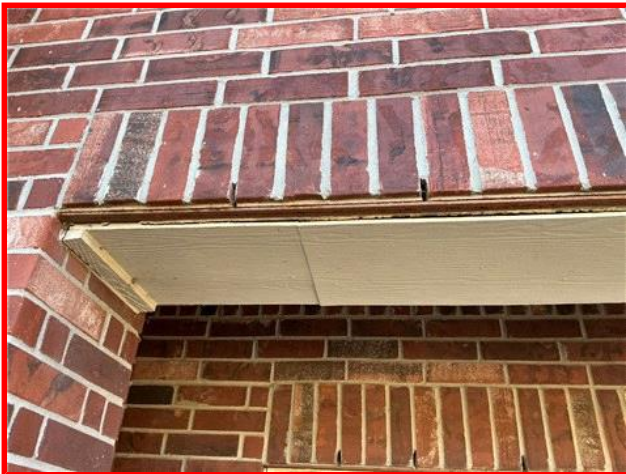
Rusted Lintel & Gap in Trim

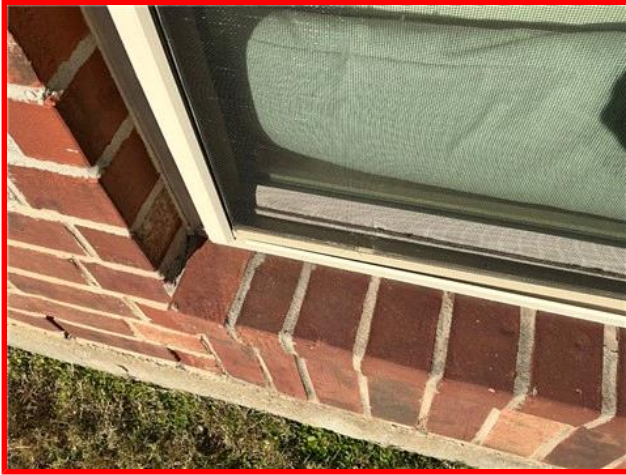
Crack in Mortar at Rear

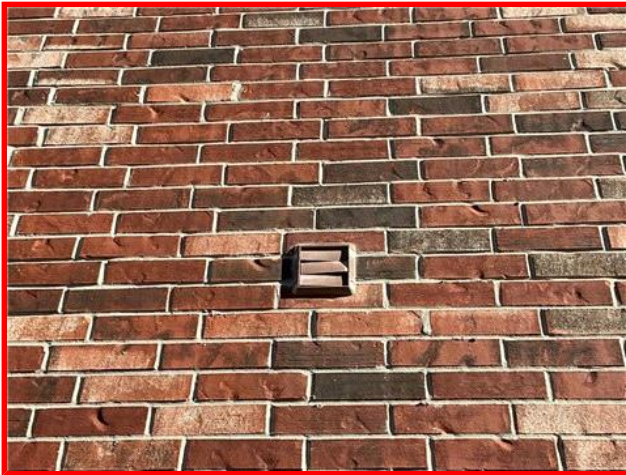
Damaged Vent Cover at Right

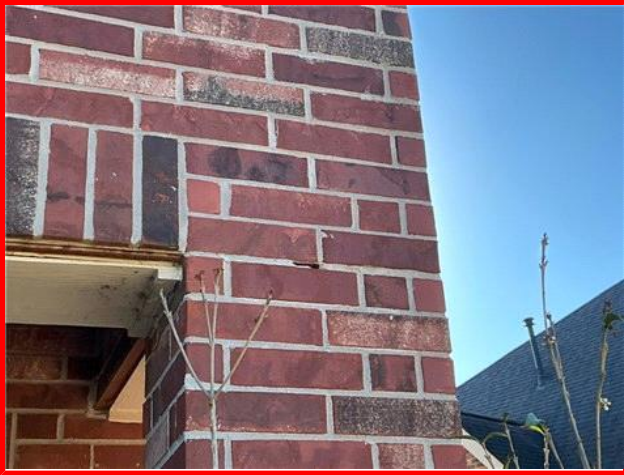
Lintel Exposed Through Wall at Garage

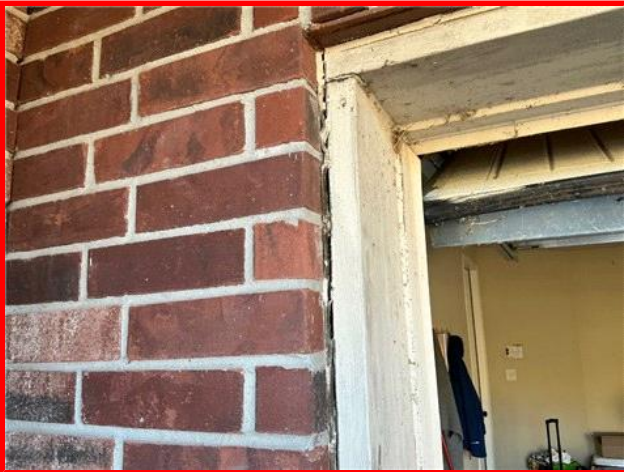
Garage Trim Separation

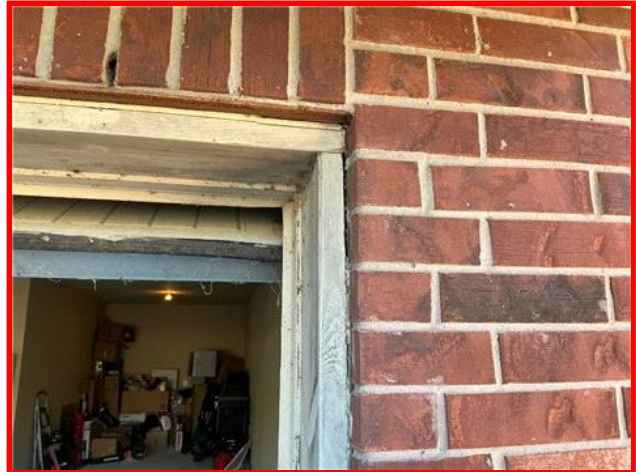
Garage Trim Separation

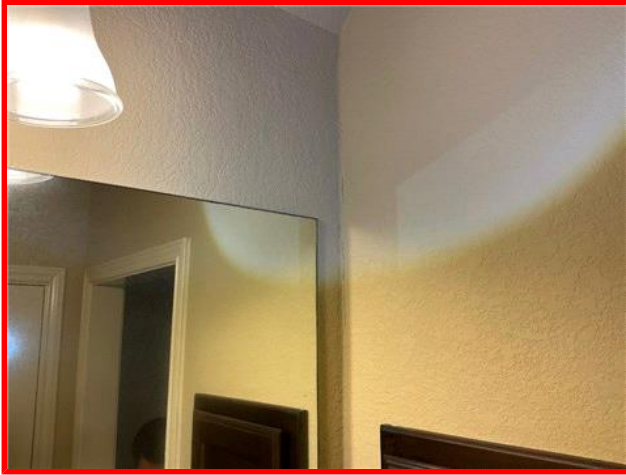
Corner Crack at Jack and Jill Bathroom

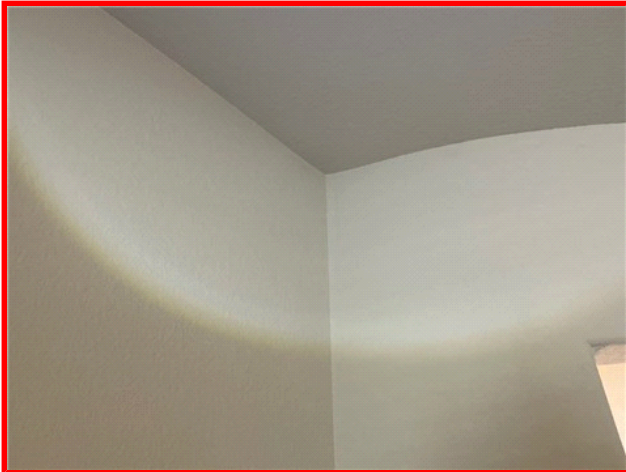
Seam Tape Failure in Game Room

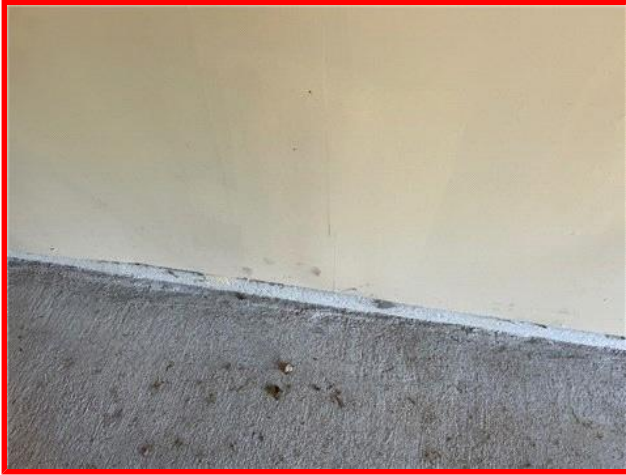
Crack in Garage Wall

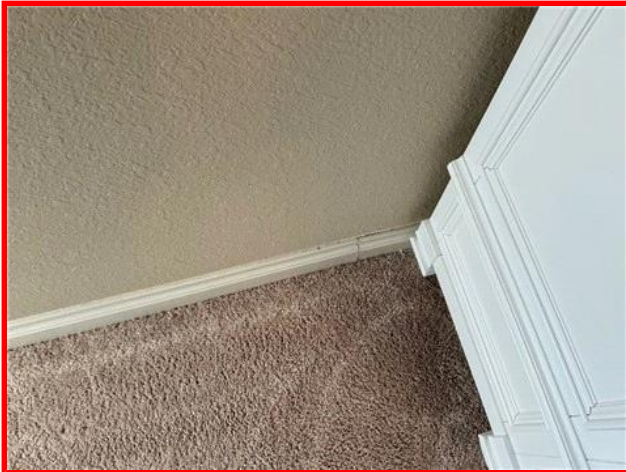
Baseboard Separation in Primary Bedroom

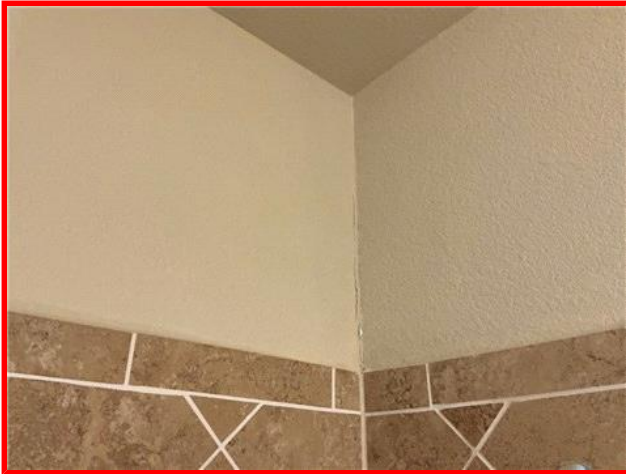
Wall Separation in Downstairs Bathroom

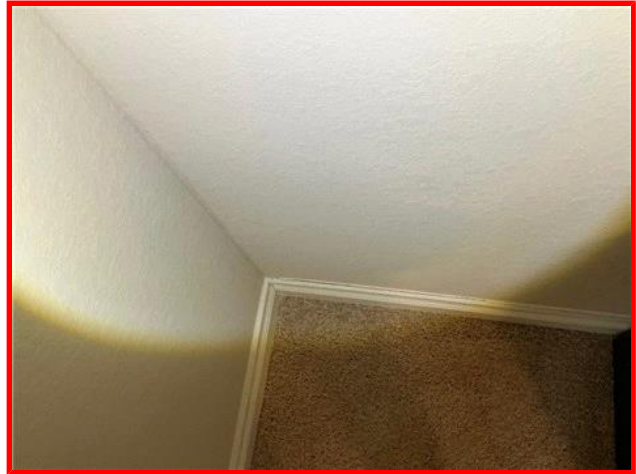
Baseboard Separation in Upstairs Game Room

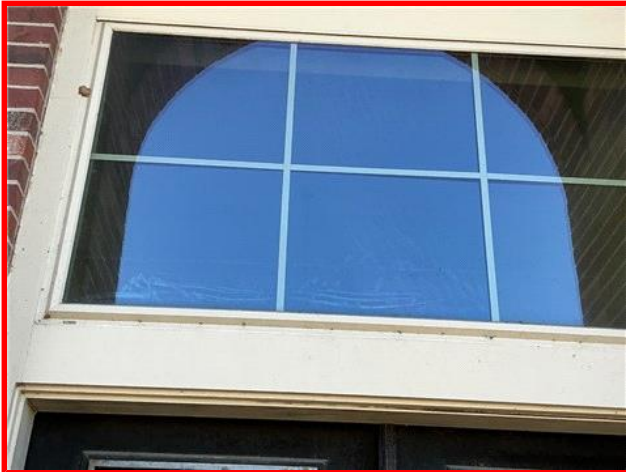
Failed Thermal Seal at Over Front Door

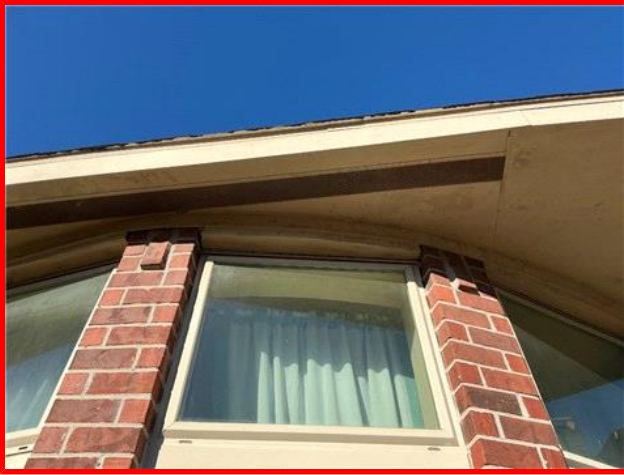
Failed Thermal Seal at Primary Bedroom

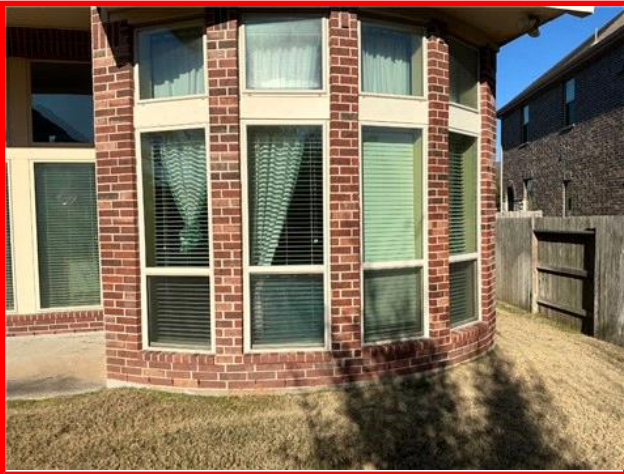
Failed Thermal Seal at Primary Bedroom

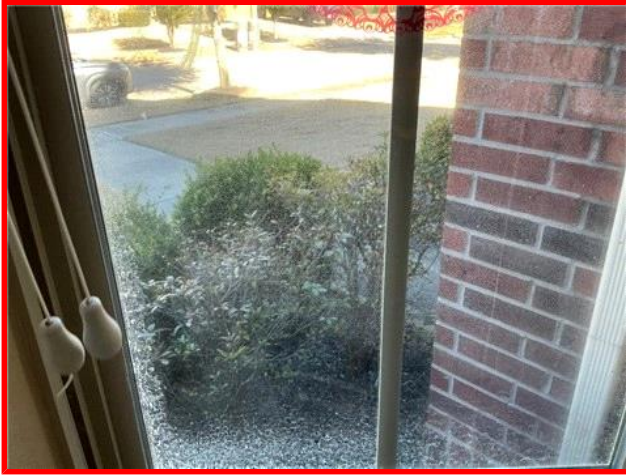
Failed Thermal Seal at Dining Room

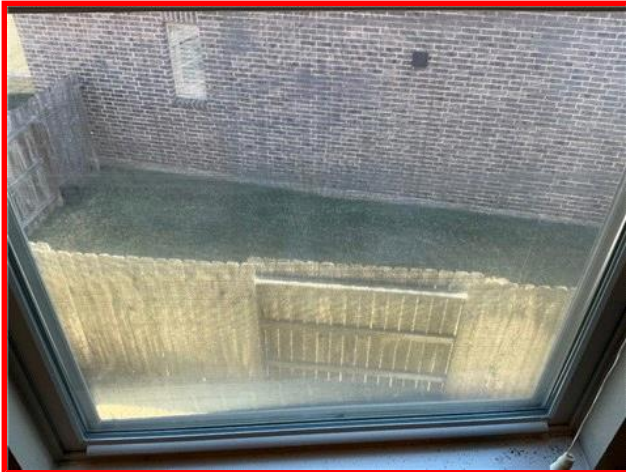
Failed Thermal Seal at Left Upstairs Bedroom

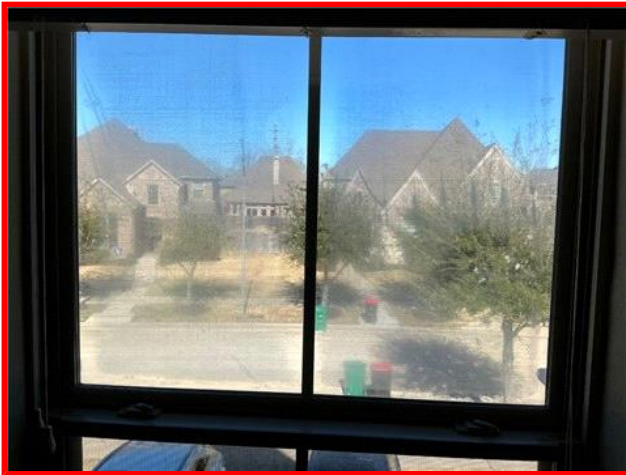
Failed Thermal Seal at Upstairs Front Bedroom

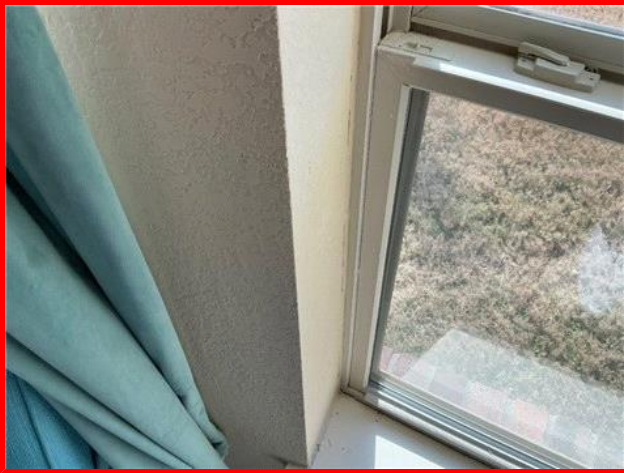
Separation / Cracks at Window Framing in Primary Bedroom

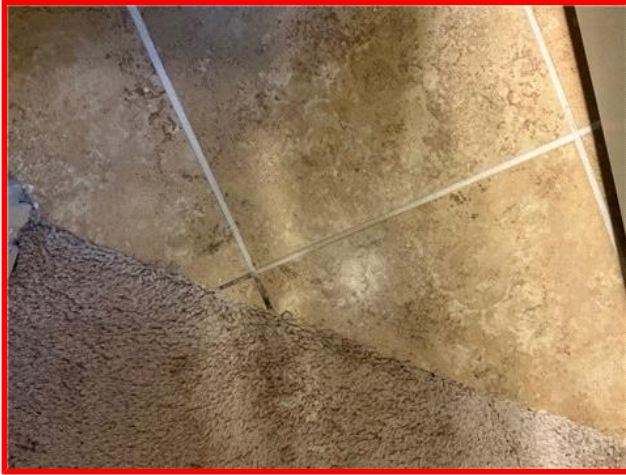
Missing Grout in Downstairs Bathroom Floor

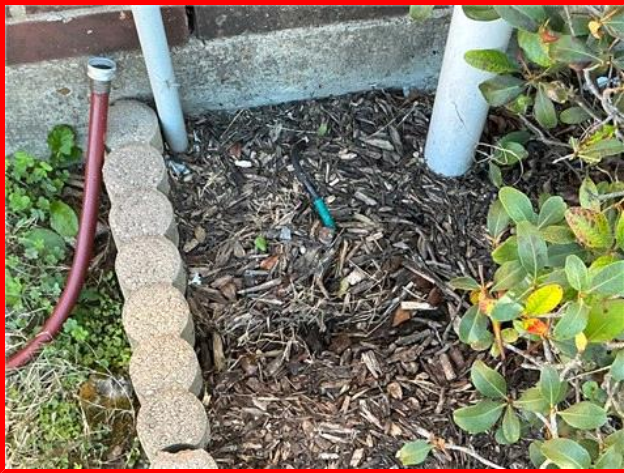
Grounding Rod Too Deep

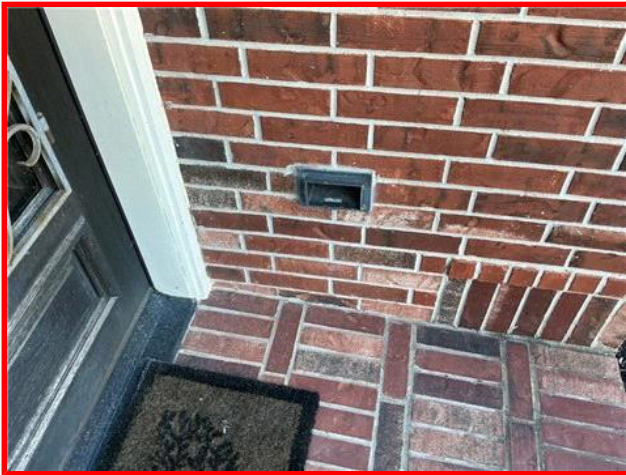
Missing Exterior Outlet Cover

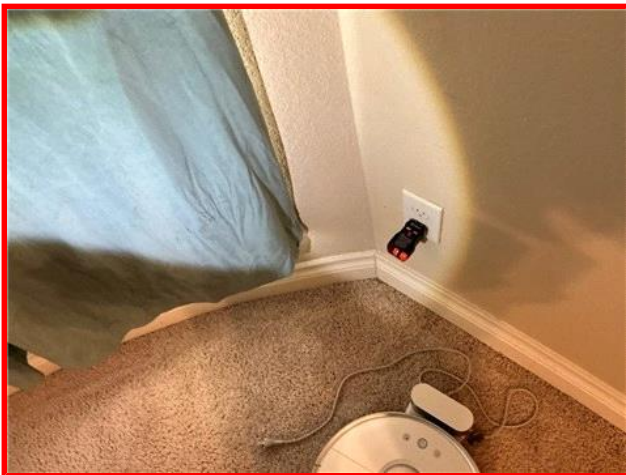
Loose Outlet in Primary Bedroom

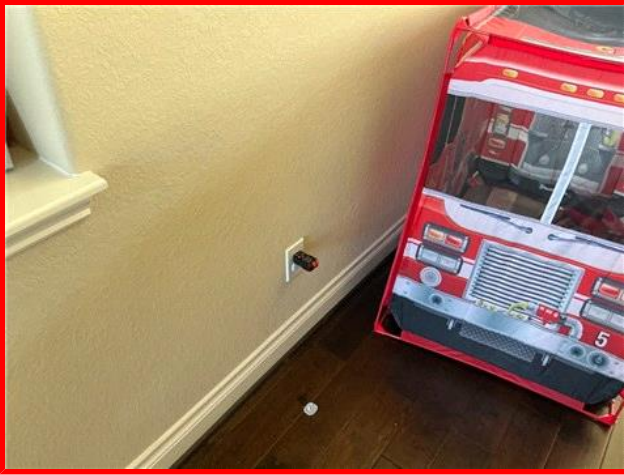
Loose Outlet in Foyer

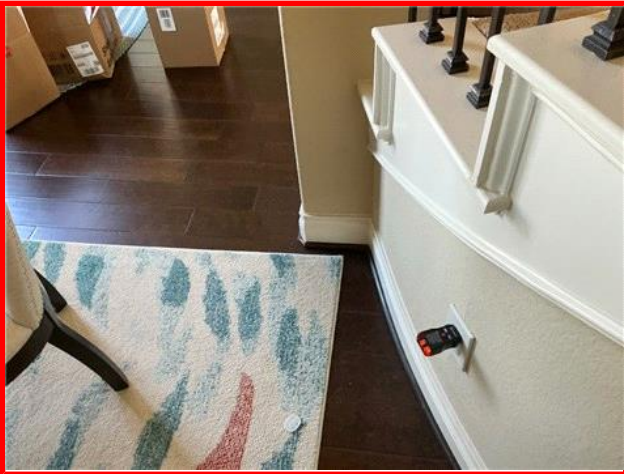
Loose Outlet in Dining Room

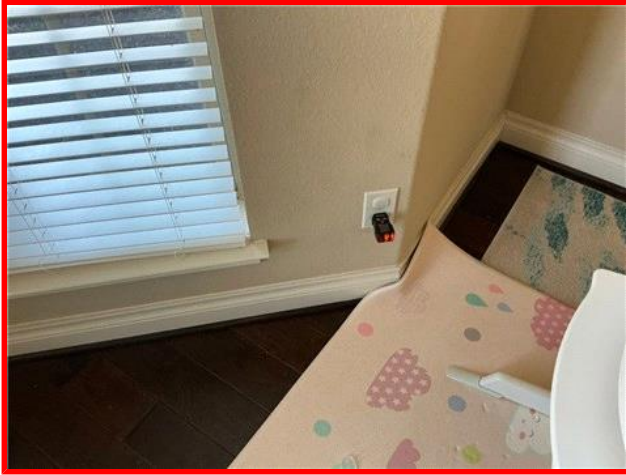
Loose Outlet in Dining Room

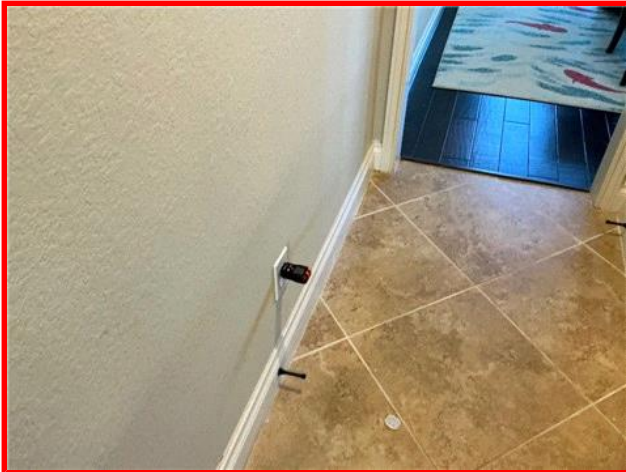
Loose Outlet in Half Bathroom

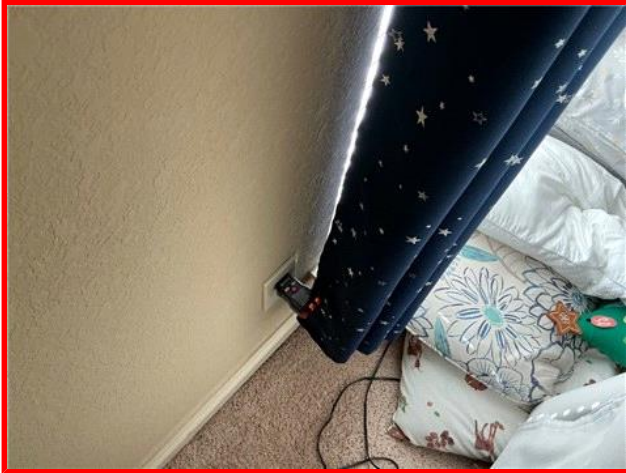
Loose Outlet in Downstairs Bedroom

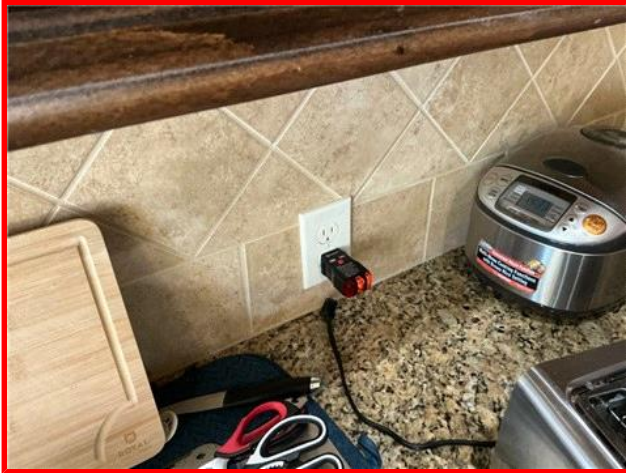
Loose Outlet in Kitchen

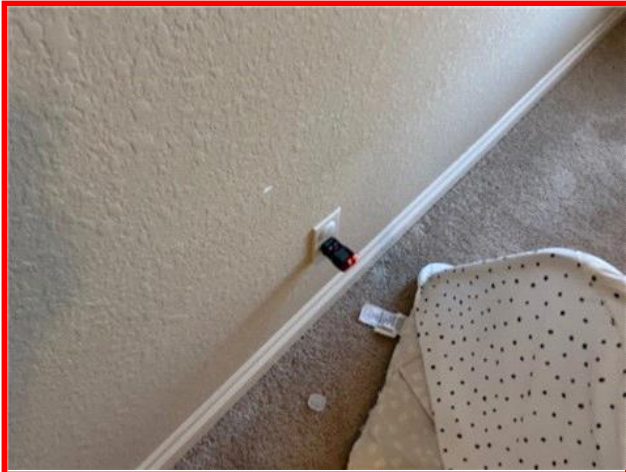
Loose Outlet in Upstairs Front Bedroom

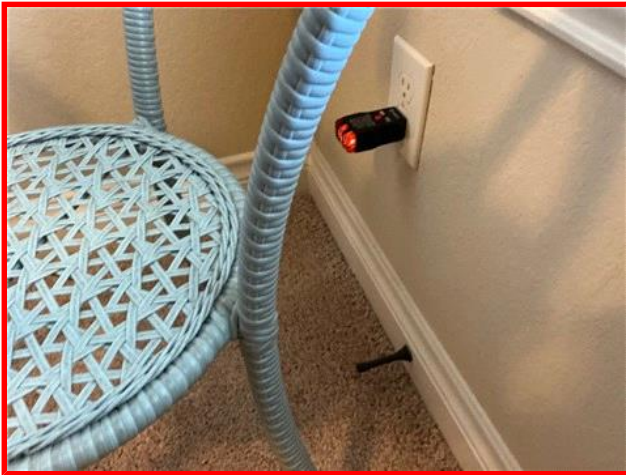
Loose Outlet in Upstairs Back Bedroom

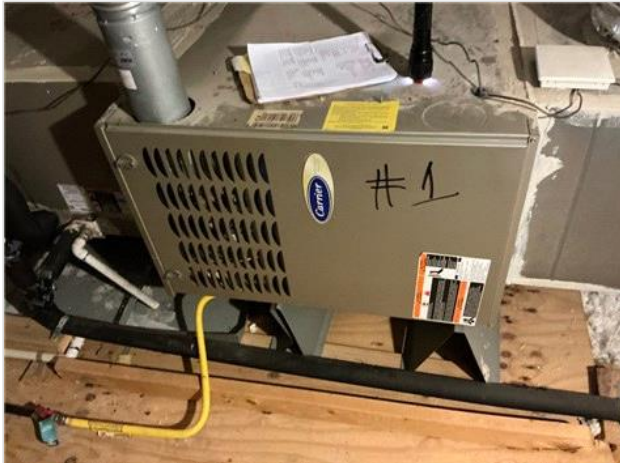
Heating Equipment Cover Not Removed

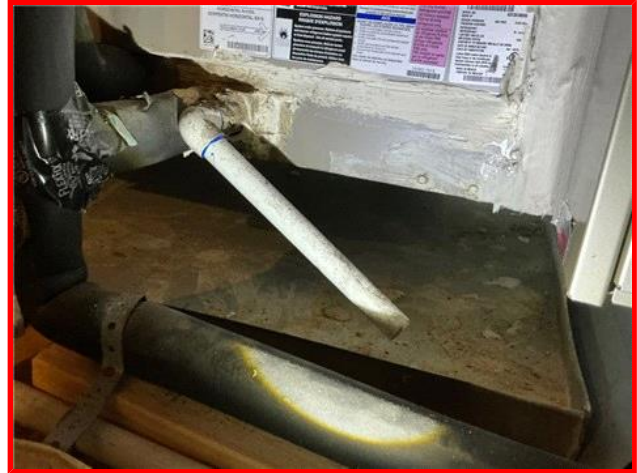
Drip Pan Not Properly Sloped

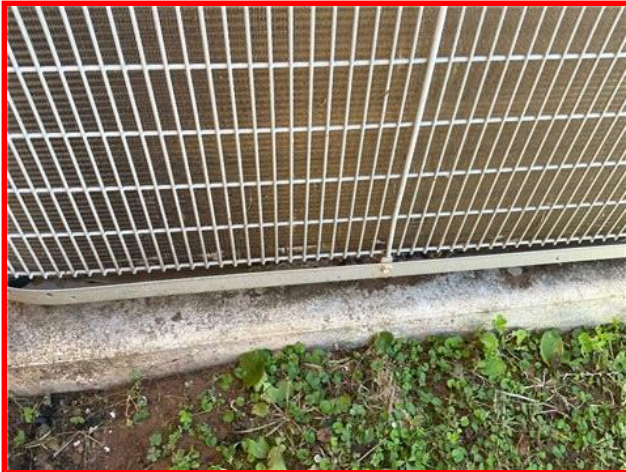
Damaged Coils at A/C Unit

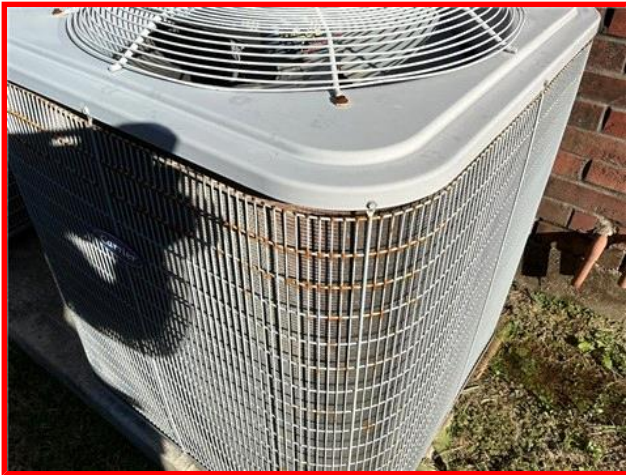
Rust at A/C Housing

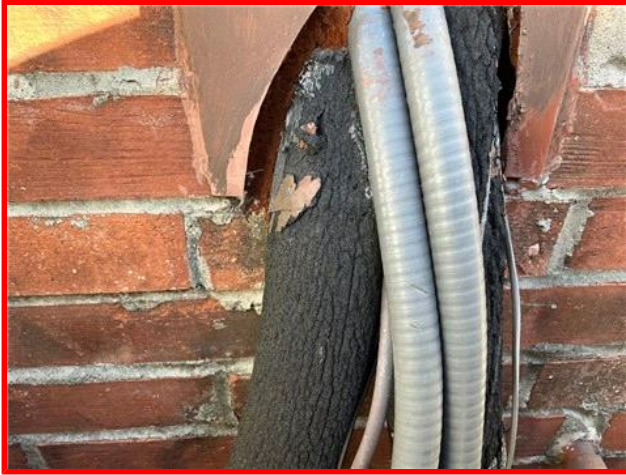
Deteriorated Refrigerant Line Insulation

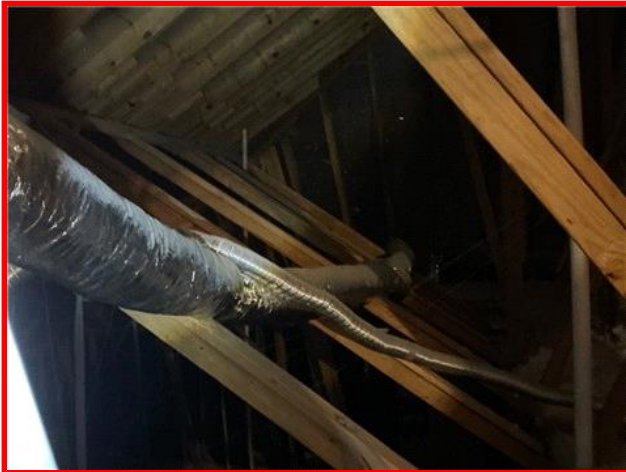
Exhaust Vent Pipes in Contact with Ducts

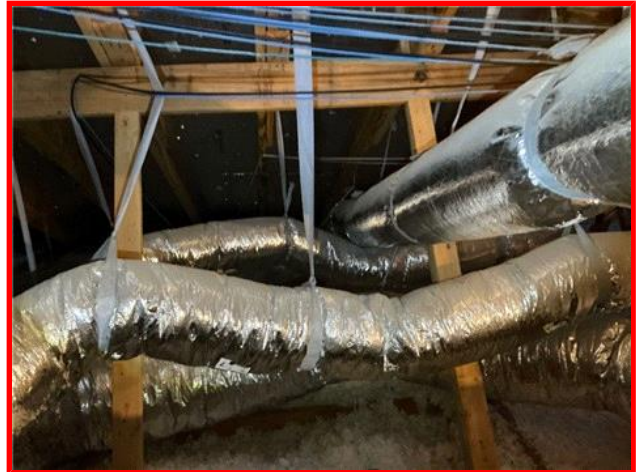
Ducts in Contact

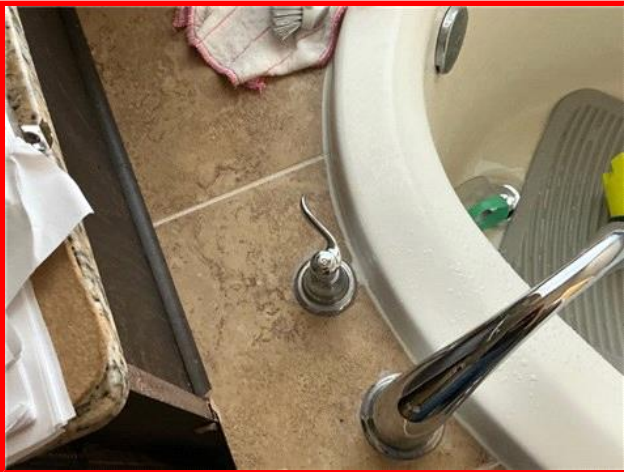
Loose Handle at Primary Bathroom Tub

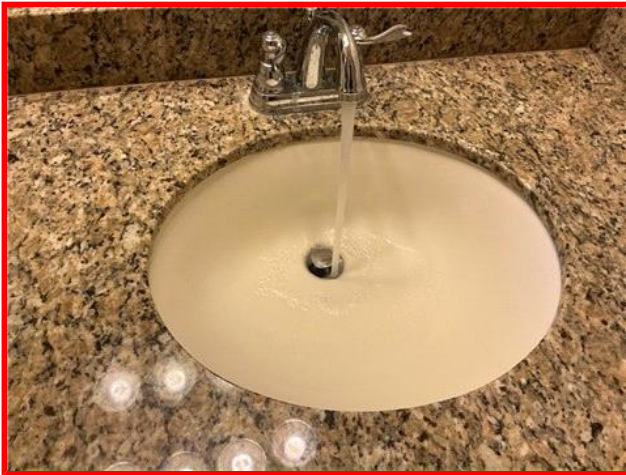
Stopper Does Not Engage in Jack and Jill Bathroom

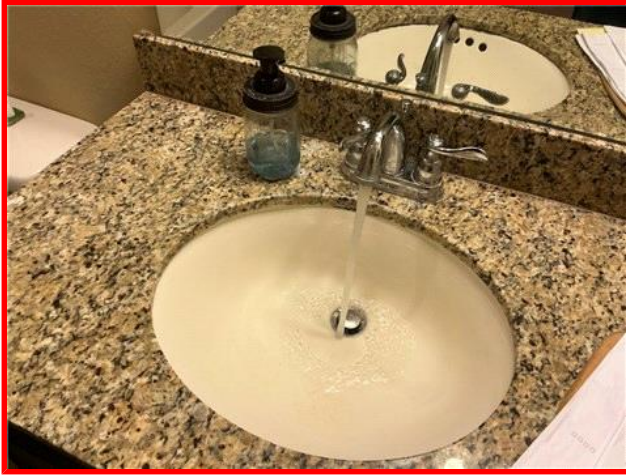
Stopper Does Not Engage in Upstairs Bathroom

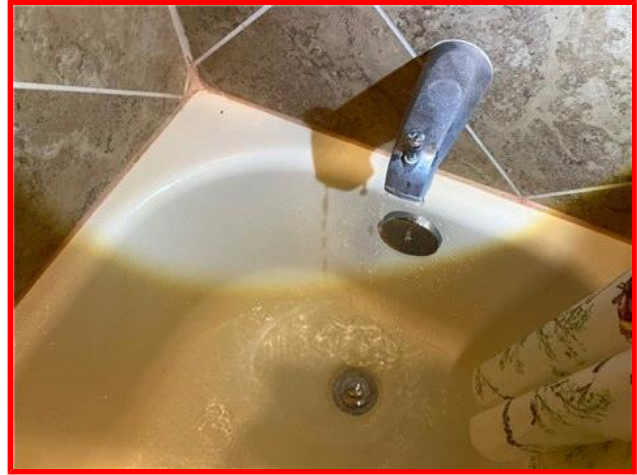
Upstairs Bathroom Diverter Does Not Function Properly

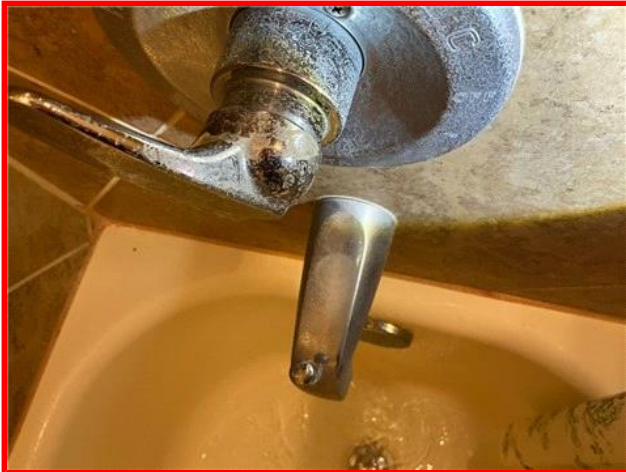
Missing Caulk at Tub Faucet

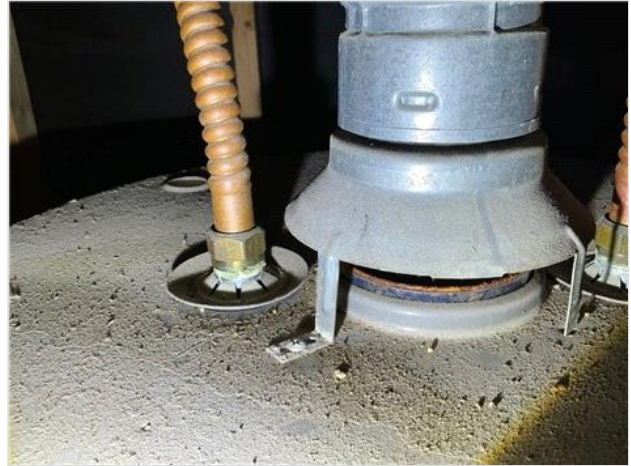
Rust beginning at Water Heater

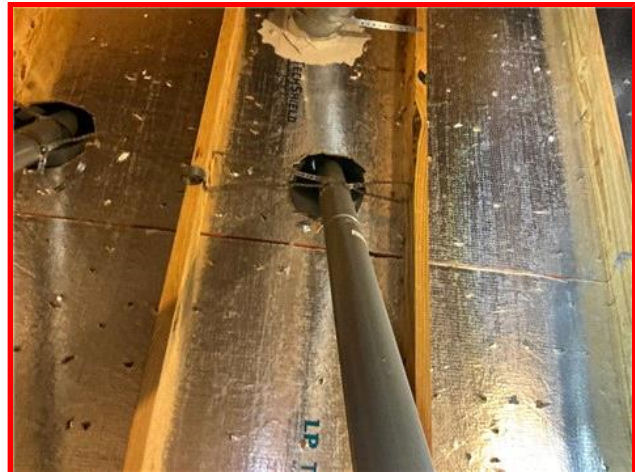
Light Coming Through at Water Heater Vent

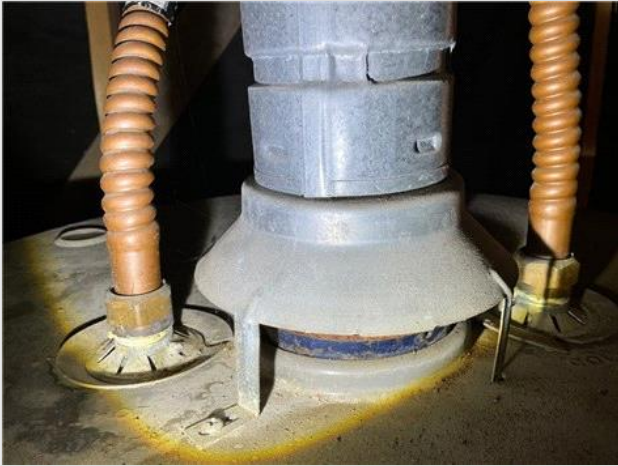
Rust beginning at Water Heater

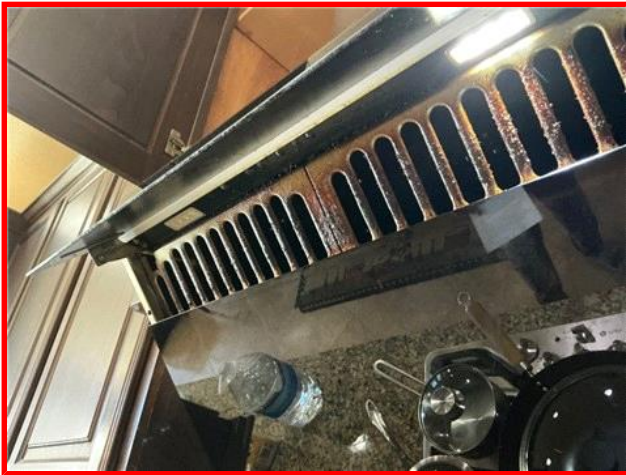
Dirty Range Vent
