## **INSPECTION REPORT**

**533A-M5SW  
Ebraheem Hamed  
5515 E Terrace Gable Cir  
Katy, TX 77494**

# PROPERTY INSPECTION REPORT FORM

5515 E Terrace Gable Cir, Katy, TX 77494

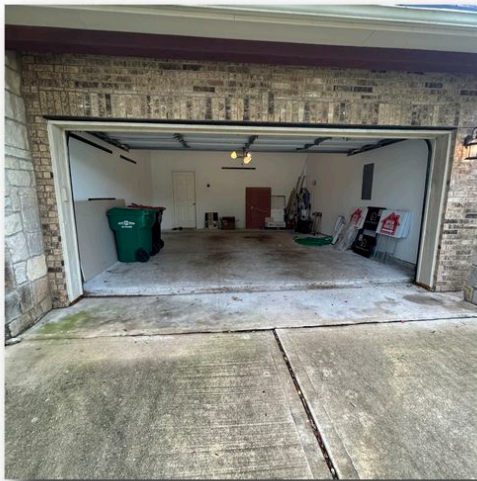
The overhead garage door operated as intended and was in serviceable condition at the time of our inspection.

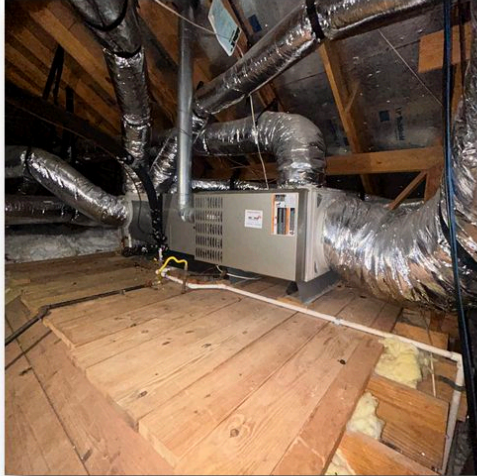
Location: downstairs Type: Zoned Forced Air.  
Energy Source: Gas.  
Furnace information:  
Manufacturer:Carrier. Age: 10.  
Model number: 58STA070-13112  
Serial number: 1507A15917  
Filter location:Return air grills.

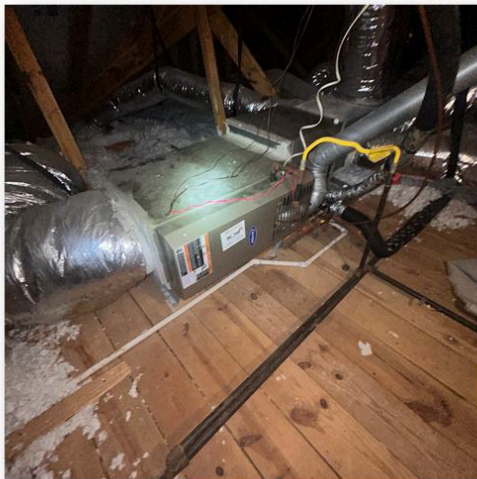
The furnace(s) operated as intended and all visible components were in serviceable condition at the time of our inspection.

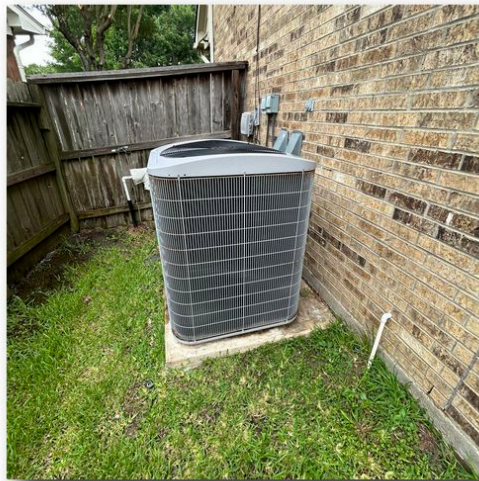
Upstairs unit:

The return air temperature was 72°F and the supply air temperature was 52°F, giving a temperature differential of 20°F, which was within a serviceable range.

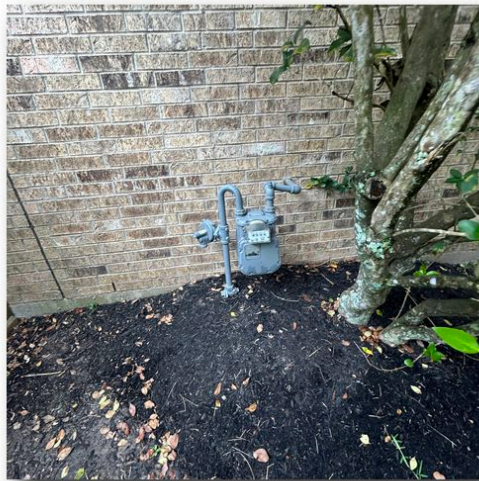
Type of piping used: Black iron  
Location of gas meter North exterior.

All visible components were in serviceable condition at the time of our inspection.
